Archaeological Services & Consultancy Ltd

HISTORIC BUILDING RECORDING: CHURCH HALL FARM BARN BROXTED ESSEX

July 2013

ASC: 1601/BCE/2

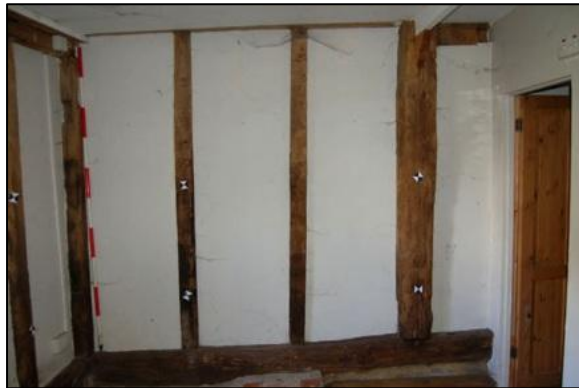
Plate 9: Bay 1, north elevation, looking north

timber boards (Plate 8). At ground floor level four timbers are visible in the north wall of Bay 1, the westernmost of which has three empty mortice holes (Plate 9). These timbers sit on a 0.16m deep sole plate, which in turn sits on a 0.08m deep brick plinth, partially covered by concrete. Original timber framing is also visible in the west wall, although a modern timber window has been inserted into the centre of the bay (Plate 10). The sole plate and brick plinth are as previously described. No further timber framing was visible in the bay, and the eastern side was inaccessible at the time of the fieldwork.

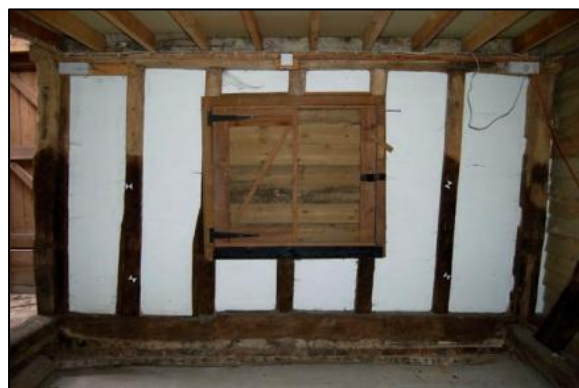
Plate 11: Bay 2, west elevation, looking west

The western elevation of Bay 2 (Plate 11) contained all original timbers, with the northernmost principal post containing three complete empty mortices, and one possible partial empty mortice that was truncated by the wall plate. The southern principal post has one large empty mortice close to its top. The eastern elevation retains four original posts (Plate 12), and the northern principal post, although this is largely obscured by plaster. There is a modern timber window to the north, which cuts two of the remaining posts, and a modern stable door with a three course brick step in front of it to the south. There is an edge halved scarf joint in the sole plate, beneath the window.

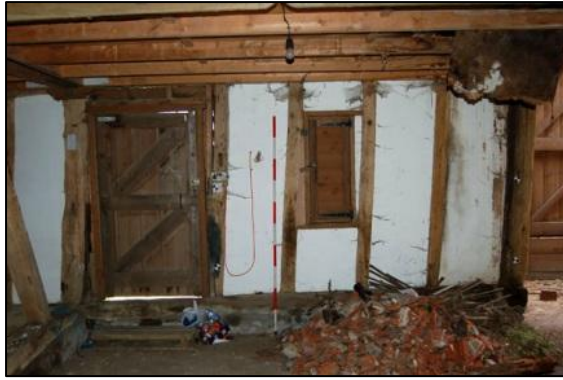
Plate 19: Bay 4, west elevation, looking west

The west elevation of Bay 4 has original studs and principal posts, with a modern door inserted to the south and a modern window in the centre (Plate 19). Below these the sole plate measures 0.16m, beneath which is a layer of concrete, possibly concealing a brick dwarf wall. The wall plate is obscured by the insertion of a modern floor. The east elevation of this bay also has original studs and principal posts (Plate 20). From north to south, the first, third and sixth studs have seatings for braces. The sole plate measures 0.17m, and sits on a concrete layer, as in the west elevation. The wall plate consists of a re-used timber with several empty mortices along its underside. There are two modern square windows inserted into this elevation.

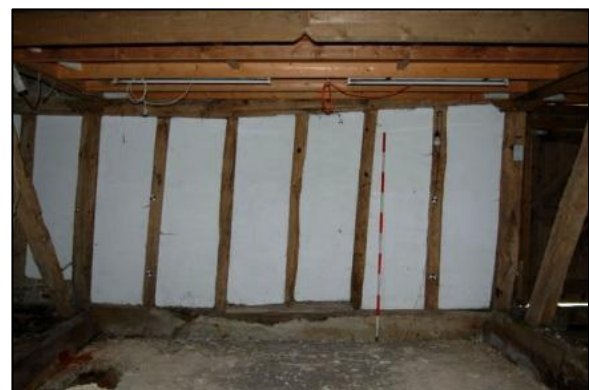
Plate 24: Bay 5, west elevation, looking west

The west elevation of Bay 5 comprises original timbers, with no modern insertions of doors or windows (Plate 24). The sole plate and the wall below are largely obscured

by concrete render. The wall plate is largely obscured by the inserted floor mentioned in Bay 4, but a scarf joint is partially visible behind a wooden brace attached across the centre of the wall plate. The east elevation of this bay comprises original timbers, and again has no inserted modern openings (Plate 25). Several of the studs show signs of re-use with notches cut into them, and the southernmost principal post has an empty seating for a brace close to its base. Both the sole plate and wall plate have scarf joints at their northern ends, and the wall plate has an iron tie reinforcing the two pieces of wood. One course of the brick dwarf wall is visible below the sole plate.

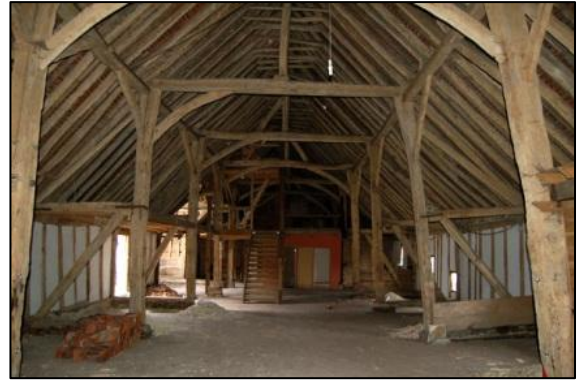
Plate 26: Truss 5, looking north

Unlike the previous trusses, Truss 5 has no brace to the tie beam, and no obvious fittings to imply a brace has been removed (Plate 26). The eastern arcade post has a sloping jowl, while the western arcade post has only a very slight jowl. There is a concave brace to the west. The western aisle elevation has a sole plate and brick dwarf wall that extend to the western arcade post (Plate 27). Above this is a diagonal brace. The mid rail is attached to the arcade post and the wall of the barn by iron ties. There is also an empty notch in the southern face of the mid rail. There is an offset rafter reaching from the midrail to the arcade post. The eastern aisle elevation also has a sole plate and brick dwarf wall that extend to the eastern arcade post (Plate 28). A test pit has been excavated in to the floor of the barn to the north of this elevation, showing that the wall extends at least three further courses of brick below the current floor level. There is a large mortice visible in the northern face of the sole plate. This side also has a diagonal brace, and two courses of weatherboarding. The brace is jointed to the midrail with an oblique mortice and tenon joint, with extra support provided by a 'jowl', presumably to try to counteract sideways motion. There is an offset rafter reaching from the midrail to the arcade post.

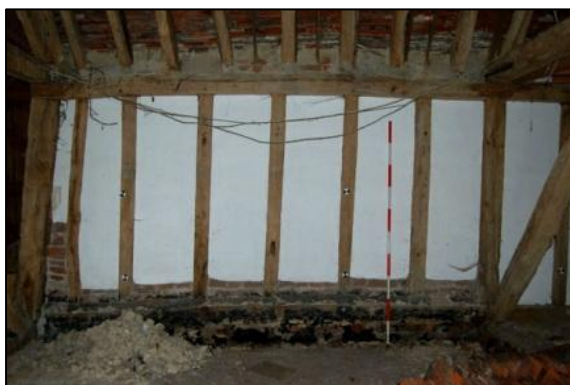
Plate 29: Bay 6, west elevation, looking west

The western elevation of Bay 6 is constructed of original timbers, with no modern insertions of doors or windows (Plate 29). The sole plate is largely obscured by concrete render, as is the majority of the brick wall below. In this elevation there are two courses of bricks above the sole plate, apart from at the southern end where there are at least six bricks between the southernmost stud and the principal post. The eastern elevation is constructed in original timbers, with some modern supports obscuring the original studs (Plate 30). There is a modern window inserted in the centre of the bay, behind the central stud, with modern timbers filling the gaps left between the edge of the window and the studs either side. There is a modern timber nailed to the stud to the north of the window which reaches the floor below the sole plate and the brick dwarf wall. The lower part of this elevation between the studs is infilled with brick, set in no particular bond. There is a joint in the wall plate between the third and fourth studs from the north. Unlike in previous bays, the sole plate for the eastern aisle in Truss 6 is not directly beneath the southern principal post.

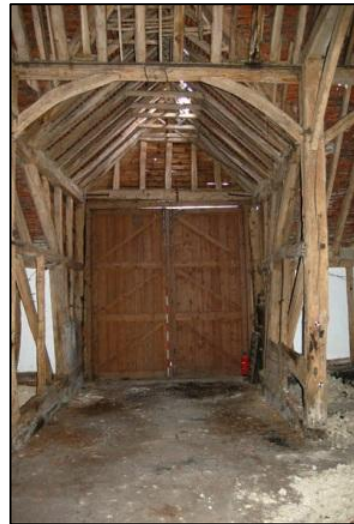
Plate 34: Bay 7, midstrey, looking west

This bay contains the second midstrey within the barn. The western elevation in this bay is dominated by a set of modern double doors, which presumably replace an earlier set of doors (Plate 34). Above the doors is a gap, caused by the list of the barn compared to the relatively straight angles of the modern door. This gap decreases in size from south to north, and is infilled by modern timber and occasional pieces of tile. Either side of the doors are the original principal posts. Both are partially obscured by the adjacent north and south elevations, but some evidence of possible re-use can be found on the south post, which a notch cut into its north face *c.*1.9m up from the ground. Above the inserted doors, the tie beam, studs and collar beam are original. The tie beam is reinforced at both ends by iron ties, and there is an iron chain around the tie beam. The eastern elevation in this bay contains a modern plank and baton door to the south, and a modern window to the north (Plate 35). There are two exposed original timbers close to the window, and one horizontal timber between the door and the window. The rest of the elevation is covered by plaster, apart from a small area of exposed brick to the south of the window. The sole plate has been cut to house the inserted door, and is obscured by a modern timber. The wall plate is visible over the door, but is obscured in the rest of the elevation by an inserted internal roof.

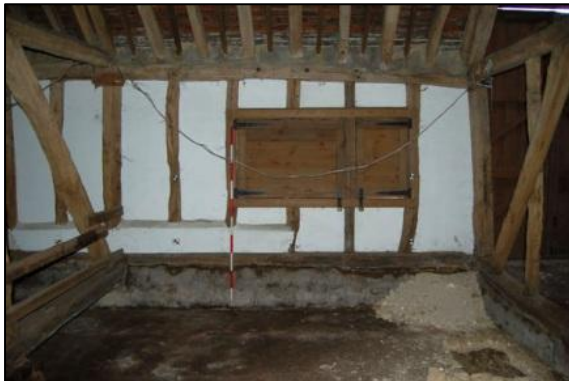
Plate 39: Bay 8, west elevation, looking west

The western elevation of Bay 8 comprises mostly original studs and principal posts, with two modern windows with wooden shutters inserted at its northern end (Plate

39). The second stud from the north is a replacement, presumably put in at the same time as the windows. The windows cut four of the five studs in the elevation. There is a joint in the wall plate above the second stud from the south which is obscured by a wooden tie, attached to the wall plate by wooden pegs. The gaps between the studs are filled with plaster, and there is a c.0.15m plaster ledge stretching from the middle stud into Bay 9 to the south. The sole plate is partially obscured by concrete render, while the dwarf wall is not visible at all. The eastern elevation retains all its original timbers (Plate 40). The northern and southern studs both contain empty brace seatings. There is a modern window with wooden shutters inserted into the centre of the elevation, cutting the middle three studs. There is a partially obscured joint, possibly an edge halved scarf joint, in the sole plate between the first and second studs from the north, and a further joint, again possibly an edge halved scarf joint, in the wall plate between the northern principal post and the first stud. There is a plaster ledge similar to that discussed in the western elevation along the entire elevation, obscuring the lower parts of the second and third studs from the north. As with the western elevation, the sole plate is partially obscured by concrete render, while the dwarf wall is not visible at all.

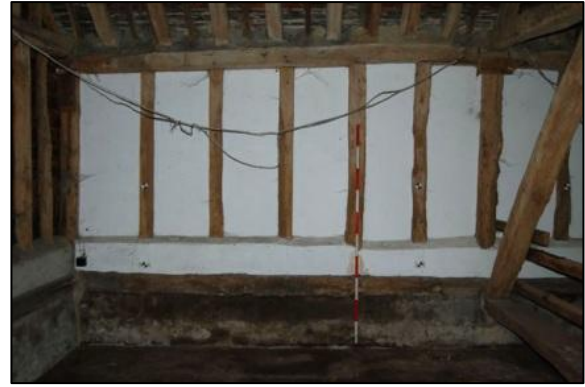
Plate 44: Bay 9, west elevation, looking west

The western elevation of Bay 9 comprises original timbers (Plate 44). There is a possible face halved scarf joint in the sole plate, just to the north of the northernmost stud. The plaster ridge noted in Bay 8, above, continues in this bay to the gable end, obscuring the lower part of each stud. The sole plate is partially obscured by concrete render, while the supporting wall is completely obscured. The eastern elevation comprises original timbers, with a modern window with wooden shutters inserted in the centre of the bay, cutting the three central studs (Plate 45). There is an empty brace seating at the base of the northern principal post, and another empty seating, possibly for a half lap joint, in the second stud from the north, directly below where the stud was cut to insert the modern window. The plaster ledge is present in this elevation too, obscuring the base of all the timbers, apart from the northern principal post and the northernmost stud. There are two empty mortices on the northern face of the southern principal post.

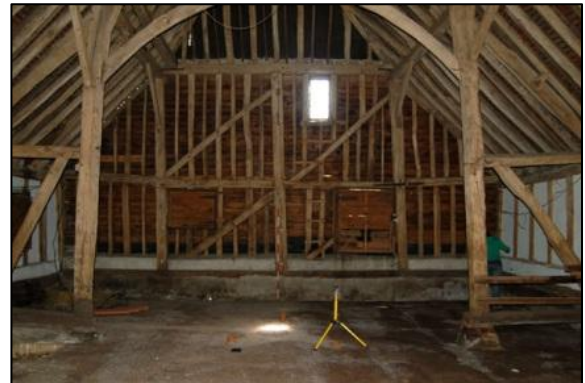
Plate 46: Southern gable end, looking south

The southern gable end contains a mixture of original and replacement timbers (Plate 46). There are three windows in this elevation, two below the mid rail and one above. The one above may be original, while the two below are modern insertions with wooden shutters. The east and west arcade posts have braces to their respective arcade posts in Truss 8. The central principal post has a corresponding empty mortice, and peg holes either side. Both arcade posts are tied to their respective midrails, on the eastern side by a wooden tie with pegs, and on the west by an iron tie. The central four sections of this elevation all have west to east down braces, although the brace in the lower west section has been cut by the insertion of the modern window. The brace in the lower east section has four empty mortices along its length. There is the suggestion of a ladder in the western sections of the elevation, to the east of the western window, and leading possibly into the section above and to the window there. The studs in this section of the elevation are misaligned and do not match above and below the brace, suggesting it has been rebuilt. The brick dwarf wall is covered by concrete render, which also partially obscures the sole plate. The extra timber noted in Truss 8 is attached to the top of the midrail by a single notched joint, which is reinforced by an iron tie (Plate 47).
