HISTORIC BUILDING RECORDING ALL SAINT'S CHURCH CROYDON CAMBRIDGESHIRE

on behalf of Croydon Parish Council

September 2005

ASC: 707/CAS/1

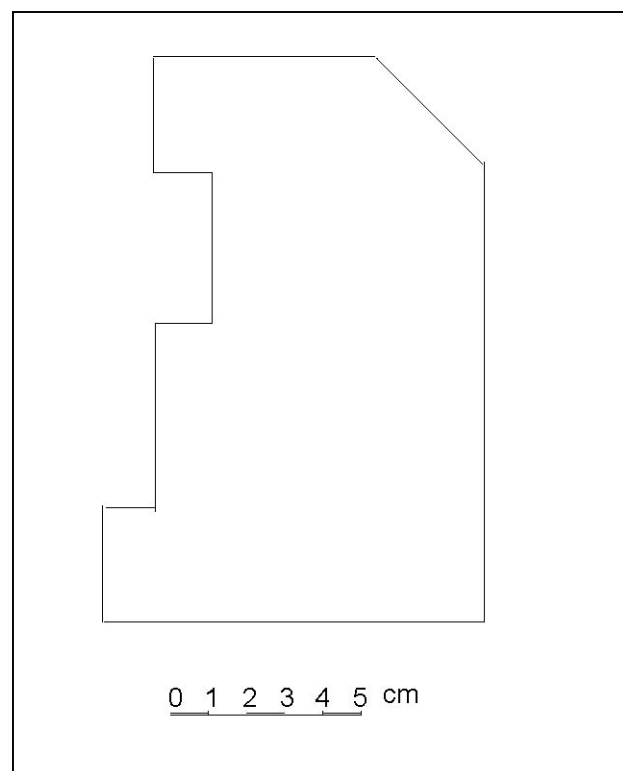
The inner wallplates supporting the ashlar pieces were once dentilated along the entire length. Only random sections of dentilation have survived (Fig. 8). Because the wallplates appeared to be upside down and the joints between some of the ashlar pieces and the wallplates were poorly wrought, it was initially thought that the wallplates were replacement timbers. However, similar wallplates form part of the trussed rafter roof at St. Mary's church at Strethall (Essex) and these appear to be part of the original medieval fabric (Michael Pearson pers. com.). It is therefore possible that the wallplates at Croydon could also be original timbers, which were modified at a later date, possibly when the ceiling was plastered.

Figure 8: West facing section of the southern wallplate (*Scale 1:2*)

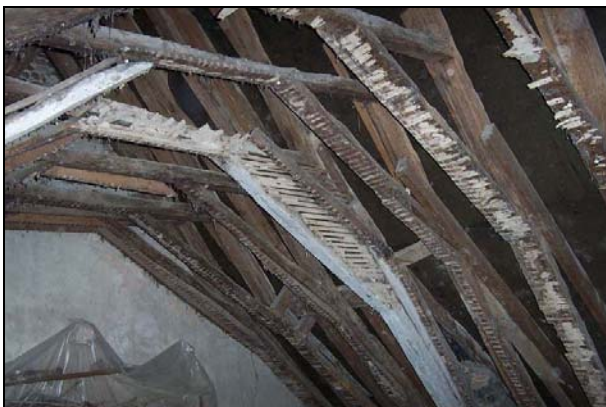
The timbers are mostly oak and generally c.8cm wide. The greatest variation in size appears to be in the ashlar pieces, which are between 5 and 8cm in width. Numerous additional timbers, such as the occasional rafter, tile battens and braces have been added seemingly at random to strengthen structurally weak areas of the roof. However, no longitudinal bracing has been added despite serious racking to the east.

Plate 5: Additional bracing on Truss 23

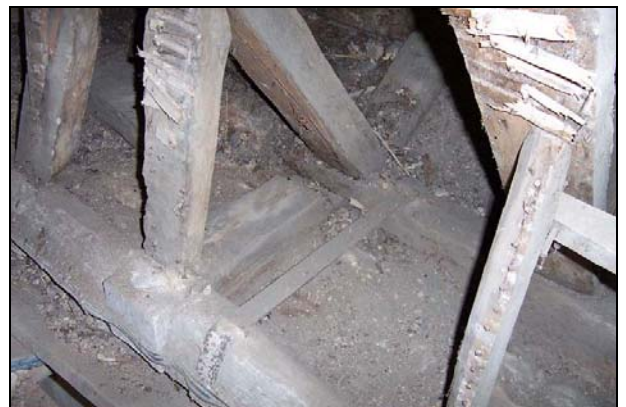
There were originally four tie beams; one at either end and as part of Trusses 10 and 16. Not only have these been sawn off across the nave, but they no longer tie the inner and outer wall plates. Iron ties have subsequently been inserted to clamp these two wall plates. The two tiebeams that now span the nave are completely independent of the roof trusses and appear to have been added at a considerably later date. They are of softwood, which has probably been imported from the Balkans (Robinson pers. com.). They are approximately 28cm high x 15cm wide and have simple mouldings on the lower face and an iron tie of possible 17th century date at either end. The date of these beams remains enigmatic, in that the origin and style would suggest an 18th century date, the ties appear to be older, yet the condition of the timbers would suggest a much more recent date. Having been observed by Weir in 1928, it would be fair to say that they are certainly no later than 19th century and no earlier than the late 17th century.

Plate 6: Cut tiebeam and iron clamp

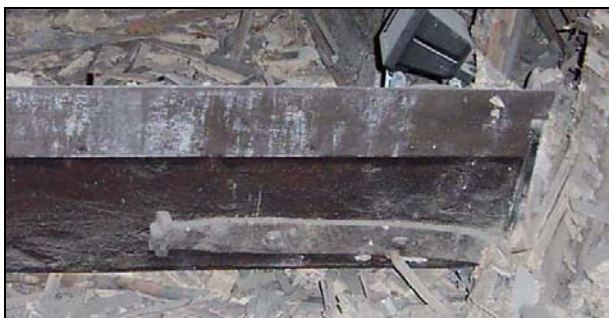
Plate 7: Strapwork on tiebeam

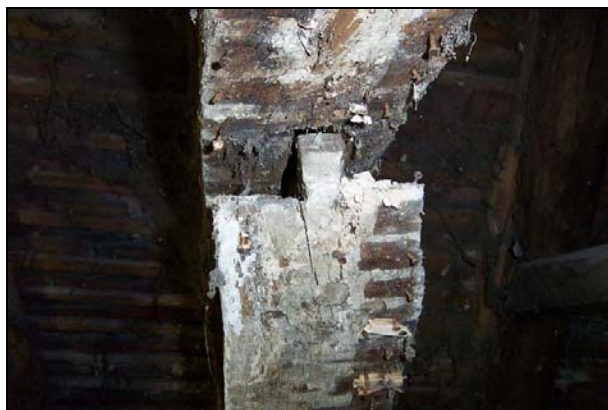
One of the most interesting trusses is number 22 where the southern rafter rests between the two wallplates and the two rafters are jointed with a lap joint rather than tenoned together as is the case for the other trusses. The southern soulace, which has been replaced is failing again; the present soulace has a very small tenon and three wooden pegs to joint it to the collar where there is a mortice designed for a larger tenon.

Plate 8: Truss 22; mortice & tenon joint

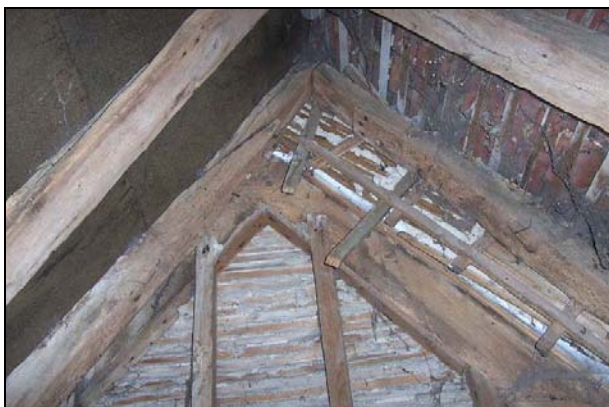
The easternmost truss (Truss 1) has simple splayed scarf joints at the upper end of both rafters, which would suggest an earlier date for the roof as this type of joint was becoming obsolete by the end of the 13th century. The location of these joints is rather unusual, as rafters tended to be made of complete timbers, and the reason for needing to heighten the truss is unclear.

Plate 9: Truss 1; scarf joint

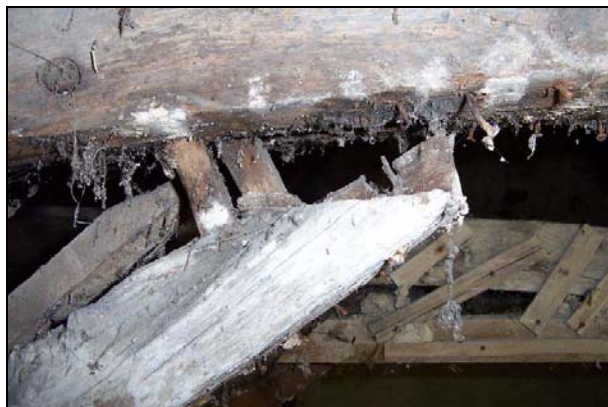
The predominant means of joining the timbers in the trusses is by mortice and tenon joints. A number of these have partially or completely separated showing that some of the tenons are narrower than the standard $\frac{1}{3}$ width of the timber.

Plate 10: Truss 1; failed joint

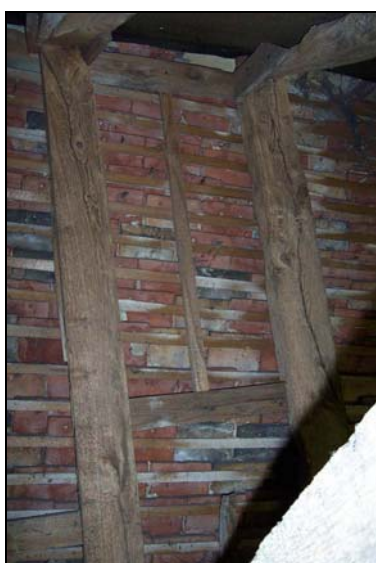
Although some of the rafters have notches on the outer face and/or redundant peg holes, there are no nails or other roof fittings on the outer face of the A frame rafters, which would suggest that the roof was originally thatched. It was common for thatched roofs in East Anglia to be built on woven fleeking, which had been tied to the trusses by honeysuckle or blackberry cord (Jack Lewis pers. com.). Could the peg holes have provided another means of attaching the fleeking to the frame? The tiles which now cover the roof are plain peg tiles of indeterminate date. The pegs themselves are largely of wood.

Plate 11: Tiling detail

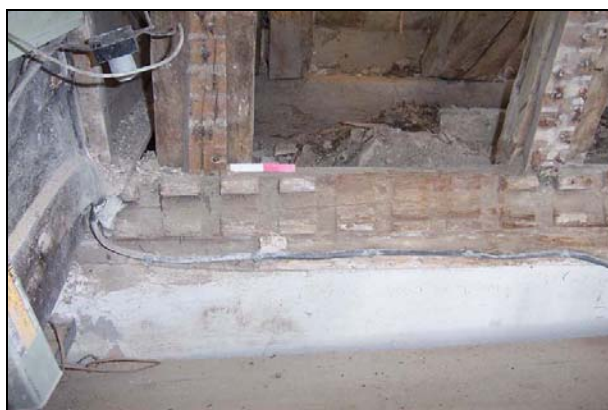
Plate 12: Dentilation on north wallplate

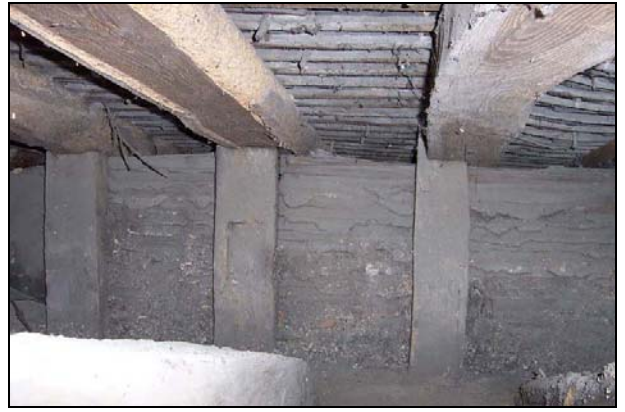
Diagonal braces unite the two sets of rafters at wall plate level, but the joints are obscured by the remains of the lath and plaster ceiling. Rafter seatings are apparent in some of these braces, which would suggest that these are re-used timbers.

Plate 14: Rafter seating

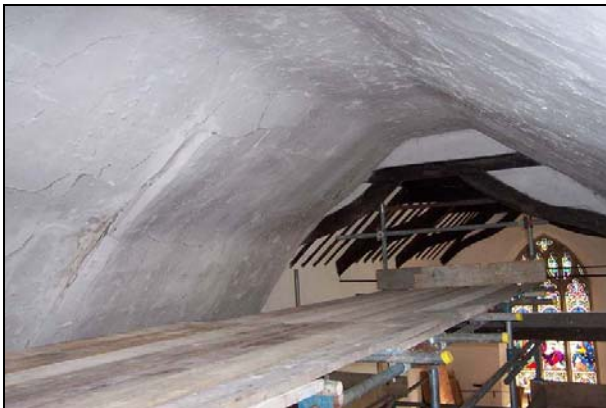
The plaster has been replaced as necessary over recent years. As such it is of various depth, density and composition. The sample removed for the purposes of this report was between 1.5 and 3cm deep, fairly coarse with horsehair and small stone inclusions and coated with two layers of limewash. The post-medieval date ascribed to the plasterwork was substantiated by the discovery of lead shot in the northern rafter of Truss 6.

Plate 15: Ceiling looking east

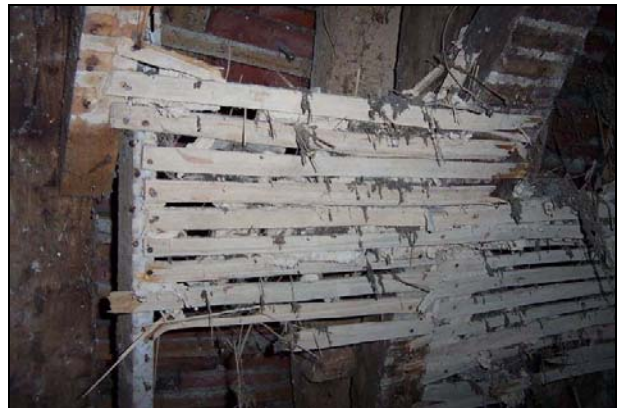
Whilst many of the laths appear to be riven and are fastened with hand made nails, those at the south western end of the nave are modern replacements, roughly cut and attached using machine made nails. The 1928 report on the condition of Croydon Church (Weir 1928) noted that the laths were to be replaced by riven oak laths, and certainly those at the eastern appear to be of oak (Robinson pers. com)

Plate 16: Lath & plaster at the south-western end of the nave

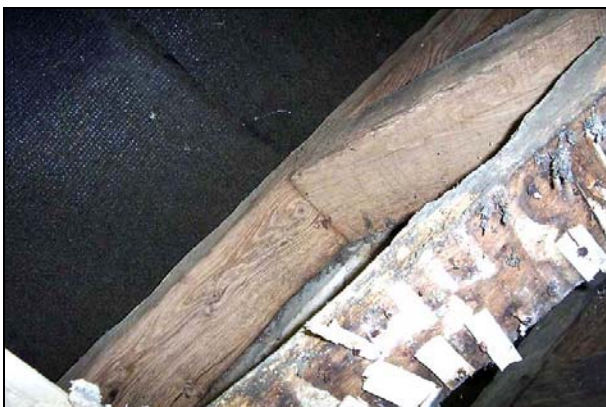
Some of the trusses at the eastern end have carpenters' assembly marks scratched into the collars, braces and rafters. These are of some interest as the marks between collar and rafter match, as do those between the rafter and the lower end of the brace, yet there is a variation between the upper and lower marks and neither follow a logical sequence from truss to truss. The reasons for the mismatch are unclear.

Plate 17: Carpenter's assembly marks

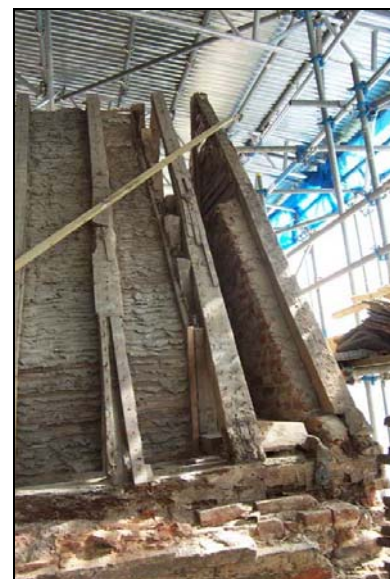
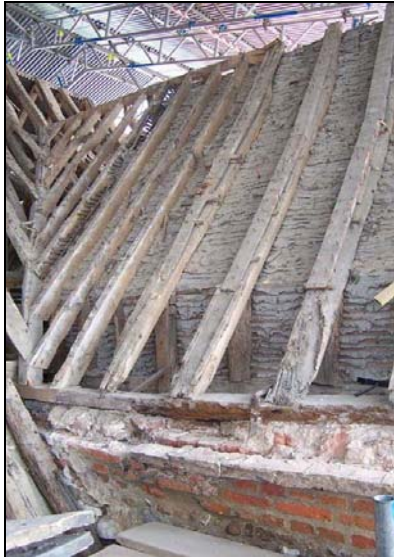
The southern end of the south transept roof appears to have retained many of the medieval roof trusses, but the northern end has replacement, roughly sawn softwood rafters set onto a replacement wallplate and attached to a ridge post. The northern gable has been replaced using sawn studs of uniform scantling (c.6cm wide) set approximately 30cm apart and there is a false gable at the southern end set one truss in from the south wall. These appear to be of 19th century date. The documentary evidence as well as the appearance of the battens, however, suggest that these are more likely to belong to the 1930s restoration programme.

Plate 18: South-west end of the south transept

Plate 19: North-west end of the south transept

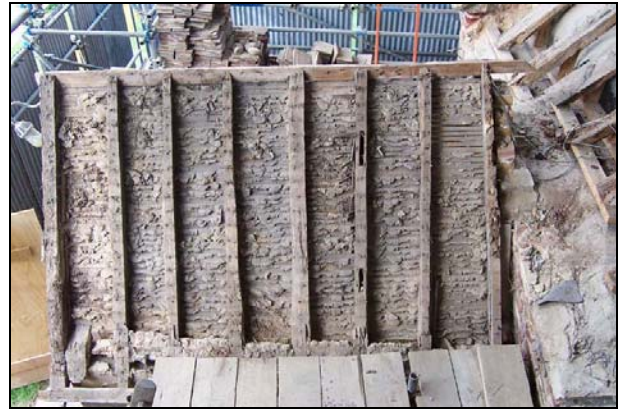
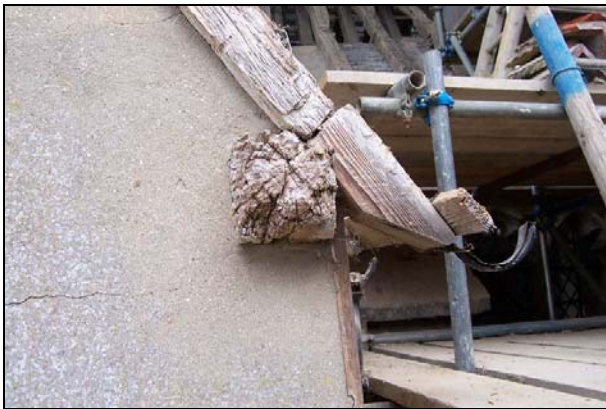
The south porch is a simple structure thought to have been built in the 17th century (RCHME 1968, 74; VCH 1982, 41). The roof contains a mixture of oak and softwood timbers and shows evidence for various episodes of alteration, including the removal of the bargeboard and the lengthening of the rafters to accommodate guttering.

Plate 20: South porch, east side

Plate 21: South porch, eastern horn & later additions to rafter
