**HISTORIC BUILDING RECORDING
ST. DENIS' CHURCH
EAST HATLEY
CAMBRIDGESHIRE**

on behalf of South Cambridgeshire District Council

December 2005

ASC: 717/EHC/1

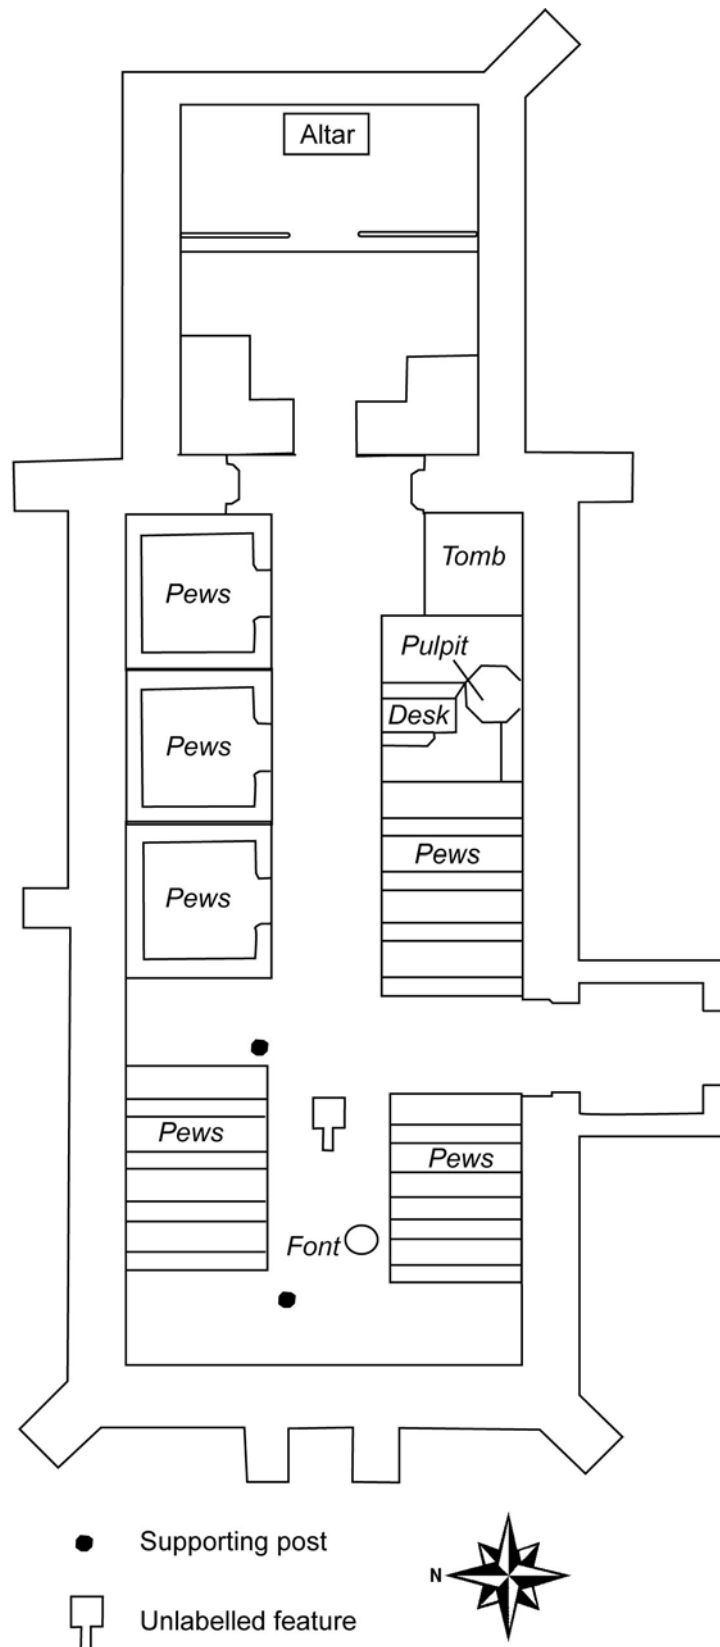
Figure 4: Groundplan of the old church based on Butterfield's drawing (*not to scale*)

- 4.4** The nave roof was described in the 1865 survey as having four oak tiebeams, king posts and braces and each pair of rafters being framed together with diagonal ties. The roof was plastered below the diagonal braces. As the steeple had collapsed by 1748 a chamber had been built between the west wall and the first tiebeam to house the last surviving bell. This had caused the tiebeam to fail, and was consequently supported by a post set into the nave floor. A second tiebeam was also broken and similarly propped (Fig. 4).

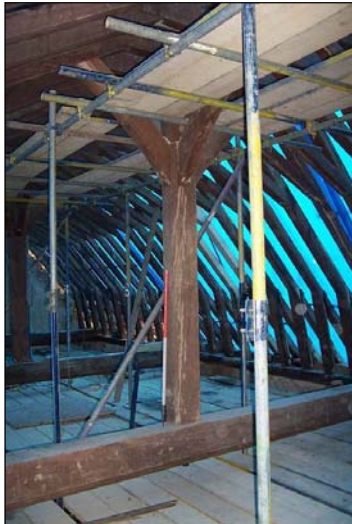
Plate 7: Crown post

The crown posts are simple, rectangular timbers c. 0.23 x 0.23 x 2.85m high with up braces that are 0.20m wide (Plate 7). The tiebeams on which they rest are 0.29m high, practically double the height of the wallplates. The rafters are set approximately 30cm apart and are 10cm wide, as are the scissor braces and ashlar pieces. Each bay contains 9 couples except the westernmost one, which has two exposed couples and two original, oak couples set 33cm apart behind the west wall.

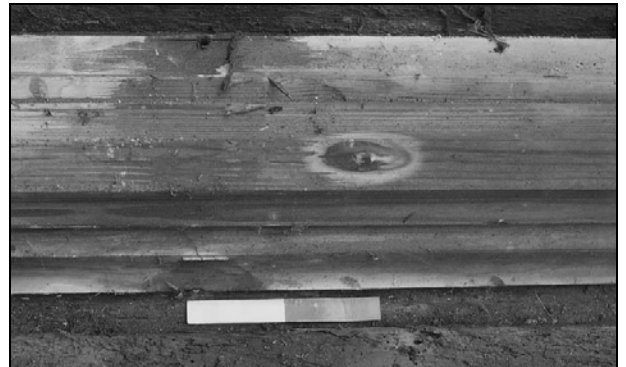
Plate 8: Wall plate moulding

The wallplates are decorated with simple double hollow mouldings and the theme has been carried through to the chancel, where they are embellished with additional mouldings over the wallplate consisting of a double hollow chamfer over a roll (Plate 8). The lower arrises of the tiebeams are also decorated with hollow chamfers.

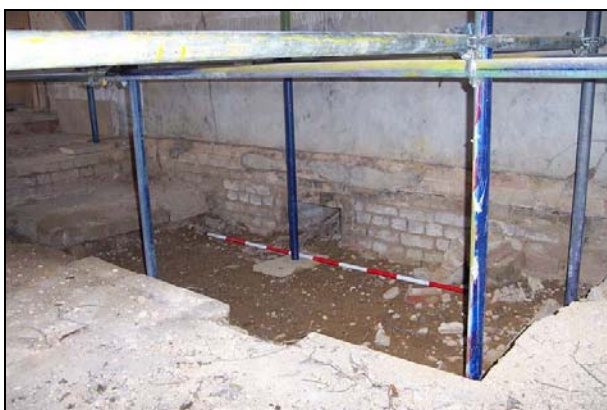
Plate 11: Brickwork at the base of the south chancel wall

The chancel has been rebuilt in field stones and limestone dressings. All new stone was intended to be Bath stone acquired from either Randall & Saunders or another approved quarry. A sample taken from the north chancel window was a cream/grey, oolitic limestone, very similar to Clipsham but very friable. The tracery and hood mould of the east window appears to be Clipsham stone, and Ancaster stone appears to have been used in the dressing to the chimney (Plates 9-10). Certainly there are fragments of Ketton, Weldon and other oolitic limestone from the Lincolnshire Limestone group within the walls throughout the church. Much of the interior is brick built, as is evident in the lower aspects of the north and south chancel walls and the altar steps (Plate 11). Some brickwork is also evident on the gable end of the nave wall.

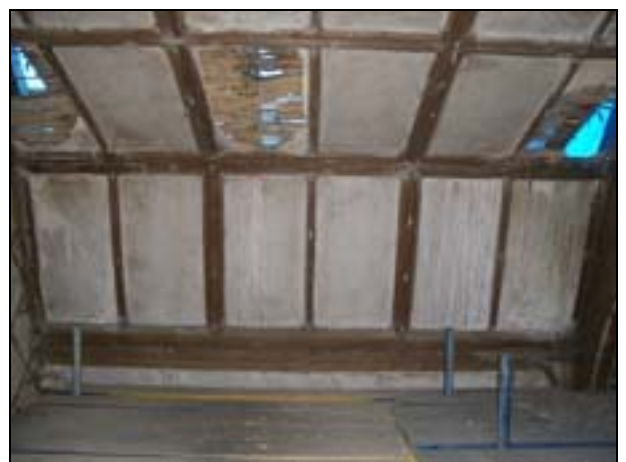
Plate 12: Panelling in the Sanctuary ceiling

The chancel has a trussed rafter roof with scissor bracing and a plastered ceiling. The ceiling over the sanctuary has rectangular panels, whereas the rest of the chancel

ceiling is plastered and painted between the rafters (Plates 12-13). The rafter scantlings and their spacing are similar to those in the nave, with the rafters being approximately 10cm wide and 30cm apart. There are 12 couples in the chancel and 9 in the sanctuary. Three of the rafters on the north side have assembly marks chiselled into them and all have either an open mortise or the outline of a mortise partly cut into the timber (Plate 14). The number of timbers in the nave and chancel roofs reflect the medieval tendencies towards harmonious geometry and the numerological bias of the number 3, which signifies, *inter alia*, the Holy Trinity (cf. Krautheimer 1942, Male 1972, Rapoport 1982 & Semmelmann, 2000). The corbels are long and slender and are used to emphasise the boundary between the chancel and the sanctuary (Plate 15).

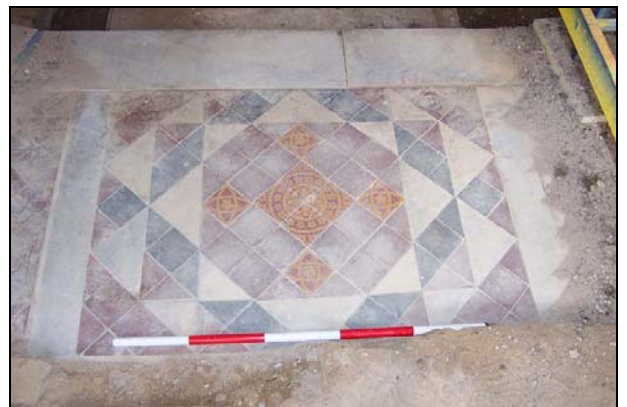
Plate 18: Altar step

The wall decorations in the chancel lie largely above a stone dado and primarily consist of parallel, horizontal lines with red lozenges above and a border to the vestry door and windows (Plate 16). These are created using red and black tiles, presumably the Minton tiles mentioned in the Specification of Works. The clunch-built reredos, which deviates somewhat from Butterfield's original design, consists of a central crucifix within a trefoiled arch flanked by two orders of quatrefoils, all of which is set against a red tile background (Plate 17). There are three geometric, quatrefoil based tiled areas on either side of the altar, bordered by red and black tiles. The tiles used to decorate the altar steps and risers are plain red and black as well as decorated with medieval motifs, primarily floral in concept (Plate 18). The floor elsewhere is plain.

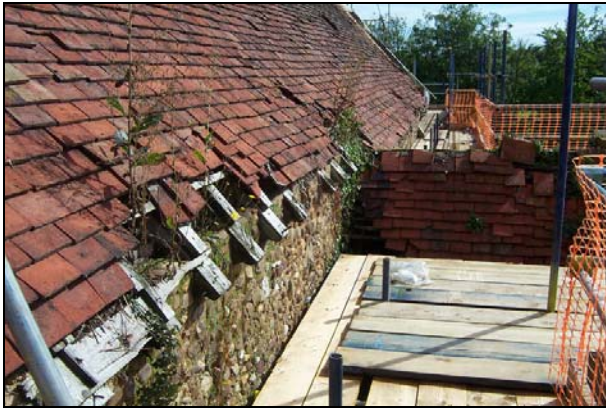
Plate 19: South side of the roof

The roof tiles, which are a mixture of 19th century tiles and earlier gault ones are hung on softwood battens (Plates 19 & 21). A few decorative ridge tiles survive.
