**WATCHING BRIEF:
ST GILES'S CHURCH
TATTENHOE
MILTON KEYNES**

The PCC, St. Giles's Church, Tattenhoe

August 2006

ASC: 779/TSG/2

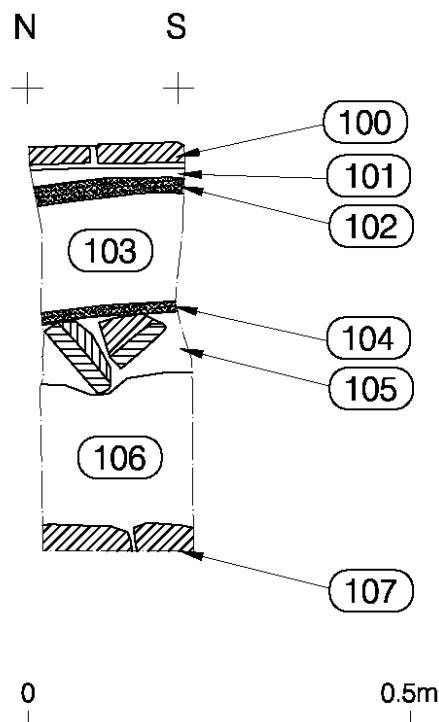
Figure 3: West facing section of pipe trench excavated within church (1:10)

- 4.4 The section visible in the small area excavated within the church interior revealed that the current quarry tile floor was laid on a thin layer of sand (100) overlying a *c.*0.03m of sandy organic soil (101) deposited upon a *c.*0.02m deep mortar floor (102) laid upon the surface of *c.*0.15m of organic soil (103). Beneath the soil was a *c.*0.05m deep mortar floor (104), which sealed a deposit of disturbed fired clay floor tiles (105) (Plate 5). The tiles overlay *c.*0.2m of sandy organic soil (106) which in turn covered deliberately laid large sub-angular limestone clasts (107) possibly forming the primary stone course of the walls of an earlier building (Plate 6).

- 5.3 The stratigraphic profile of the small, 0.4m deep, area excavated within the church showed that the existing relatively modern quarry tile flooring covered two mortar floors, which were separated by a layer of organic soil from which the distinct aroma of horse manure emanated. Beneath the lower and therefore earliest of the mortar floors was a layer of disturbed late medieval decorated Brickhill floor tiles overlying a layer of clean sandy organic soil that had developed on deliberately laid sub-angular limestone blocks.

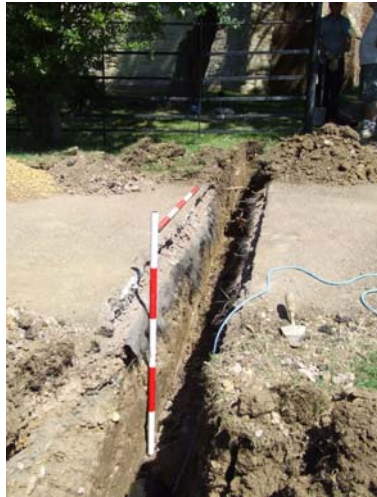
- 4.1 The section of the *c.*0.3m wide service trench that ran NNW-SSE alongside the footpath outside the churchyard was machine excavated through *c.*0.2m of dark greyish brown organic topsoil and *c.*0.4m of mid greyish brown silty clay subsoil. Fragments of ceramic building material (CBM) were present in the topsoil and subsoil, and a discrete deposit of modern and post medieval CBM was noted extending from *c.*3m to *c.*7m southeast of an existing footpath gate at a depth of *c.*0.5m. The natural stratum was not reached in this part of the service trench and no archaeological finds or features were observed.

Plate 1: Trench crossing footpath toward church

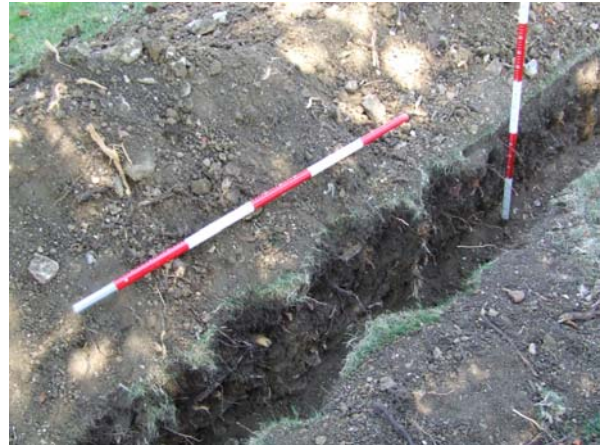
- 4.3 The service trench was hand dug within the churchyard revealing a depth of *c.*0.4m of organic soil containing frequent tree roots and fragments of CBM (Plate 2). The eastern extremity of the trench exposed the four foundation courses of a brick built buttress and the base of the southern wall of the stone built church (Plate 3). The exposed section of the base of the church wall lacked foundation courses although sub-angular limestone clasts within a matrix of subsoil underlay the wall and this material may have been deposited to help support its weight. The basal 0.4m of the wall had been faced with a cambered file of protective concrete probably during recent decades (Plate 4). Archaeological finds or features were not observed and human remains were not disturbed.

Plate 2: Section through trench in churchyard

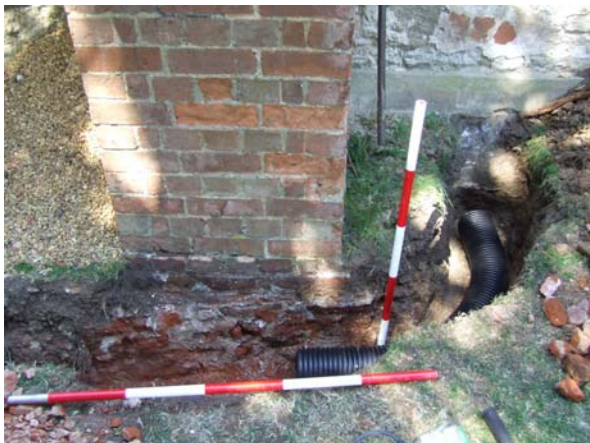
Plate 3: Foundation courses of brick buttress and base of church wall, facing N

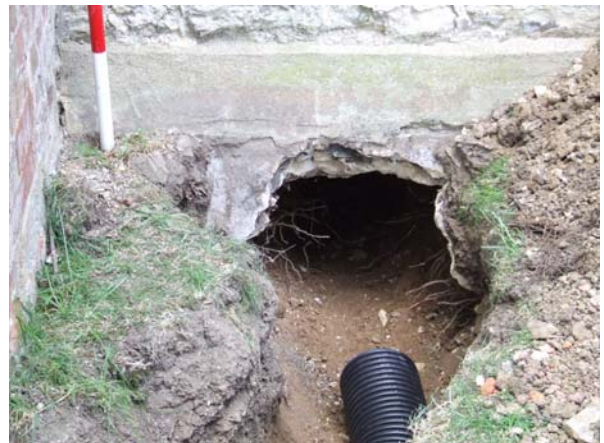
Plate 4: Hole cut through modern concrete at the base of the church wall, facing N

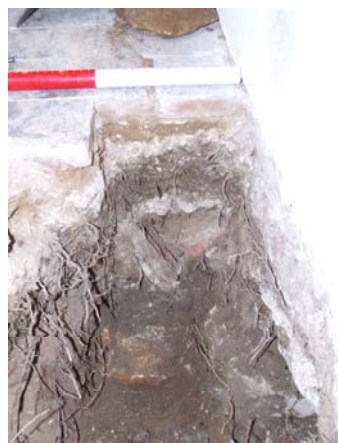
Plate 5: Section within the church with two tiles in situ, facing E

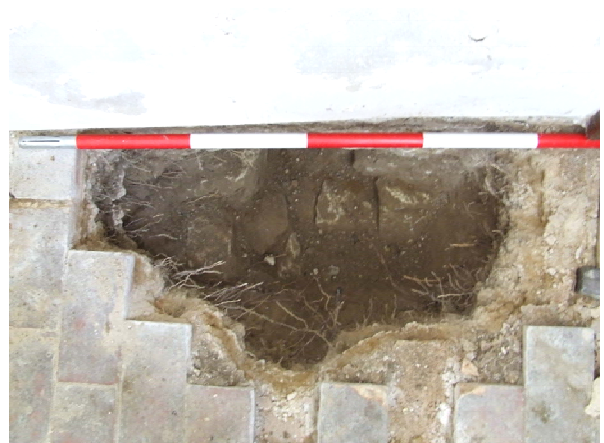
Plate 6: Sub-angular limestone foundation blocks at the base of excavation within the church.

- 5.4 The limestone blocks at the base of the excavation did not appear to support the walls of the current church building and some of the blocks could suggest the position of a north-south aligned internal wall, which may indicate the presence of the walls of an earlier building. The clean sandy organic soil above the limestone blocks indicates that this earlier building fell out of use prior to the construction of the extant church.

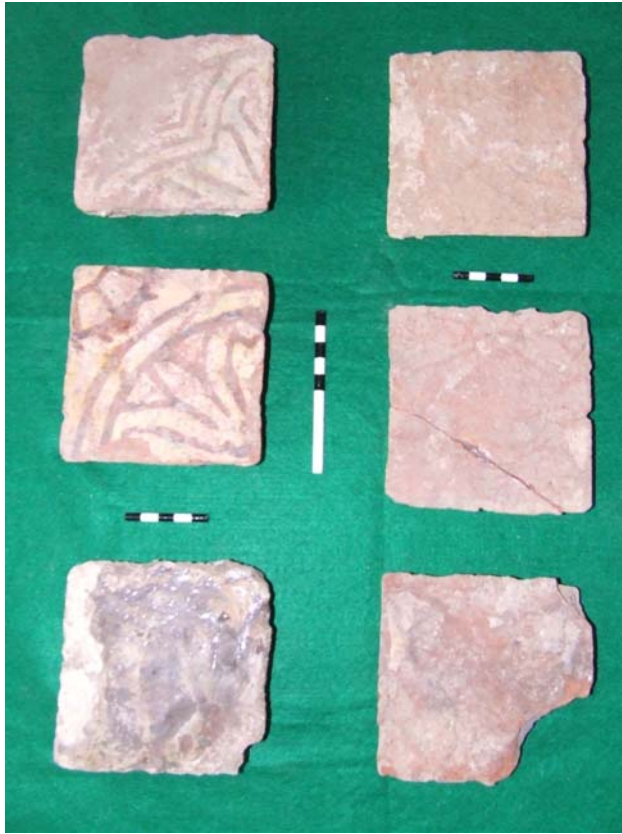
- 4.5 Six floor tiles were recovered from within the church, their form, fabric and surface decoration (Plate 7), are typical of those manufactured at the Little Brickhill tile kilns, probably during the late 15th – early 16th centuries. The tiles are described in the following sections using the “Little Brickhill Type” classifications employed by D.C. Mynard (1975).

Plate 7: Surface of all tiles

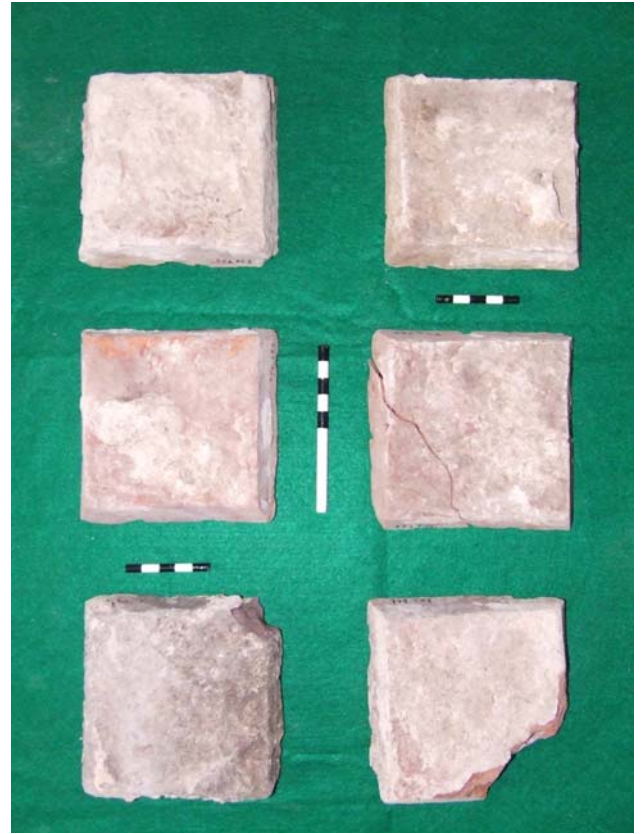
- 4.6 All of the tiles were made of a well fired sandy clay, two broken examples possessed a red oxidised surface and a mid grey reduced core, all possessed chamfered edges and had dimensions of 11.5cm x 11.5cm. Five of the tiles were 2.2cm thick, while the remaining tile was 3cm thick. Remnants of the mortar used to fix the tiles adhered to their bases but none appeared to possess any basal indentations (Plate 8).

Plate 8: Base of all tiles

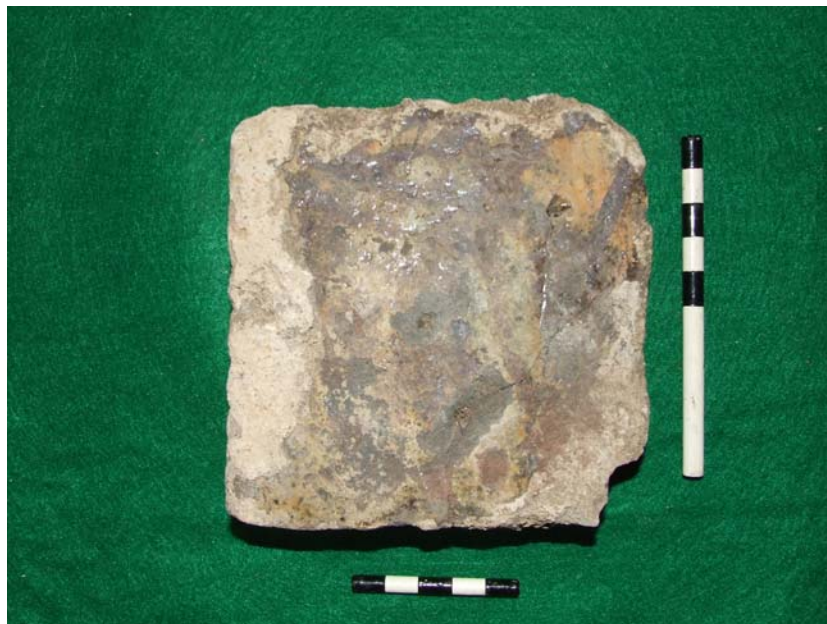
- 4.8 The surface of the 3cm thick tile showed remnants of decoration but the tile had been overfired during manufacture and it was impossible to determine the exact design (Plate 9). Mortar was present on the decorated surface of the tile, which could suggest that the overfired tile was used as building material rather than being discarded. The presence of a small spoked circle is suggested at one corner of the tile and indicates that it belonged to a four tile design.

Plate 9: Decorated surface of overfired tile

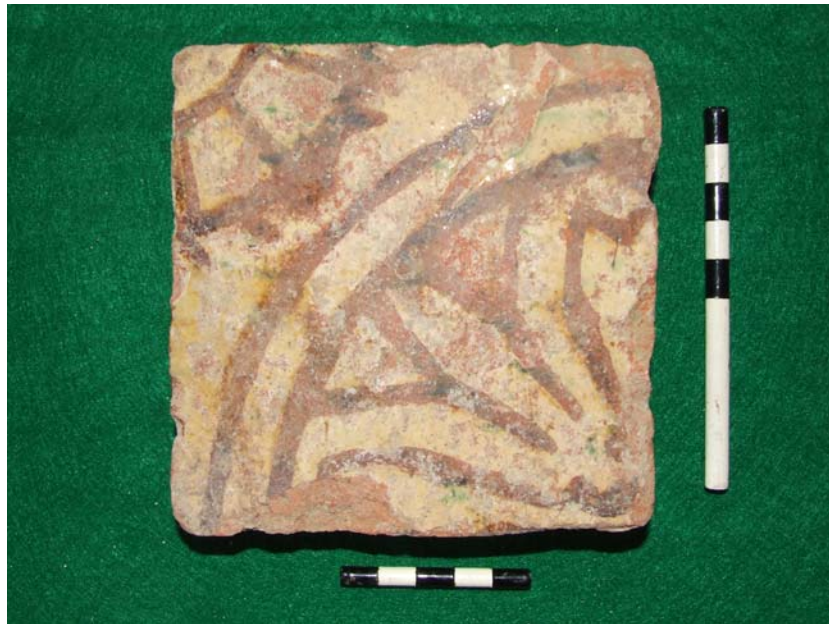
- 4.9 The yellow slip decoration of one of the tiles was almost complete and matched the description and illustration of design 11 (Mynard 1975, 61 and 69), which is characterised by a large quarter circle containing a fleur-de-lis and a smaller spoked quarter circle (Plate 10). The yellow slip decoration on the other tile was less complete but was sufficiently distinctive to allow attribution to design 18, (Mynard 1975, 62 and 70), which is described as a plain bordered circle enclosing a quatrefoil containing eight petals (Plate 11). Both tiles would have formed part of a repeated four tile design.

Plate 10: Tile with design 11

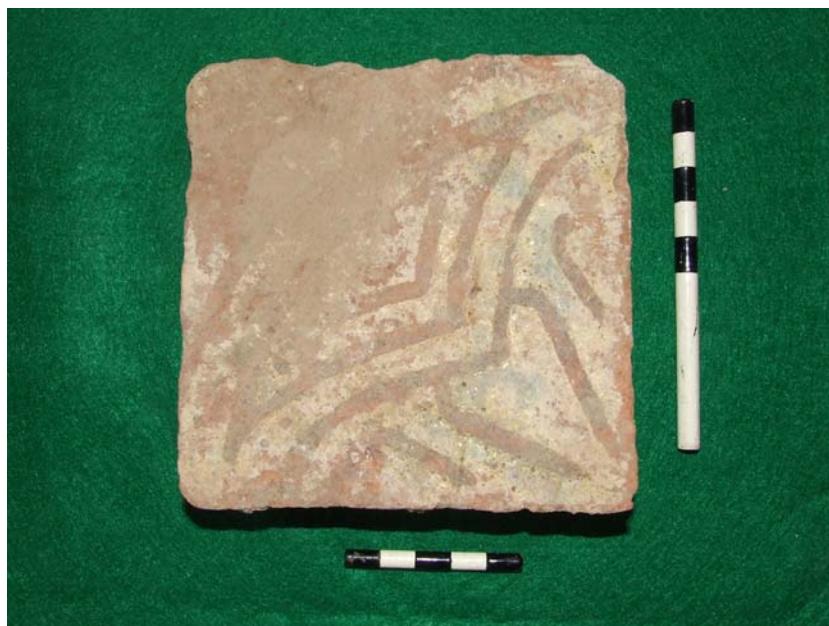
Plate 11: Tile with design 18

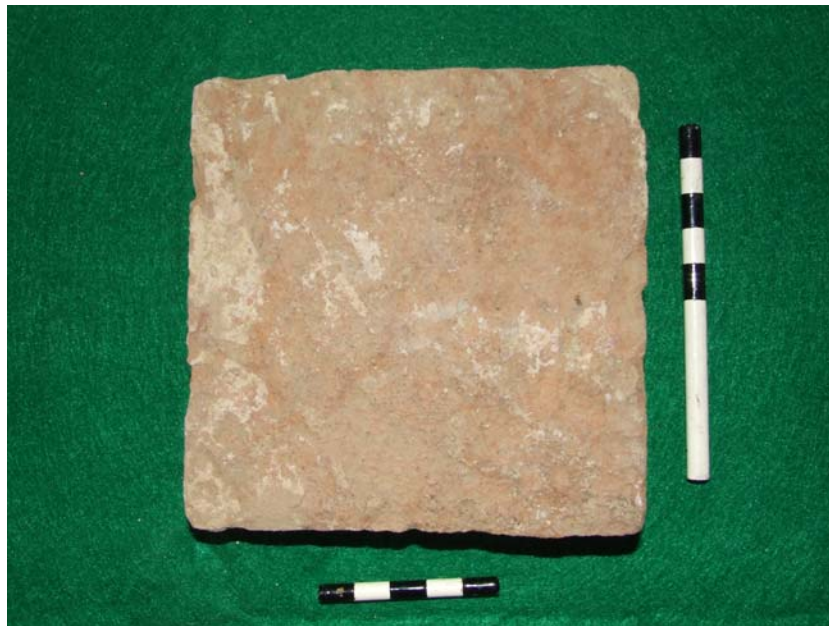
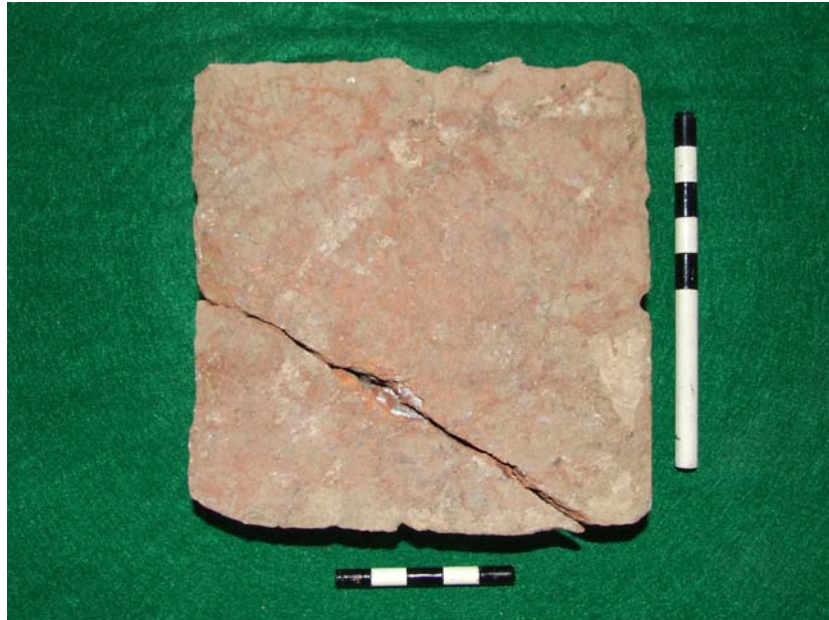
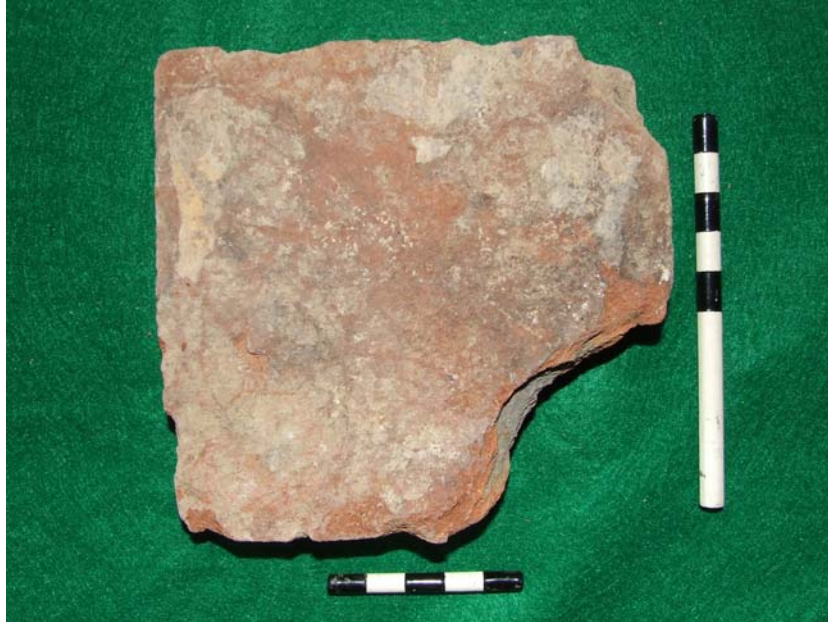
- 4.7 The surface of all six tiles were decorated although three were extremely worn and the surviving areas of decoration were not sufficiently complete to enable characterisation of the design (Plate 12-14).

Plate 12: Surface of worn tile (a)

Plate 13: Surface of worn tile (b)

Plate 14: Surface of worn tile (c)
