**BUILDING RESTORATION RECORDING:
ST. NICHOLAS CHURCH
TINGRITH
BEDFORDSHIRE**

on behalf of Tingrith Parochial Church Council

March 2007

ASC: 827/TSN/1

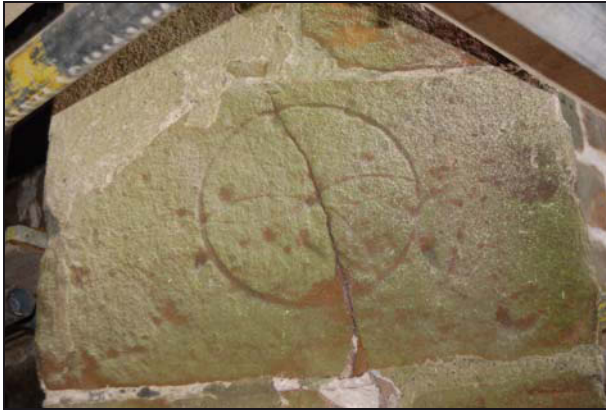
Tool marks are present on some of the ironstone pieces and a consecration rose was observed on the southwest buttress.

Plate 1: Consecration rose

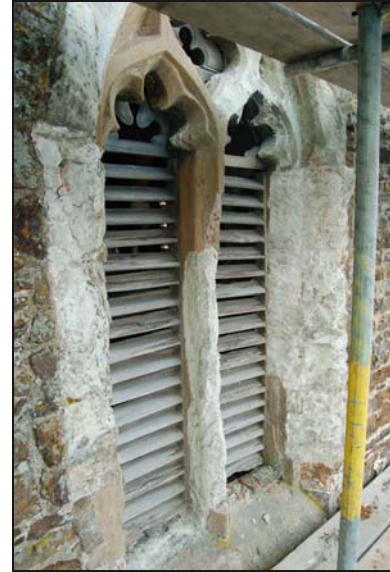
Prior to the start of the restoration work, the western label stop on the belfry window was decorated with an eroded head. The other had eroded beyond recognition. Both had been removed before the initial site visit and were not replaced.

Plate 2: South elevation belfry window

During the restoration programme, most of the belfry window was replaced; the hood mould in stone from the Stoke Ground quarry, the tracery in Totternhoe Clunch and the sill in ironstone. Several pieces of clunch were replaced in the two base offsets and ironstone pieces were replaced in the string bands in Lifts 1 and 4. The entire string band in Lift 6 was replaced with clunch.

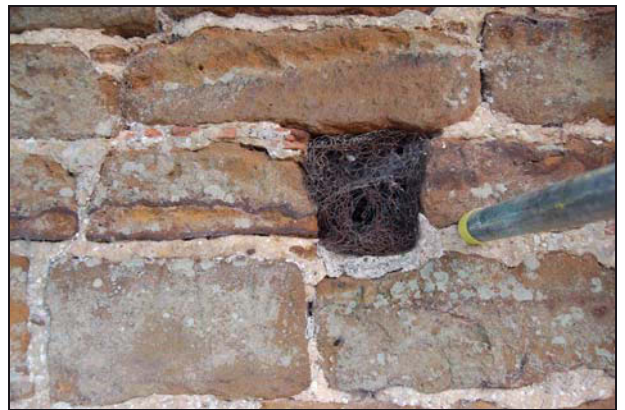
Two sets of putlog holes, indicating where scaffolding beams had originally been inserted into the stonework during construction, were noted; the lower pair was located just below the first string course in Lift 1 and the second pair was situated in Lift 4, three courses below the second string course.

Plate 4: South elevation: Lift 4 east putlog

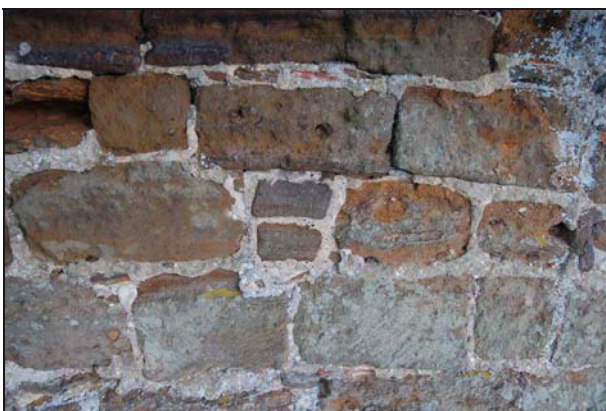
Plate 5: South elevation: Lift 4 west putlog

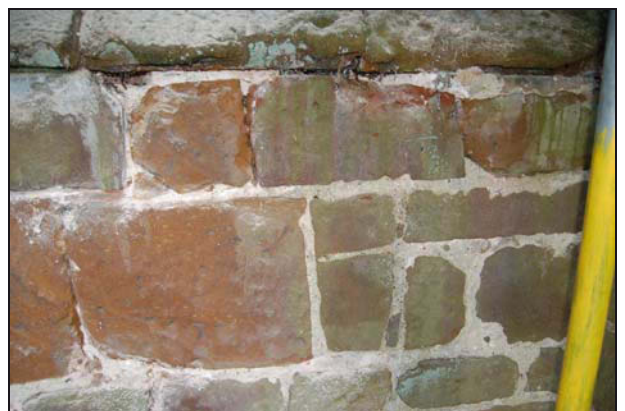
Plate 6: South elevation: Lift 1 east putlog

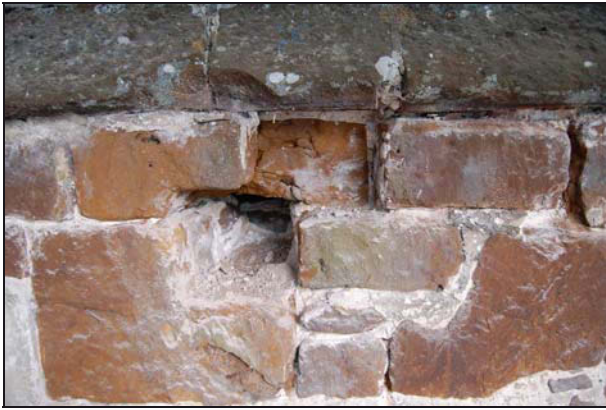
Plate 7: South elevation: Lift 1 west putlog

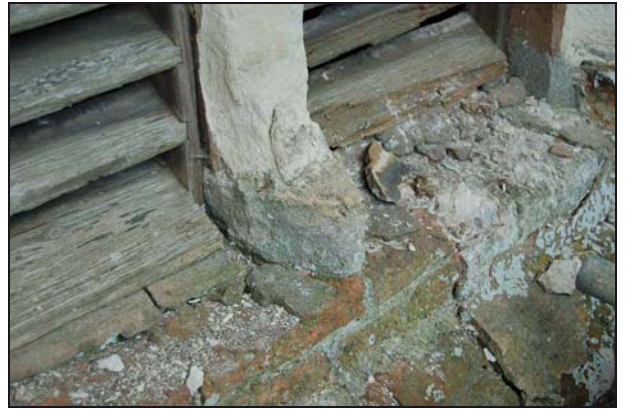
The west elevation has a door under a pointed arch, a 3-light Perpendicular style window in the second stage and a 2-light, cinquefoiled window with a head on the south label stop in the belfry. Patchy remains of render, probably of the 19th century restoration, had survived on all the openings. Further indication of earlier repair work was seen at the base of the belfry window mullion, where a piece of Ketton stone had been inserted.

Plate 11: West elevation: Ketton insertion to base of mullion

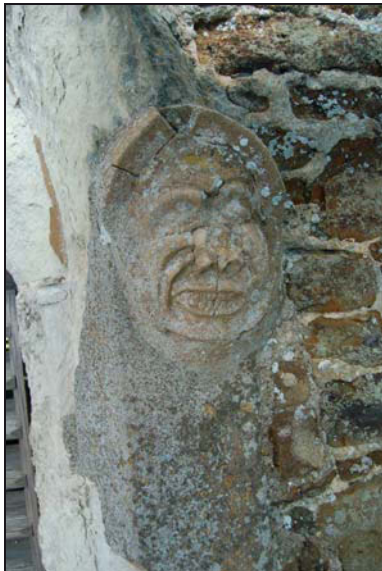
Plate 12: West elevation: belfry label stop

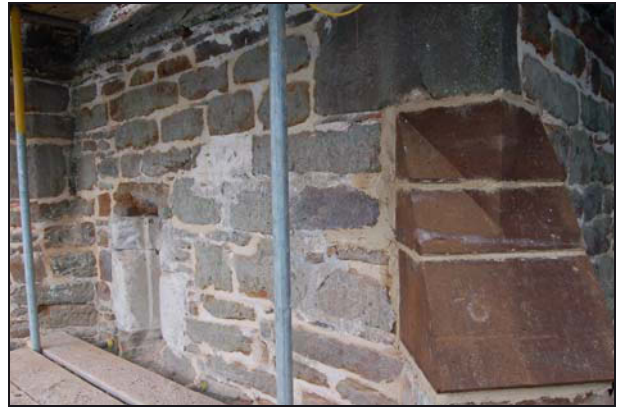
Plate 21: North buttress restoration

A number of ashlar ironstone pieces were inserted throughout the elevation, and particularly in both buttresses. The northern buttress was almost completely repointed with a 1:3 lime:mortar mix, and the other areas of more intense remortaring were below the string courses in Stages 1 and 2 and immediately above the Perpendicular window in Lift 5, which may indicate an entire building lift. The base of the elevation was also completely remortared using a cement:lime:sand mix.

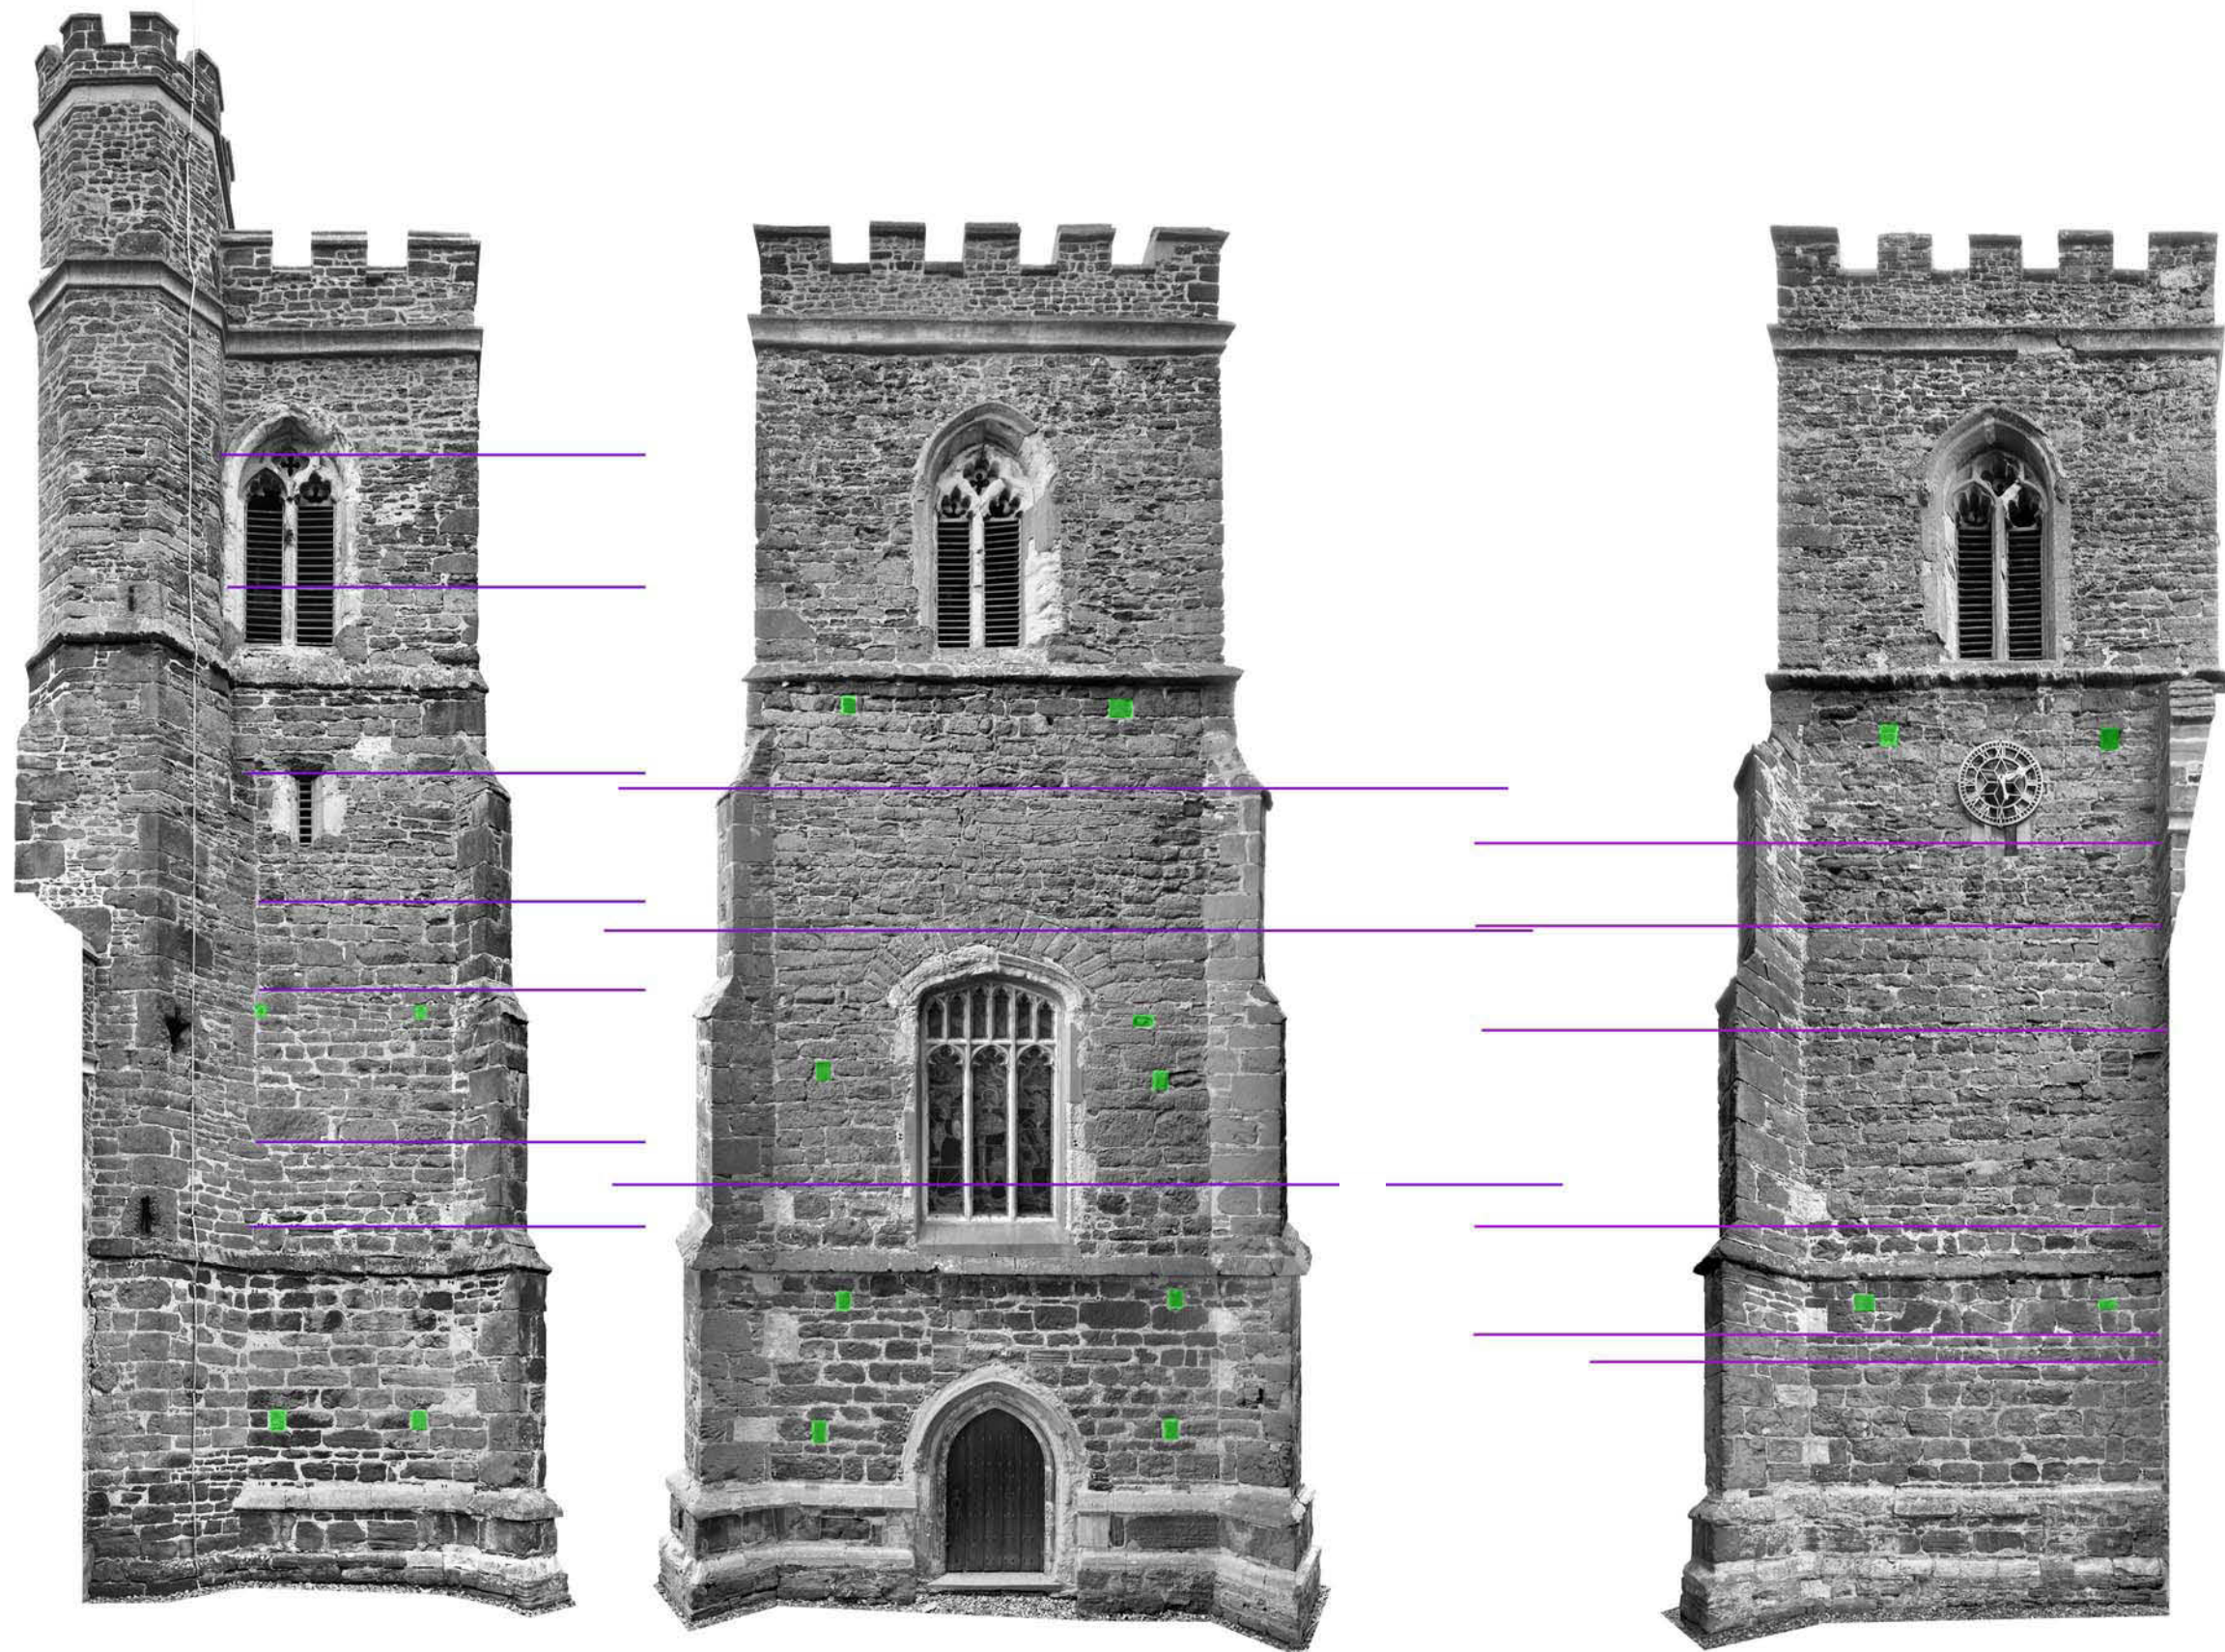
Figure 6: Putlog holes & suggested building lifts (*not to scale*)
(Based on rectified photographs produced before the restoration by Plowman Craven & Associates)

Although it was not possible to determine the building lifts before the restoration programme started, the size and coursing of the stonework has allow a hypothetical model to be created (Fig. 6).

The building lifts proposed here are based on the differences observed in the rectified photographs taken before the restoration began. These photographs were an extremely useful tool for the recording and analysis of the tower, the only regret being that they were not produced in colour, as this would have shown even greater detail.

As is largely typical of pre-modern church construction, the lower part of the tower generally consists of larger blocks of roughly dressed stone. The most carefully built is the south elevation, almost certainly as it was symbolically as well as visually the most significant elevation of the entire church. As the building progressed, it became more difficult to raise the stone to the building platforms and so the masonry became smaller. This change is apparent in Lift 2, again half way up Lift 3 and by the belfry stage the masonry consists of small pieces of rubble.
