ARCHAEOLOGICAL RECORDING & MONITORING: WOODSPEEN MILL SPEEN, NEAR NEWBURY WEST BERKSHIRE

on behalf of The Environment Agency

NOVEMBER 2007

ASC: 900/WWM/2

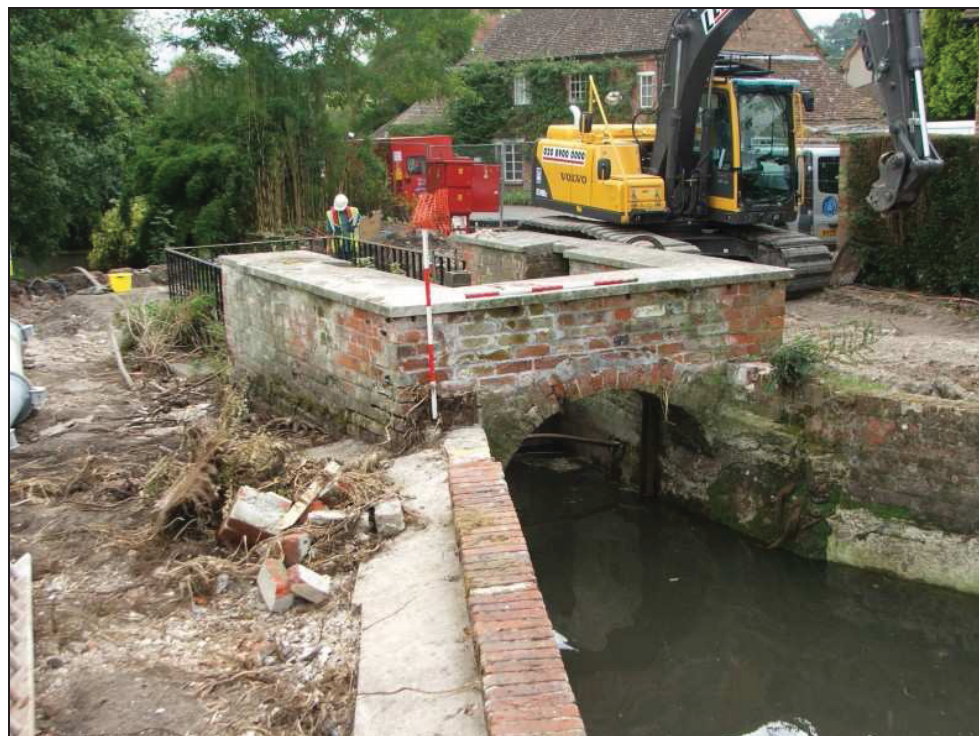
Plate 1: The sluice, from the north-west

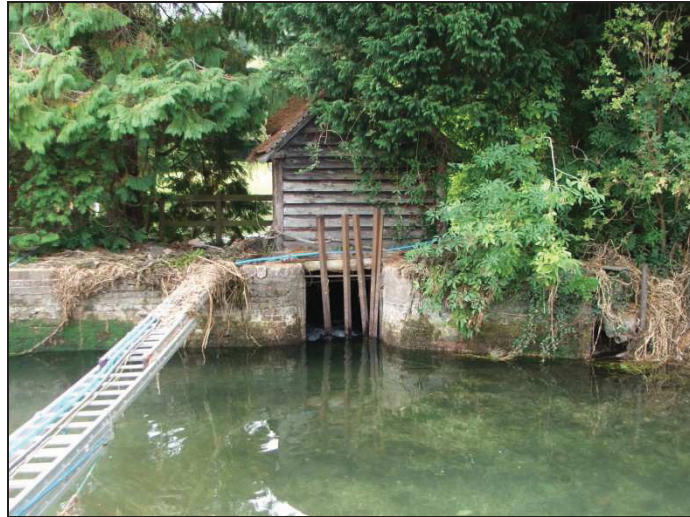
Plate 2: South river bank wall, overflow and 'Turbine House', from north

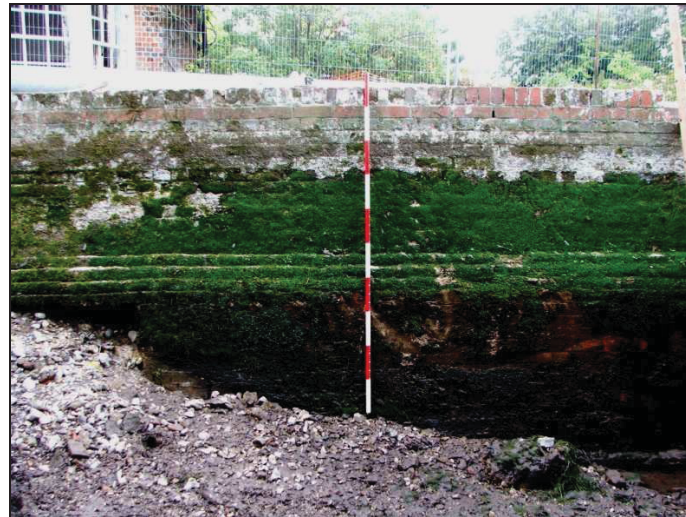
The river walls upstream of the sluice are *c.*2m high, constructed of brick laid for the most part in Flemish bond, with a cap of edge-set bricks. The north wall (Plate 3) is more or less straight: the south wall (Plate 4) curves south-westwards from the sluice, because of the offset location of the sluice in relation to the river. Limited cleaning of weed and calcareous deposits from the lower parts of the walls show them to have been constructed of red-orange handmade bricks. Accurate measurements were difficult to obtain, but most of the bricks appear to have been in the region of 240 × 120 × 80mm. The upper part of both walls – about eight courses (*c.*600mm) – had been rebuilt in a harder, darker red brick of similar dimensions. Where the channel narrows to pass into the sluice, ashlar blocks (sandstone?) are set into the brickwork of the south wall between 0.8 – 1.8m above the river bed (Plate 5), presumably to reduce damage to the brickwork by water-borne debris. From the weed and calcareous deposits on the walls, the normal depth of water immediately upstream of the sluice appears to have been *c.*1.6m. The only feature worthy of note in this area is a rough vertical break in the lower brickwork of the south wall, *c.*3.5m west of the sluice structure (Plate 6). The wall west of this break is normal brickwork, while to the east it is slightly offset, and appears to have been rendered. The rendered section appears to have been *c.*1.5m wide, though its eastern edge is less distinct.

Plate 3: North river wall

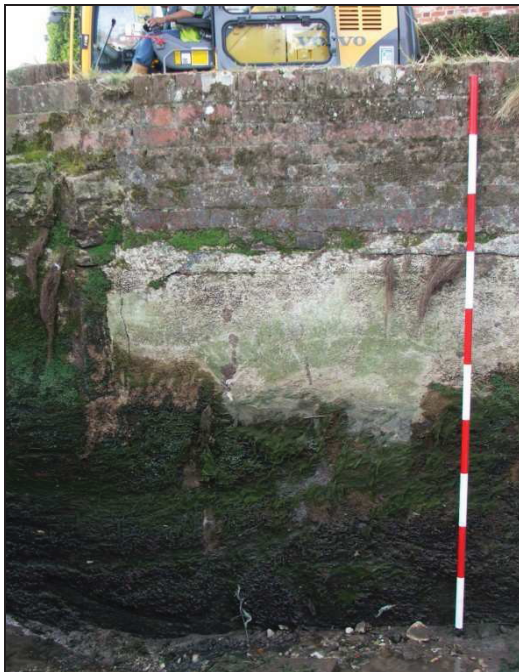
Plate 4: South river wall

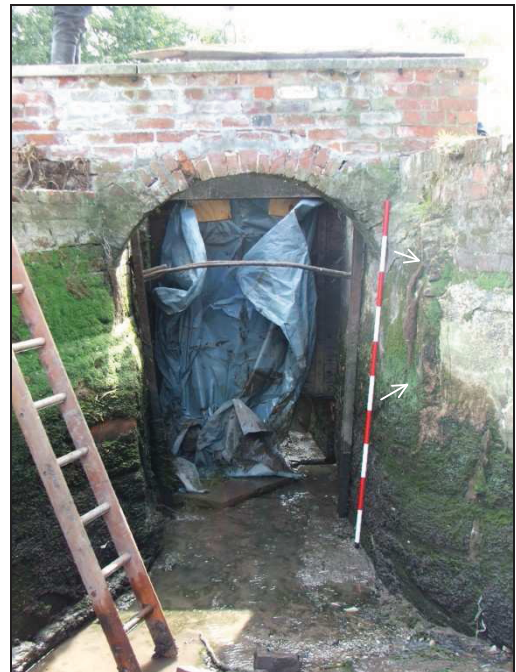
Plate 5: South river wall, showing ashlar blocks

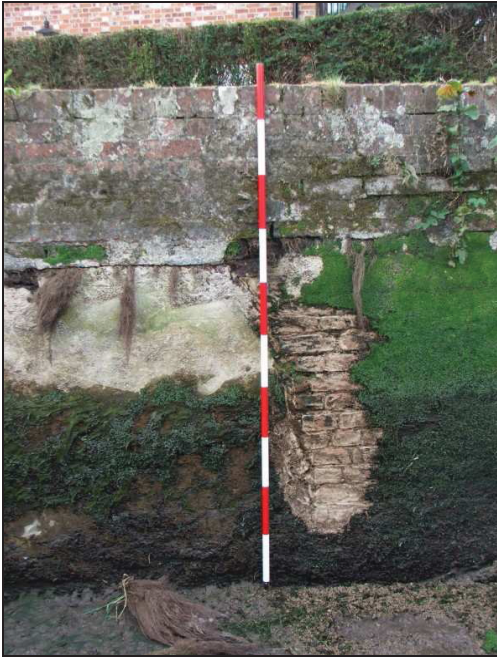
Plate 6: South river wall, showing edge of possible blocked culvert

- 5.4 The culvert revealed by the excavations provides the missing link in interpreting the waterpower arrangements at Woodspeen Mill. The surviving sluice to the north was evidently intended to regulate the head of water upstream of the mill, as it contains no evidence for a water wheel. It is likely that the parallel culvert to the south formed the outflow for an undershot water wheel, which was probably located in a wheelpit alongside the sluice gate. The break noted in the brickwork of the south river wall, upstream of the sluice, could mark the edge of a bricked-up entrance to a short culvert leading to the wheelpit.

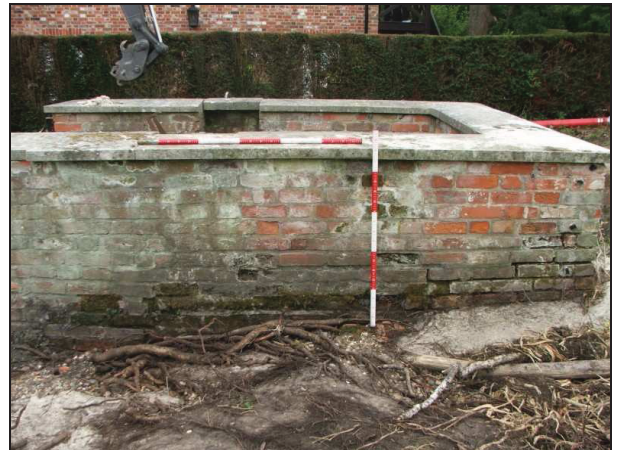
Plate 7: Sluice, detail of brick surround, from north

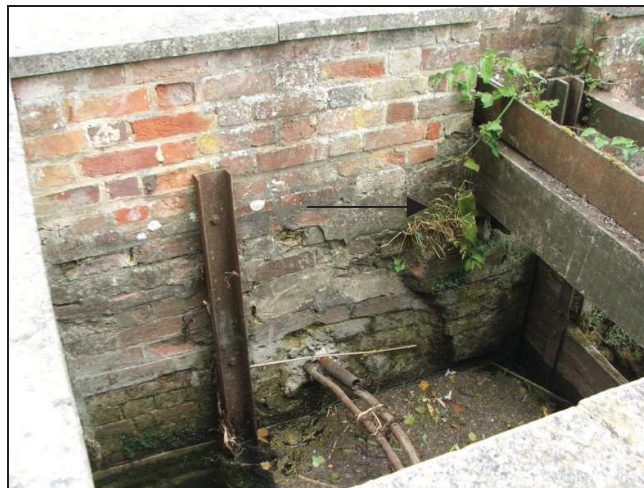
channel (Fig. 8A, Plate 6). On the channel walls, upstream of the gate, are two vertical iron channel sections, *c.*100mm wide (Plates 8 & 9). These are not mounted directly opposite each other. The walls of the eastern part of the channel, 4.1m in length, terminate at ground level (Plate 10). This section of channel is bounded by iron railings, 0.85m high (Plate 11). The floor of the channel is comprised of bricks, laid lengthwise (Plate 12). The bricks used appear similar to those in the lower part of the upstream river walls. Some bricks around the slot for the gate are missing, and there is evidence of deep scouring in the floor, east of the gate.

Plate 8: Sluice interior, north side, showing iron channel section

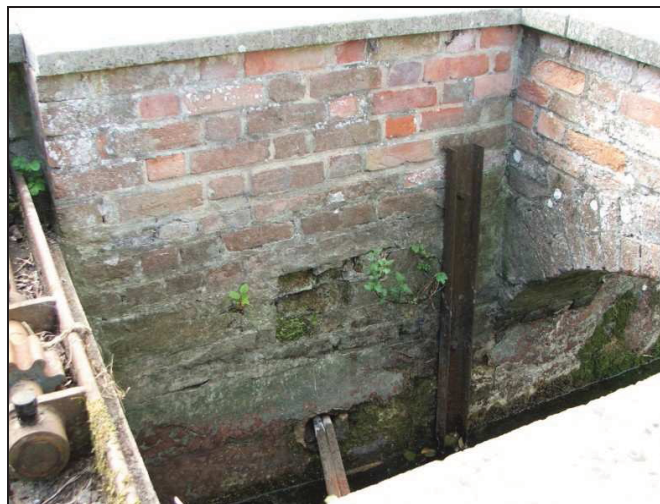
Plate 9: Sluice interior, south side, showing iron channel section

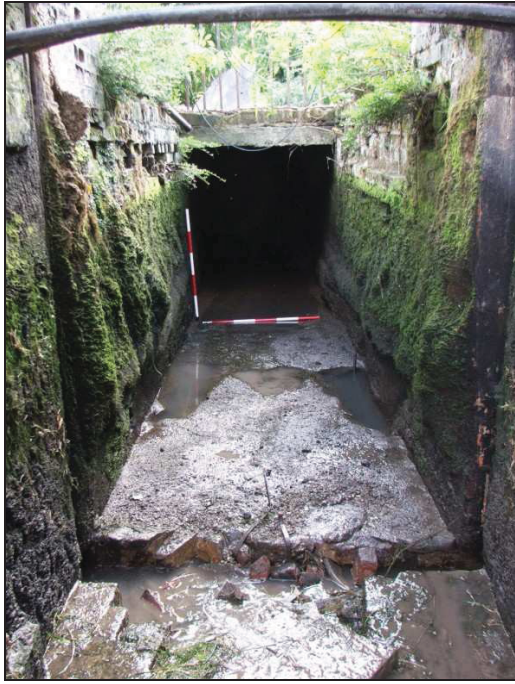
Plate 10: Sluice east of gate, and culvert entrance

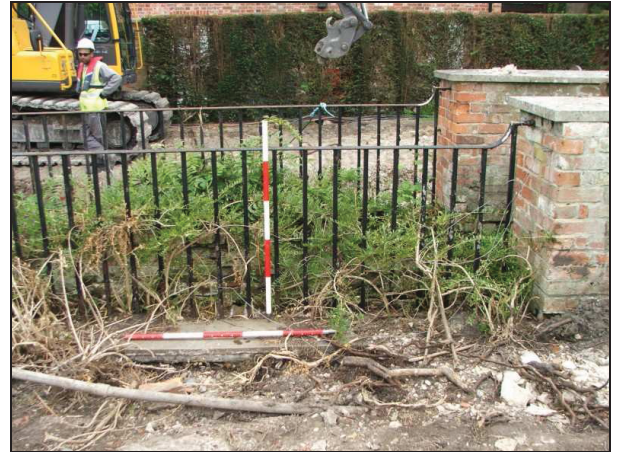
Plate 11: Sluice, detail of railings from north

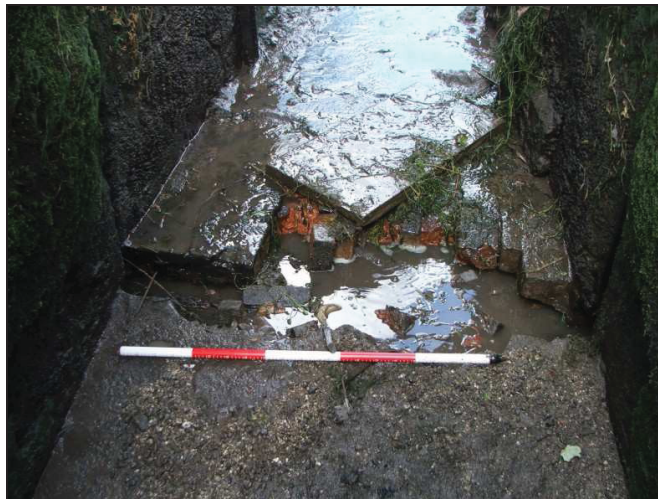
Plate 12: Sluice, brick floor and gate slot

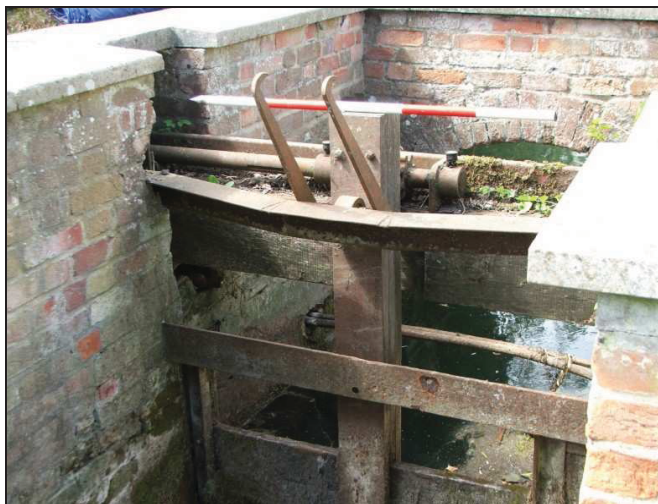
Plate 13: Detail of gate mechanism, from east

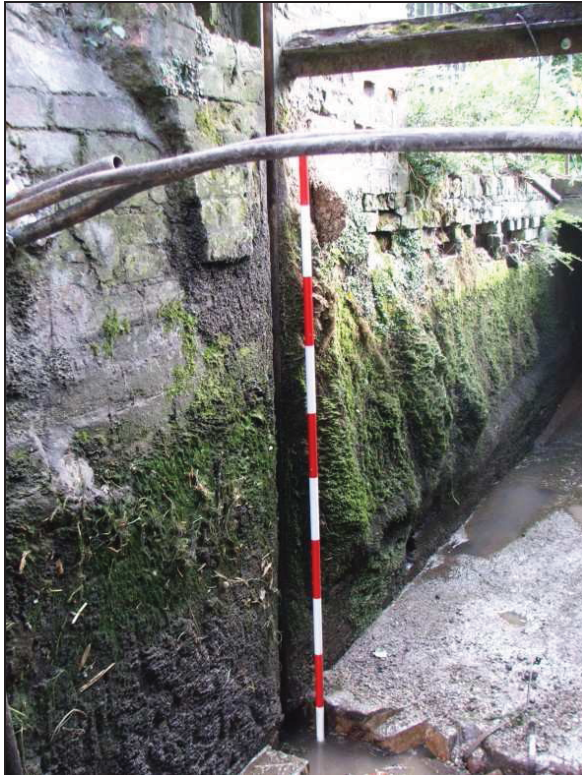
Plate 14: Sluice, north wall and gate slot

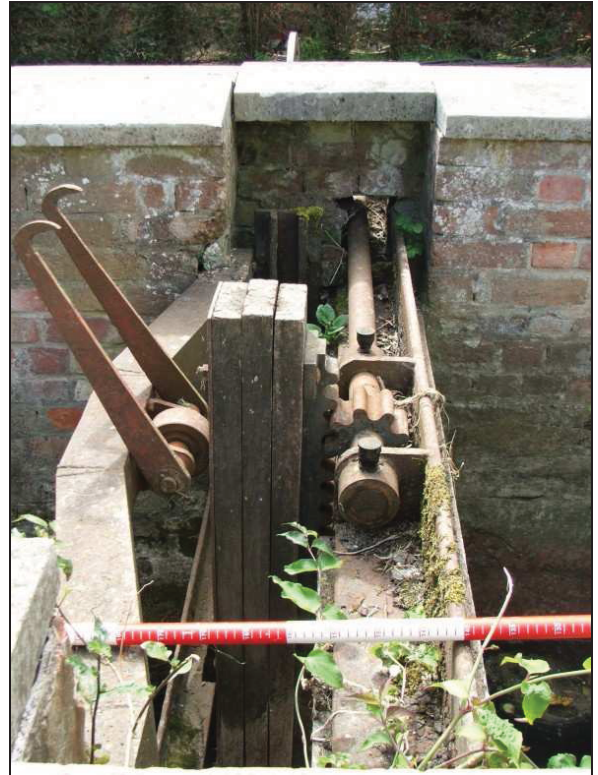
The sluice mechanism itself (Fig. 8B) comprises a vertical guillotine gate, constructed of horizontal planks (probably oak or elm) *c.*50mm thick, held together by vertical iron strapping, with a substantial central vertical beam on the downstream side carrying the cast iron rack used to raise and lower the gate (Plate 13). In the top edge of the gate is a cutaway section *c.*300mm deep and 1.0m wide. The side edges of the gate are located in iron channel sections set into the sluice walls and a slot in the sluice floor (Plate 14), and is raised and lowered by a pinion gear and shaft mounted on a substantial L-section iron beam set into the upper walls of the sluice (Plate 15), and driven by a wheel and reduction gear mounted on the south wall of the structure (Plates 16 & 17). Mounted on a cranked L-section iron beam immediately downstream of the gate are two hooked catches, which appear to be for locking the gate in the raised position (Plate 15).

Plate 15: Rack, pinion and shaft mechanism, from north-east

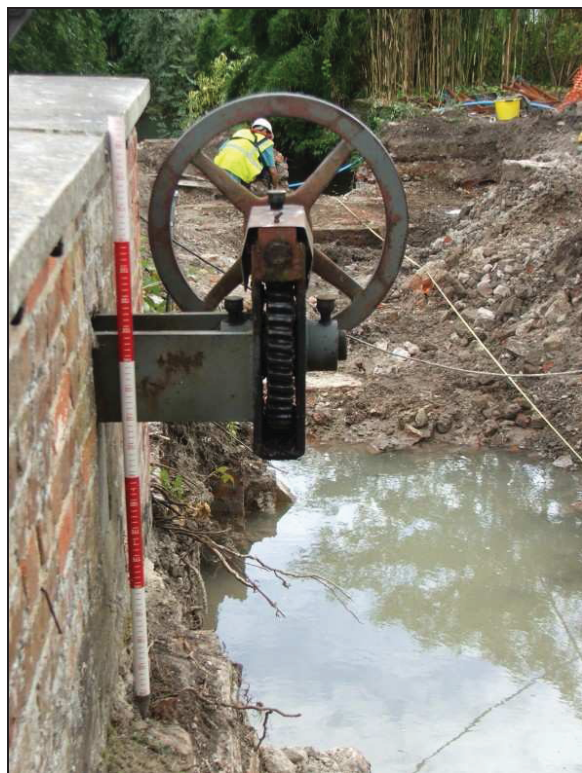
Plate 16: Reduction gear and winding handle, from north-west

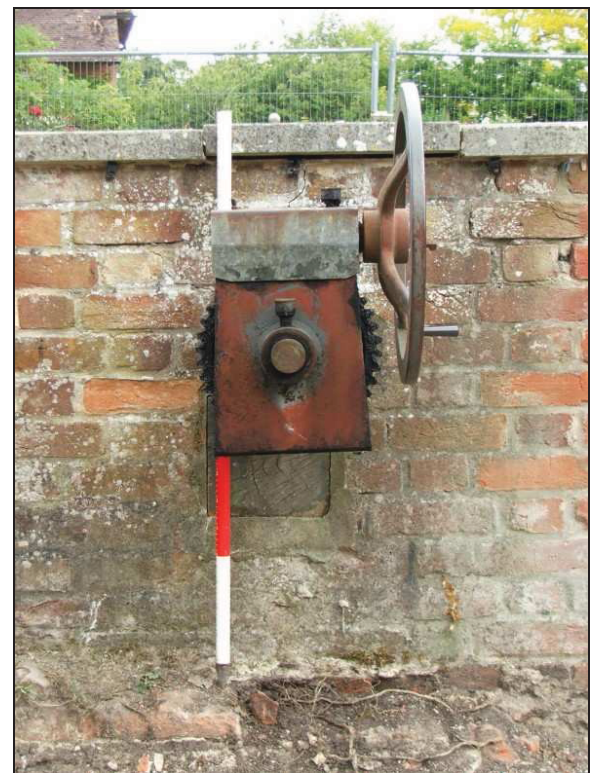
Plate 17: Reduction gear and winding handle, from south-west

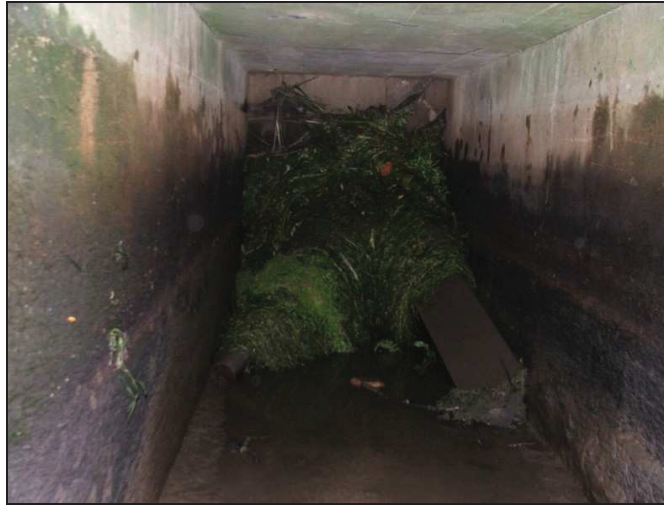
At the east end of the open channel the sluice passes into a culvert, 1.6m high and 1.2m wide, with walls and floor of concrete, capped by a concrete slab *c.*300mm thick (Plate 18). Judging from the size of the slab, this concrete culvert is at least 6m in length. At the time of the survey its lower end was blocked with debris from the recent flooding, so accurate measurement underground was not possible. From observations at its east end, the final 4.6m length appears to be a brick arched culvert, 1.4m wide and 1.2m high (Plate 19).

Plate 18: Concrete culvert beneath slab, from west

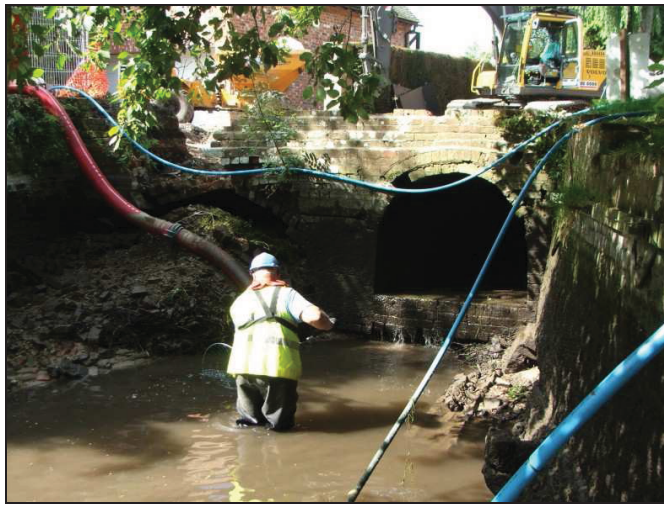
Downstream of the sluice, the water re-enters the river from the mouth of the aforementioned brick culvert. The river walls here are of brick, of similar type and construction to the upstream walls, though in a much poorer state, showing little evidence of repair, other than the insertion of a large 'X' tie plate to the north wall, to combat damage by tree roots. In the east-facing wall, south of the 'live' culvert mouth, the entrance to a silted up and partially collapsed second culvert of similar dimensions was observed when the site was dewatered (Plate 19).

Plate 19: Outflow arches downstream of mill site

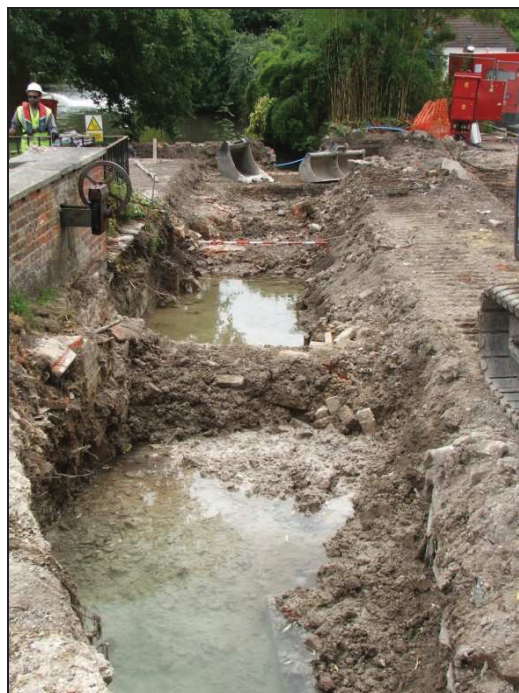
Plate 20: Excavated area from south-east, before cleaning

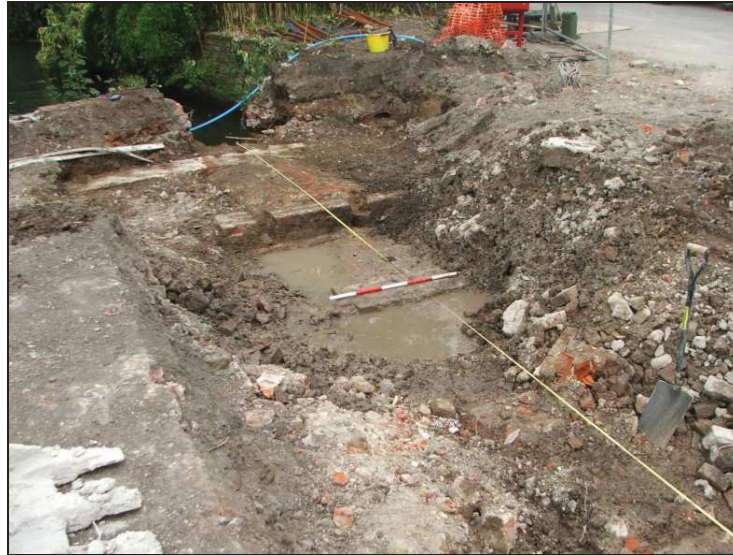
Subsequent hand cleaning of this area revealed five parallel closely-spaced north-east to south-west walls (Fig. 7A, 1-5; Plates 21-23), on a similar alignment to The Mill

Plate 21: Excavated area, looking south

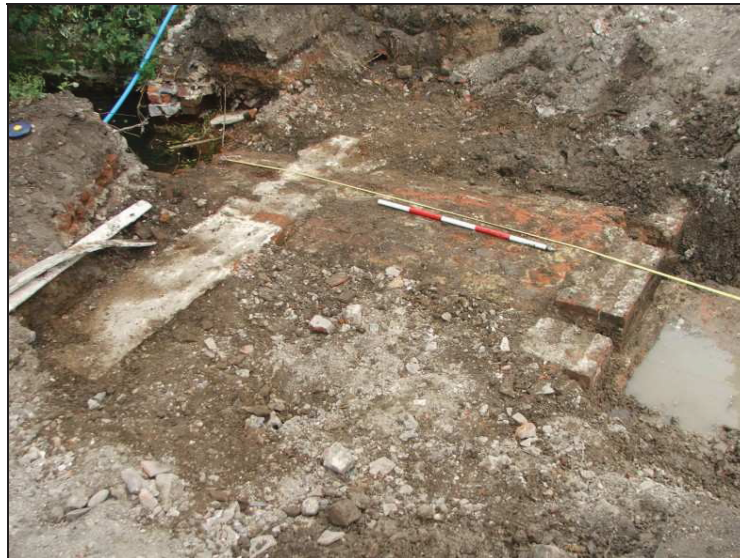
Plate 22: Walls 1, 2 and culvert roof, from north

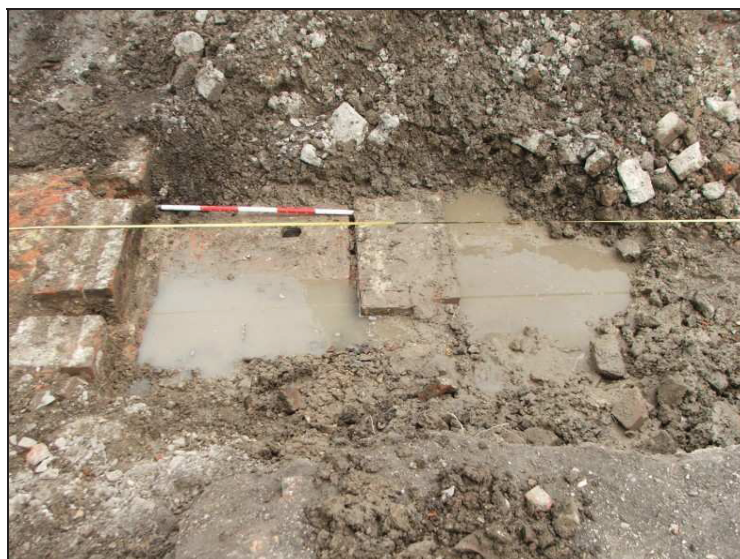
Plate 23: Walls 2, 3 and culvert roof, from north

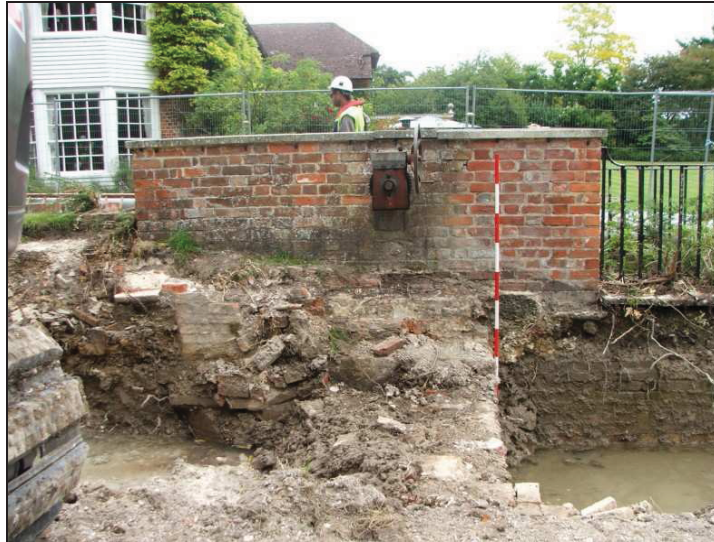
House. A sixth wall (Plate 24, Wall 6) followed a slightly more northerly alignment to the west. These walls were all constructed of orange-red brick, laid in Flemish bond, similar to the lower part of the river walls described above. Walls 1, 2, 4, 5 and 6 were *c.*500mm wide. Walls 1, 2, 4 and 5 were constructed across a vaulted brick culvert, only the top of which was revealed, running parallel to the sluice from the blocked collapsed culvert mouth to the east. The roof of the culvert was *c.*200mm higher between Wall 2 and the outflow arch: for what reason is uncertain. The culvert was traced to a point *c.*2m west of Wall 5, beyond which it had either been robbed out, or destroyed during machining (though this seems unlikely). Wall 3 was wider than the others, at 600mm, and appeared to have been constructed through the culvert. Wall 2 (Plate 22) was pierced by two (probably three) transverse slots, each 200-250mm wide, which appeared to be part of its original construction.

Plate 24: Wall 6 and sluice, from south

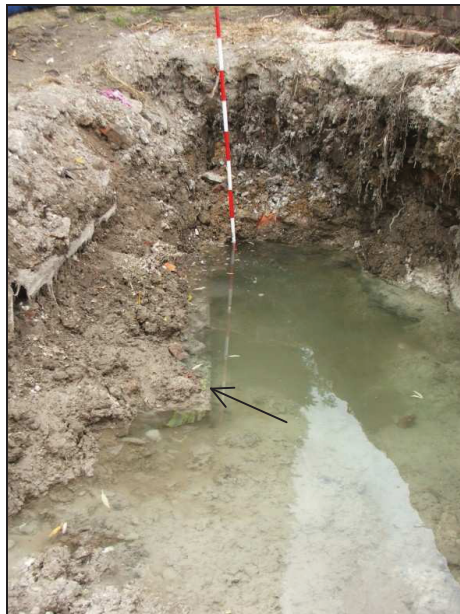
At the west end of the excavated area, a large mass of stone or concrete was noted (Fig. 7A; Plate 25), just below water level. While it was possible to record this on plan, its location made it impossible to determine its relationship to other structures in the trench, or its function.

Plate 25: Excavated area, north end, showing stone/concrete feature

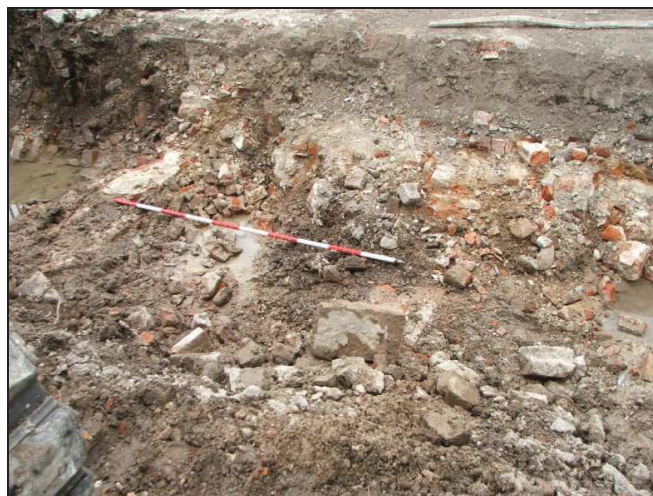
In addition to the above structures, excavation revealed the outer face of the brick-built culvert, and a large mass of brickwork to the immediate south of the concrete culvert (Plate 26). The form and function of the latter could not be determined. Apart from quantities of bricks, no finds were present to provide more precise indications of dating, and hand excavation below the machined depth of the site was not possible because of the water level in the trench.

Plate 26: Mass brickwork on south side of culvert, from south
