HISTORIC BUILDING RECORDING & WATCHING BRIEF: ALL SAINTS CHURCH CHALGRAVE BEDFORDSHIRE

on behalf of Chalgrave Parish Council

May 2007

ASC: 838/CAS/1

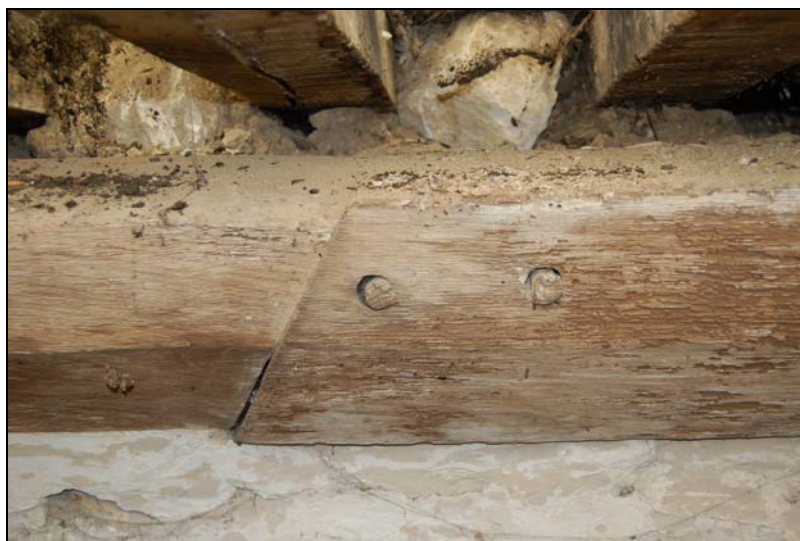
There are two scarf joints visible on the inner wallplate: a splayed, bridled and pegged scarf joint in Bay 3 and an edge-halved scarf joint where a new section of wallplate has been inserted at the western end of Bay 4. The wallplate itself is also chamfered.

Plate 5: North aisle, splayed & bridled scarf joint in north wallplate

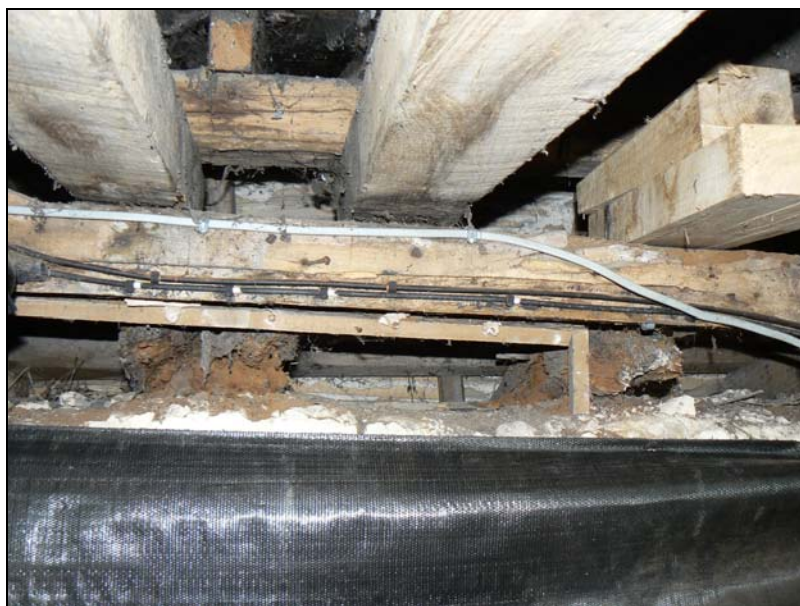
A timber structure had been added at some indefinable date to the south wallplate adjacent to Principal Rafter 3, presumably as part of a support system.

Plate 6: North aisle, additional timber box

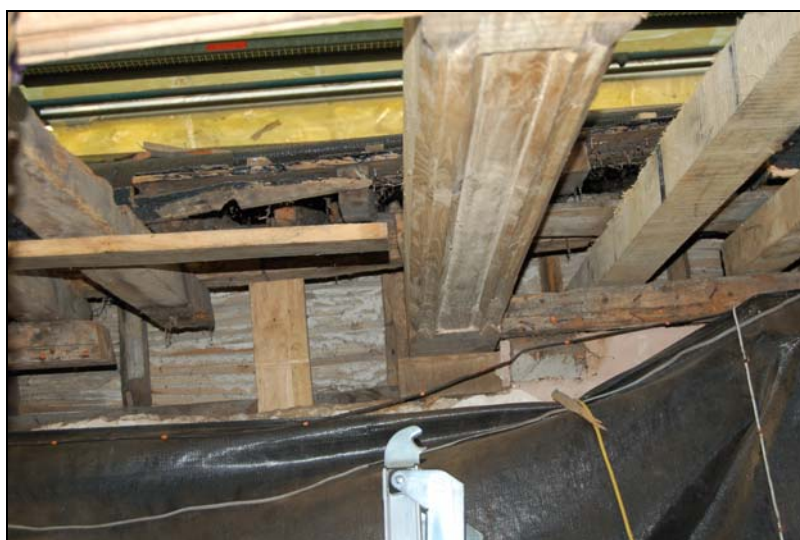
Plate 7: North aisle, new Principal Rafter 3

The repairs to the north aisles timbers were concentrated in Bays 2-4. Principal Rafter 3 and Common Rafters 12, 16, 17 and 18 were replaced in their entirety. The southern end of Common Rafters 5, 7 and 11, and the northern end of Common Rafter 22 were also replaced. Additional stub rafters were added to the northern end of Common Rafters 6, 15 and 19. Common Rafter 21 was repaired, as was Principal Rafter 2, where a section of the west facing section was replaced at the southern end. A section of the outer wallplate between Bays 1 and 2 was also replaced.

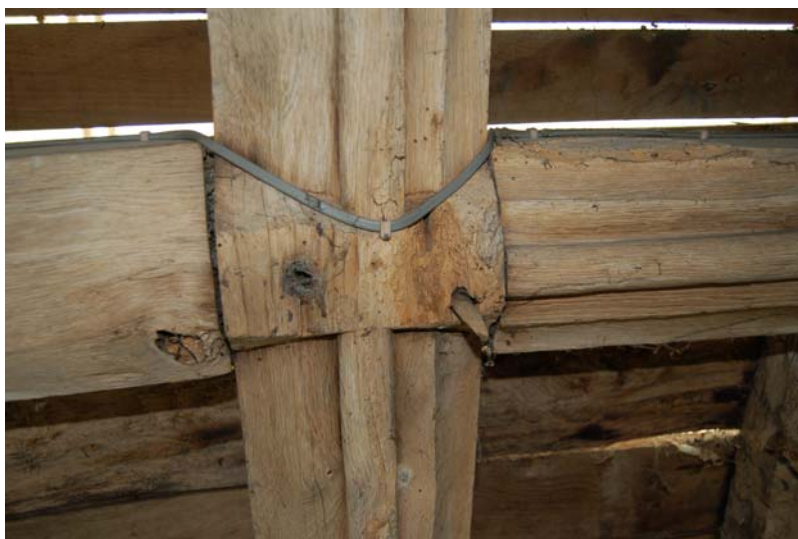
Plate 22: South aisle, purlin differences seen at Principal Rafter 5

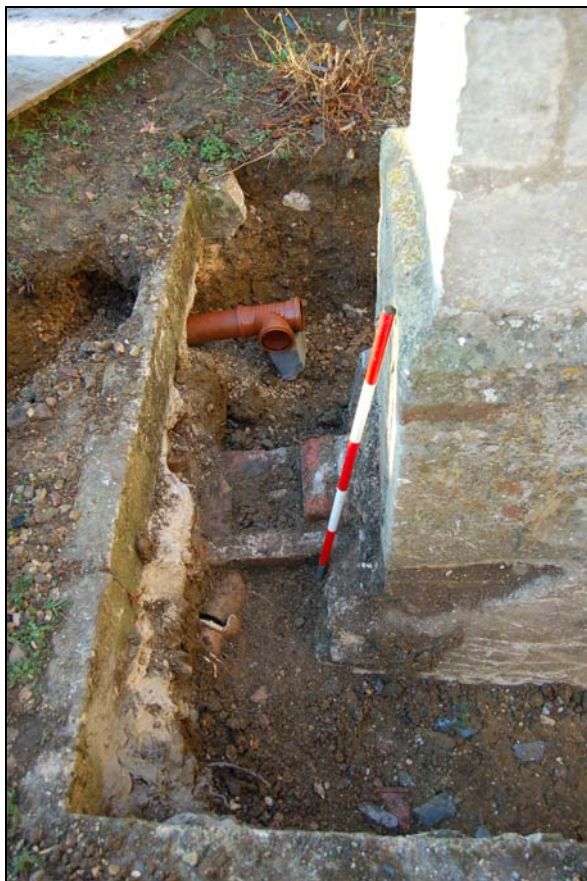
The trench along the south wall to the east of the porch the south wall was 0.90m wide and approximately 0.70m deep and contained dark brown sandy soil over clay natural. The base of the southeast buttress was seen to be rendered and a brick gully was revealed running southeast from the building. The gully, which was of modern bricks with cement mortar and a clay drainage pipe, was 42.5m wide and 0.52m below the present ground surface. The footings that were revealed at the junction between the chancel and the south aisle were similar to those observed at the eastern end of the south wall.

Plate 29: Southeast buttress

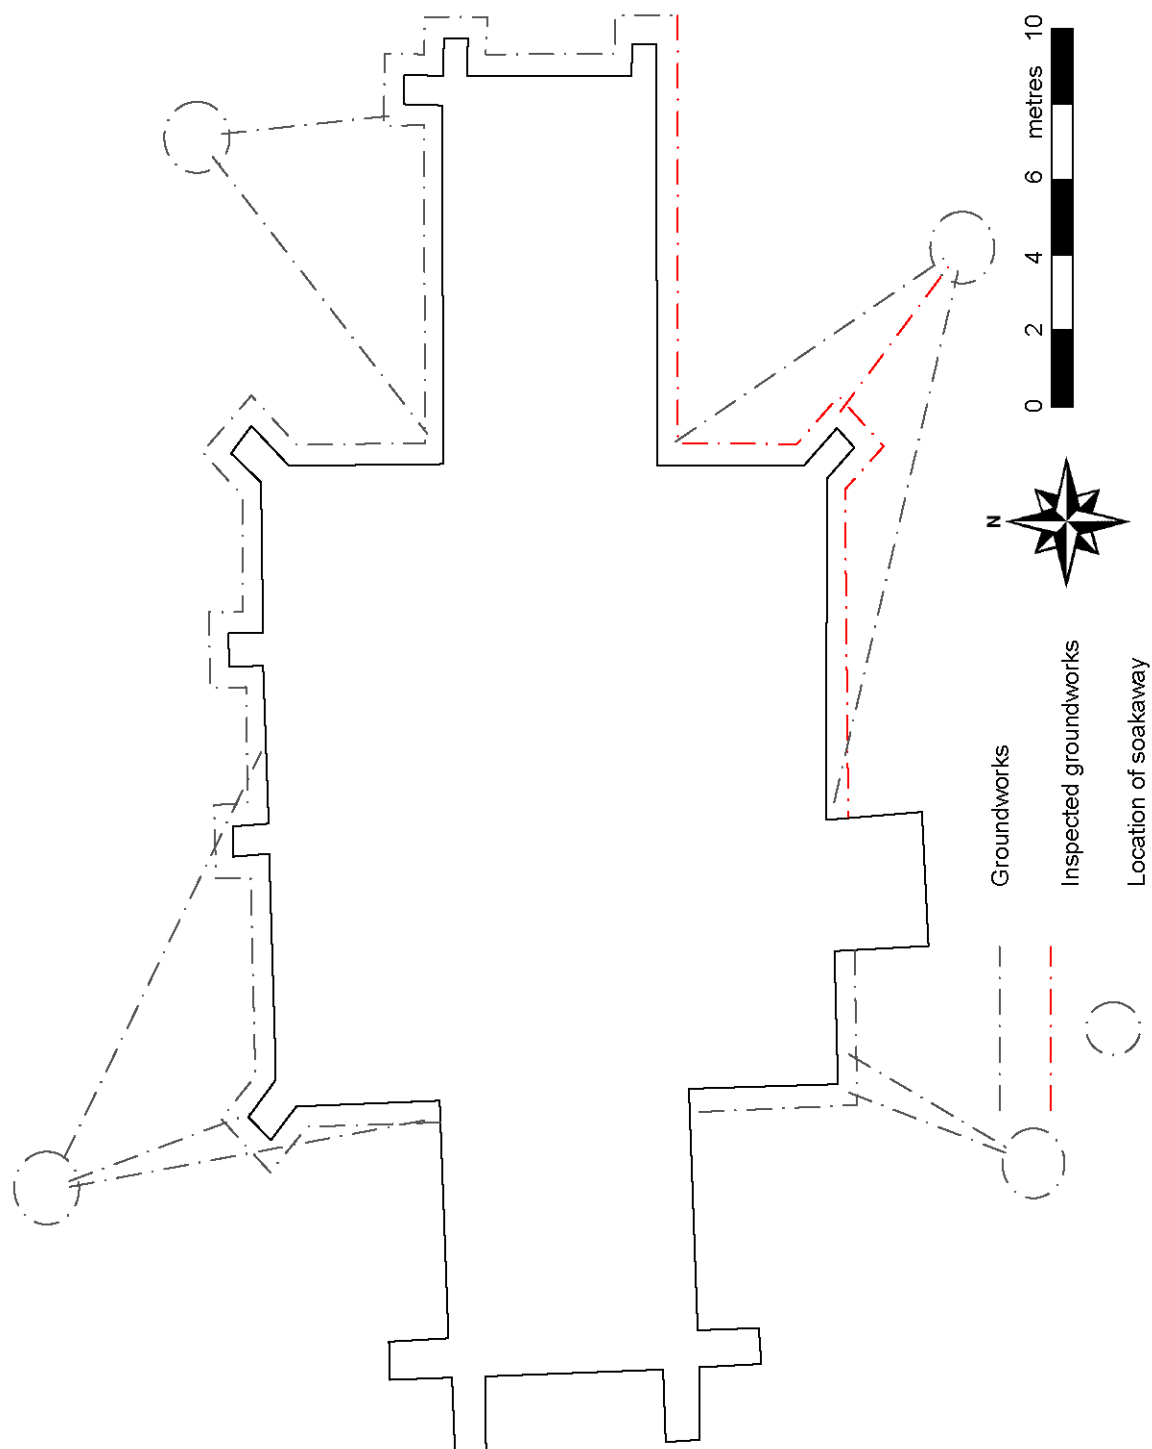
Figure 4: Groundworks (*scale 1:200*)

The soakaways were completely excavated prior to ASC being commissioned for the archaeological works. Most of the French drains were also excavated without ASC being informed and were therefore not recorded. A small section had been left open at the southeast corner of the building, revealing the foundations of the chancel, which comprised rubble, tile fragments and stones in a loose matrix, approximately 0.25m deep. According to the machine driver, there were flint footings, approximately 0.60m deep to the north of the church and brick footings to the west of the south porch.

The trench leading from the southeast buttress to the soakaway was 0.40m wide x 0.60m deep. Pea shingle had been deposited within the trench before arrival and no archaeological features and finds were observed.
