**HISTORIC BUILDING RECORDING & WATCHING BRIEF:
NEWTON BARN
LAVENDON MILL
OLNEY
MILTON KEYNES**

on behalf of Mrs Alicia Cavanagh

January 2007

ASC: 696/ONB/2

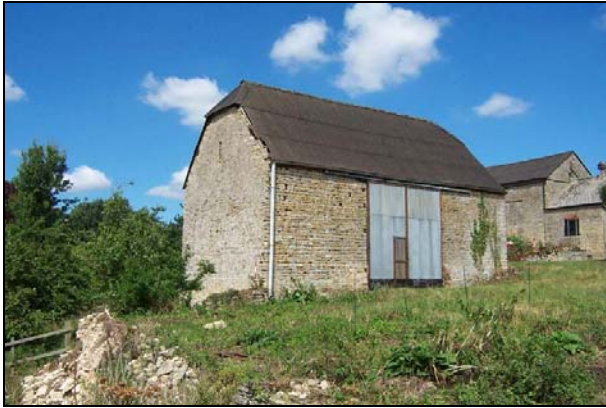
Plate 1: South & east elevations

The south elevation has a single splayed window and a number of randomly placed iron bars sticking out of the wall. The remains of a small piece of timber (0.10 x 0.05m) that also once stuck out of the wall is visible towards the west end of the elevation approximately 1.53m above ground level. The wall is offset below this at a height of 1.13m above ground surface. A garden wall extends southwards from the eastern end of this elevation. The ground level is approximately 1.10m higher to the east of the garden wall. The ends of the wall plates and purlins are exposed due to the re-roofing.

Although the double barn doors have been replaced by sliding doors, the original doorframe is still in place. There are four bonding timbers measuring between 12 x 13cm and 8 x 17cm running through the wall on either side of the door.

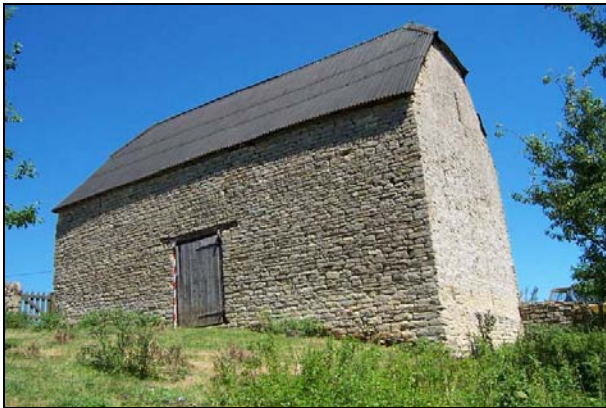
Plate 3: West elevation

The west elevation has a centrally located, single, ledge and braced door and a small opening (c.0.12m dia.) for the drainage gully approximately 1.33m to the south of it. The land to the south of the door drops steeply towards the river and the wall is offset immediately south of the drain. There are two possible putlog holes at the northern end of the elevation and a further one in a lower course at the southern end.

No alterations appear to have been undertaken to the west wall apart from a replacement lintel over the door.

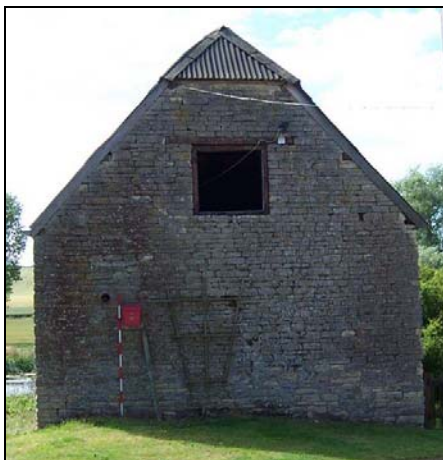
Plate 5: North elevation

The main characteristics of the north wall are the large rectangular window with a wooden lintel and a circular opening containing a ceramic drain (c.0.18m dia.) towards the eastern end of the elevation. The opening has a wooden lintel over it on the internal wall and appears to have been a putlog hole that has been maintained for ventilation. Two putlog holes are present at wall plate height in the external elevation. The one at the eastern end has subsequently been blocked. The ends of the wall plates and purlins are also exposed, as in the south elevation.

The window in the south elevation appears to be an original single splayed opening with a wooden lintel and sill. In contrast, the window in the north elevation is a large, rectangular opening with a wooden lintel above. The window truncates one of the bonding timbers, and, as such would appear to be a later addition. Although it could have replaced an earlier splayed window, there is no remaining evidence to support this.

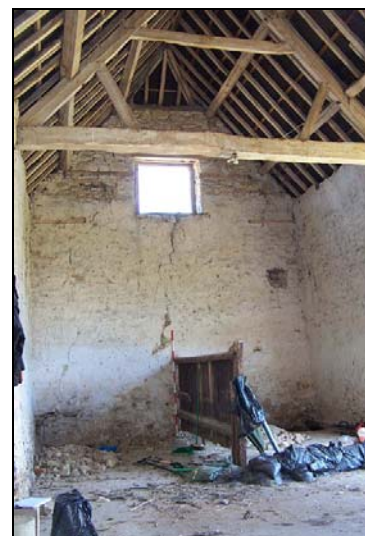
Plate 6: North wall

The south wall has been plastered to a height of c.0.82m in recent times, which is in keeping with farming practices in the 1950s and later. The north wall has the remains of earlier horsehair and lime plaster.

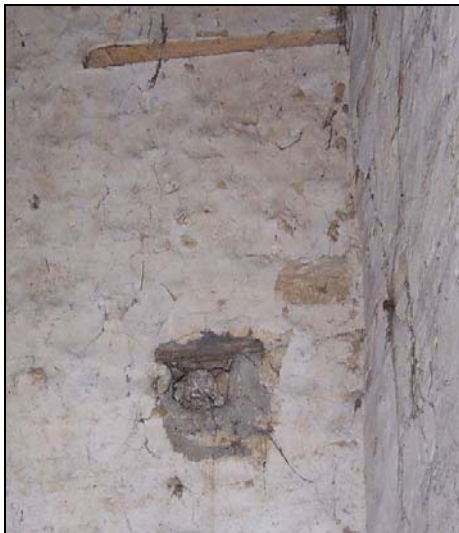
Plate 9: Putlog hole in north wall

An interesting feature of this otherwise stone built barn is the use of randomly located bonding timbers, which were thought to aid the structural stability of a stone or brick building and commonly used in the 18th and 19th century. Most of these are original and riddled with woodworm preventing the identification of the timber used and destroying any possible features, such as nail holes associated with them.

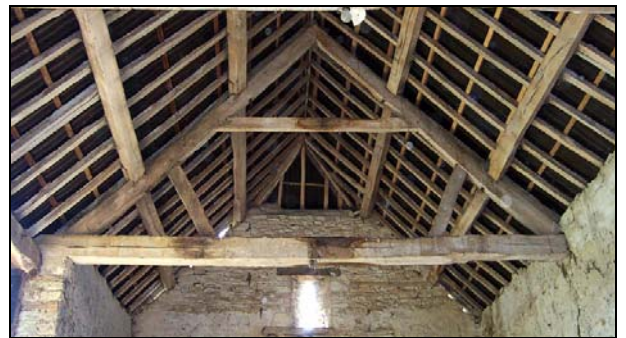
Plate 10: Southern roof truss

The roof has been rebuilt to provide replacement rafters and a corrugated metal roof covering. The roof trusses and purlins, however, are original and consist of trenched purlins with raking queen struts and collar beams. There are simple face halved scarf joints on all the purlins where they meet the trusses. Metal bolts have been added to strengthen these joints that are showing signs of failure. The tie beams are elm. Carpenters' assembly marks have been gouged and chiselled on both trusses. The roof features would suggest an early 18th century date for the building.

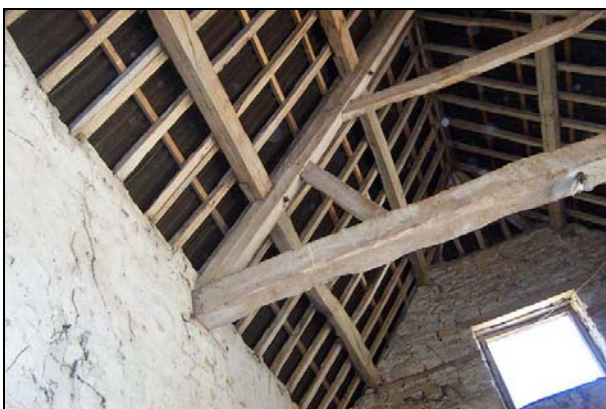
Plate 11: Face halved joints and metal bolts

Comments: Face halved scarf joint noticed at each of two junction on all 4 pillars metal bolts attached to provide added security as joints are moving. N door post replacement timber, but S original

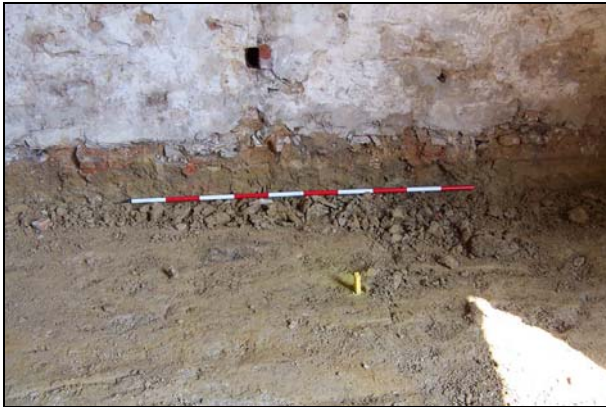
Plate 13: Ground reduction at the north wall

5.1.2 The barn floor was reduced by approximately 46cm at the northern end and 40cm at the southern end (Plate 13). The foundations of the north wall and the ground upon which it had been built were exposed by the work. A small area of walling at the eastern end of the north wall had partially collapsed, revealing 19th century pottery fragments and bits of glass within the thickness of the wall. Occasional fragments of CBM and pottery were also observed in other sections of wall.

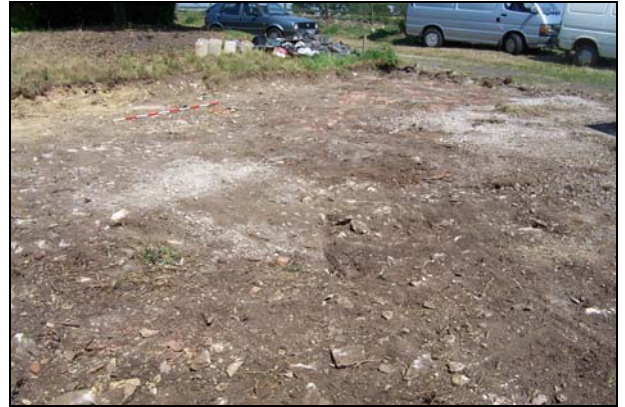
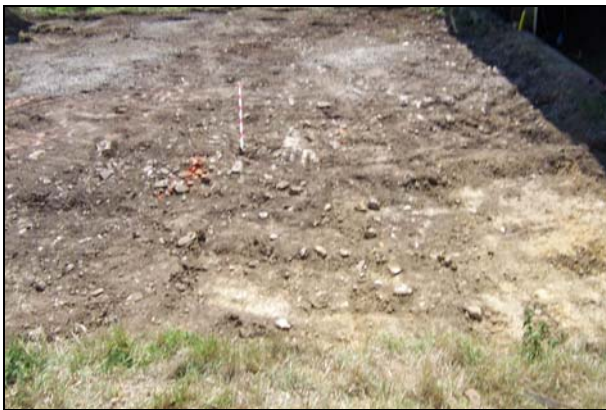
5.1.3 The ground surface in the yard area was reduced by 5 –20cm revealing a layer of modern brick, gravel and stone with occasional pieces of wood, plastic, rubber and a single cola can (Plates 14-15). This would appear to be a modern levelling layer, possibly started when the modern doors were installed in the barn and added to as necessary since then. There was no evidence for the earlier buildings, possibly as these lay below the levelling layer, or equally because the foundations for these had also been extremely shallow.

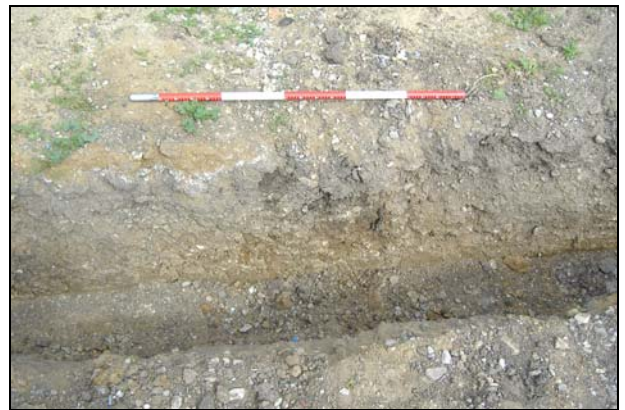
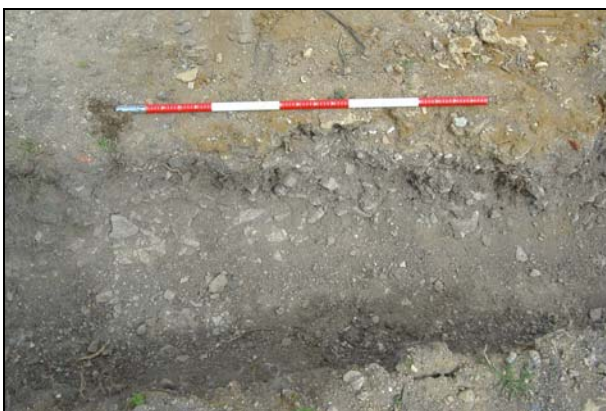
5.2.1 The footings for the garage, which were 0.30m wide and up to 0.60m deep, revealed 0.05m of overburden overlying a 0.28m deep layer of dark greyish brown silt (Plates 16 -17). Below this was mid-orange brown clay natural. The trenches to the south were shallower and wide than those to the north, and contained a greater quantity of stone including fairly large slabs of very weathered local stone. No archaeological features or finds were observed.

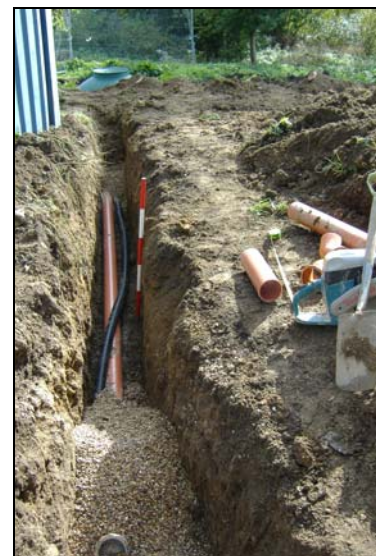
Plate 18: Drainage trench looking southeast

5.3.1 The single drainage trench that impacted on an unmonitored area of the development site ran from the north-east corner of the garage to a septic tank approximately 11m to the south-east of the garage. The trench was 0.50m wide and up to 0.80m deep (Plate 18). The natural clay was reached in the northern end of the trench approximately 0.70m below the reduced ground surface. Above this was a light brown sandy silt subsoil with occasional brick/tile and moderate stone inclusions. No archaeological features or finds were observed.

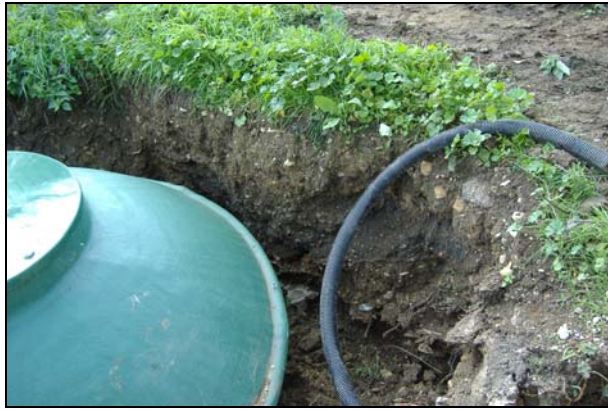
Plate 19: East facing section of the septic tank

5.3.2 The septic tank, which was 3.0 x 2.80 x >1.30m deep, cut very stony made ground containing brick/tile and glass fragments (Plate 19).
