**HISTORIC BUILDING RECORDING:  
LITTLE CASSIOBURY  
31 HEMPSTEAD ROAD  
WATFORD  
HERTFORDSHIRE**

NGR: TQ 10343 96961

*on behalf of Hertfordshire County Council*

February 2008

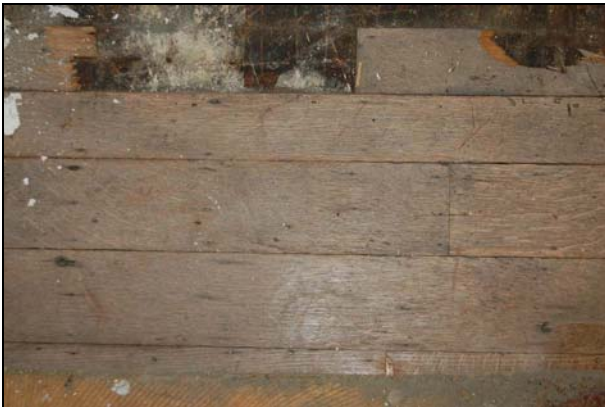
*Floor:* Thin veneer of possible 1930s date over 19cm wide timber boards, probably 17<sup>th</sup> century

**Plate 7:** Room G3: two layers of floorboards

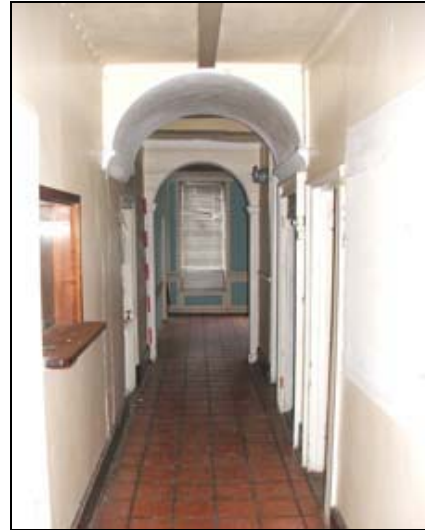
*Fittings:* The eastern arch one by the cellar door appears to be a 1930s addition but the western one is liable to be 17<sup>th</sup> century.

**Plate 14:** Room G4 showing hatch and 1930s arch

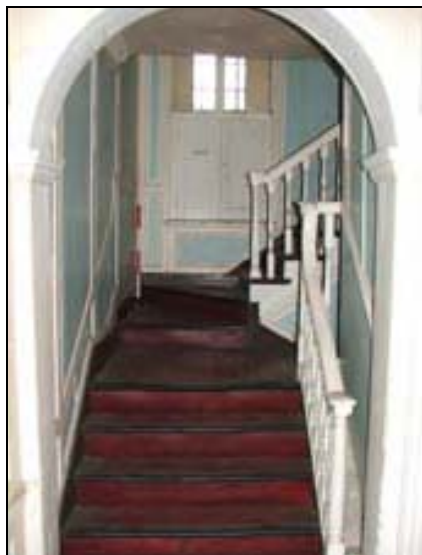
*Fittings:* Fireplace – possibly 17<sup>th</sup> century. Staircase – largely rebuilt in the 1930s but may have used some of the original timbers. The window in the half landing has been reglazed but the frame and shutters may date from 17<sup>th</sup> century.

**Plate 22:** Room G6: stairs

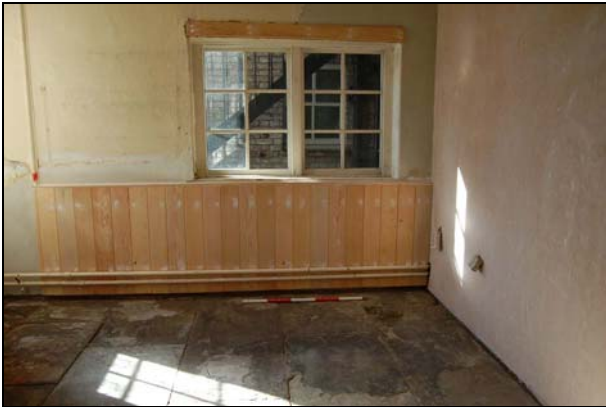
*Walls:* North, south & east – brick, west wall- plasterboard

**Plate 29:** Room G8: west wall undergoing restoration

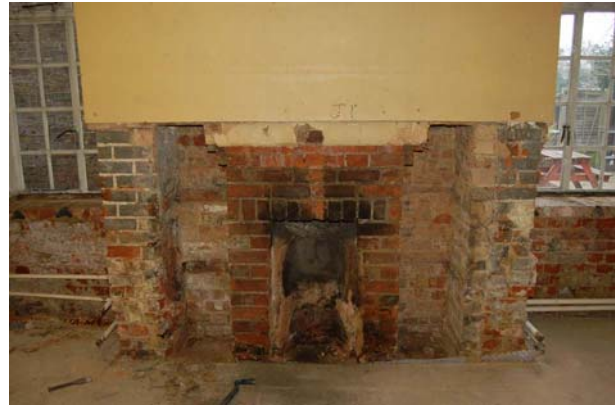
*Fittings:* Panelling replaced, fireplace within inglenook, 19<sup>th</sup> century

**Plate 30:** Room G8: fireplace in east wall

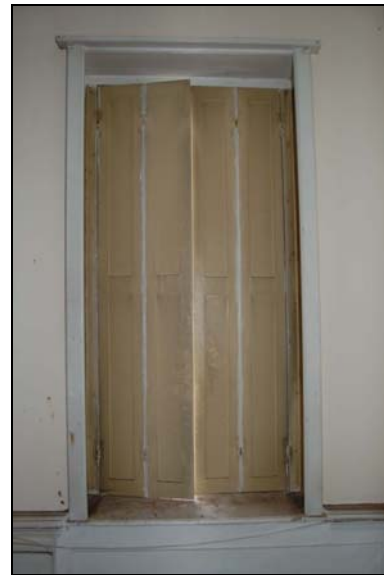
*Windows:* West – 17<sup>th</sup> century, South – 19<sup>th</sup> century. Shutters to northern window in west wall are modern replacements but with original hinges

**Plate 53:** Room F4: replacement shutter

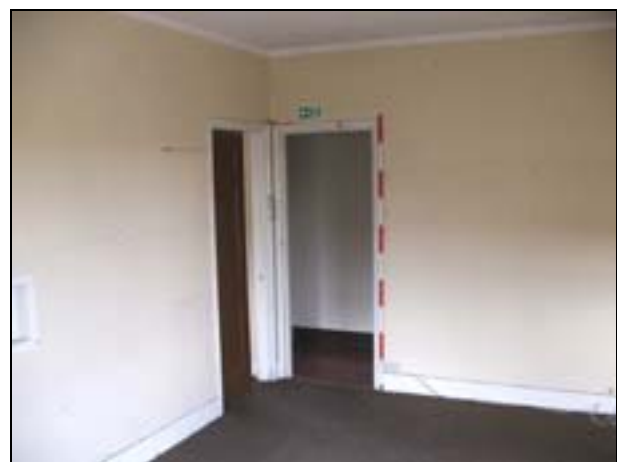
*Walls:* West – post 1930s fibreboard, others brick. All painted

**Plate 61:** Room F7: NE corner showing modern north wall and sliding door

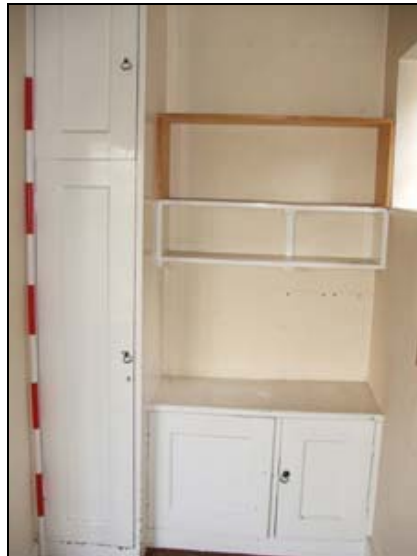
**Plate 62:** Room F8: early 20<sup>th</sup> century cupboards

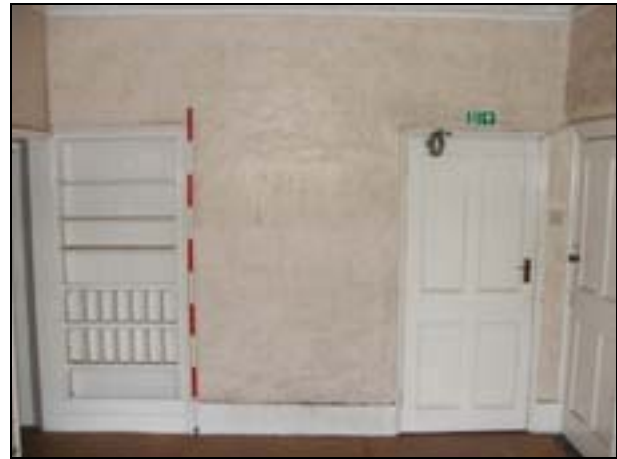
*Fittings:* Shelving in former doorway – modern. Panelling in recess to east of fireplace – possibly 20<sup>th</sup> century. Fireplace – 1930s

**Plate 64:** Room F11: east wall showing modern shelving & 1930s door

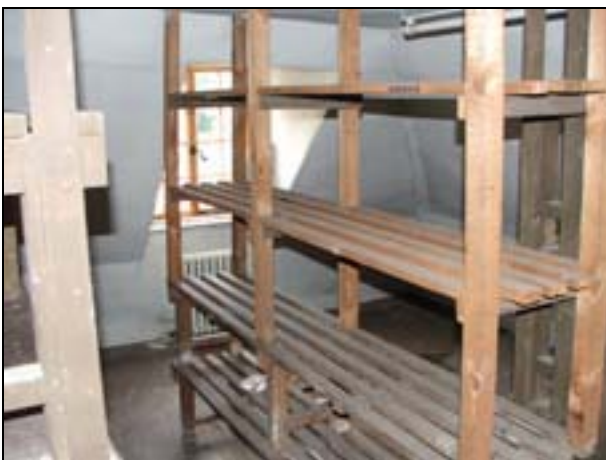
**Plate 73:** Room S2: northwest corner showing modern racks and replacement dormer window

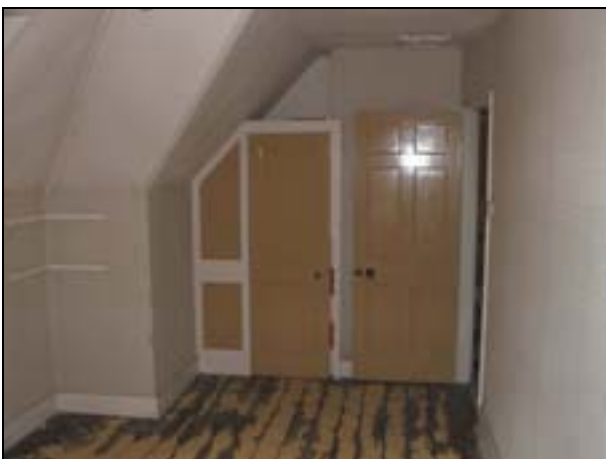
**Plate 79:** Room S6: west wall & 1930s cupboards
