**BUILDING RECORDING & WATCHING BRIEF:
LOWNDES ARMS, WHADDON
BUCKINGHAMSHIRE**

on behalf of C.J. Bricknall & Co.

June 2005

ASC: 684/WLA/2

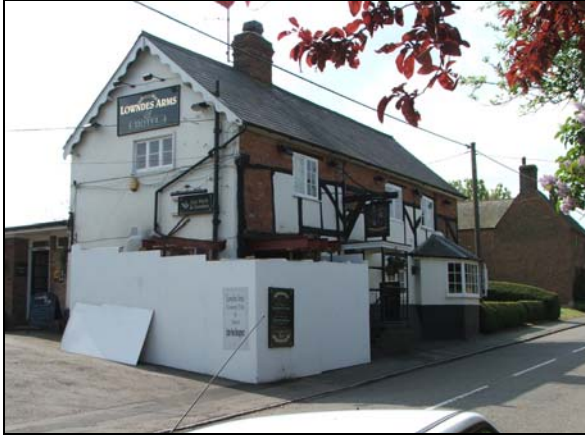
Plate 1: Lowndes Arms, north-west corner

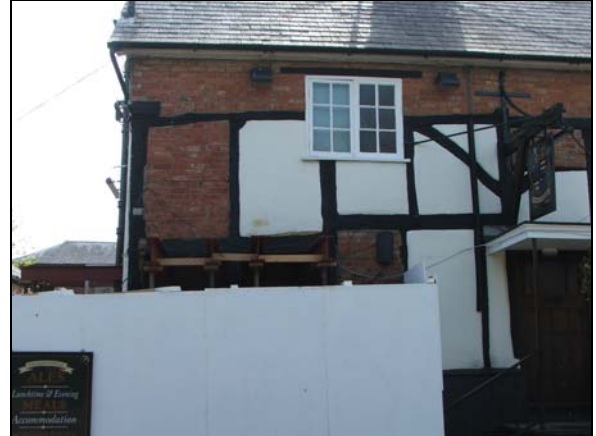
Plate 2: Lowndes Arms: area undergoing repairs

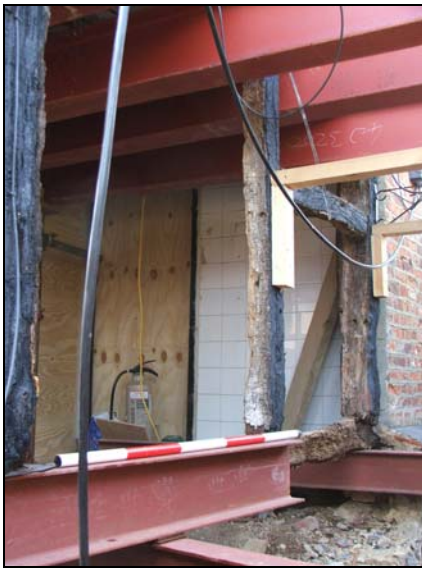
Plate 3: Repair area, view from north-west

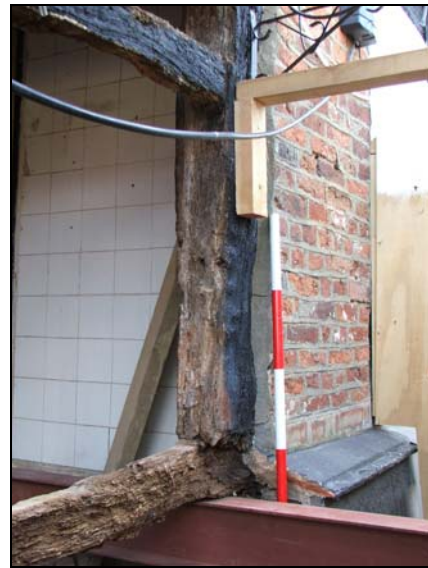
Sill plate A and the bottom ends of posts B, C and D were all badly rotted, and there was evidence of rot in rail F at its junction with post B, which had been reinforced with iron straps externally and internally. A large gap in the joint area had been filled with modern filler. Post B itself had suffered considerable erosion on its exposed surfaces, and a repair piece *c.*1.0m long had been let into its north face, presumably to make good rot or damage. The repair piece appeared not to be oak, though positive identification could not be made. Nothing remained of the joints between B, C, D and the sill plate.

Plate 4: Timbers A, D & E, from north-west

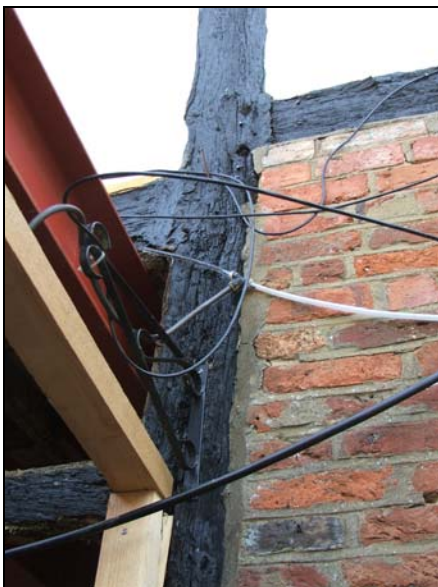
Plate 5: Timber D, junction with F

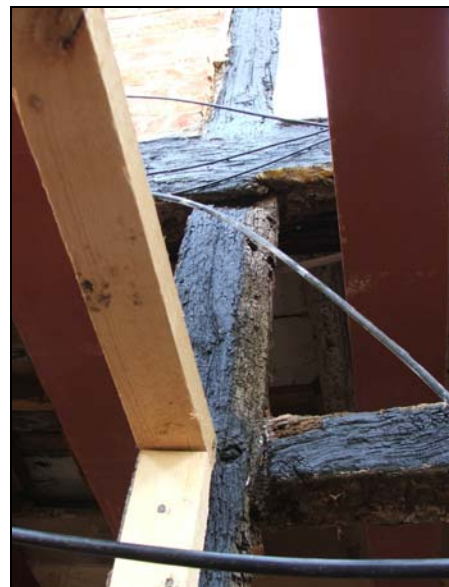
Moving up the frame, rail E was mortised into post C, and fastened with a single peg, passing right through the post. Two adjoining pegs indicated that there had been a similar rail between posts C and B, a slightly higher level. The mortises for this on the north side of C and the south side of B had been plugged. The joint between E and D was probably also a mortise and tenon, but this could not be confirmed, and no pegs were visible. Post C was mortised into F: two pegs were visible on the inner face. F appeared to be mortised into post B: the joint was pegged on the inside face.

Plate 6: Timber C, junctions with E and F

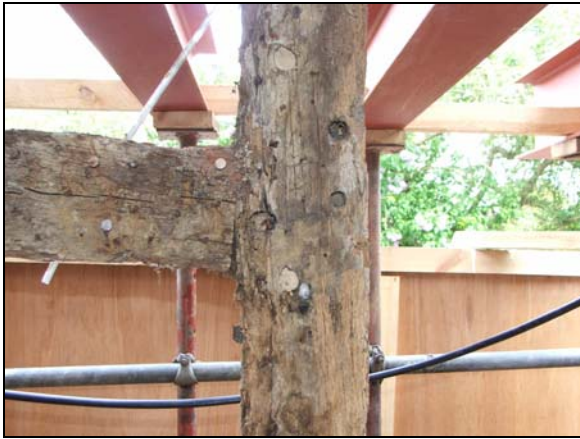
Plate 7: Timbers C & E junction, internal view

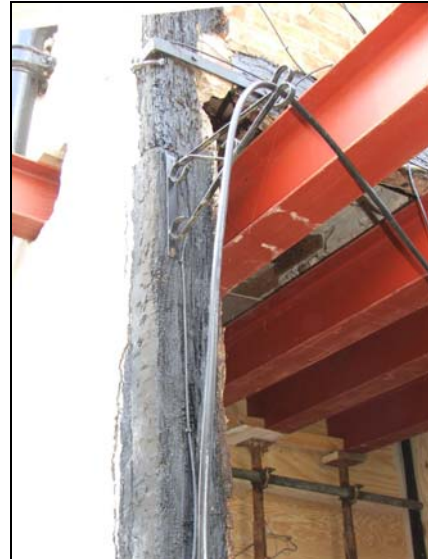
Plate 8: Timber B, junction with F

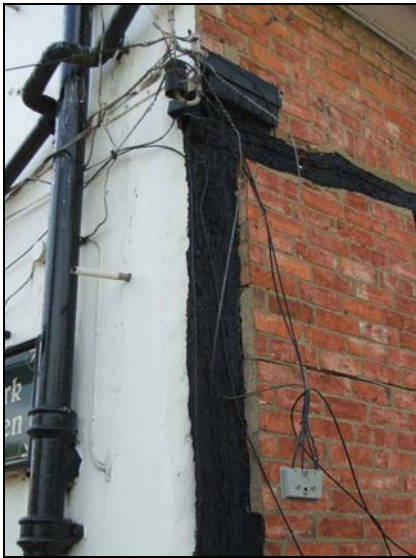
Plate 9: Timber B, upper part

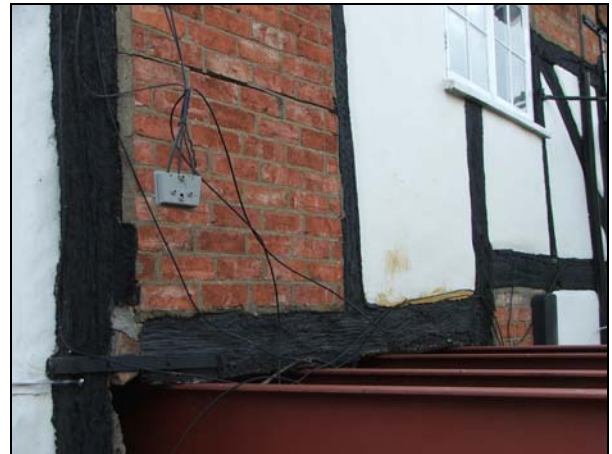
Plate 10: Timber F and wall above repair area

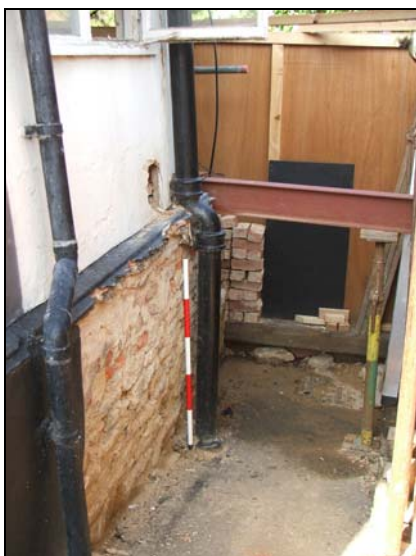
Plate 11: North elevation, west corner

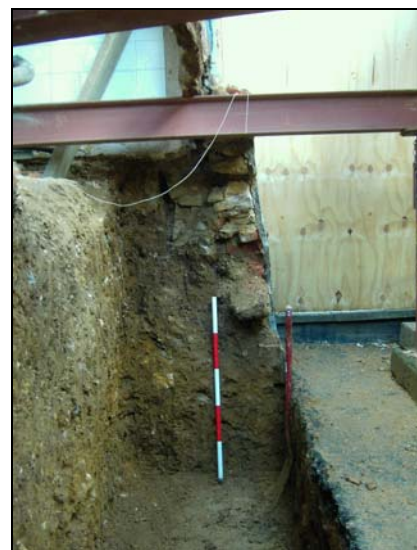
The full height of this section of wall, from the soleplate of the timber frame to the base of its footing trench, was 1.6m. The footing trench itself was 0.6m deep, measured from pavement level. The section on the east side of the trench, below the present internal concrete floor of the building, was as follows:

0.0 - 0.5m	Reddish orange sandy clay and rubble
0.5 – 1.0m	Dark yellowish-brown sand, 1% gravel
1.0 – 1.3m	Yellow clay, slightly sandy
1.3 – 1.6+m	Sandy clay, 15% gravel

Plate 12: Section revealed by removal of wall

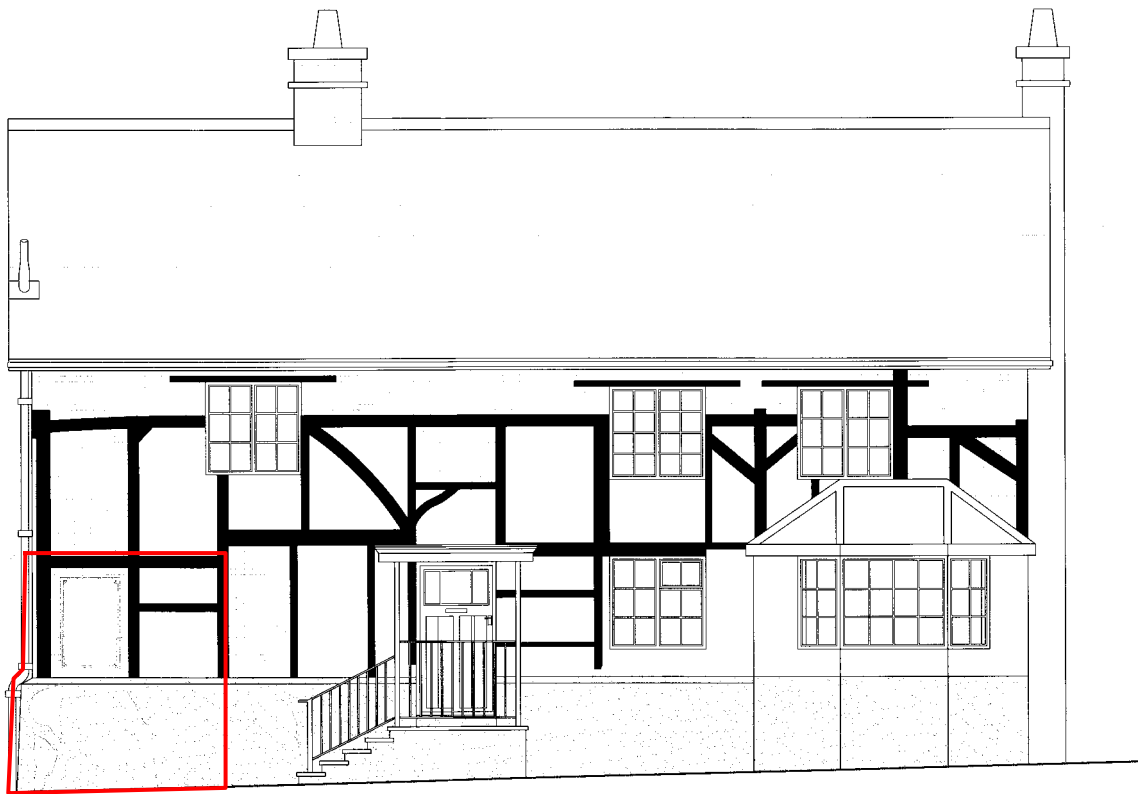
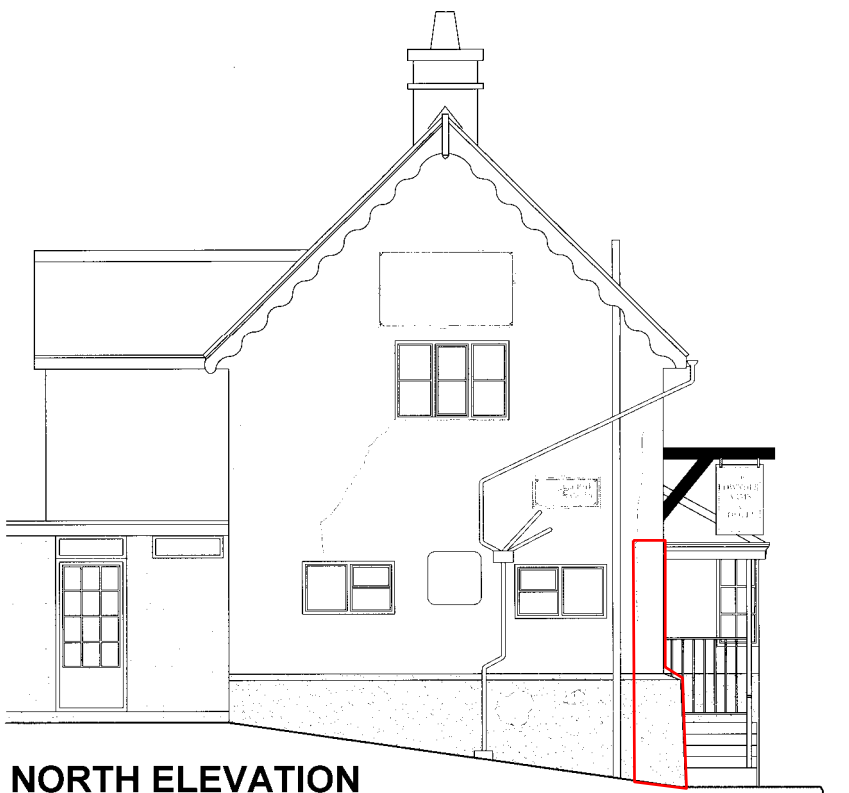
Figure 5: External elevations, showing extent of repairs in red (*scale 1:100*)

The proposed development comprises remedial works to the north-west corner of the *Lowndes Arms*. As a result of rotting of the corner upright and soleplate beams of the building's frame in this area, and subsidence of the rubble wall on which they stand, the corner of the building has sagged. It is proposed that the rotten sections of framing are replaced by new wood, and the supporting wall is rebuilt on sound footings.

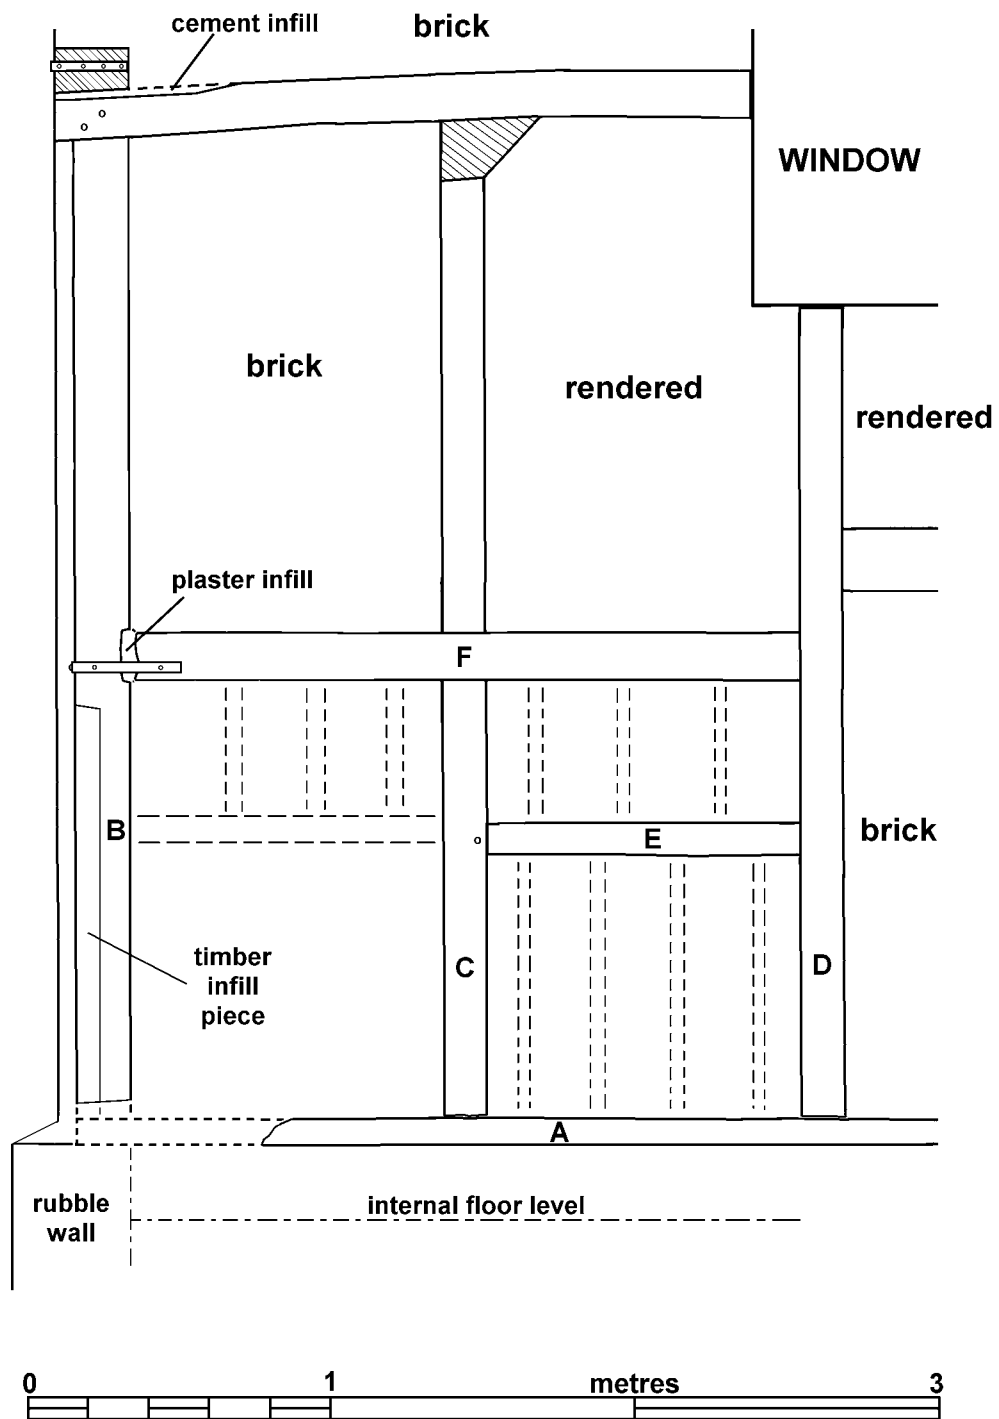
Figure 6: The exposed area of frame (scale 1:25)

That part of the building directly affected by the repairs was the west end of the north bay, extending about 2.5m along the frontage (west wall), and to a lesser extent along the north gable wall. That part of the box frame exposed for recording comprised the lower half of the west wall, an area of *c.*2.0 × 2.5m. The timbers recorded (Fig. 6) comprised the sill plate (A), corner post (B), wall post (C), principal post (D), and intermediate rail (E) and side rail (F). While no detailed analysis was possible, the framing appeared to be oak. All external surfaces were covered with a heavy coat of a black paint, possibly bitumen-based.

Examination of the upper and lower faces of E and F revealed evidence for the original wattle-and-daub infill panels. Auger holes to take the wattle staves were present in the lower face of F, and the upper and lower faces of E. The stave holes were all eroded by rot, so reliable measurements of diameter and depth could not be obtained. However, it was possible to ascertain the arrangement of staves: this is shown in Fig. 6.

- 5.2 The section of the box frame undergoing repair appeared to be original, though it was evident that it had been subject to remedial repair on one or more occasions in the past. Previous problems at the north-west corner of the building were evidenced by the strapping on the B/F joint and at the top of B (Fig. 6), and by the infill piece in B.
