Merryhill Farm, Haywood, Herefordshire:  
archaeological monitoring and building recording

Dan Lewis  
2004

Client: Mr M Mitchell, Merryhill Farm owner

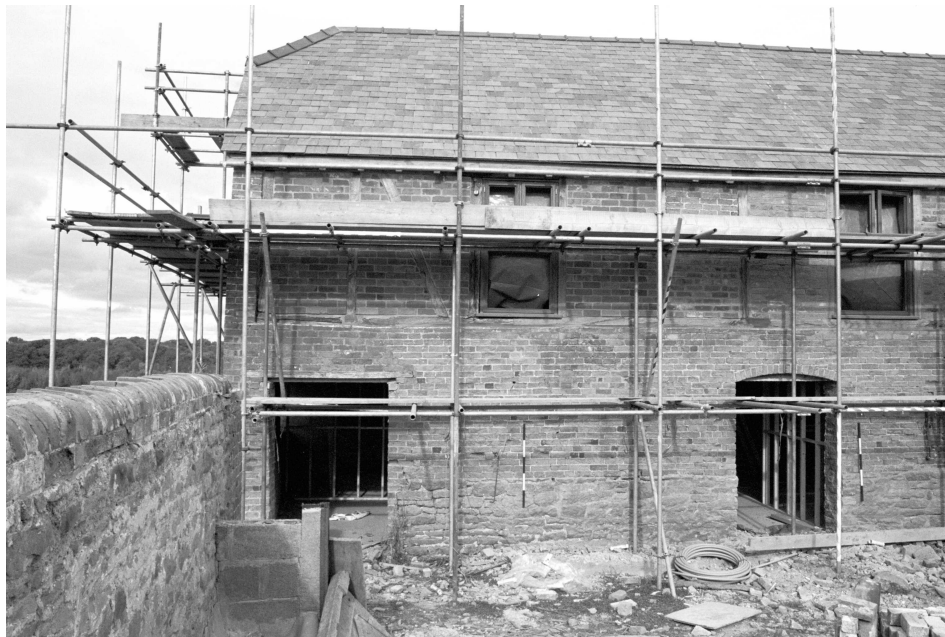
**Plate 2: Inserted doors and windows in the south elevation of the stable**

The south elevation of the stable (drawings 1 and 2) originally had five doors, three of which were stable doors opening onto the fold yard. Six windows rested on the stone plinth. The window of the store room at the east of the building is of a different form, being above the stone plinth and narrower and taller.

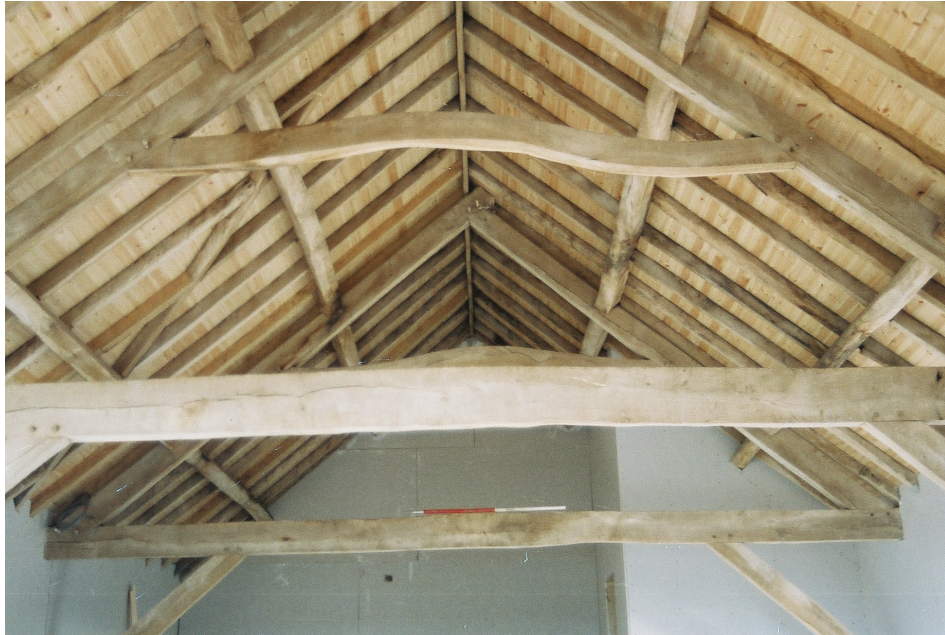
**Plate 3: Internal A frame truss (cross section L-K) in the stable**

At the time of the survey the stable was undergoing conversion. The internal wooden frames of the barn and the rafters from the roof were all cleaned using a sandblaster. The truss and roof detail above and below show cleaned timbers. A wind brace can be seen to the left in plate 3 and 4.

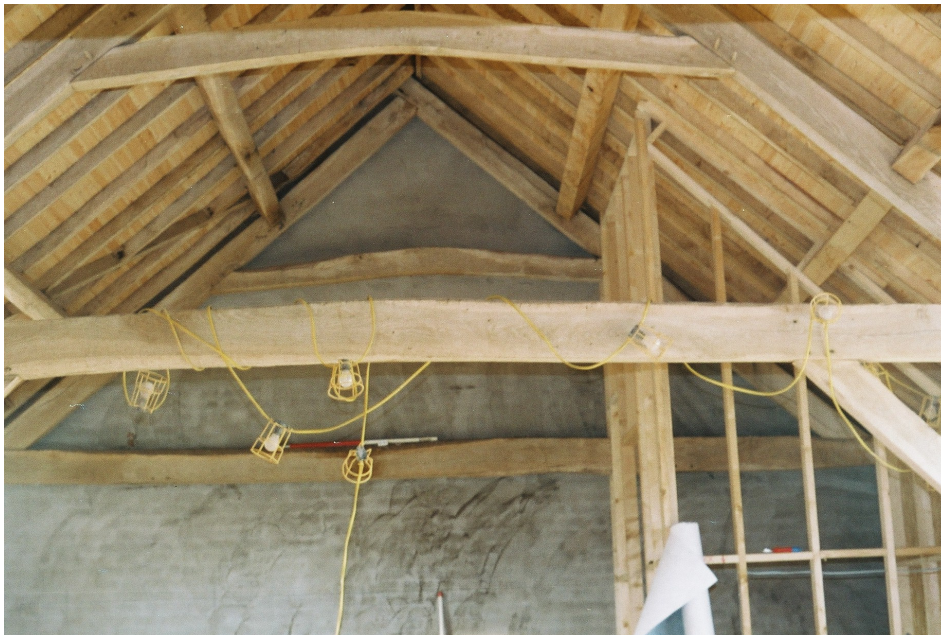
**Plate 4: An A-frame truss in the stable**

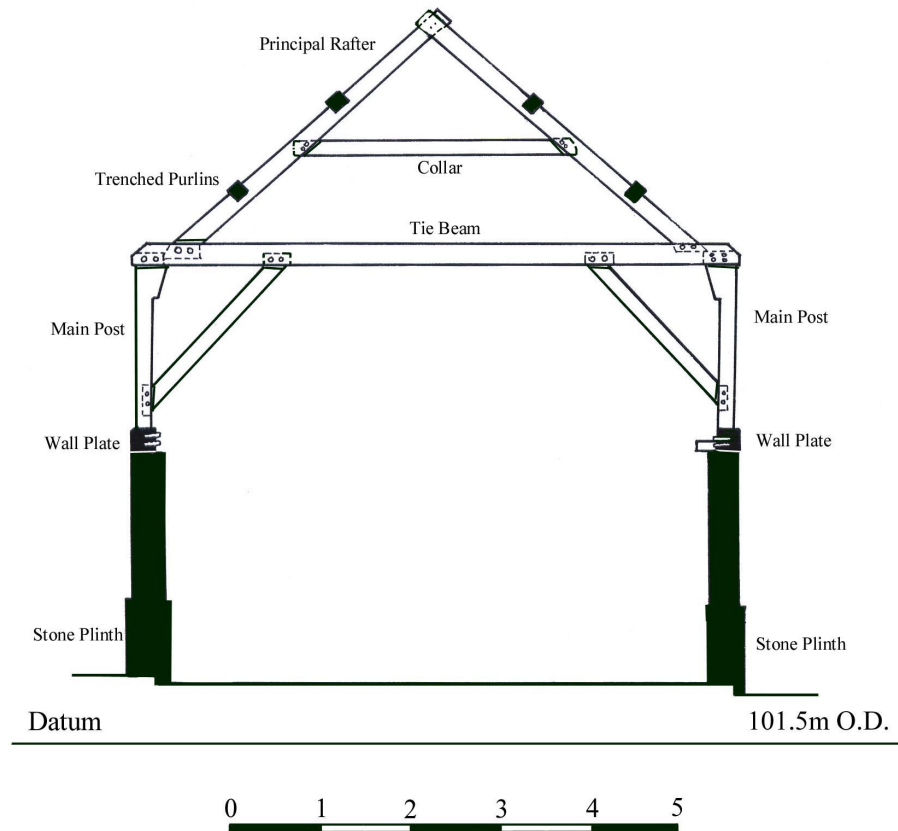
**Figure 10: Section K-L. An example of one of the truss frames in the stable. This truss type, with the jowled stops on the post and struts from post to tie-beam, became increasingly common in the 16<sup>th</sup>/17<sup>th</sup> centuries.**

An example of one of the truss frames from the stable was recorded to show construction detail. The two main posts are attached to the wall plates with mortice and tenon joints. The construction detail of the tie beam, post and wall plate is shown in Figure 9. The collar was attached to the principle rafters with a mortice and tenon joint while the purlins have been trenched into principle rafters.

The stable had 12 simple A-frame trusses similar to section K—L. The trusses had no scars, such as empty mortice joints or peg holes, suggesting that they are all original timbers.

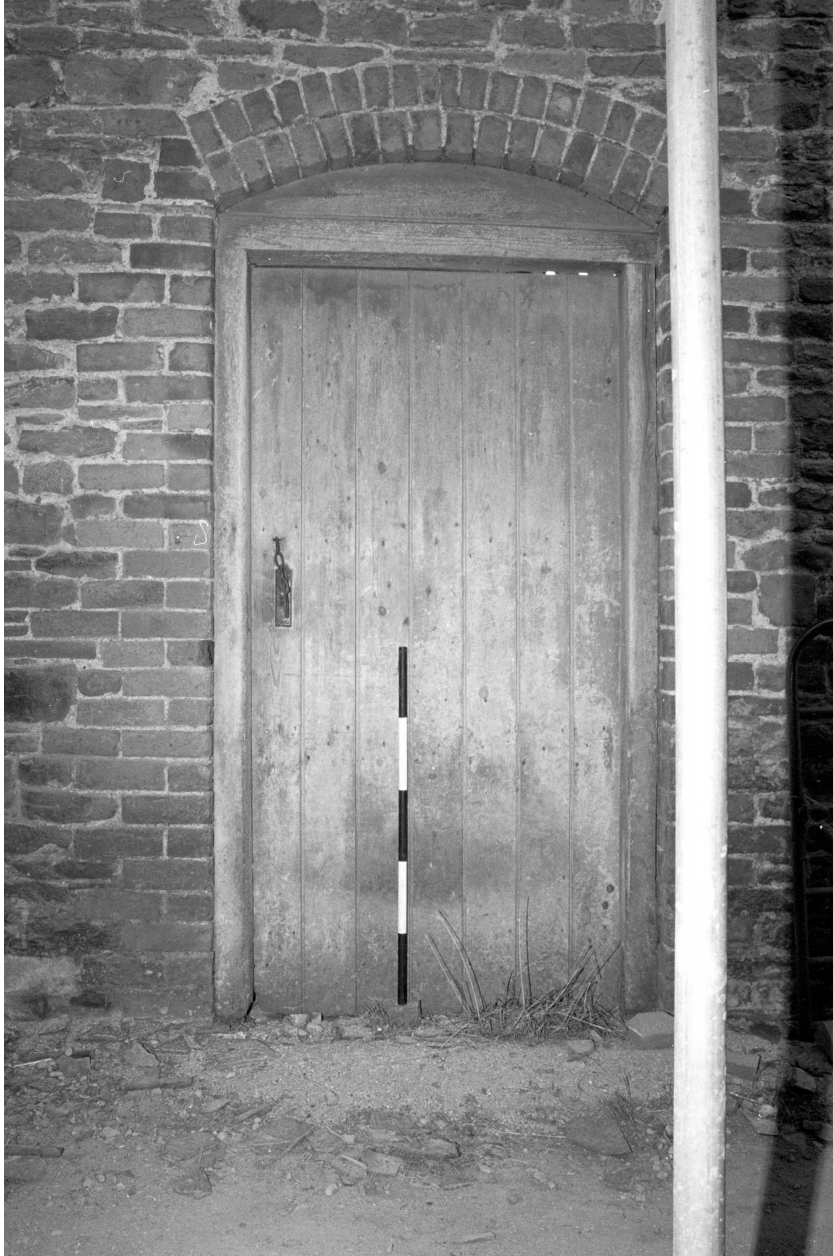
**Plate 7: Inserted doorway in the north end of the cattle shed**

The north wall of the cattle shed is the only one that was stone built and on the west side, the brick foundation of the wall of the northern most cattle pen butts the stone wall (see plate 7 and drawing 32).

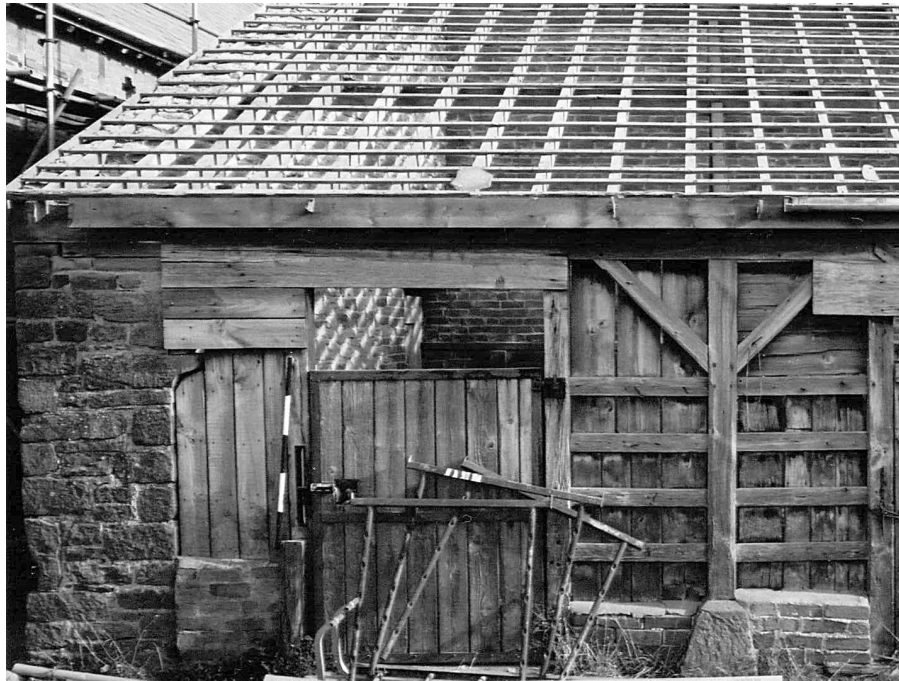
**Plate 8: The north end of the west elevation of the cattle shed. A stone support can be seen on the wall in the right of the picture, and a stone pad for the timber post.**

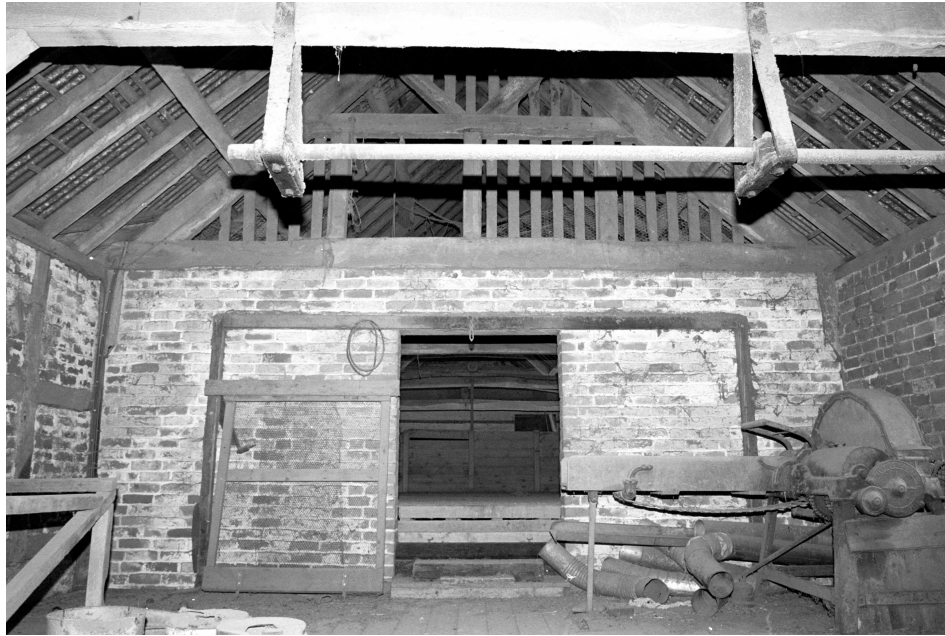
**Plate 12: Shafting for the drive wheel. The machine to the right is a Bomford & Son's "Safety" chaff cutter, of late 19th century design. The shafting and drive wheel suggests that there was provision for a steam engine to power the chaff cutter, and possibly others, such as a root slicer or corn grinding mill.**

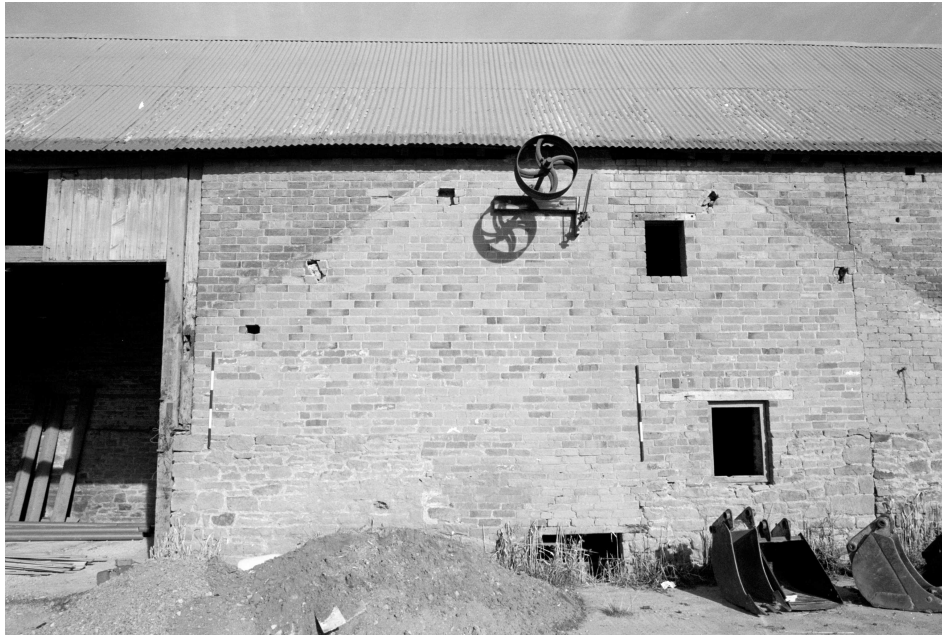
**Plate 13: An iron drive wheel on the south wall. The wheel is inside the line of a building scar suggesting, that at some stage, the engine that powered the wheel was housed in a building attached to the barn. The square holes in the brick wall would have been for the roof purlins of the north-south building. A construction break, where the later west barn was added to the original threshing barn, can be seen just to the right of the lower window.**

Inside the building scar from the north-south building is an area of inserted bricks within the stone plinth. Within this scar is a window, between the height of the stone plinth and the bricks.

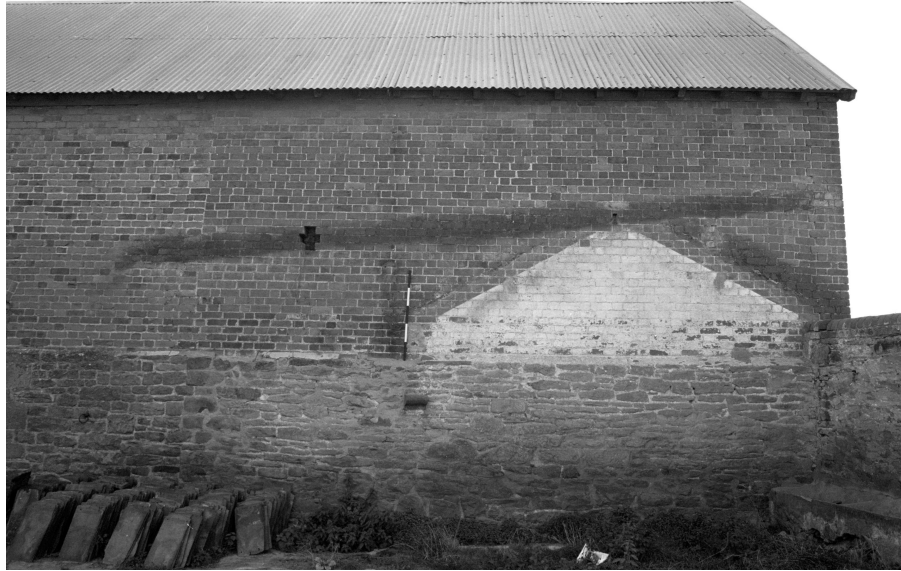
**Plate 14: Building scar on the north elevation of the barn. A stone support can be seen below and to the right of the scale and slates (possibly from the original roof of the barn). A cross shaped ventilation hole and a construction break to its left can also be seen. The construction break is a scar from the in-filled through-way door of the barn. To the east of the in-filled door is a section of timber framing similar to that of the stable (drawings 11 and 12).**

The building scar (see plate 14 above and drawings 11 and 12) is the scar of a building that was possibly a smaller version of the standing cattle shed. No evidence of the foundations of the former building was observed in the survey, but the stone support (see plate 13 above) in the north elevation was identical to supports used in the cattle shed. Two cattle sheds would have not only housed more stock, but with a central yard between the sheds, would have made the gathering and storing of manure (possible in a shed or a dung-pit) more efficient.

This building may have been knocked down in the final (third) phase of alterations to the farmyard complex.

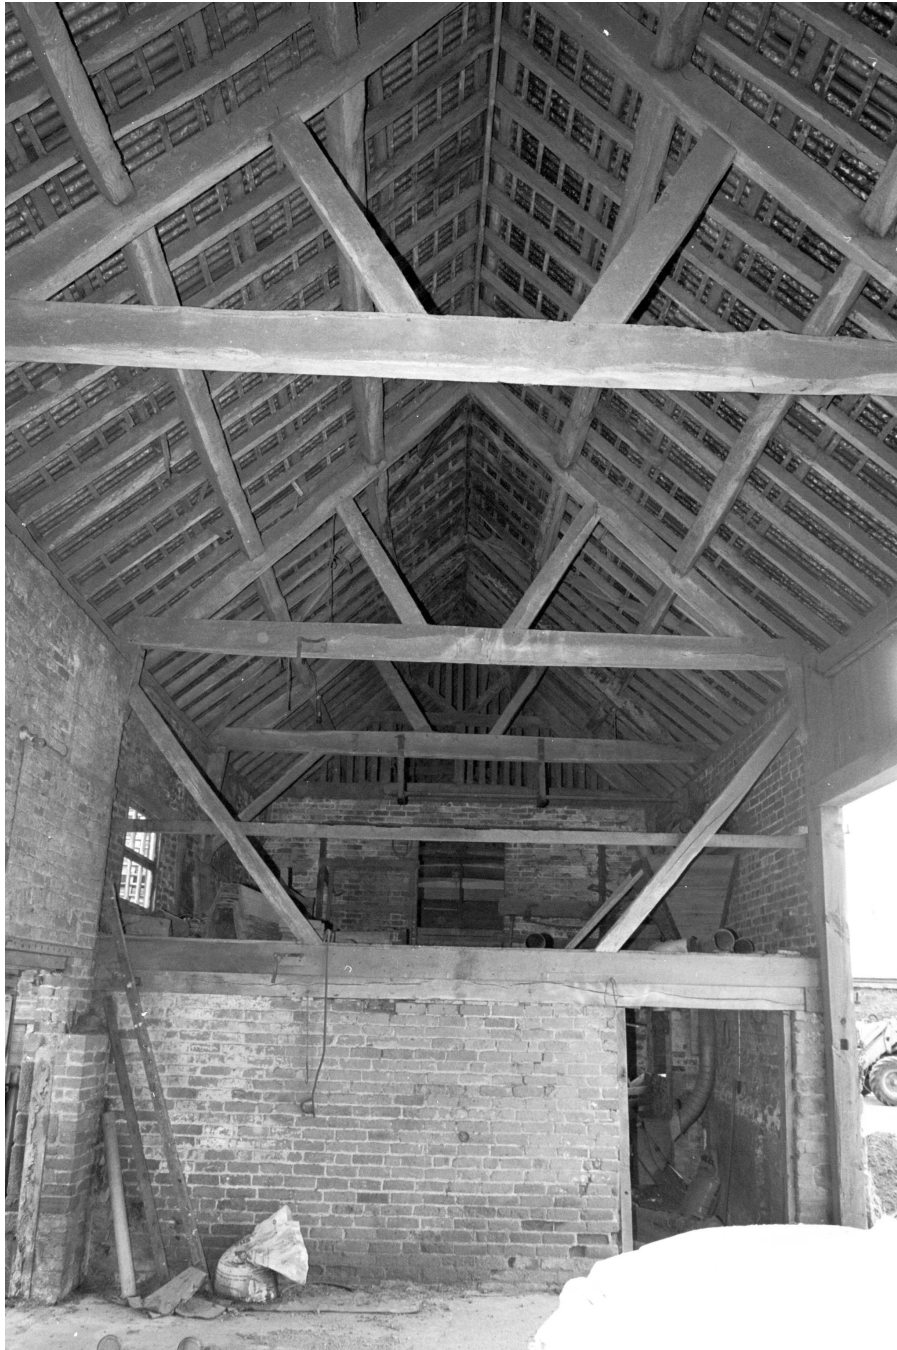
**Plate 15: Roof and truss detail in the later west end of the barn. The truss from section G-H can be seen in the background, as can the top feeder and tubes from the chaff cutting machine. The in-filled brick door of the through-way can be seen of the left.**

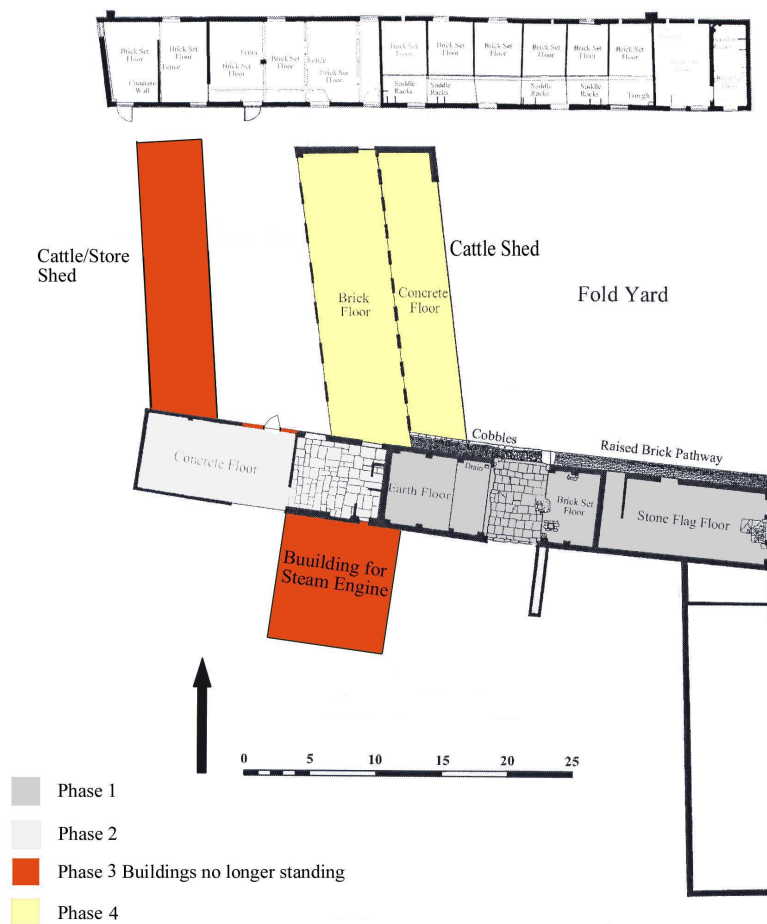
**Figure 18: Phase plan of Merryhill Farm. The phase 3 buildings (shown in red) were, at the time of the survey, only visible through scars on the standing building. The width of the buildings is accurate but the length has been estimated from the 1930 OS map.**

A further stage in the modernisation would have seen the steam power replaced. The building that housed the steam engine was demolished (post 1930) and the north entrance to the through-way door in the later barn was in-filled with brick and a smaller door. The standing cattle shed was possible the last of the buildings to be constructed.
