**HISTORIC BUILDING SURVEY REPORT:
MANOR FARM, WEST WINCH, NORFOLK**

Planning Reference: 10/01911/EXF

By
Allen Archaeology Limited
Report Number 2012099

October 2012

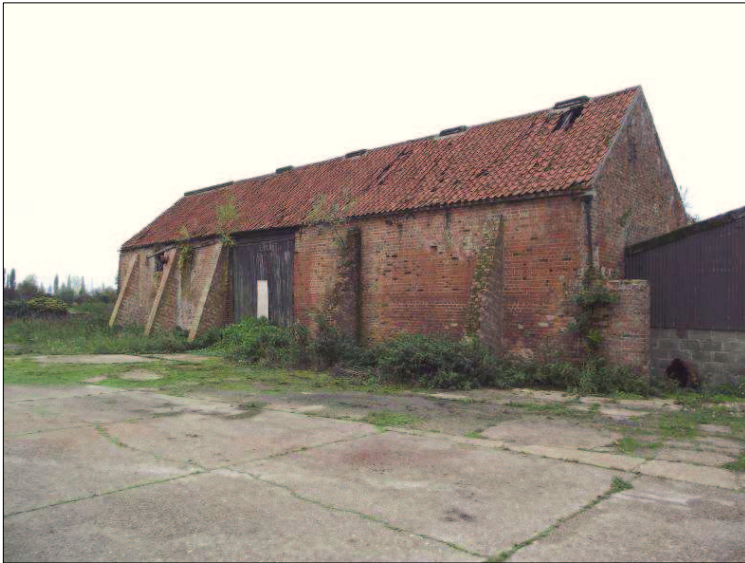
- 6.1.2 There are large double doors with metal strap hinges in the centre of the east elevation, typical of a threshing barn (Plate 1). To the south of the barn doors is an area of recent repair where a former extension has been demolished. Three new buttresses have also been added (Plate 2). Also in this elevation is a square opening with electric ventilation fan, and adjacent metal outlet pipe, probably an exhaust for internal farm machinery housed in the barn.

Plate 1 (Shot 1): East elevation of Barn 1, looking southwest

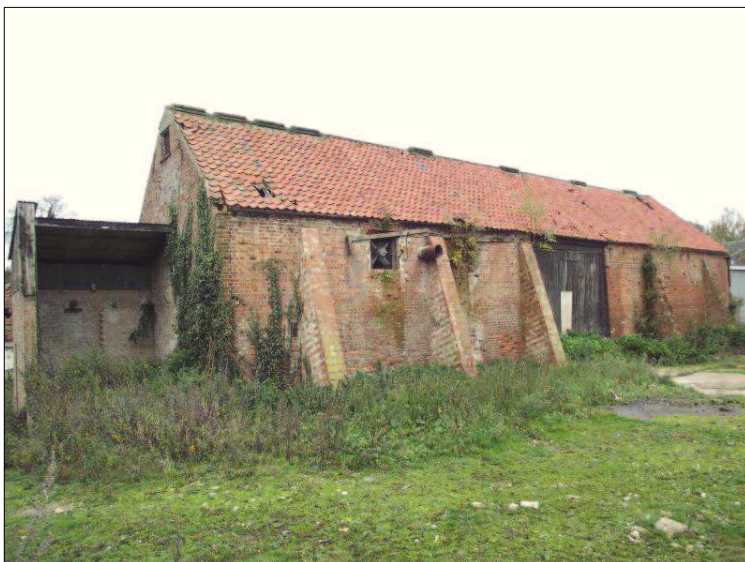
Plate 2 (Shot 5): South end of Barn 1, looking west-northwest, showing area of repair and extension to south end of the barn. Also note the ventilation fan and outlet pipe in this elevation

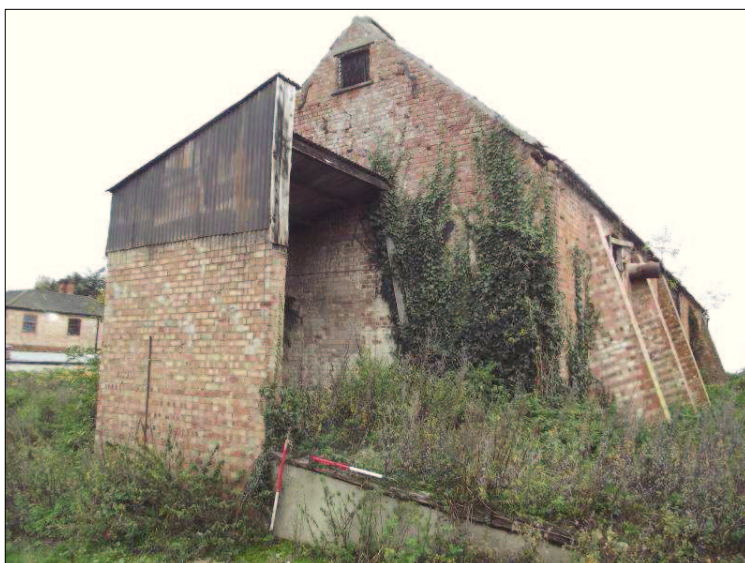
- 6.1.3 A small open fronted outbuilding abuts the south elevation, built in brick with a wooden and corrugated tin roof. A low wooden ramp runs up to the open front. Above, close to the apex of the roof is a square window or pitching hole with stone sill and lintel. This is flanked by two S-shaped metal tie plates (Plate 3).

Plate 3 (Shot 6): South elevation of Barn 1 showing later outbuilding. Scales are 1m

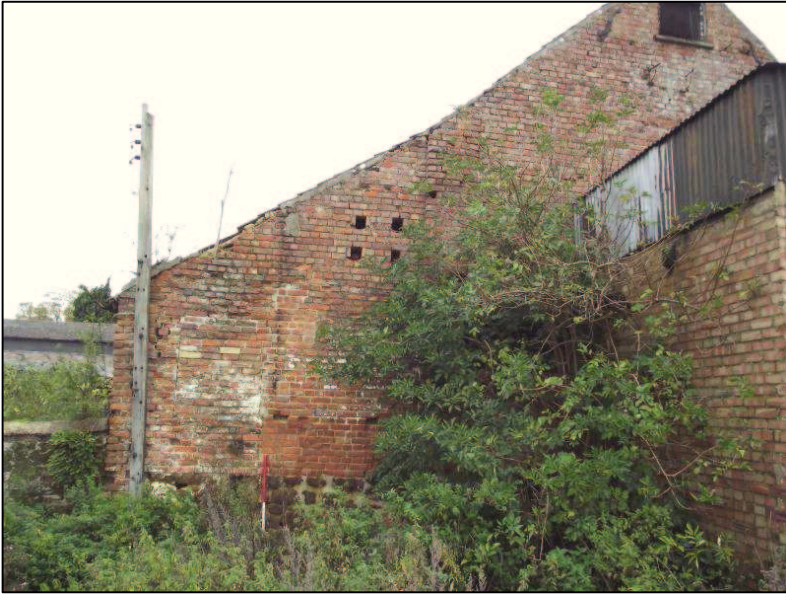
- 6.1.4 A single storey extension has been added to the west elevation of the barn (Plate 4). In the south elevation of this extension are four small square openings, each with a ceramic roof tile at their base, which are most probably for ventilation. A blocked opening is also visible in this elevation and a further wooden door was hidden by a tree. At the base of the wall is a small area of coursed ironstone rubble.

Plate 4 (Shot 8): South elevation of Barn 1 showing possible ventilation holes and bricked up opening, looking north. Scale is 1m

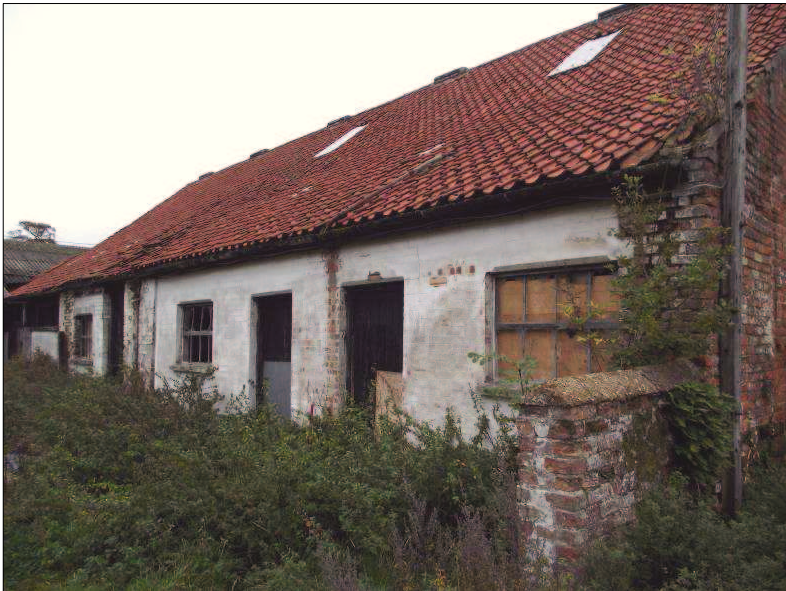
- 6.1.5 The west elevation of the barn is painted white and has three sets of steel framed eight light hopper windows and three doorways (Plate 5). Steps lead up to the central doorway. At the north end of the elevation is an area of recent repair or alteration (Plate 6). This has a single stable door, and a low brick wall, with the upper part of the wall comprising wooden panelling.

Plate 5 (Shot 9): West elevation of Barn 1, looking northeast

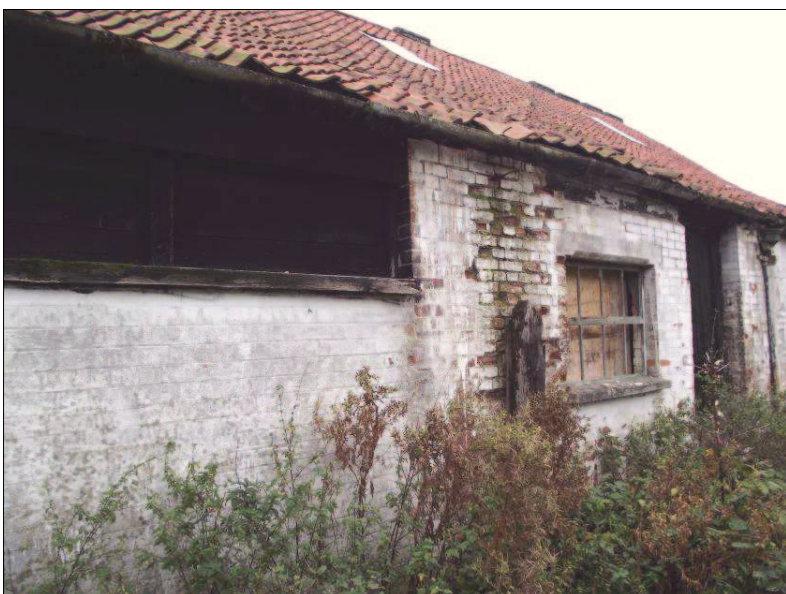
Plate 6 (Shot 42): North end of west elevation of Barn 1, looking southwest

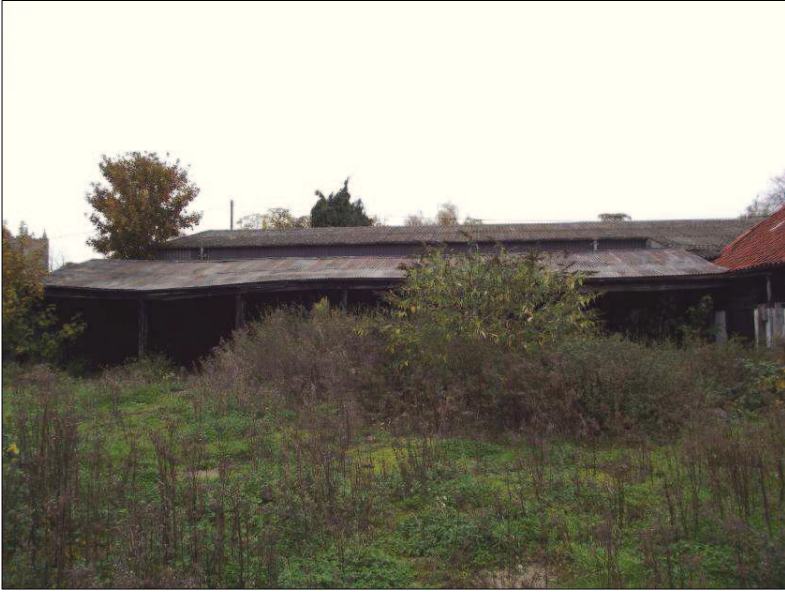
- 6.1.6 To the north, Barn 1 is abutted by a group of 20th century steel frame farm buildings that partially overlap the west face of the building and extend to the west (Plate 7).

Plate 7 (Shot 10): 20th century farm buildings abutting Barn 1 to the north. Looking north

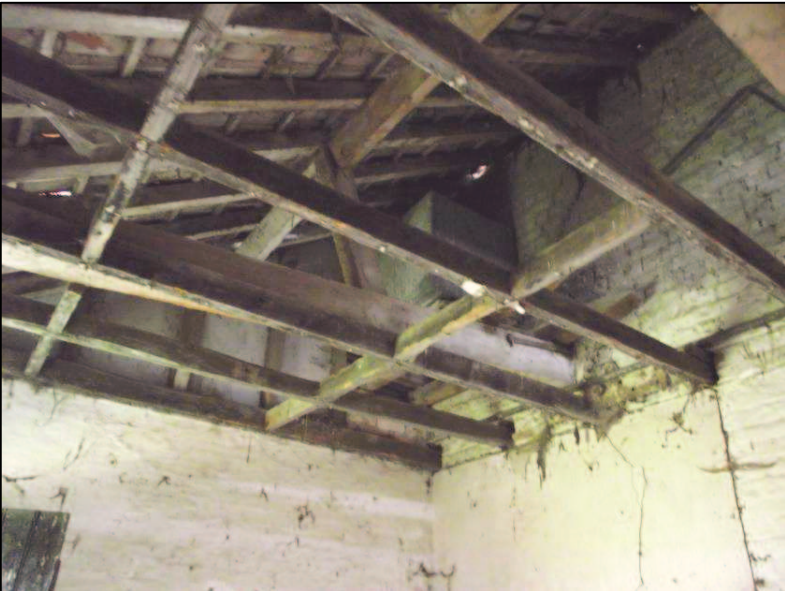
- 6.1.7 Most of Barn 1 was inaccessible during the site visit and as such only two rooms at the south end of the western extension could be surveyed. Room 1 had a concrete floor and whitewashed walls. The wooden joists for the floor of a loft space remained by the floor timbers had been removed. A steel water tank was visible within this loft space (Plate 8).

Plate 8 (Shot 34): Floor joists and water tank in Room 1 of Barn 1, looking north

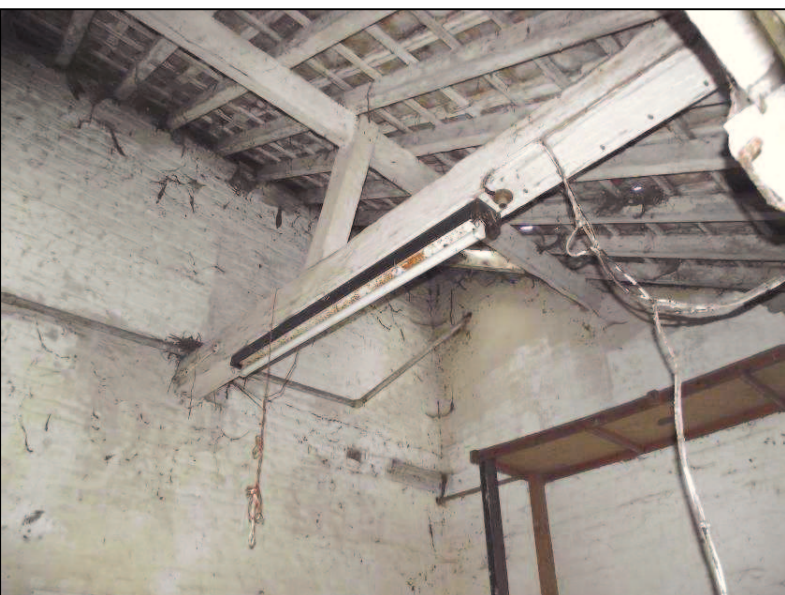
- 6.1.8 Room 2 retained few features of note. The walls had also been whitewashed and rendered and it again had a concrete floor. As in Room 1, the roof structure comprised a tie beam, with bracing strut and purlin supporting the overlying rafters (Plate 9). A pipe leads from the tank in Room 1 through Room 2, and into the adjacent room to the north.

Plate 9 (Shot 37): Roof structure in Room 2 of Barn 1 showing metal water pipe. Looking southeast

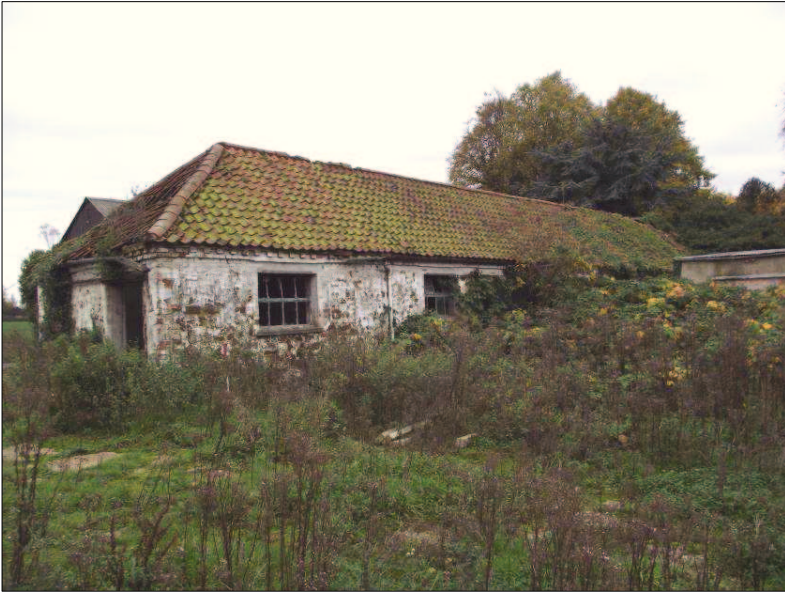
- 6.2.1 Barn 2 is located in the south part of the site, aligned west-southwest to east-northeast. It is a single storey structure built in whitewashed, coursed ironstone rubble, with brick dressings around the openings and brick dentillation under the eaves. The roof is hipped and covered with S-shaped pantiles and half-round ridge tiles (Plate 10).

Plate 10 (Shot 11): Barn 2 looking southwest. Scale is 1m

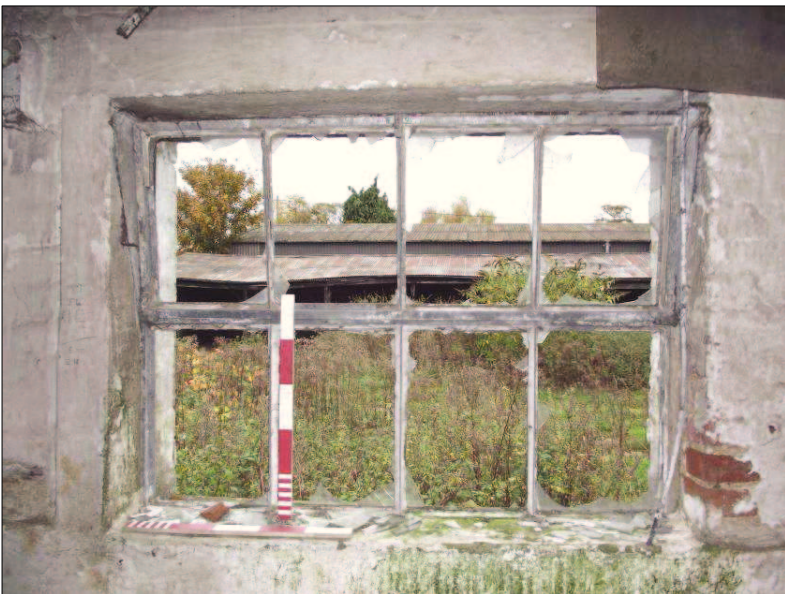
- 6.2.2 The north elevation, facing into the crewyard has five sets of hopper windows with rendered sills and lintels (Plate 11), identical to those on the west elevation of Barn 1, as well as a set of double wooden doors with bullnose bricks around the opening.

Plate 11 (Shot 19): Hopper window in north elevation of Barn 2, looking north-northwest. Scales are 0.5m

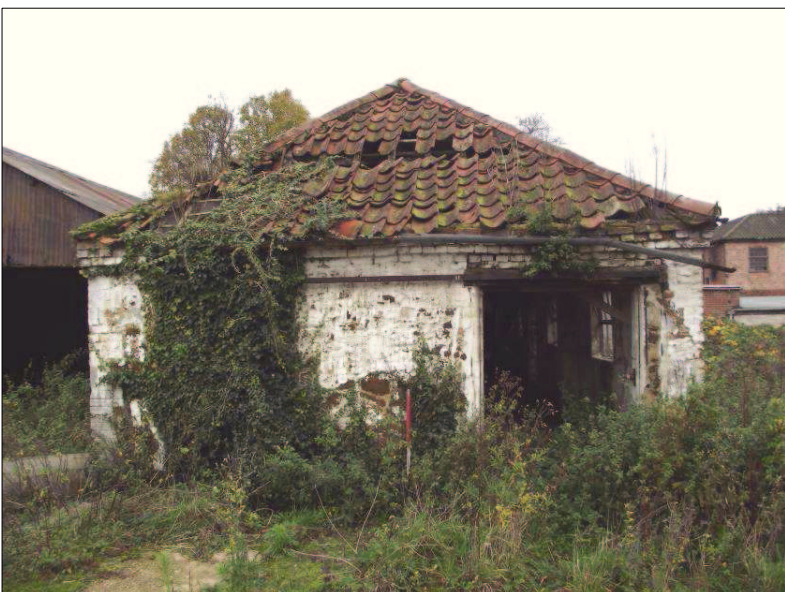
- 6.2.3 There is another doorway with bullnose bricks on the east elevation (Plate 12) and a recently bricked up window opening with remaining wooden frame and strap hinges (probably for a former shutter) on the south elevation (Plate 13).

Plate 12 (Shot 61): East elevation of Barn 2, looking west-southwest. Scale is 1m

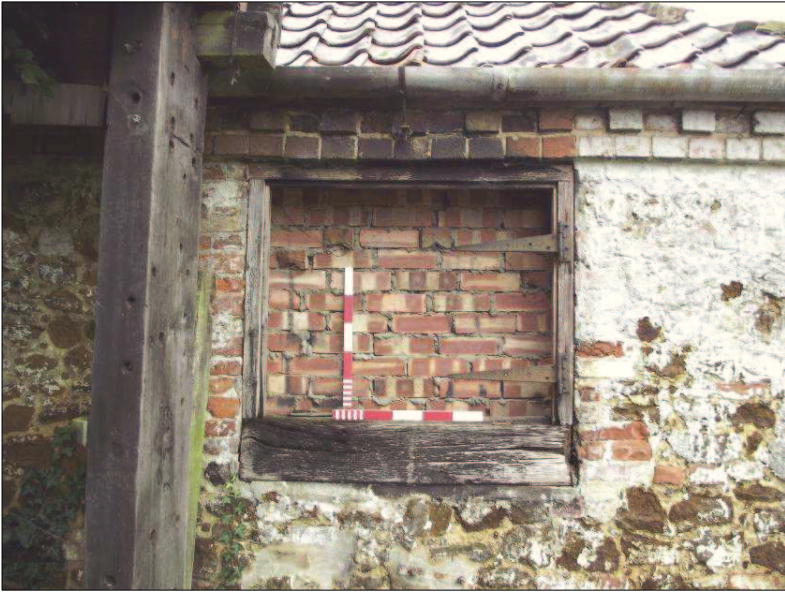
Plate 13 (Shot 44): Blocked window in south elevation of Barn 2, looking north-northwest. Scales are 0.5m

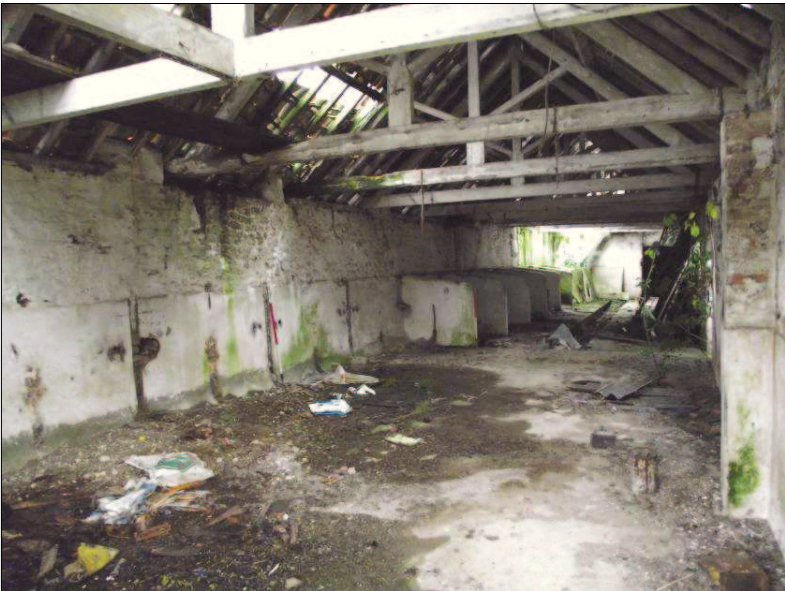
- 6.2.4 The majority of the building appears to have functioned as an animal feeding barn, with a series of concrete feeding stalls along the south side of the building (Plate 14). Several of the concrete partitions have been removed. The building has a concrete floor, with a slurry trench to carry away waste in the western half of the building. The roof structure comprises king post roof trusses with diagonal bracing struts (Plate 15).

Plate 14 (Shot 17): Interior of Barn 2, looking west. Scales are 1m

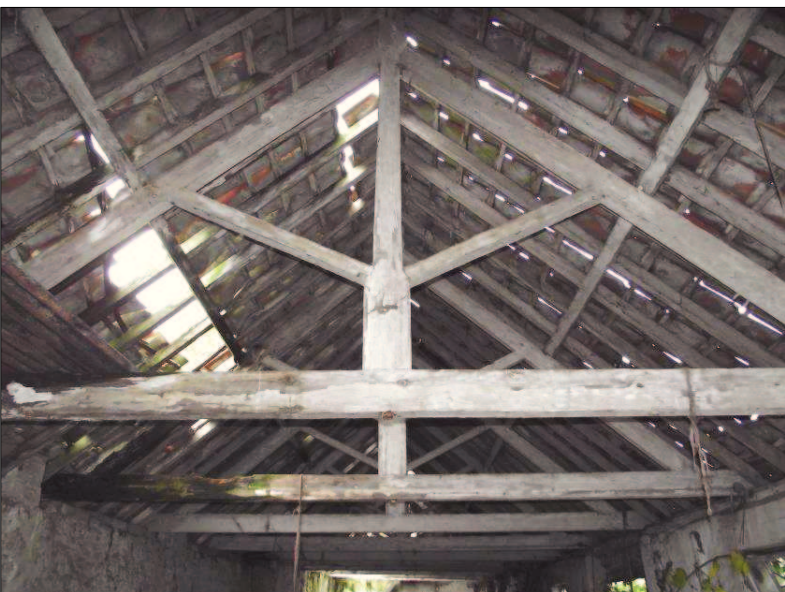
Plate 15 (Shot 22): Roof structure of Barn 2, looking west-southwest

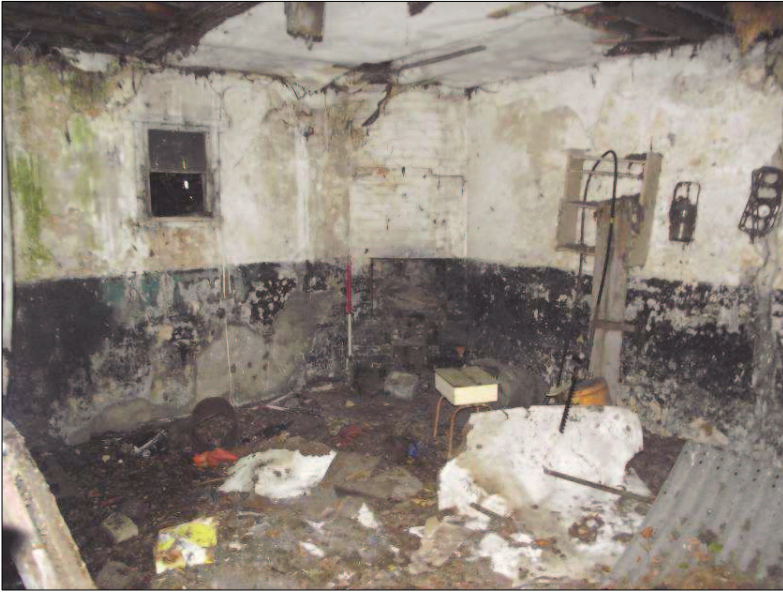
- 6.2.5 At the west end of the building is a small tack room/crew quarters with a small fireplace in the southwest corner and a small square wooden framed window in the south elevation (Plate 16).

Plate 16 (Shot 27): Tack room/crew room at west end of Barn 2, looking southwest towards fireplace. Scale is 1m

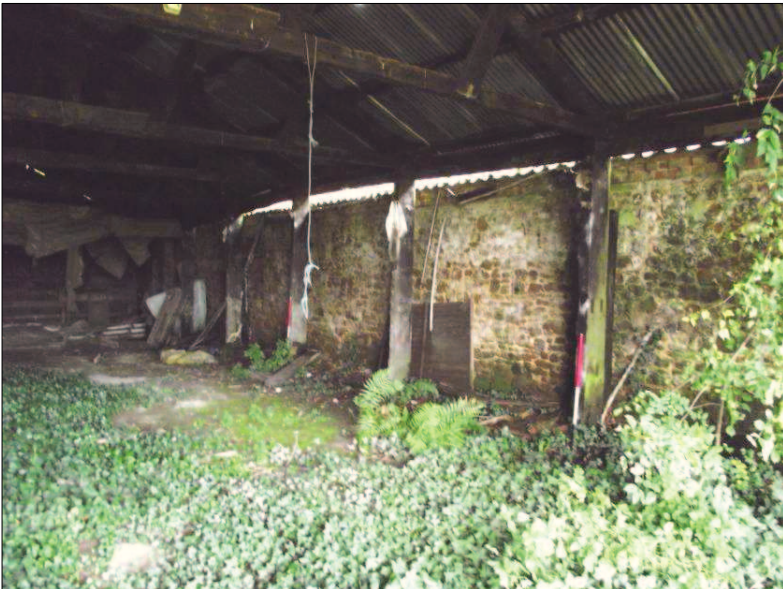
- 6.2.6 A 20th century open fronted barn with corrugated steel roof abuts the south elevation of Barn 2, within which the unpainted ironstone walls of Barn 2 (Plate 17).

Plate 17 (Shot 32): Interior of 20th century barn on the south elevation, showing ironstone wall of Barn 2. Looking west. Scale is 1m

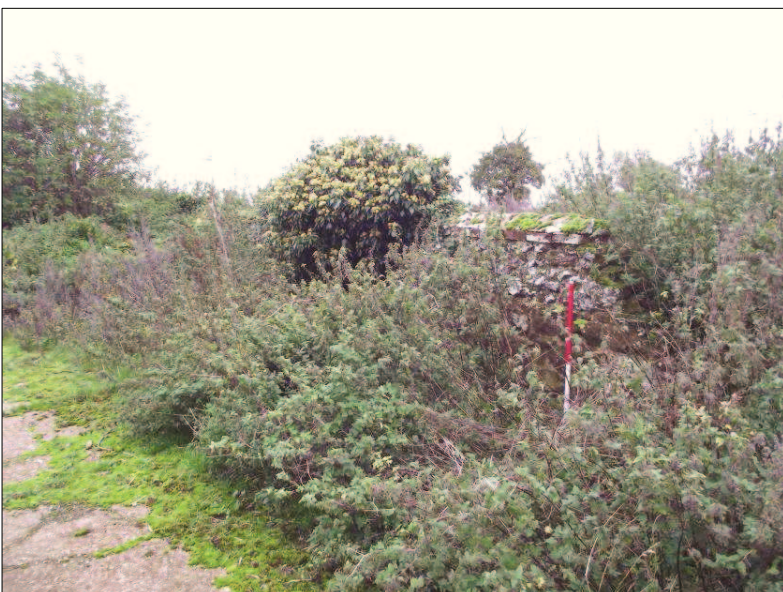
- 6.2.7 An ironstone boundary wall runs along the south edge of the site (Plate 18), with a single course of brickwork and half round concrete coping.

Plate 18 (Shot 7): Boundary wall to the south of Barn 1, looking east. Scale is 1m

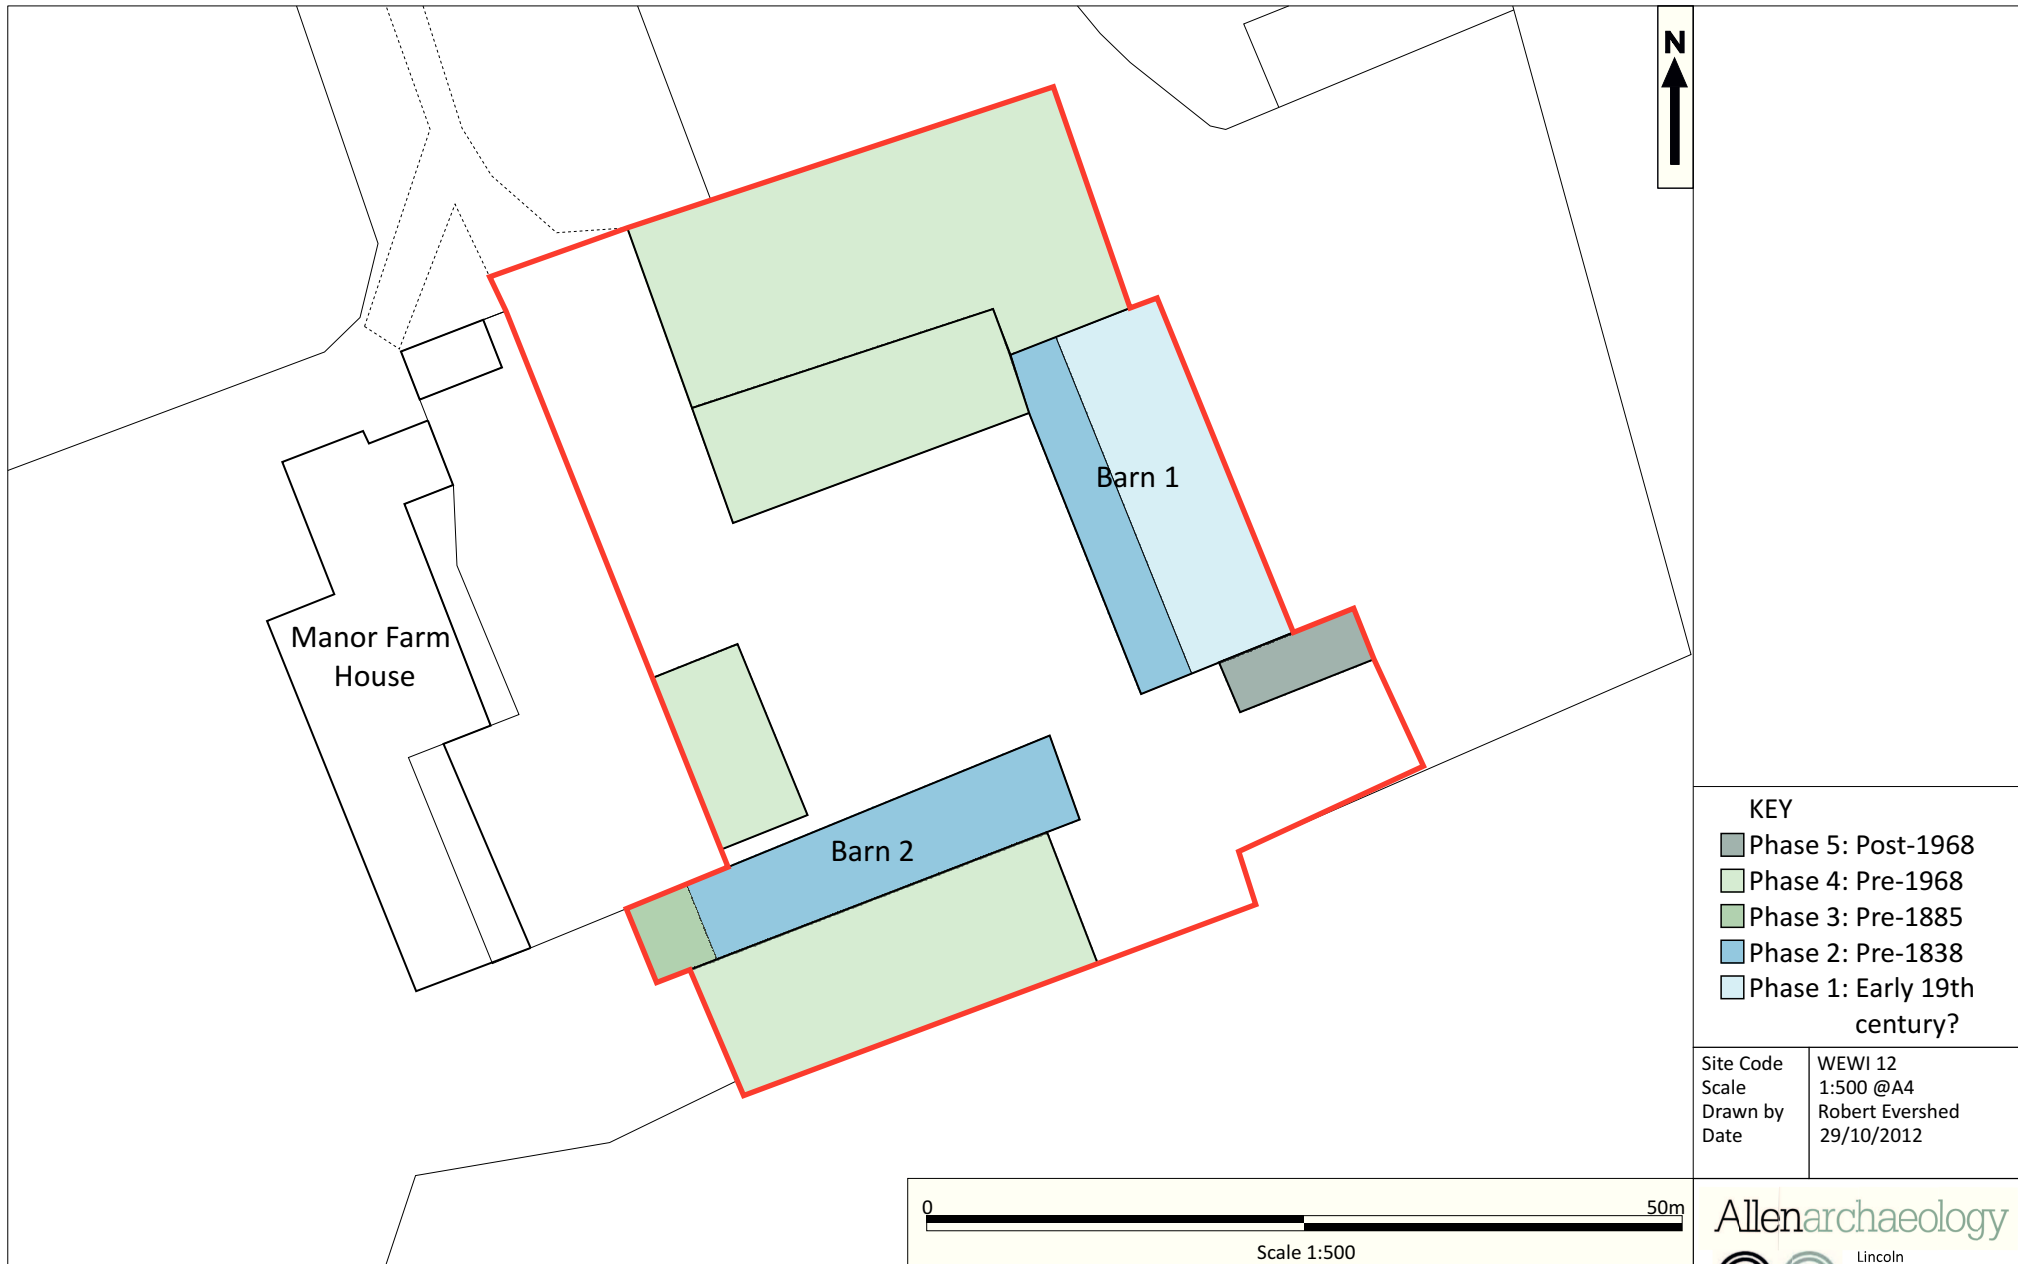
Figure 7: Provisional phasing of buildings at Manor Farm
 (base plan provided by Bidwells Property Consultants)

- 7.1 The buildings that are the subject of the survey comprises a fairly standard group of brick farm buildings of early 19th century date. Based on the results of the survey and the analysis of readily available historic mapping, a provisional phasing of the buildings is shown in Figure 7.

- 7.5 Mapping shows few changes to the buildings themselves during the late 19th and early 20th centuries. An extension is shown on the south end of Barn 1 possibly in 1885, and definitely by the time of the 1905 Ordnance Survey map. The 1968 map however shows this in a different form to that on earlier mapping, and also in a different form to the current outbuilding, suggesting the current building was built after 1968.
