**HISTORIC BUILDING SURVEY REPORT:
ROSE COTTAGE, STRAWBERRY GARDENS, ENDERBY, LEICESTERSHIRE**

Planning Application: 12/0621/1/PX

By
Allen Archaeology Limited
Report Number 2012105

November 2012

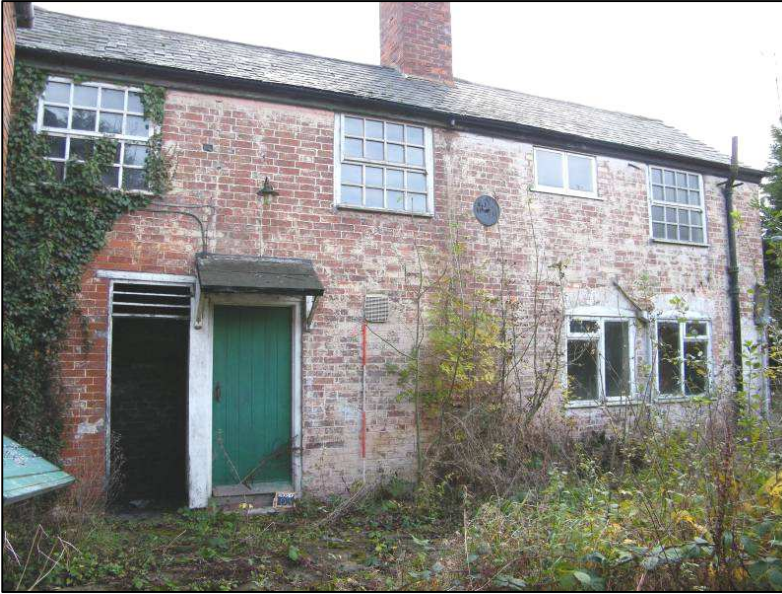
6.1.1 Building A is a northeast to southwest aligned brick building mainly built in stretcher bond but with occasional headers resulting in an irregular bond. The roof is double pitched and covered with slate tiles. There is a single brick chimney stack at the centre of the building (Plate 1).

6.1.3 The northwest elevation has two adjacent doorways towards the northeast end, one leading into a coal store and one forming the original main entrance, with a plain wooden canopy (Plate 1).

Plate 1 (Shot 3): General view of the northwest elevation of Building A, looking south. Scale is 2m

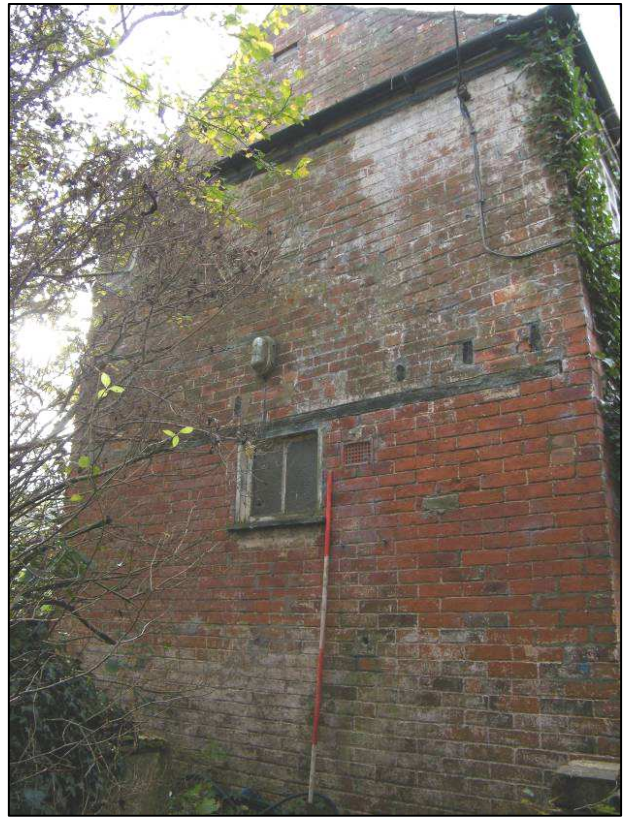
6.1.5 The northeast elevation has a single small two light window with frosted glass. Above this a wooden lintel is visible, as are the ends of a number of floor joists for the first floor (Plate 2).

Plate 2 (Shot 10): Northeast elevation of Building A showing floor joists, looking south. Scale is 2m

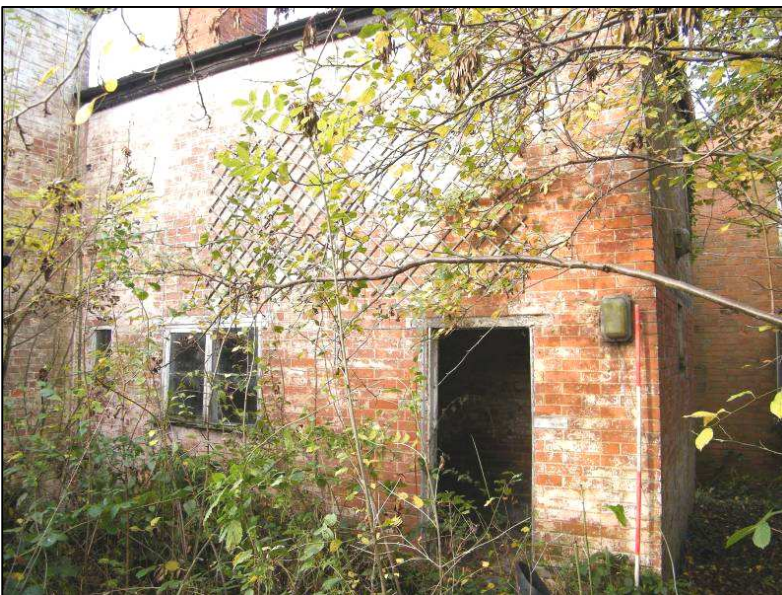
6.1.6 The southeast elevation is partially concealed by Building B. The northern end however has an opening with missing door into a store, a square, side-hung casement window with one fixed light and a smaller fixed light window to the south (Plate 3).

Plate 3 (Shot 11): Northern end of southeast elevation of Building A, looking west. Scale is 2m

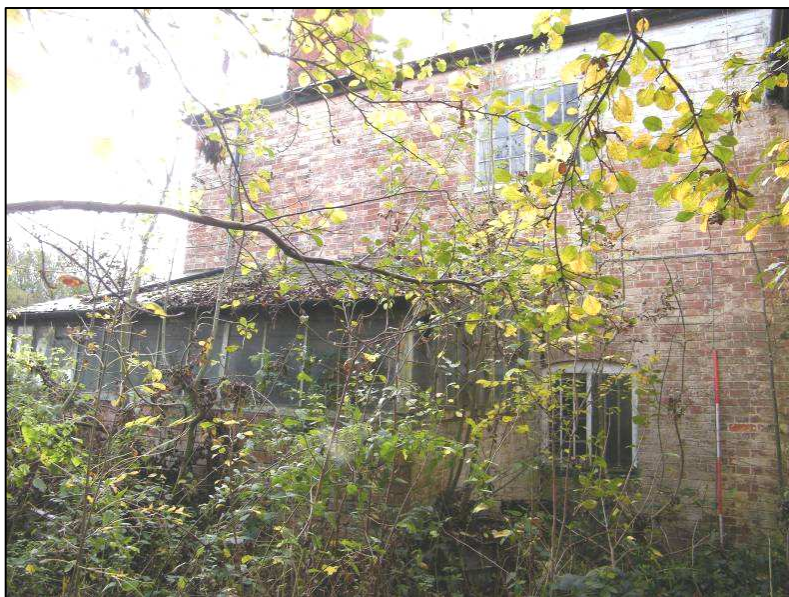
6.1.8 The northeast elevation is largely obscured by a greenhouse with brick dwarf wall and mono-pitched roof (Plate 4). The ground floor has a single window with two fixed lights and vertical metal bars beneath a segmental brick arch. Beneath the window is an opening to the basement, which appears to once have had a glass cover. There is another window on the first floor also below a brick segmental arch but with one fixed light and one side-hung casement and thin wooden glazing bars.

Plate 4 (Shot 14): Northeast elevation of Building B with greenhouse, looking southeast. Scale is 2m

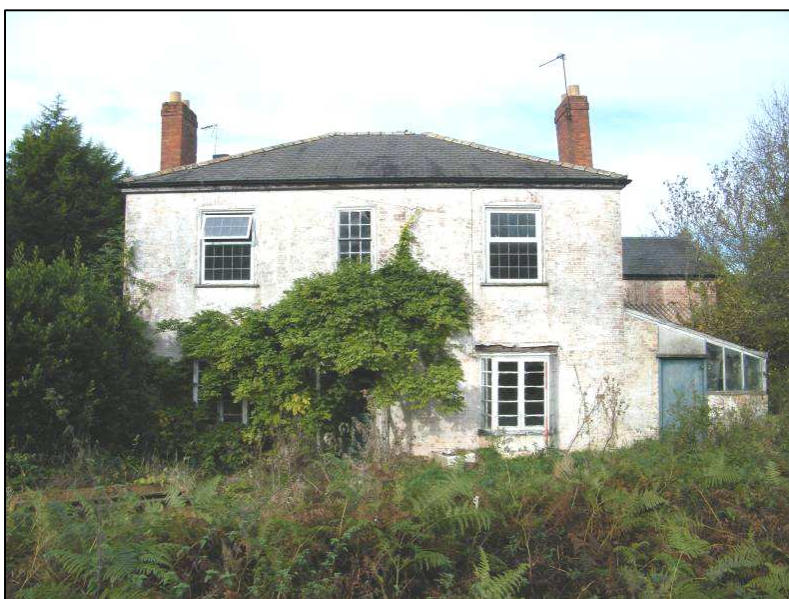
- 6.1.9 The south-eastern, front elevation retains two original bay windows on the ground floor (Plate 5), flanking a wooden porch with double ogee mouldings and wooden side panels. There is a segmental arch above the door, which is identical to that on the southwest elevation of Building A (Plate 6).
- 6.1.10 There is a tall horizontal sash window directly above the door on the first floor, flanked by two top opening casements. All have thin wooden glazing bars and a brick segmental arch (Plate 5).
- 6.1.11 The majority of the southwest elevation was concealed by vegetation; however a probably original, tall, four light casement window was visible on the first floor (Plate 7), with two modern UPVC windows fitted on the ground and first floors towards the southwest corner of this elevation.

Plate 5 (Shot 17): Southeast elevation of Building B, looking northwest. Scale is 2m

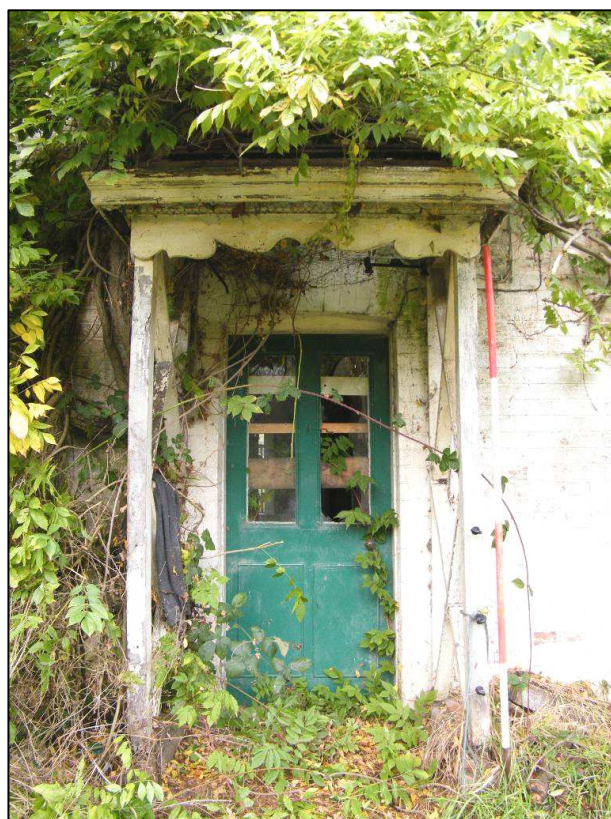
Plate 6 (Shot 18): Front porch, looking northwest. Scale is 2m

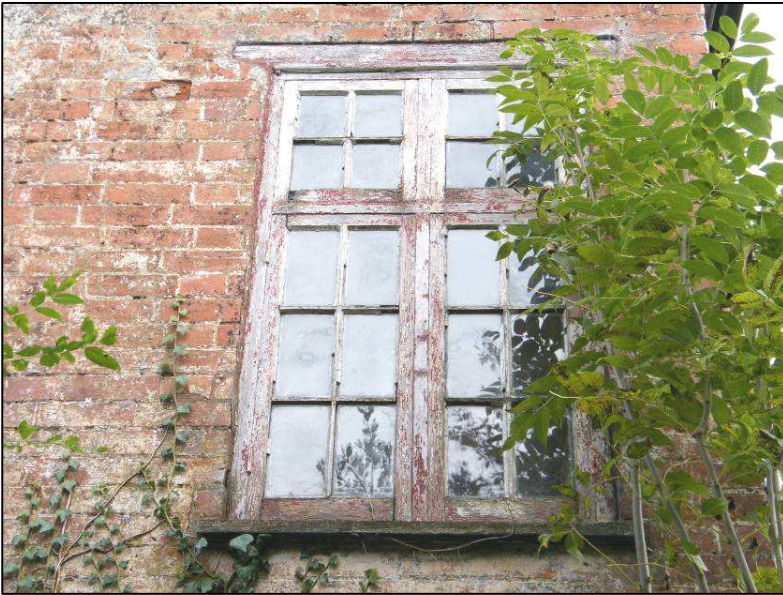
Plate 7 (Shot 22): Original window of first floor, southwest elevation, looking northeast

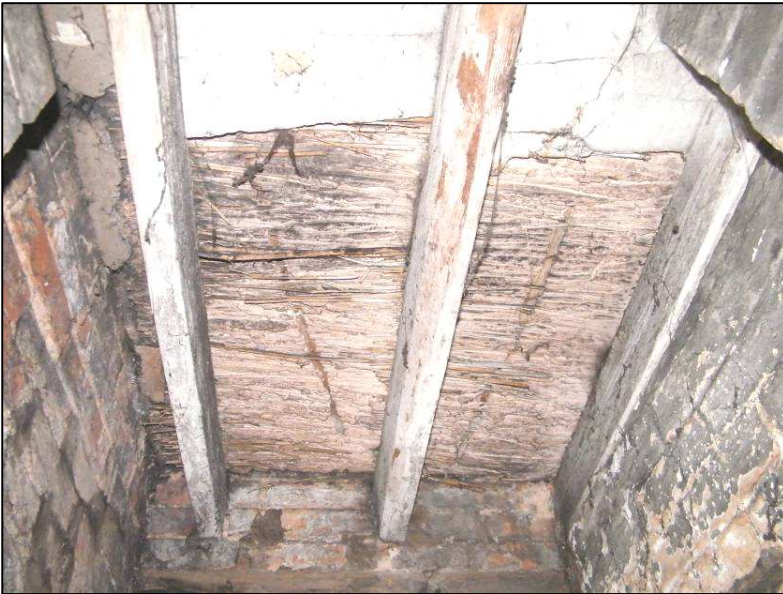
- 6.2.1 The coal store in the northern part of Building A could not be accessed although it was possible to inspect the interior of the coal store, within which the floor joists and a surviving reed floor are visible (Plate 8).

Plate 8 (Shot 45): Reed floor observed in coal store in Building A, looking northeast

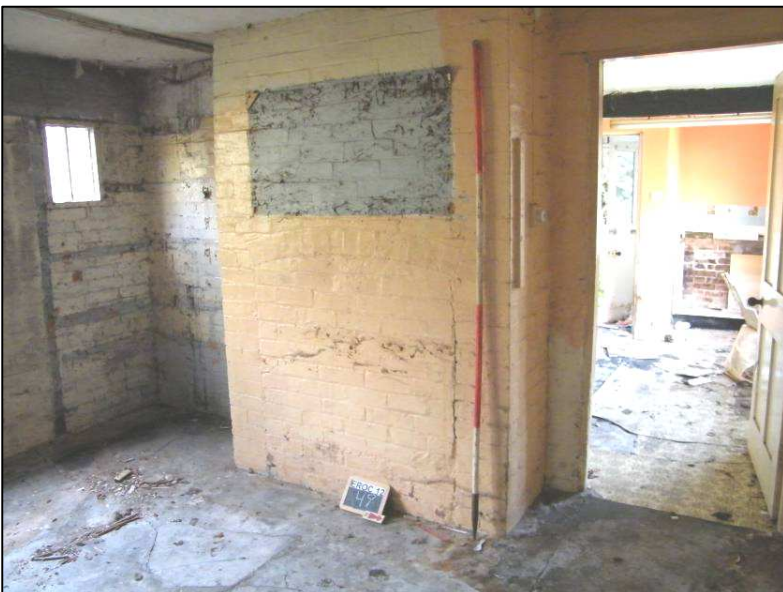
Plate 9 (Shot 49): Bricked up back to back fireplace in the dining room, looking south. Scale is 2m

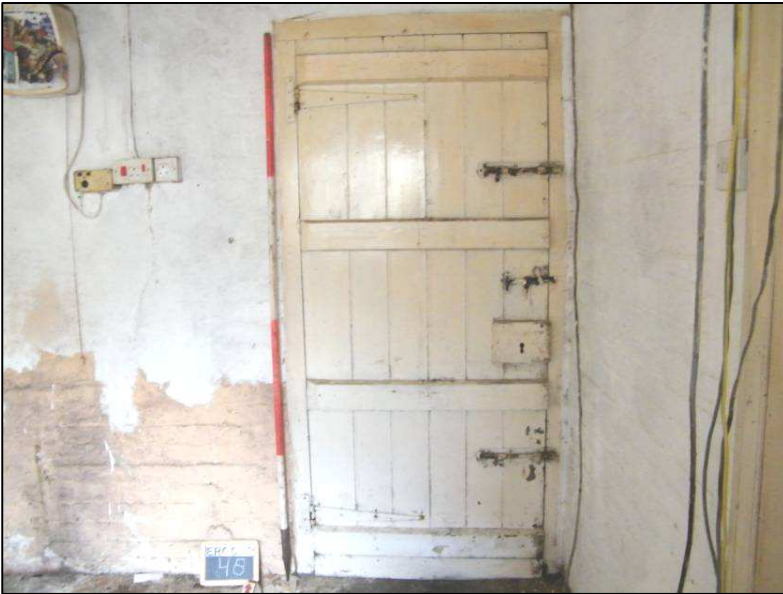
- 6.2.3 There is an entrance situated in the northwest elevation of the dining room. The door is a wooden plank and batten door hung on late 19th century type round end strap hinges with contemporary lock case and bolts (Plate 10).

Plate 10 (Shot 48): Plank and batten door in the dining room, looking northwest. Scale is 2m

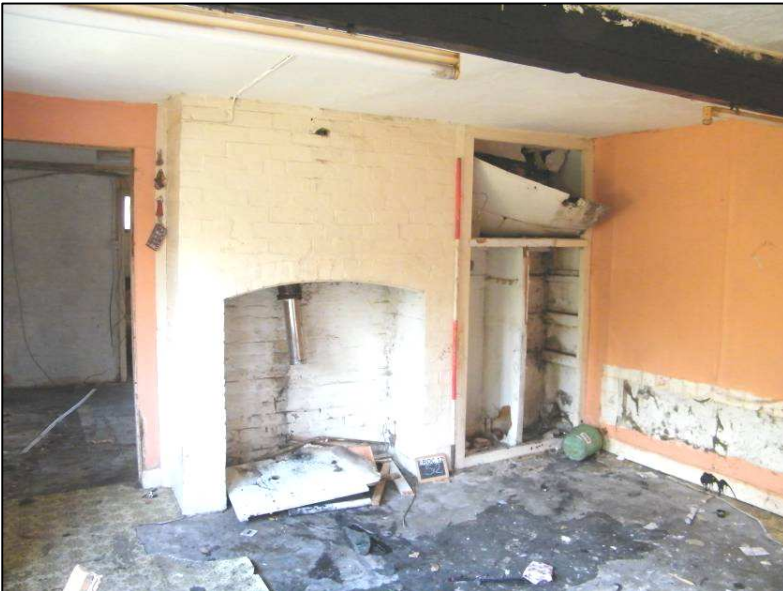
- 6.2.4 To the northeast is a WC with quarry tile floor, flanked by the store and coal store which are only accessible from outside. The opening to the kitchen is to the southwest, next to the fireplace. The recess for the fireplace in the kitchen has been converted to fit a modern cooker or stove, as a metal pipe runs up into the chimney breast. There are built in cupboards to the east side of the fireplace (Plate 11).

Plate 11 (Shot 52): Fireplace in the kitchen with built in cupboards to right of shot, looking east-northeast. Scale is 2m

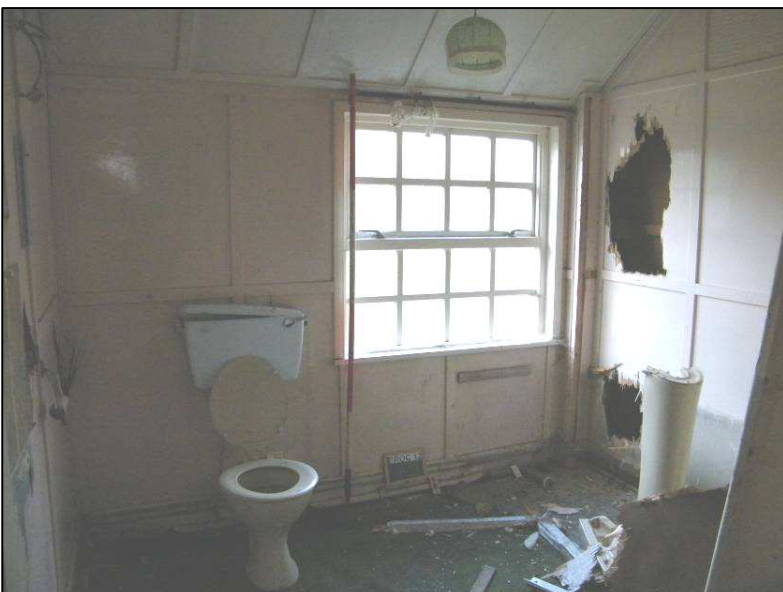
- 6.2.6 The first floor of Building A comprises three bedrooms and a bathroom, as well as a landing and two steps down from the adjacent Building B at the southern end of the landing. All the rooms have hardwood floors and the brick walls are concealed by wood panelling. The bathroom is a later addition (Plate 12), subdivided from the adjacent Bedroom 5.

Plate 12 (Shot 76): First floor bathroom of Building A, looking northwest. Scale is 2m

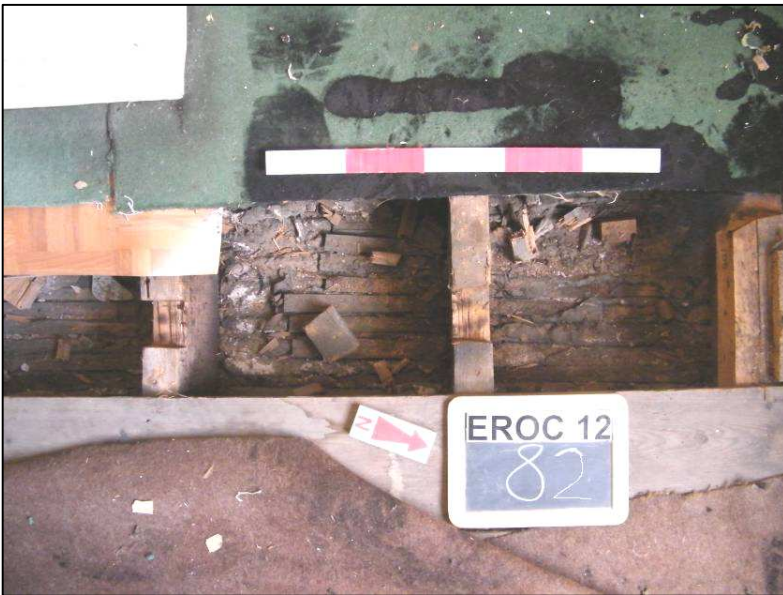
- 6.2.7 Some of the floorboards in Bedroom 6 had been removed prior to the survey exposing the underlying floor structure. The floor joists sit on wooden laths under which there appears to be a layer of reeds and another set of joists based on the evidence visible from below in the coal store (Plate 13).

Plate 13 (Shot 82): Floor make up within Bedroom 5, Building A, looking southwest. Scale is 0.5m

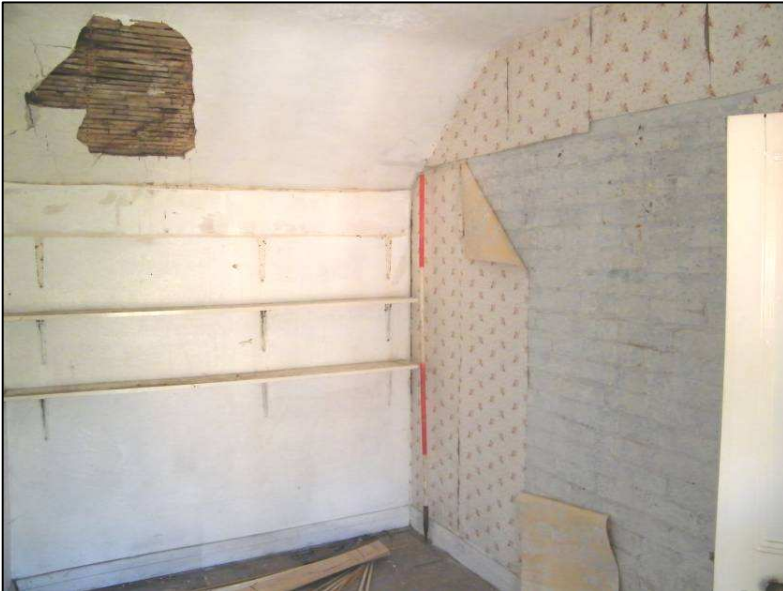
- 6.2.8 A brick partition wall separates Bedrooms 6 and 7. Within Bedroom 7 a portion of the plaster had been removed exposing wooden laths (Plate 14).

Plate 14 (Shot 83): Bedroom 6 with exposed ceiling laths, looking southeast. Scale is 2m

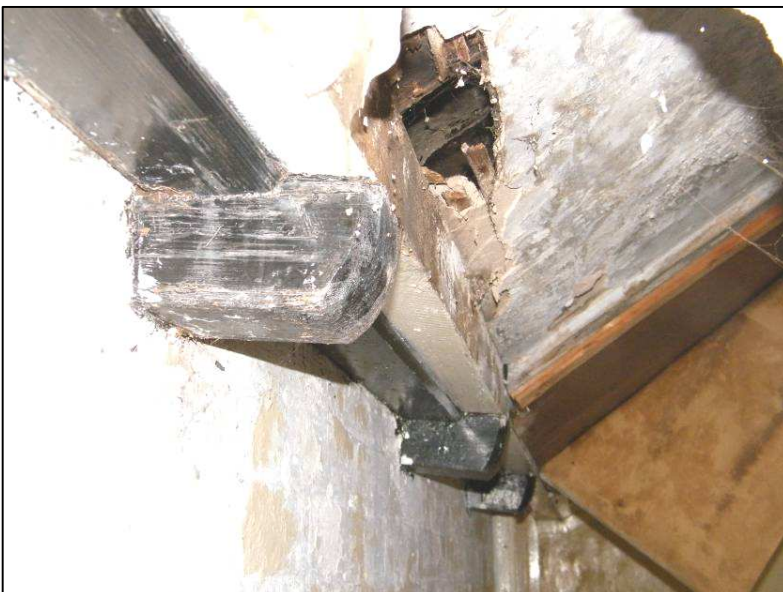
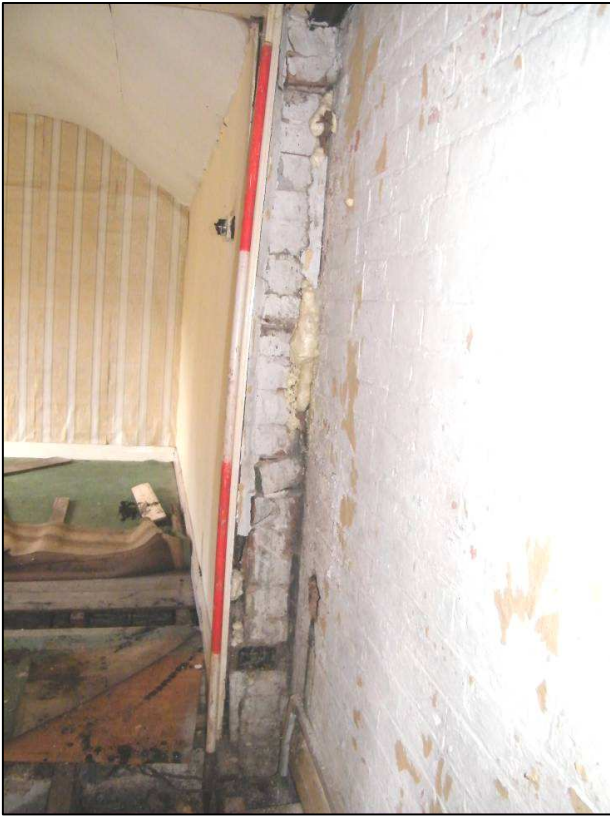
- 6.2.9 In the landing between Buildings A and B there is a clear overlap between the walls of Building A and the later Building B. The roof structure of Building A along this elevation supported by notched wooden beams (Plates 15 and 16).

Plate 15 (Shot 86): Beams supporting Building A roof structure, looking south

Plate 16 (Shot 88): View of overlap between walls of Building A (adjacent to scale) and Building B (right of shot). Looking northeast. Scale is 2m

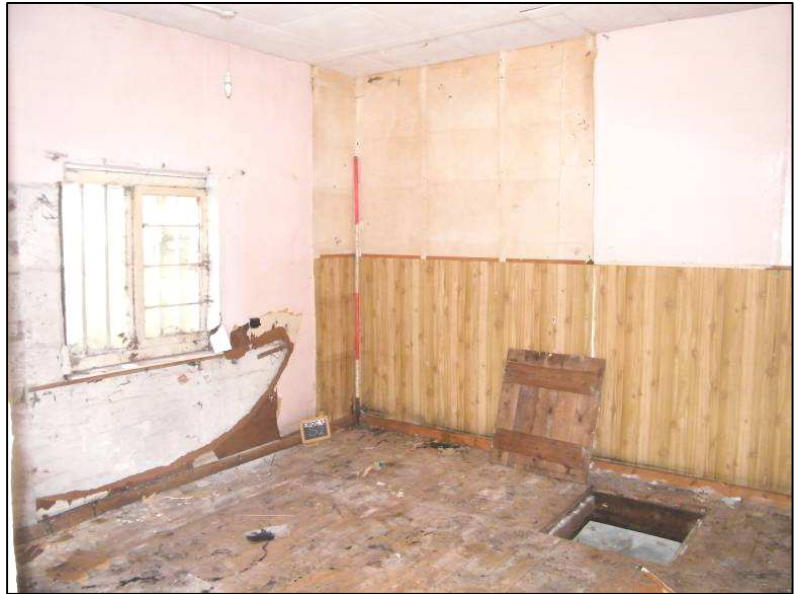
- 6.2.11 Reception Room 3 is accessed from the kitchen in Building A; it has a small hatch in the floor to the basement below (Plate 17). As the basement was flooded a detailed survey was not possible. However it was possible to discern a bench in the northeast corner supported by brick pillars, as well as the wooden joists for the floor above. The brick staircase with winder undercut the hatch in the floor, suggesting the hatch is of a later date and that the original entrance to the basement would have abutted the partition wall to the southwest entering (Plate 18). As there was no trace of the earlier entrance in the existing floor it suggests that the floor is not original.

Plate 17 (Shot 54): Reception Room 3 with access to the basement, looking east northeast. Scale is 2m

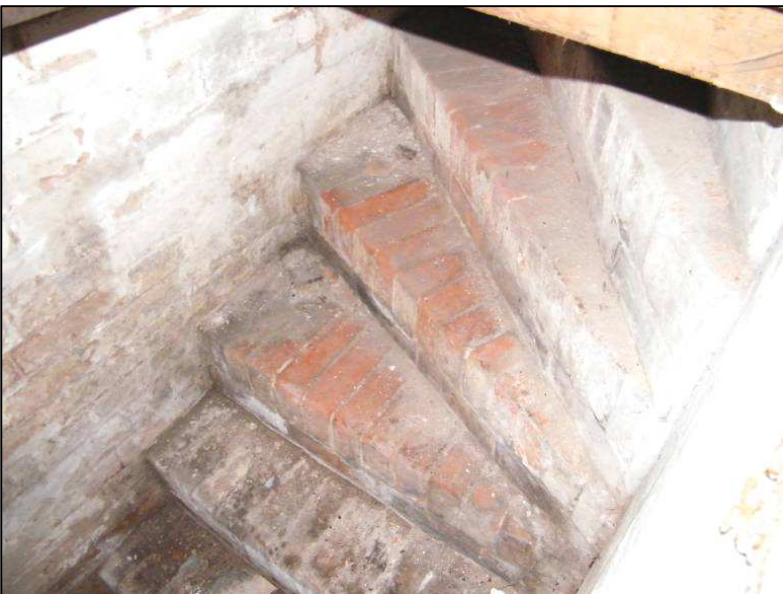
Plate 18 (Shot 56): Basement stairs, looking southeast

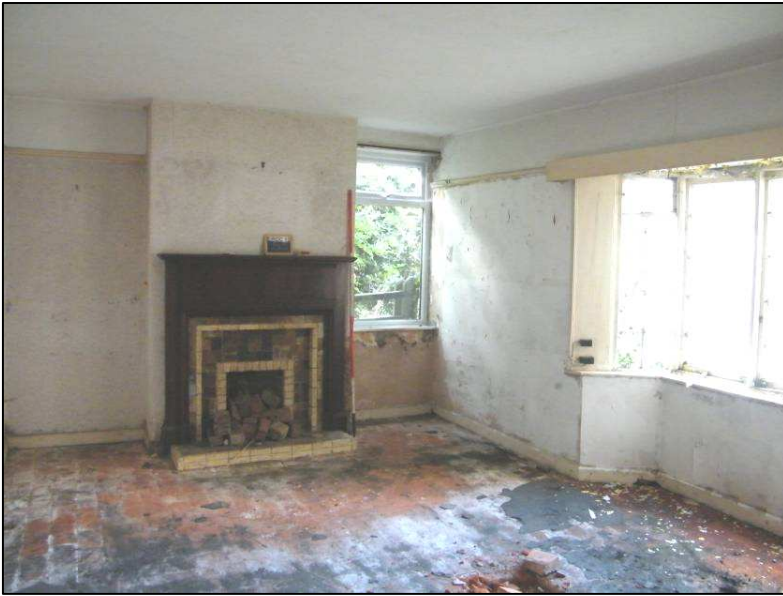
Plate 19 (Shot 57): Reception Room 4, looking southwest. Scale is 2m

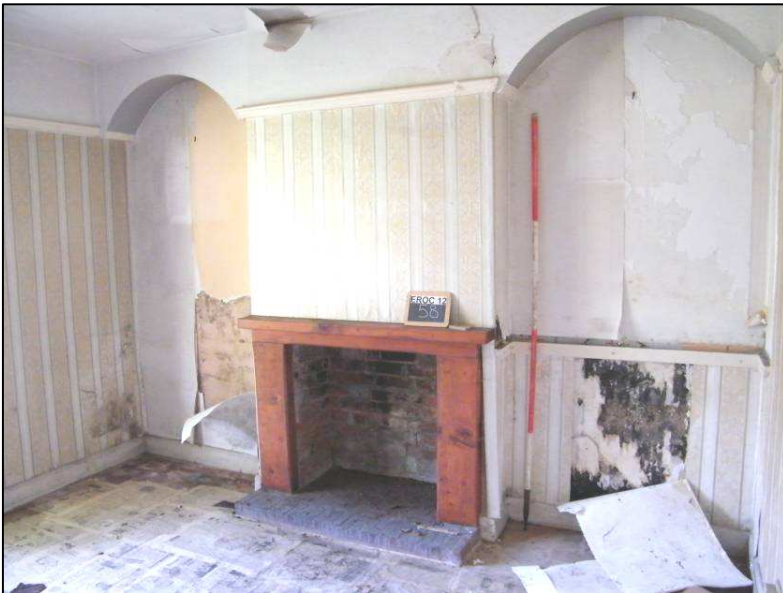
- 6.2.13 To the south of the hallway is Reception Room 2. It has a fireplace with wood surround on the southwest elevation flanked by two arched alcoves, and the floor is of brick and is currently covered with 1960s newspapers as a basic form of insulation (Plate 20).

Plate 20 (Shot 58): Reception Room 2 with fireplace and flanking alcoves, looking south. Scale is 2m

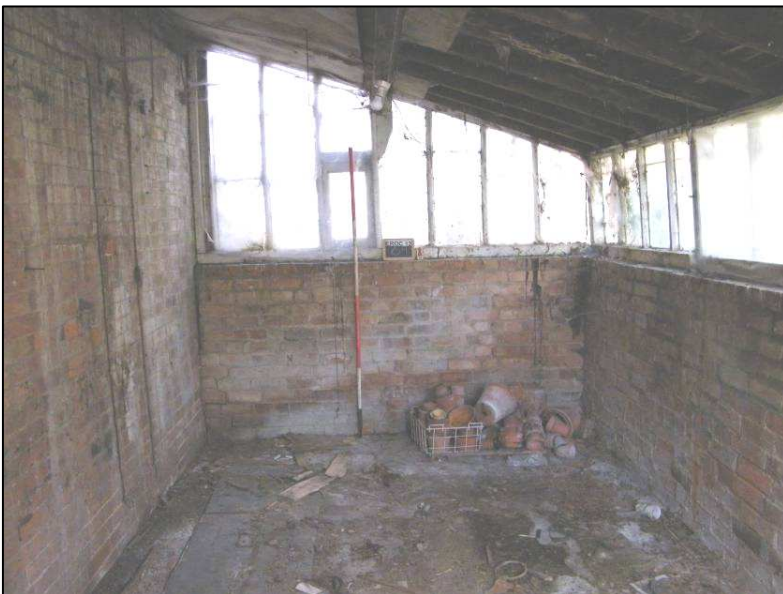
- 6.2.14 Reception Room 1 lies on the opposing side of the hallway. The tiled fireplace is situated on the northeast elevation. A door in the northeast corner leads into the greenhouse/potting shed (Plate 21).

Plate 21 (Shot 64): General view of the greenhouse interior, looking northwest. Scale is 2m

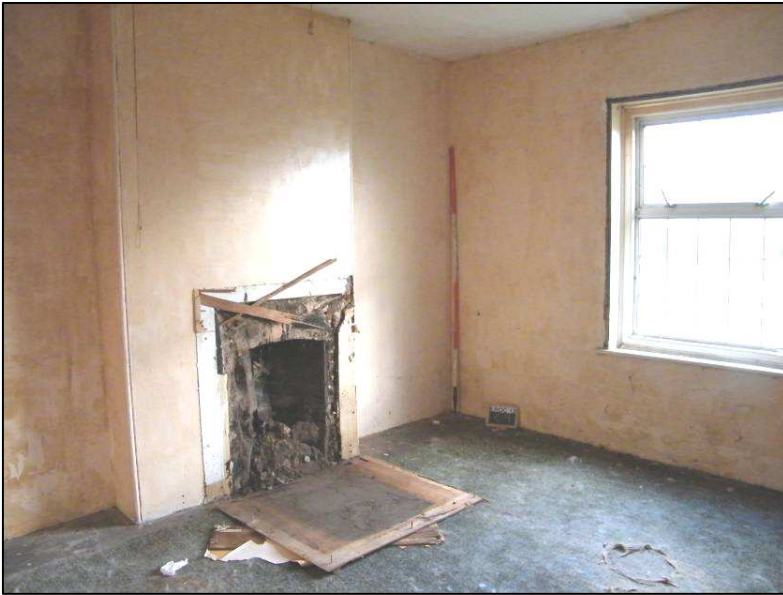
Plate 22 (Shot 65): General view of Bedroom 1, looking east northeast. Scale is 2m

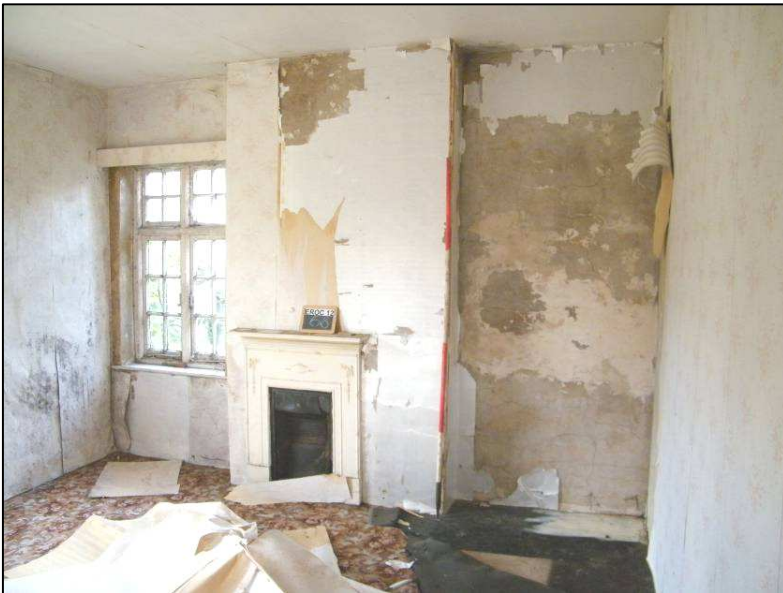
Plate 23 (Shot 69): General view of the Bedroom 2, looking south. Scale is 2m

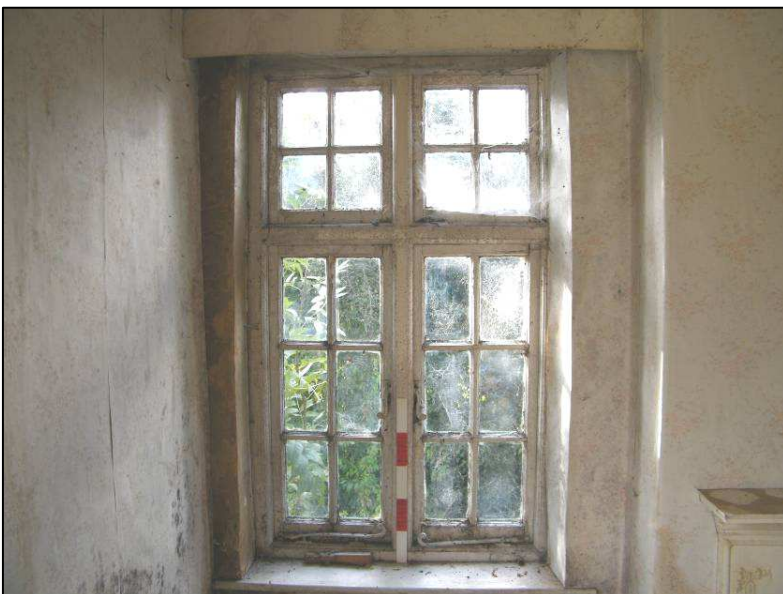
6.2.17 Bedroom 2 lies in the southern corner of the building. Where the wallpaper has peeled away it shows that the bricks walls have been cement rendered. The fireplace with its thin moulded surround and cast iron grate has been placed off centre on the chimneybreast suggesting that it has been reduced in size (Plate 23). The original window adjacent to the fireplace has spiral handles and window stays (Plate 24).

Plate 24 (Shot 72): Detailed shot of original window in bedroom 2, looking southwest. Scale is 0.5m

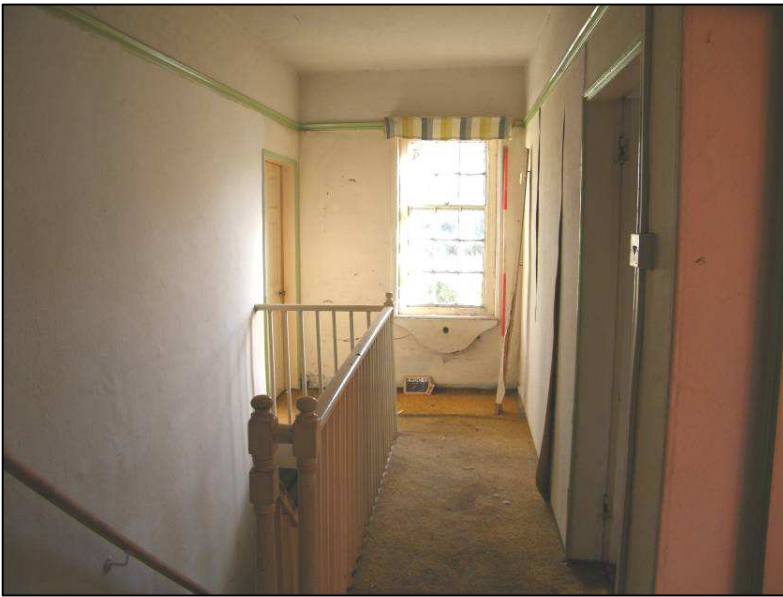
6.2.18 Another original window on the southeast elevation illuminates the landing. Beneath it is a collapsible curved shelf/seat (Plate 25).

Plate 25 (Shot 73): First floor landing showing original window with fitted shelf/seat, looking southeast. Scale is 2m

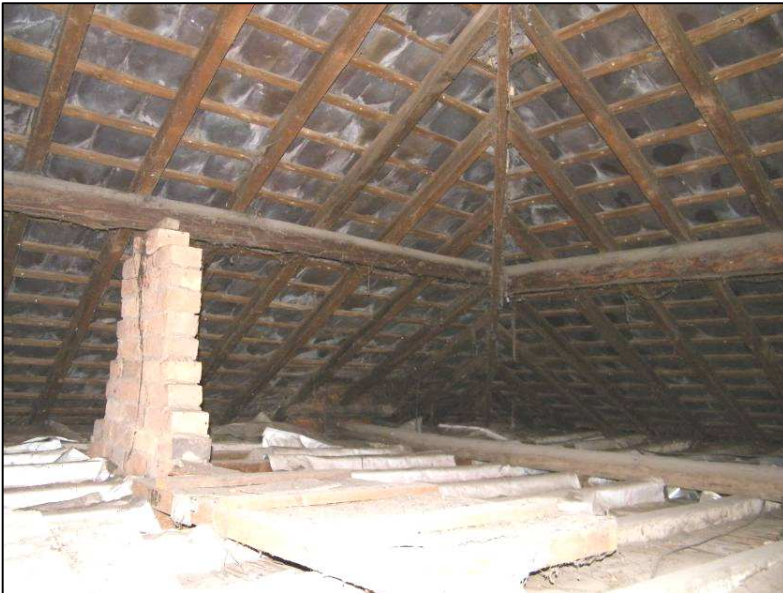
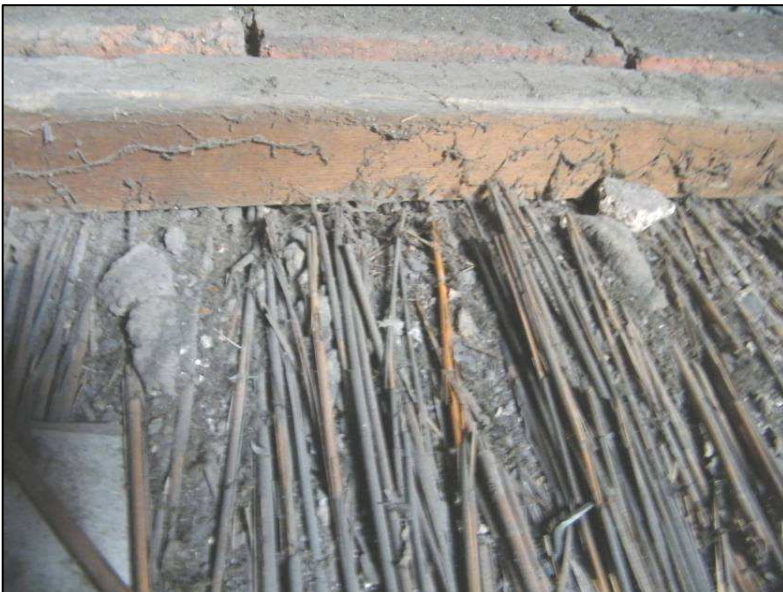
6.2.19 The attic is accessible through a hatch in the landing ceiling from where the roof structure is visible. Round logs have been used as supporting braces, with supporting brick piers. Reed flooring was also exposed between the joists in the attic (Plates 26 and 27).

Plate 26 (Shot 91): Hipped roof structure of Building B, looking west

Plate 27 (Shot 93): Reed floor in loft space of Building B, looking southwest

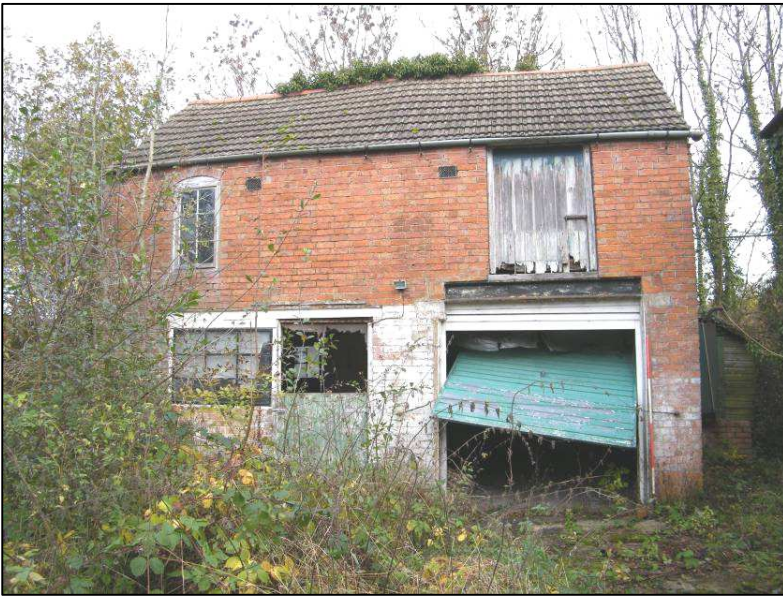
6.3.2 All elevations except the northwest have white painted mullioned windows. On the southwest elevation, the first floor window has a segmental brick arch and there is a large, fixed light window directly below, adjacent to a wooden stable door. To the southeast is a modern garage door with wooden frame and iron lintel. Above the garage door is another opening with wooden plank door (Plate 28).

Plate 28 (Shot 25): Southwest elevation of Building C, garage and storage. Looking northeast. Scale is 2m

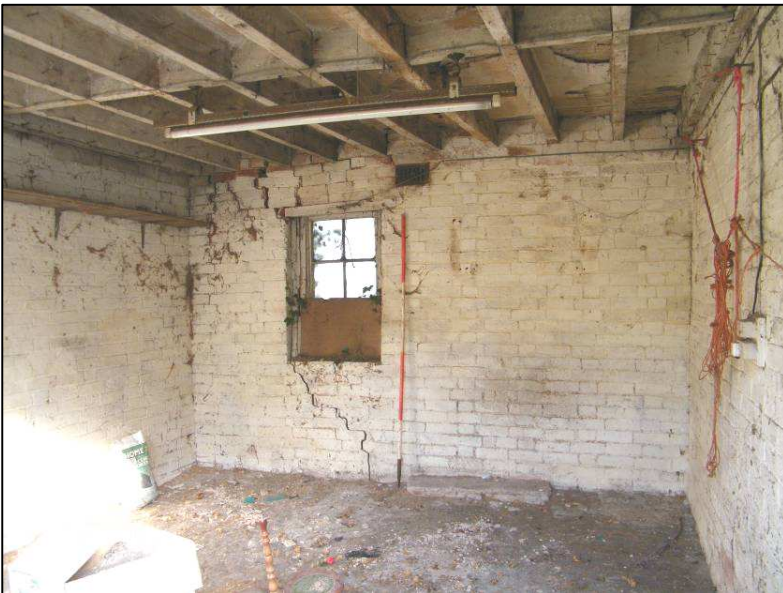
Plate 29 (Shot 36): General view of storage room interior, looking northeast. Scale is 2m

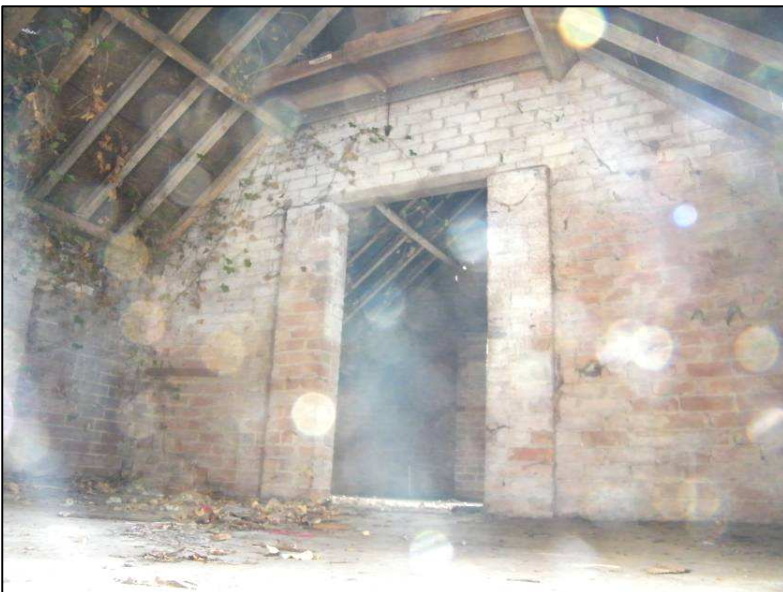
6.4.2 The upper floor has been rendered with cement, and it is divided in two by a brick partition (Plate 30). Brick buttresses support the roof structure.

Plate 30 (Shot 42): Loft partition wall, looking east northeast
