**HISTORIC BUILDING SURVEY AND EVALUATION BY TRIAL TRENCHING:
CHURCH FARM, YELLING, CAMBRIDGESHIRE**

Planning Applications: 11/02080/FUL and 11/02081/LBC

By
Allen Archaeology Limited
AAL Report Number 2013146

December 2013

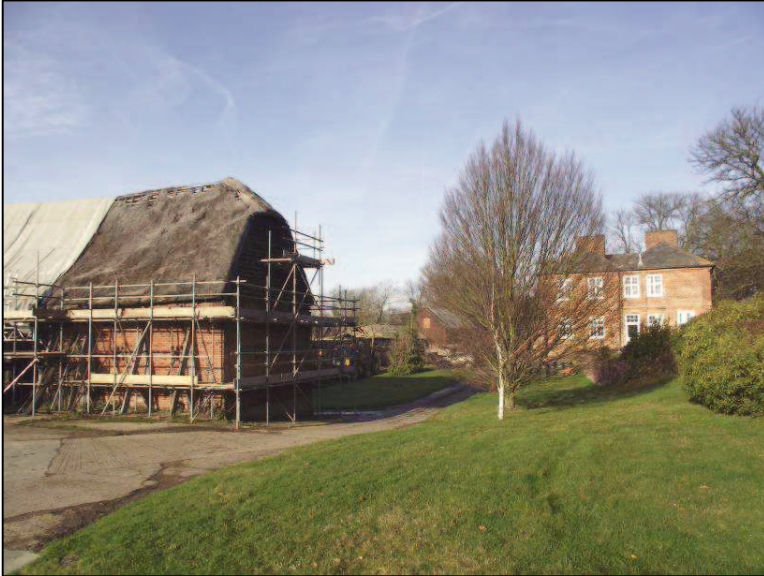
Plate 1 (Shot 46): General view of site, looking northwest

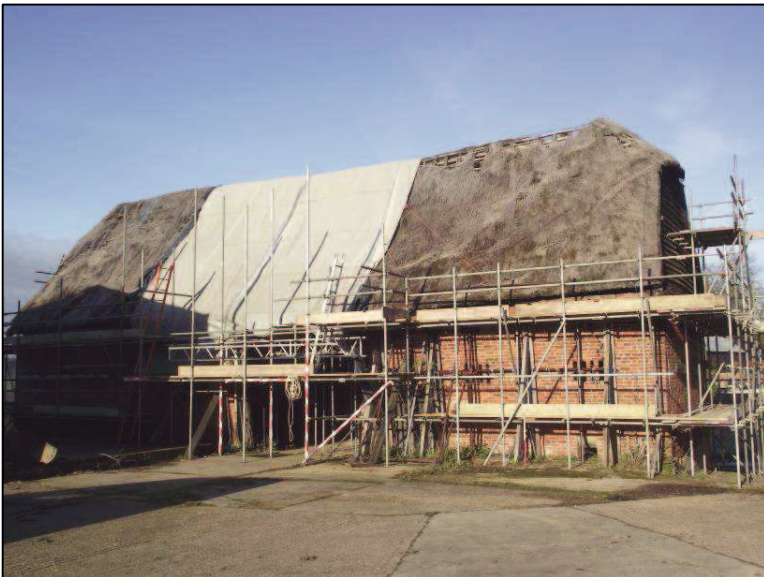
6.1.2 On the south elevation there is a large opening onto the former threshing floor. On the opposing northern elevation there is an outshut with a lean-to roof which is likely to have covered a similar large opening to allow a throughflow of air over the threshing floor (Plates 2, 5 and 6).

Plate 2 (Shot 1): South elevation of the barn, looking north. Scale is 1m

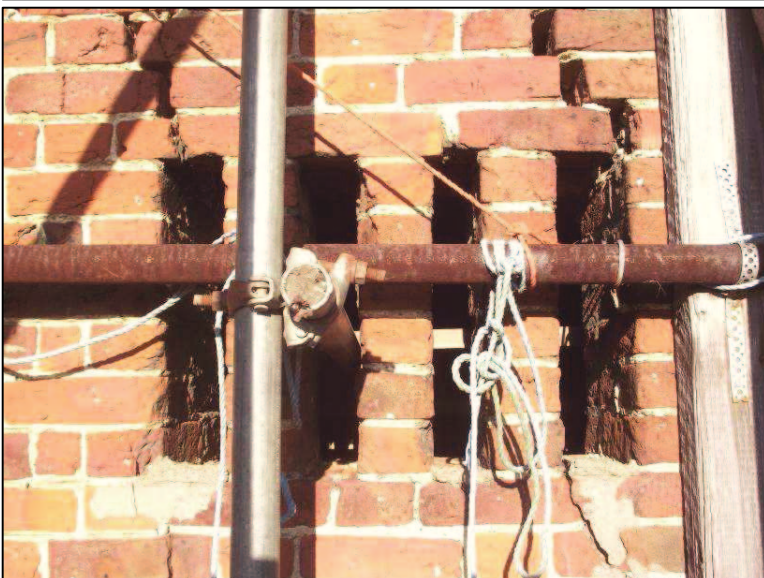
6.1.1 The barn is a 17th century, three bay, box-frame threshing barn with brick elevations. Most of the brickwork has been repaired on several occasions and only in sections is a Flemish Bond visible. The barn has also a northern brick outshut, dark painted weatherboarded gables and a half-hipped thatched roof. There are brick ventilation slits grouped in fours on all elevations (Plates 1 – 4).

Plate 3 (Shot 2): Representative shot of the barn's ventilation slits (here on the south elevation), looking north

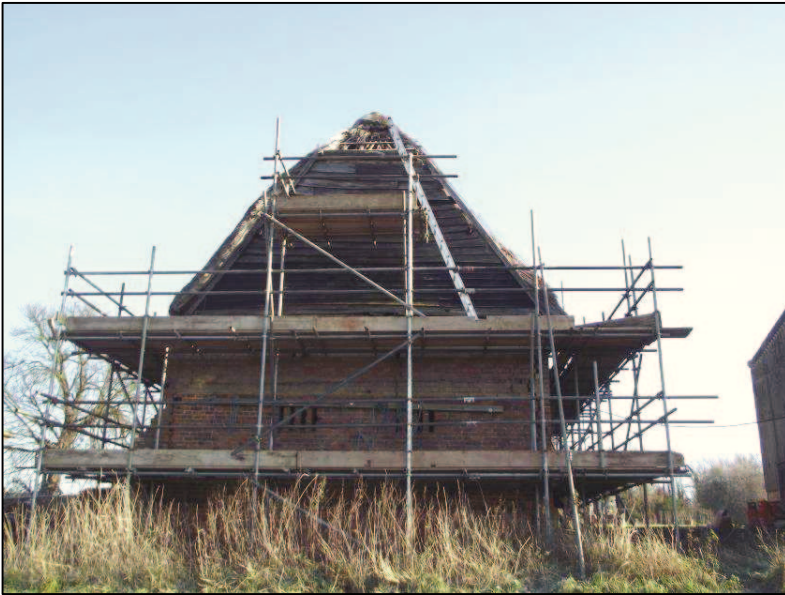
Plate 4 (Shot 4): West elevation of the barn, looking east

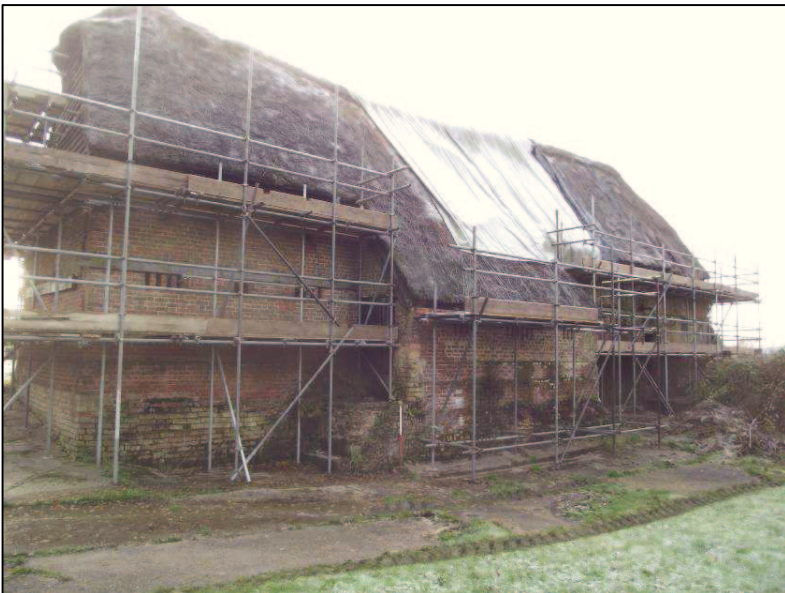
Plate 5 (Shot 23): North elevation of the barn with outshut, looking southwest. Scale is 1m

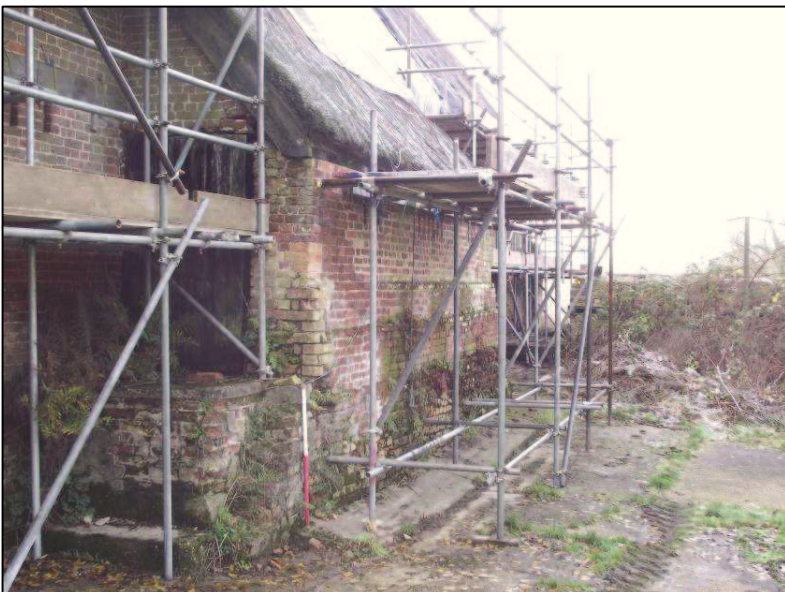
Plate 6 (Shot 24): Close up of outshut, looking southwest. Scale is 1m

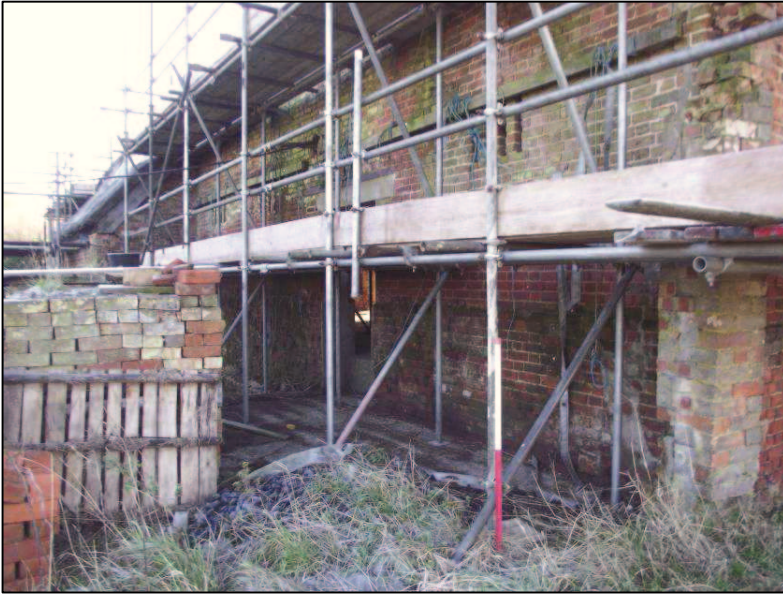
6.1.3 West of the outshut there is a second doorway on the north elevation, with a thick stone lintel (Plate 7).

Plate 7 (Shot 6): North elevation of the barn, west end, looking southeast. Scale is 1m

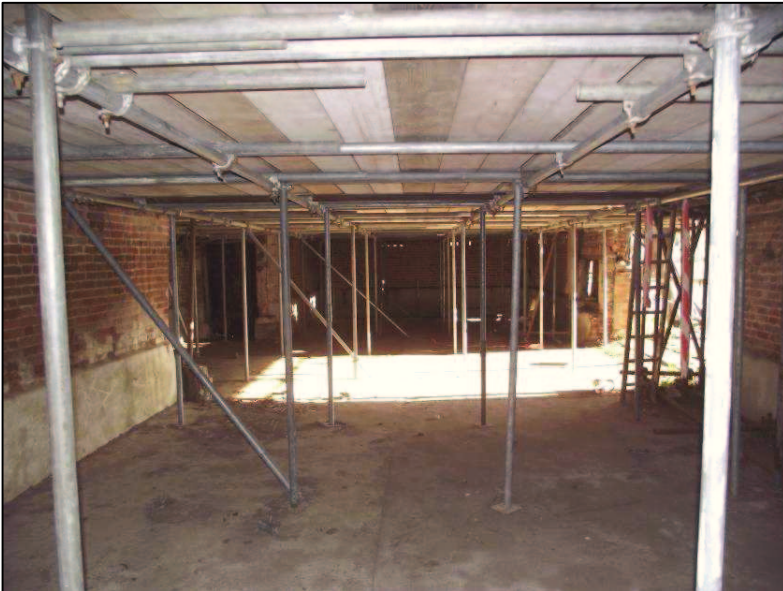
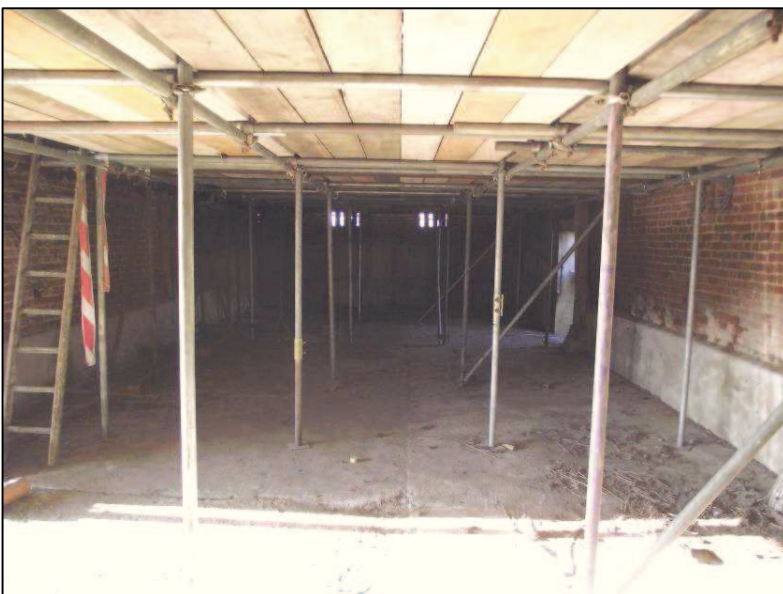
6.1.4 As with the exterior, the interior contained scaffolding, restricting a full detailed view of the structure. The ground floor was a modern concrete surface and the lower part of all interior elevations had a thick concrete render to c.0.8m height (Plates 8 and 9).

Plate 8 (Shot 7): Interior view of the barn, looking east

Plate 9 (Shot 9): Interior view of the barn, looking west

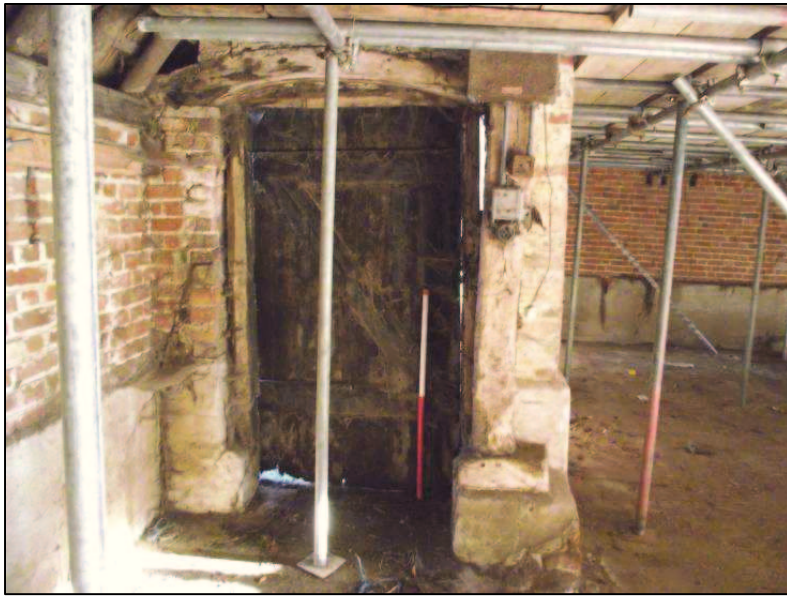
6.1.5 In front of the wooden doorframe of the outshut on the north elevation is a wooden bracing strut reinforcing the brick structure. Directly south of this a wooden post supporting the floor above sits on a chamfered stone plinth (Plate 10).

Plate 10 (Shot 10): Detailed shot of arched doorway of the outshut, looking east. Scale is 1m

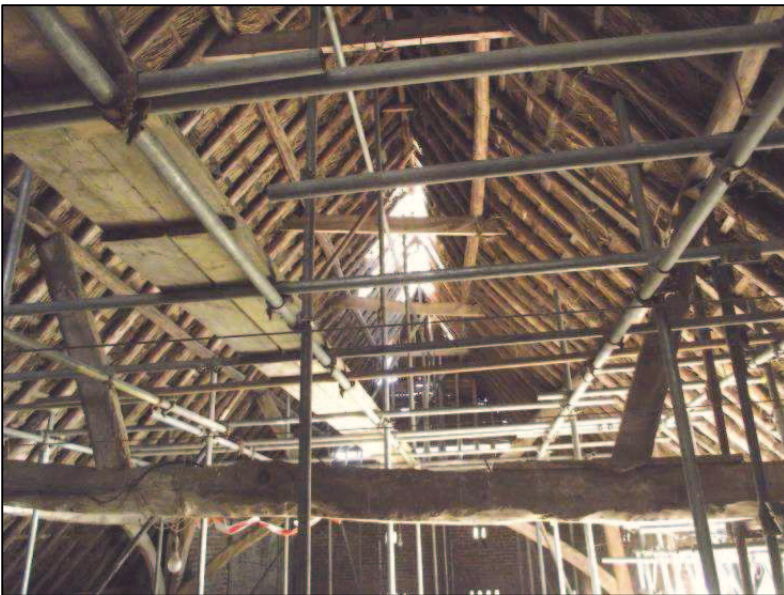
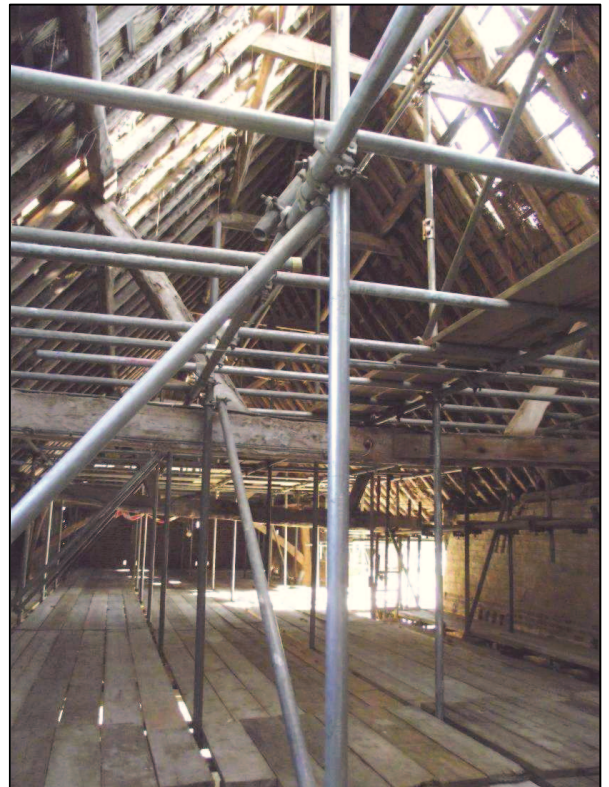
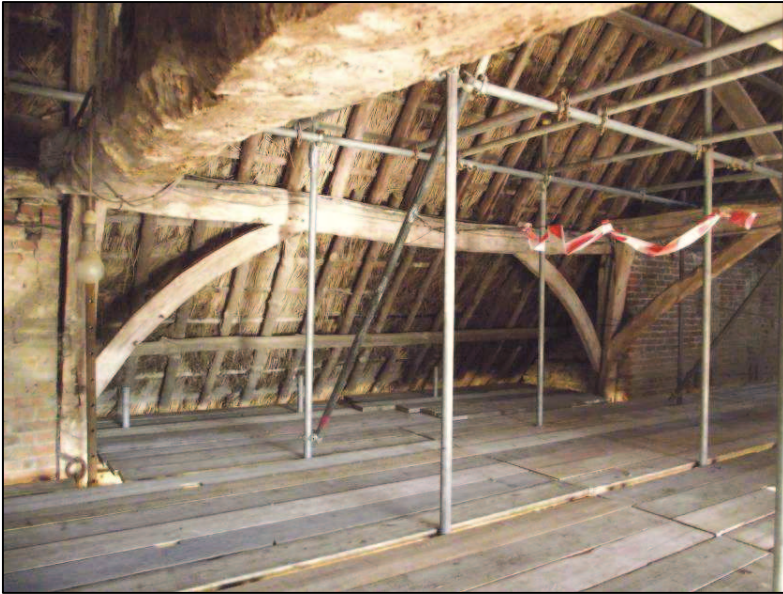
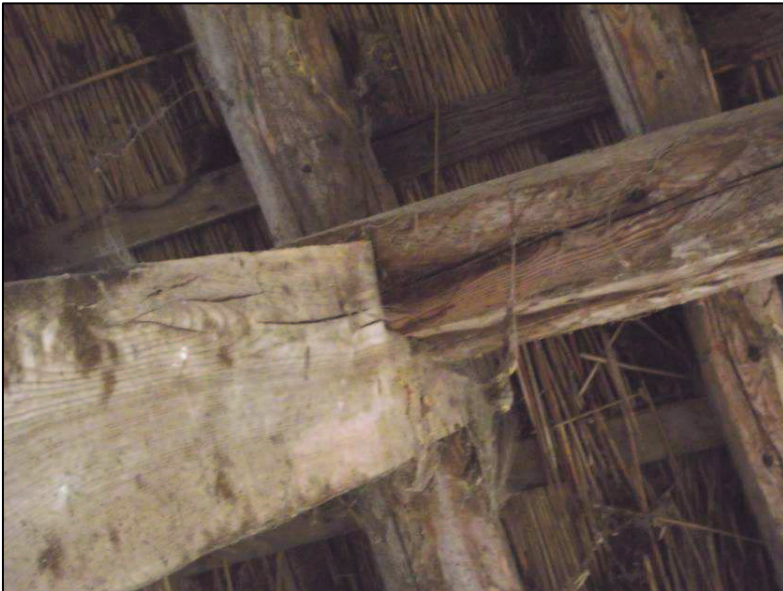
6.1.6 The thatched roof is fastened to wooden laths which lay on top of pine rafters (likely to be a later addition), supported by a 16th-17th style roof truss and trenched purlin structure. Arched braces help support the tie beams and posts (Plates 11 – 14).

Plate 11 (Shot 15): Roof truss structure with ridge and trenched purlins, looking east

Plate 12 (Shot 13): Roof structure, looking east

Plate 13 (Shot 17): Arched braces and tie beams and posts, looking northeast

Plate 14 (Shot 19): Detailed shot of trenced purlin, looking up and to the south

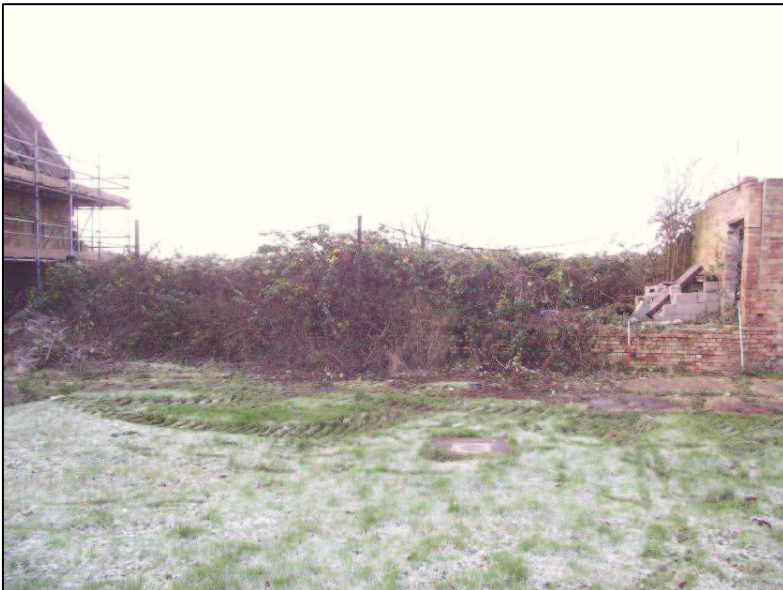
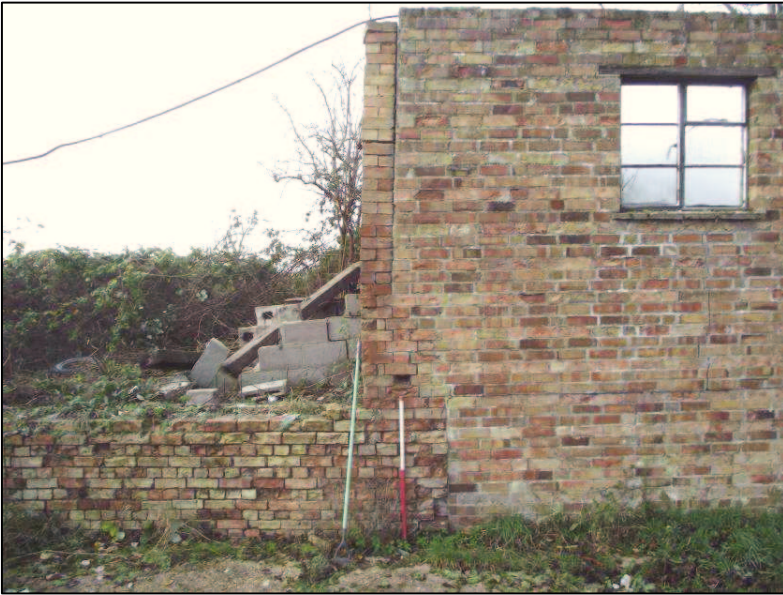
6.2.1 Outbuilding 1 had been largely ruinous for some time prior to the survey. It was very overgrown and only parts of the east and north elevation were still visible. The remaining east elevation was in English Bond whereas the north and apparently later elevation had been rebuilt using Flemish Bond (Plates 15 – 17).

Plate 15 (Shot 25): Overgrown remnants of Outbuilding 1 east elevation, looking west. Scale is 1m

Plate 16 (Shot 26): East elevation and join between Outbuilding 1 and 2, looking west

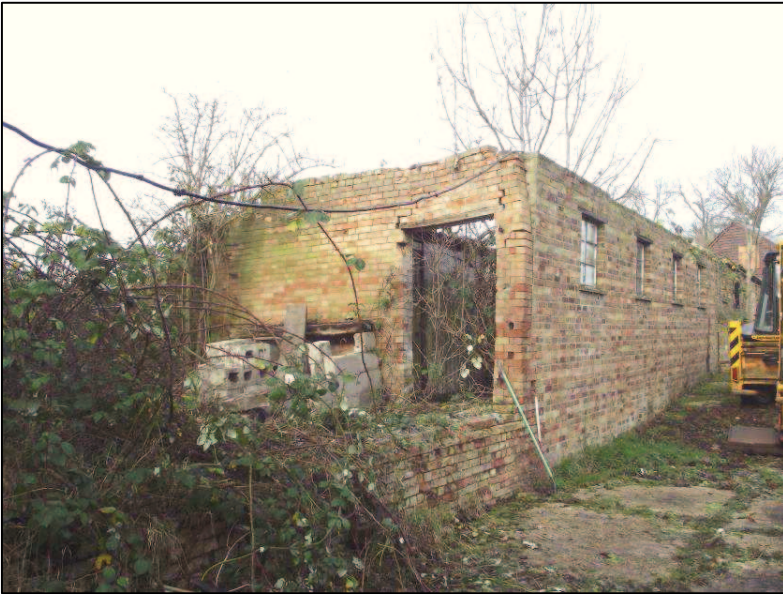
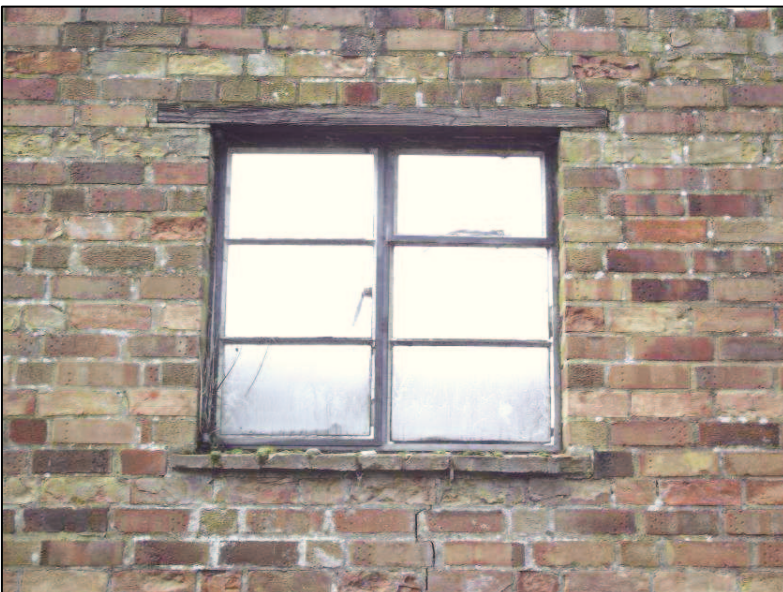
6.3.1 Outbuilding 2 was also in a poor state of repair, with no roof surviving. Access constraints and overgrowth meant only the east elevation could be photographed. This was in a probable 20th century Stretcher Bond brickwork which had been keyed into the brickwork of the earlier adjacent Outbuilding 1 at the south end. The east elevation had four windows, each with one side hung and one top hung casement (Plates 17 and 18).

Plate 17 (Shot 27): North elevation of Outbuilding 1 and east elevation of Outbuilding 2, looking northwest. Scale is 1m

Plate 18 (Shot 28): Representative window on east elevation of Outbuilding 2, looking west

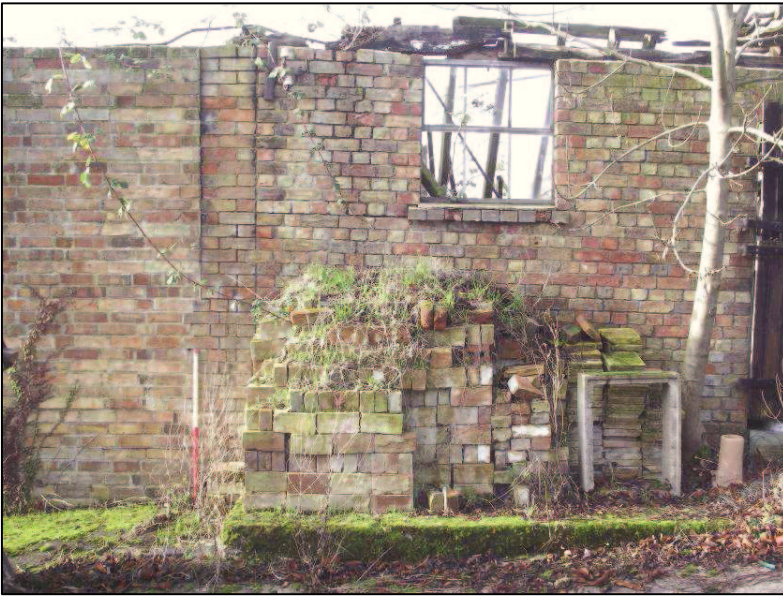
6.3.2 The north elevation serves as a partition wall to Outbuilding 3, and the later brickwork of the east elevation has been keyed into the partition wall (Plate 19).

Plate 19 (Shot 30): East elevation of Outbuildings 2 and 3, looking west. Scale is 1m

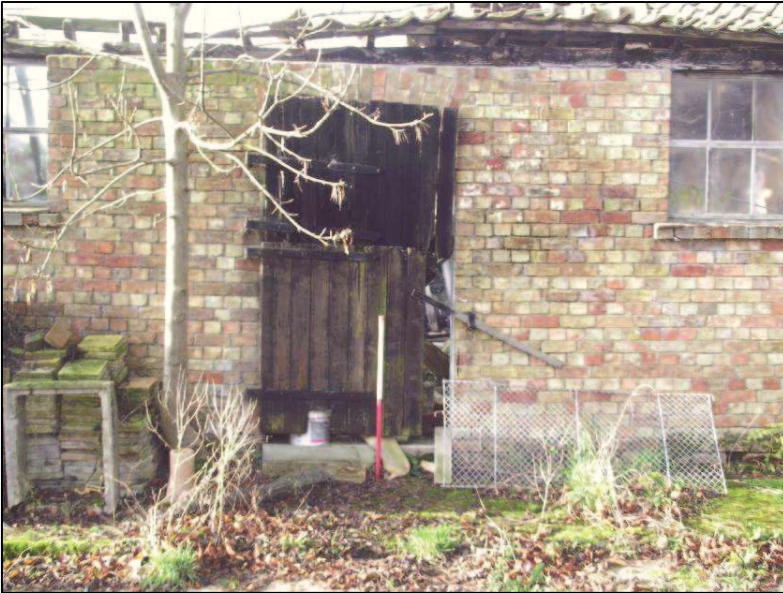
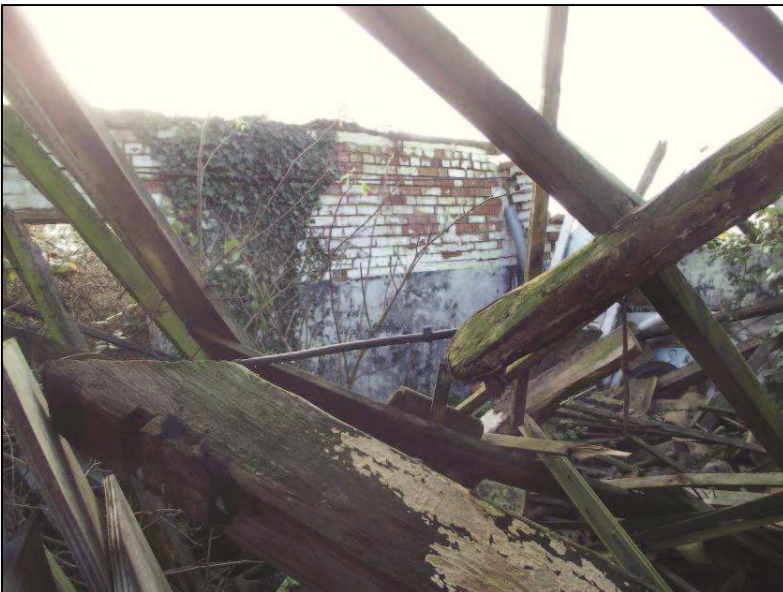
6.4.1 As with the previous structures, Outbuilding 3 was in poor shape and half of the roof had collapsed, making it unsafe to enter. The brickwork was in English Bond and appears to be identical to that used in Outbuilding 1. There is a wooden stable door in the east elevation with strap hinges and a segmental brick arch. The square, six pane, fixed light windows are probably of a later date (Plates 19 – 21).

Plate 20 (Shot 31): East elevation of Outbuilding 3, showing stable door, looking west. Scale is 1m

Plate 21 (Shot 36): Interior view of demolished/ collapsed Outbuilding 3 looking southwest

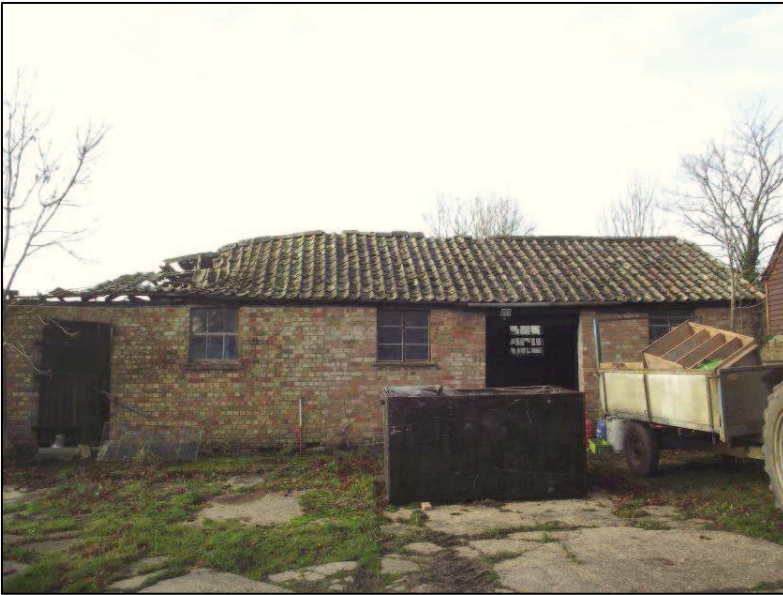
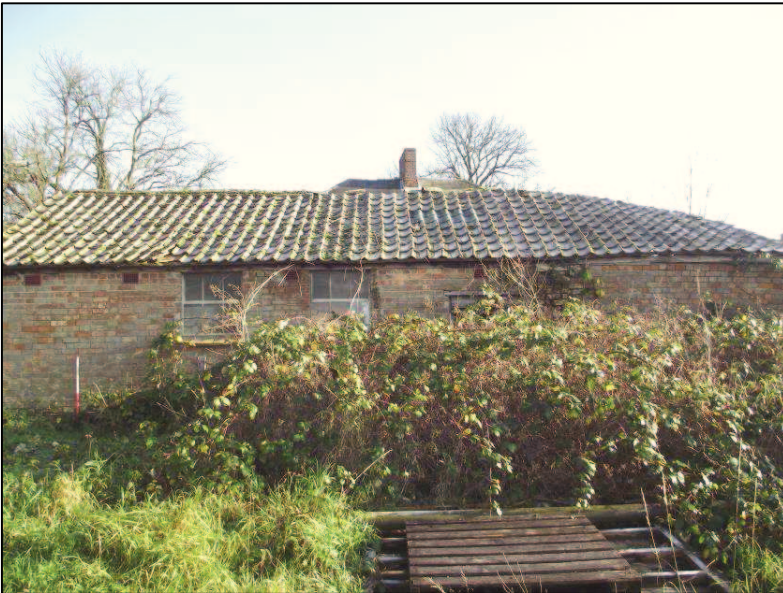
the outbuilding. The east elevation has two six pane glass windows flanking a large square opening (Plate 22), with another window in the north elevation. There are three further similar windows in the west elevation (Plate 23).

Plate 22 (Shot 32): East elevation of Outbuildings 3 and 4, looking west. Scale is 1m

Plate 23 (Shot 41): West elevation of Outbuildings 3 and 4, looking east. Scale is 1m

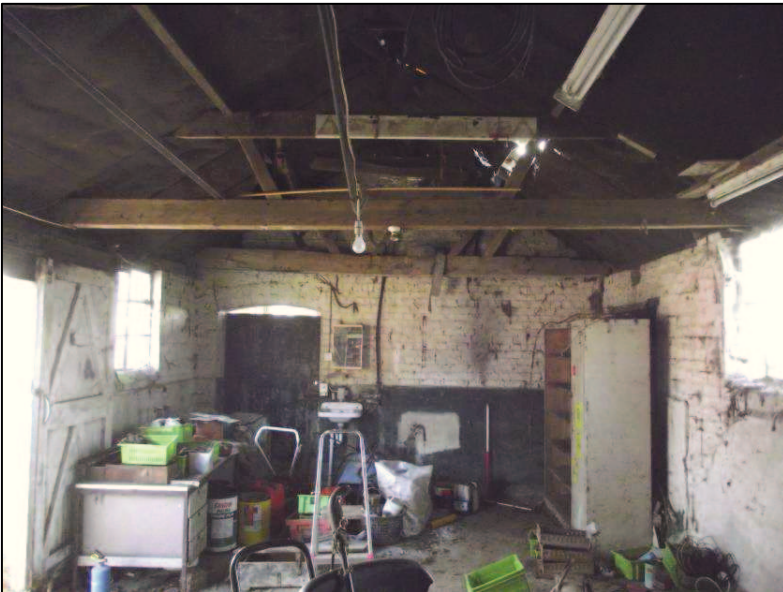
6.5.2 The building is being used as a general purpose store, and internally whitewashed walls and a concrete floor. On the southern elevation there is a segmental arched opening leading into Outbuilding 3, with plank and batten wooden door (Plate 24).

Plate 24 (Shot 33): Interior view of Outbuilding 4, looking south. Scale is 1m

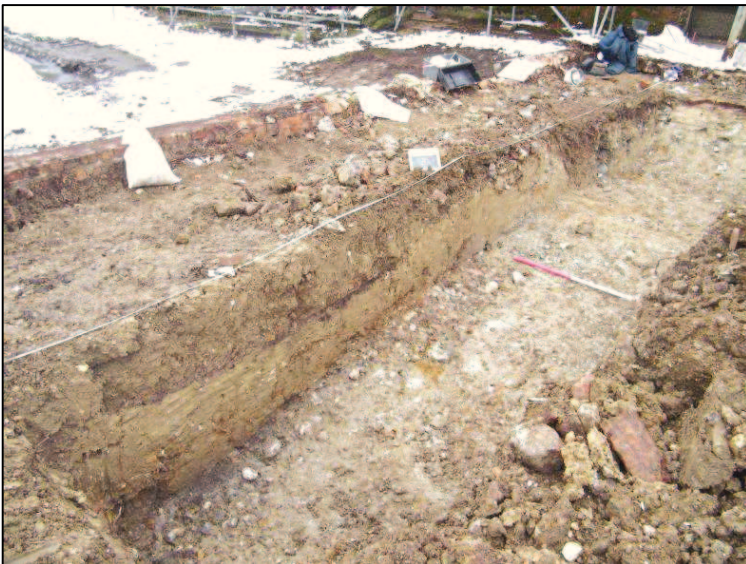
Plate 2: West facing section of Trench 1, looking southeast

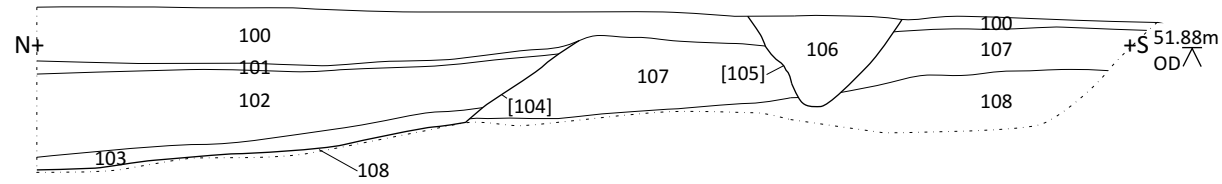
Trench 1
West Facing Section

9.1.1 The uppermost deposit was a probable levelling layer 100 of moderately loose, mid brownish grey clayey silt with occasional sub-rounded stones and brick fragments. This was cut by a broadly east – west aligned linear feature, [105]. The cut was steep sided with a concave base and contained a backfill 106 of moderately loose mid yellowish orange clay with occasional

9.1.2 Towards the south end of the trench, layer 100 sealed a dumped re-deposited natural, 107, possibly derived from landscaping of the site, as the yard area to the east of the buildings has been reduced and levelled and the former buildings sat on a raised 'plinth'.

9.1.3 At the north end of the trench, deposits 101, 102 and 103 were recorded as fills within a steep sided cut, [104]. The function of this feature is unclear, but the most likely interpretation is that [104] is not a cut *per se*, but represents the interface between dumped deposit 107 and layers 101, 102 and 103.

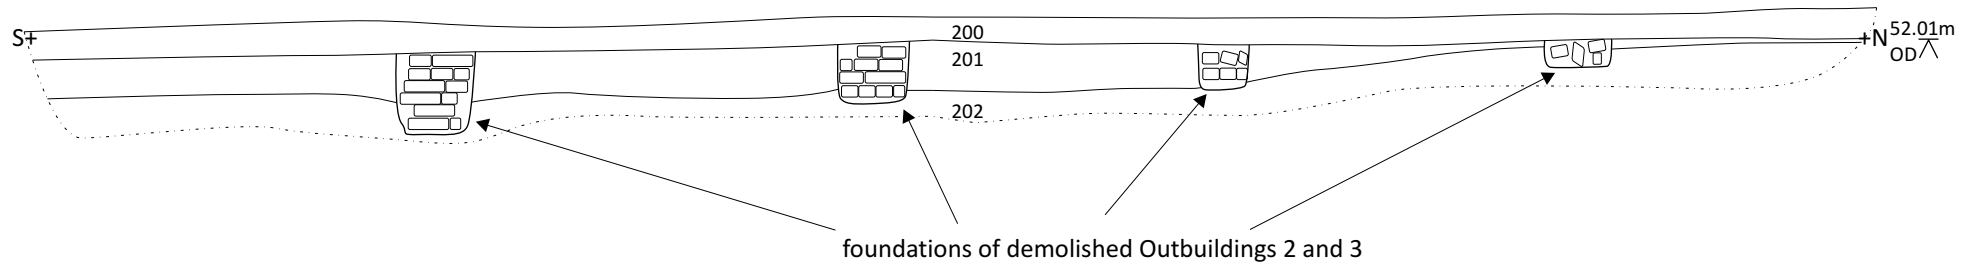
Trench 2
East Facing Section

9.2.1 The removal of Outbuildings 2 and 3 resulted in the formation of a demolition layer, 200. It was a 0.20m thick mix of loose dark grey and brown sandy clay with frequent building rubble. It sealed four brick foundations representing the walls of the former outbuildings. The depths of the foundations gradually became deeper towards the south which appears to correspond with the gradual slope of the ground.

9.2.2 The foundations were cut into a dumped levelling deposit 201, a 0.35m thick dark brown sandy clay with occasional small brick and chalk fragments, which became shallower towards the north end of the trench, and is likely to be the same as deposit 100 in Trench 1. It sealed the natural geology of mottled, compact grey clay with pockets of orange brown sand and frequent poorly sorted sub-angular chalk flecks and fragments, 202.
