HISTORIC BUILDING SURVEY REPORT:

BRUMBY RESOURCE CENTRE, BRUMBY, SCUNTHORPE, NORTH LINCOLNSHIRE

By
Allen Archaeology Limited
Report Number AAL2016006

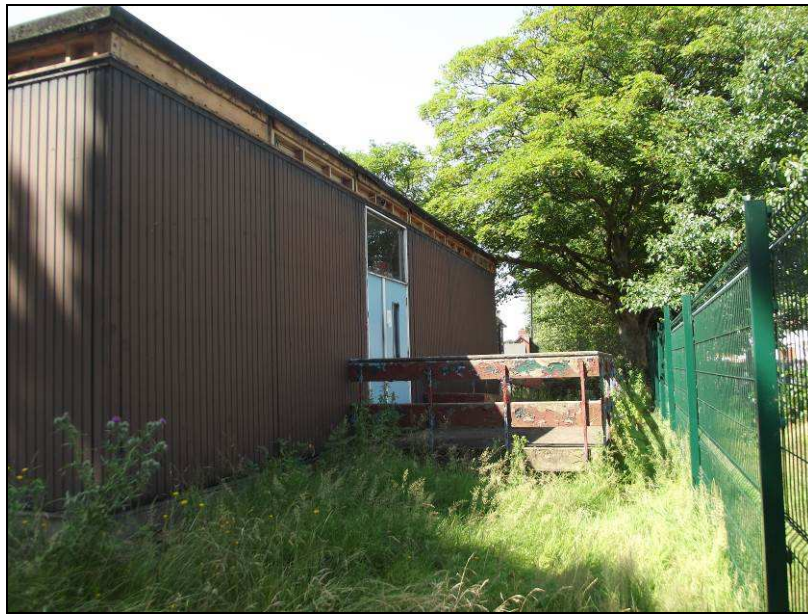
- 6.2 Ashby House comprises a series of interconnecting blocks of single storey late 20th century pre-fabricated buildings (Plate 1). It is generally flat roofed, but with double pitched roofs over glass fronted sections facing the road, with exterior wooden planking covered in asbestos paint. It covers an area of approximately 0.15ha at the northeast corner of the site.

Plate 1 (Shot 283): The exterior of Ashby House, looking north, east facing elevation

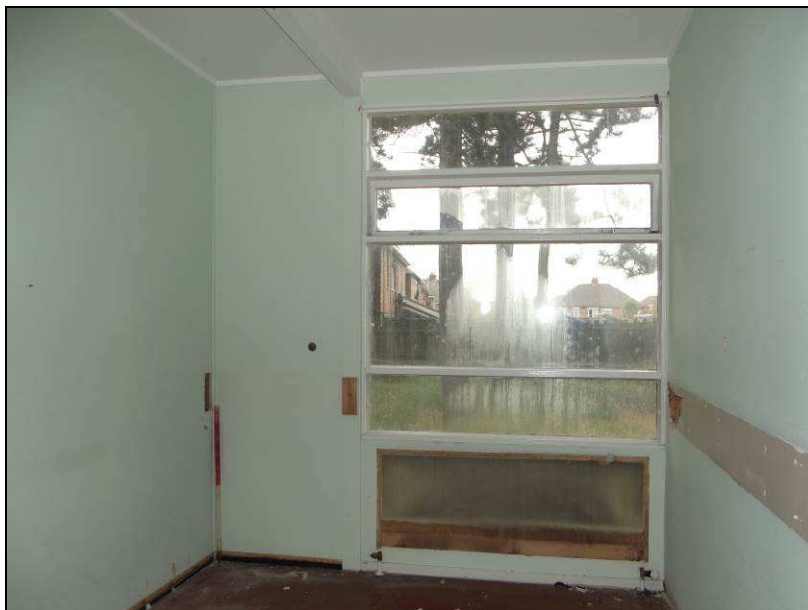
- 6.3 The interior was predominantly divided up into approximately forty office spaces (Plate 2) with five larger classrooms (Plate 3) and three sets of lavatories (Plate 4). Ceiling height was consistently 3.12m and the concrete floors were covered with a mixture of carpet and lino tiles, where still present.

Plate 2 (shot 341): One of the office rooms in Ashby House, looking east

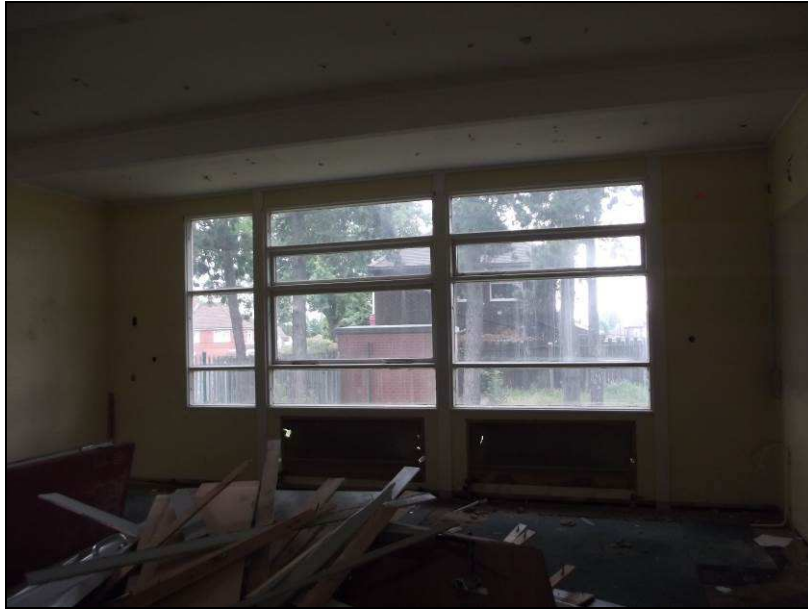
Plate 3 (shot 338): One of the larger classrooms in Ashby House, looking east

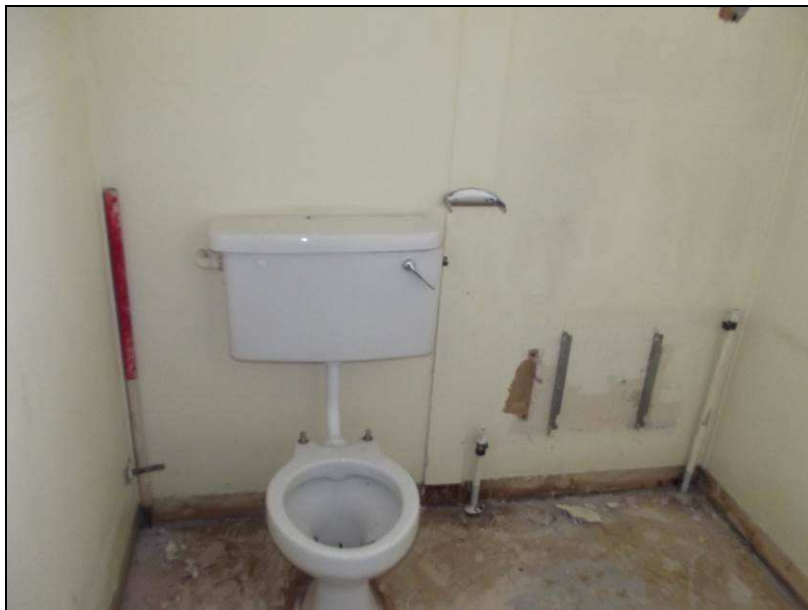
Plate 4 (shot 365): One of the lavatories in Ashby House, looking west

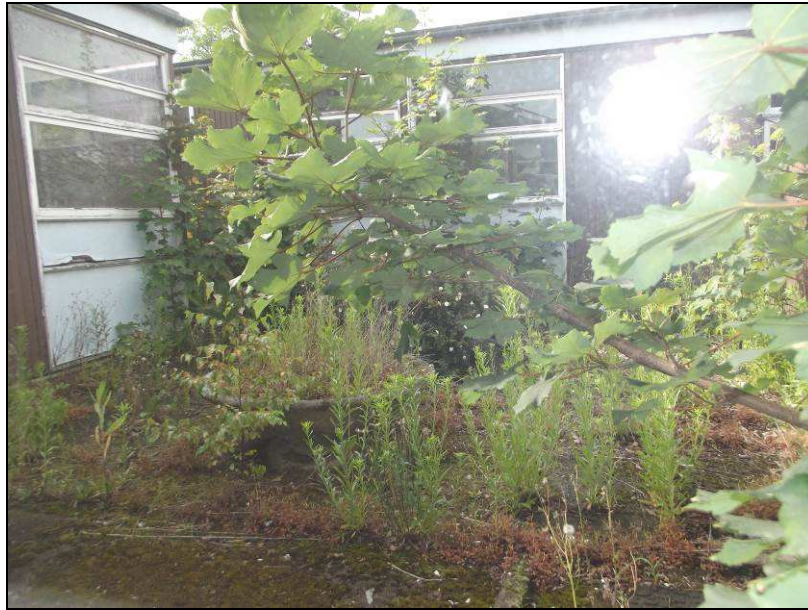
- 6.4 The building is centred on a small courtyard (Plate 5) with a corridor running along the south of the courtyard of the building aligned east-west. A second corridor is linked to the building on the eastern side and runs north-south (Plate 6).

Plate 5 (shot 414): Courtyard of Ashby House, looking southwest

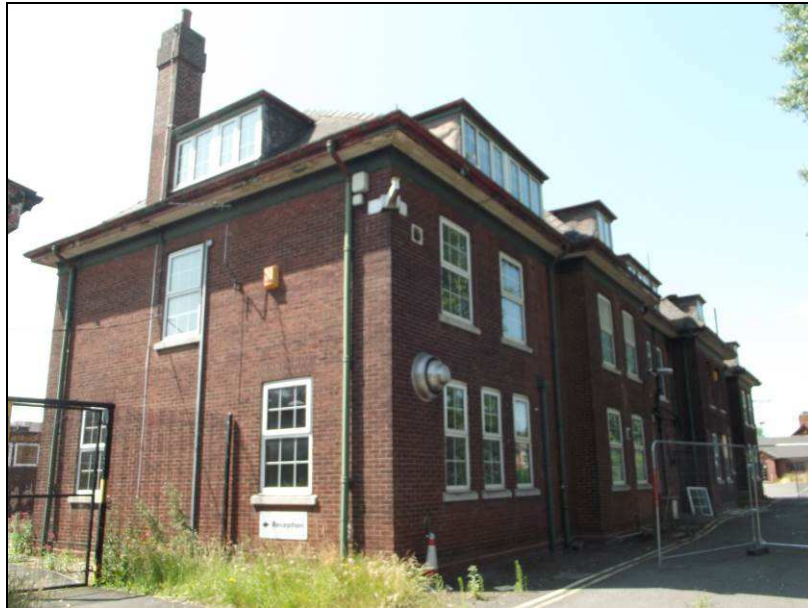
Plate 7 (shot 298): View of Barton House taken from the northeast looking southwest

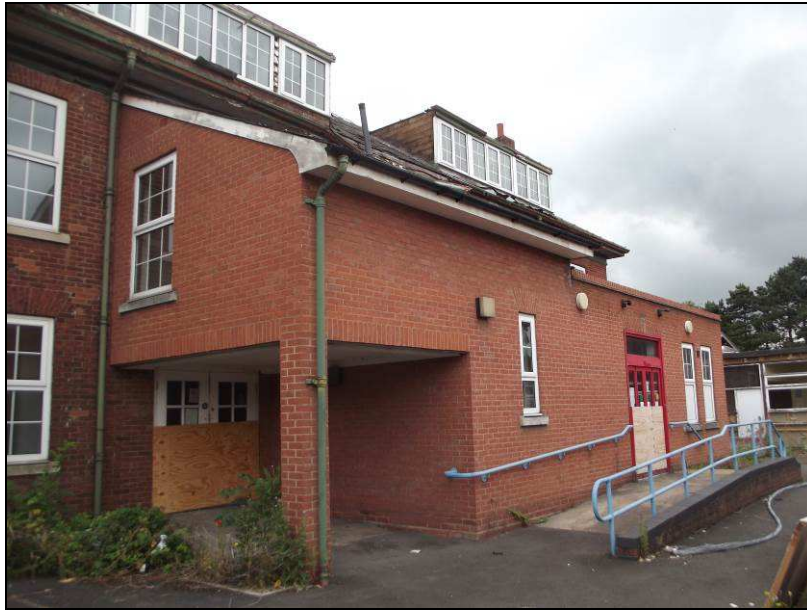
single storey with a flat roof and part being one and a half storey with a mono pitched roof, with a disabled access ramp (Plate 9).

Plate 9 (shot 151): Eastern extension of Barton House, looking northwest

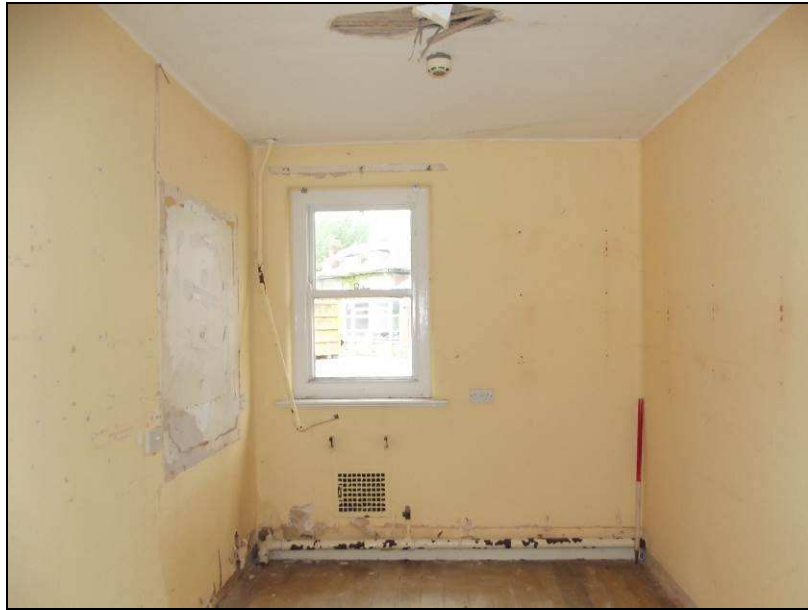
- 6.31 The northern wing is divided into two areas; C3 and C4. C3 consists of five small rooms with wooden floors which probably functioned as office space. Three of these rooms are still in good condition (Plate 47) while the other two spaces lack the internal plastered finish (Plate 48). C4 representing the north-eastern end of the original block and the later extension, consist of three larger spaces of similar design (Plate 49).

Plate 47 (shot 246): One of the small office spaces in C3, looking northwest

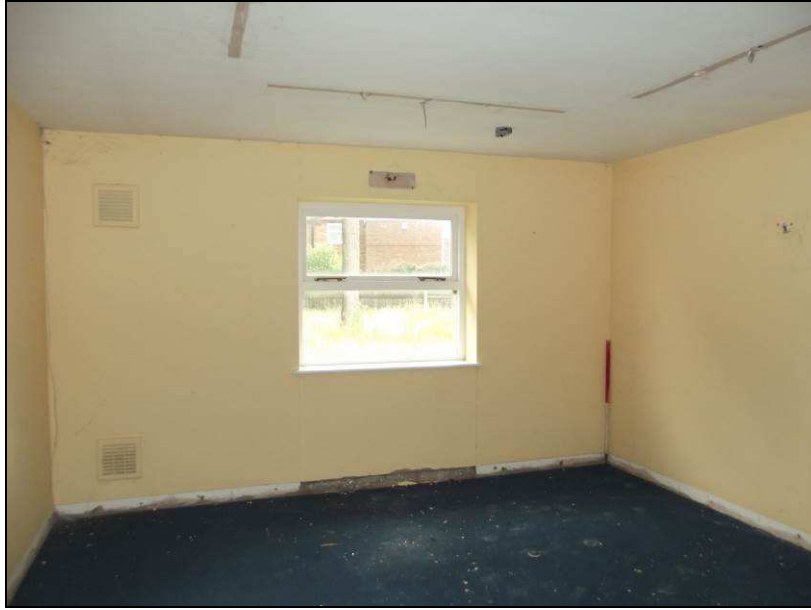
Plate 49 (shot 256): Room in C4, looking southeast

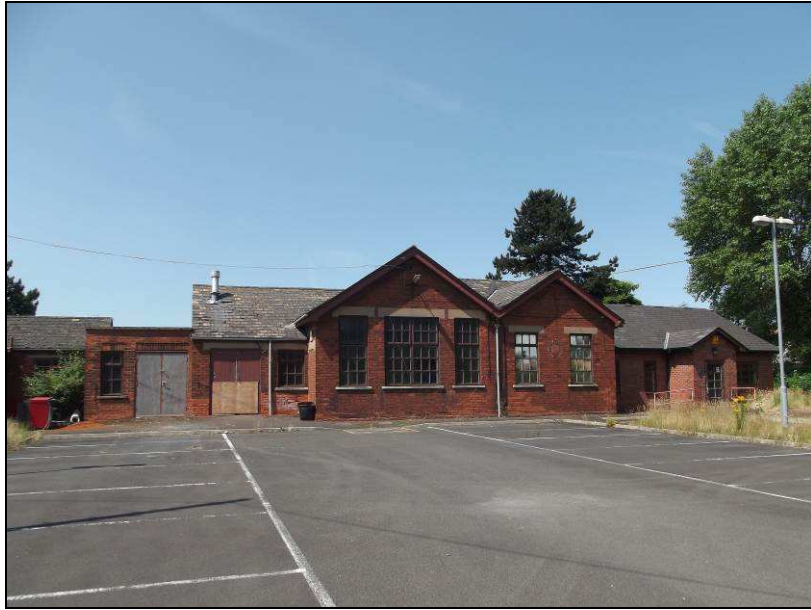
- 6.35 The original part of the building is of red brick with a double pitched slate roof, aligned north – south (Plate 50). The building is mainly in stretcher bond but with some inconsistencies in the bonding suggesting it has been repaired or replaced at some point. Windows are largely large casements with brown painted wooden muntins and have concrete lintels and large stone sills.

Plate 50 (shot 325): Exterior of Dragonby building, looking west

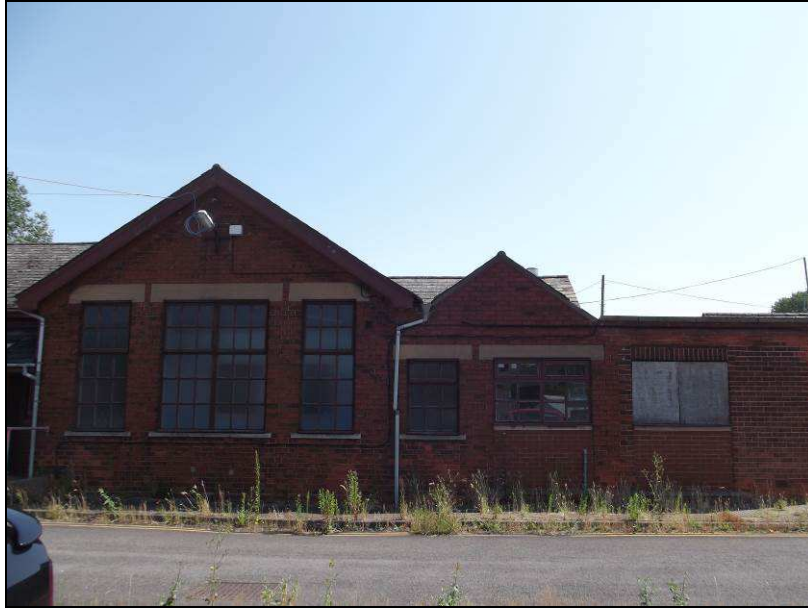
Plate 53 (shot 331): West facing elevation showing an inserted window in the southern extension, looking east

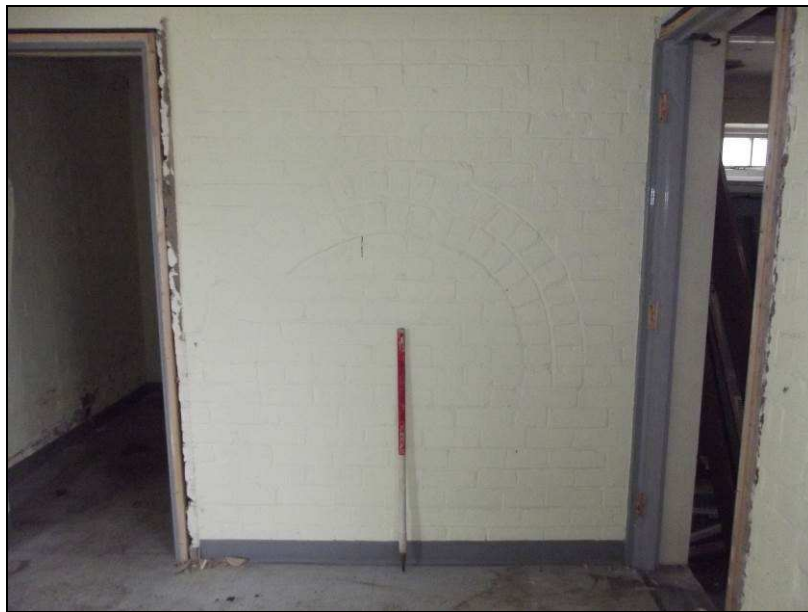
Plate 60 (shot 8): Bricked up semi-circular archway in the first southern extension of Dragonby Building. Looking east

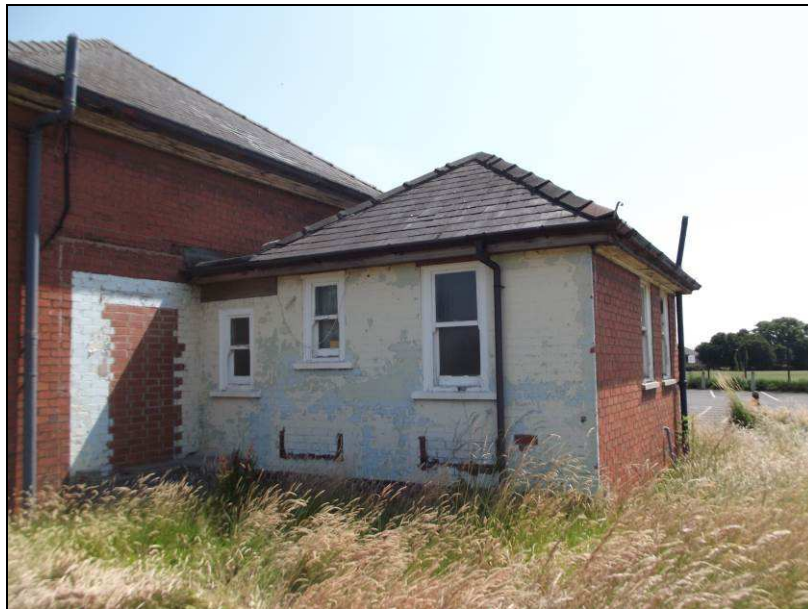
Plate 66 (shot 316): An extension has been removed from the southern end of Epworth House, looking east

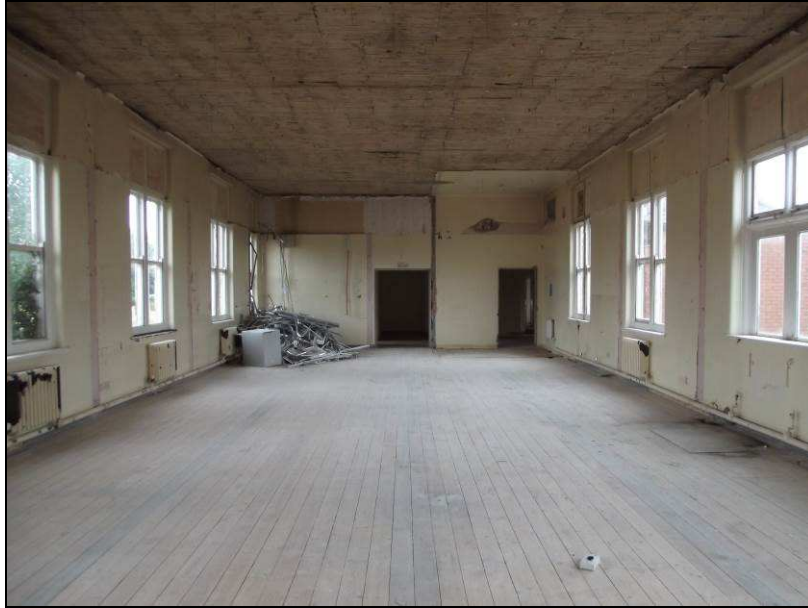
Plate 71 (shot 50): View of the southern half of Epworth House looking northeast. The interior has been stripped of its partitions.

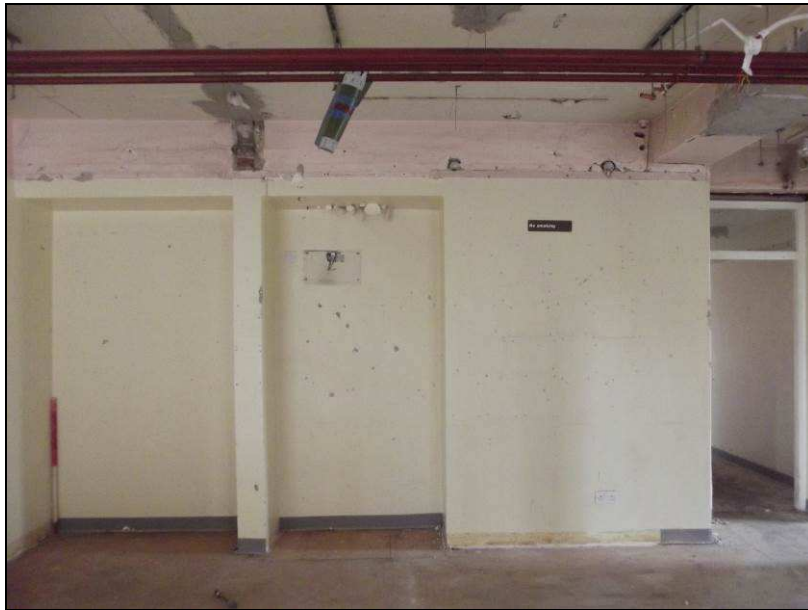
Plate 72 (shot 55): Sealed entrances to part of Epworth House, presumably due to the western extension providing access, looking northeast
