HISTORIC BUILDING SURVEY REPORT:
THE OLD SCHOOL, SCHOOL LANE, HAINTON, LINCOLNSHIRE

Report prepared for Steven Dunn Architects

By
Allen Archaeology Limited
Report Number AAL 2016041

March 2016

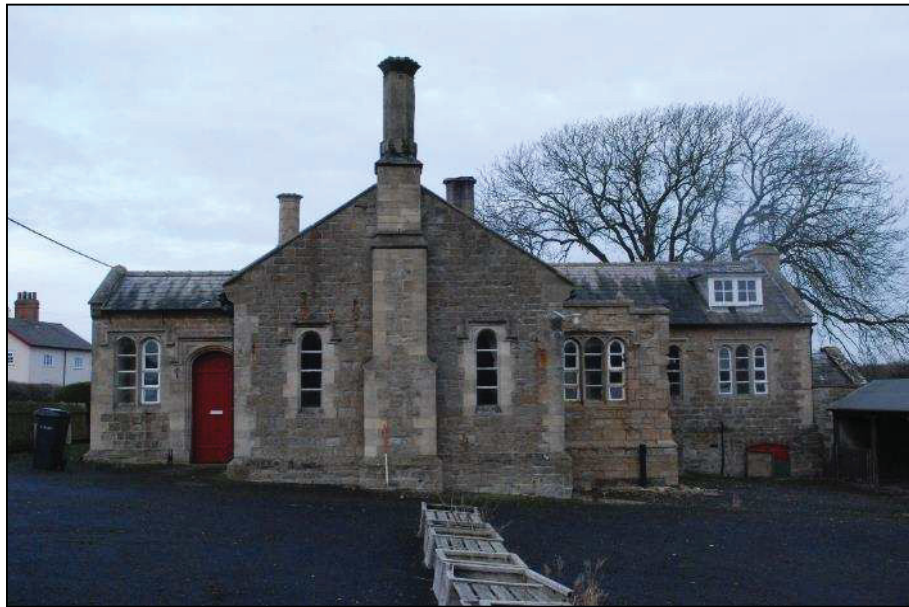
- 6.5 The entirety of the building is on a plinth, which can be seen more clearly to the northeast where the slope of the land exposes more of the masonry (Plate 1), this is likely to have been further obscured by the later resurfacing of the playground. The roofing is also markedly consistent suggesting that it has been reroofed at some point following the later extensions.

- 6.17 The final extension was built in 1930 (Plate 4). It was originally in use as the main entrance to the building, and was later converted into a toilet block. The extension projects from the southeast elevation of the original building and the northeast elevation of the second classroom, and unlike the rest of the building it has a flat roof. A stairway of five steps leads up to the doorway on the northeast elevation and the doorway is of the same style as featured on the porch. Above the doorway is a raised parapet of triangular pedimented ashlar stonework, which has been relocated from the reputed original location on the southwest facing elevation (Steven Dunn Architects 2015). A three light window occupies the southeast elevation (Plate 1).

Plate 1 (shot 110): Southeast elevation of the school building: the gable end at the centre of the building is the second classroom; the porch can be seen to the left of the image; the 1930s main entrance can be seen to the right and behind this the original building can be seen. Looking northwest, scale 1m

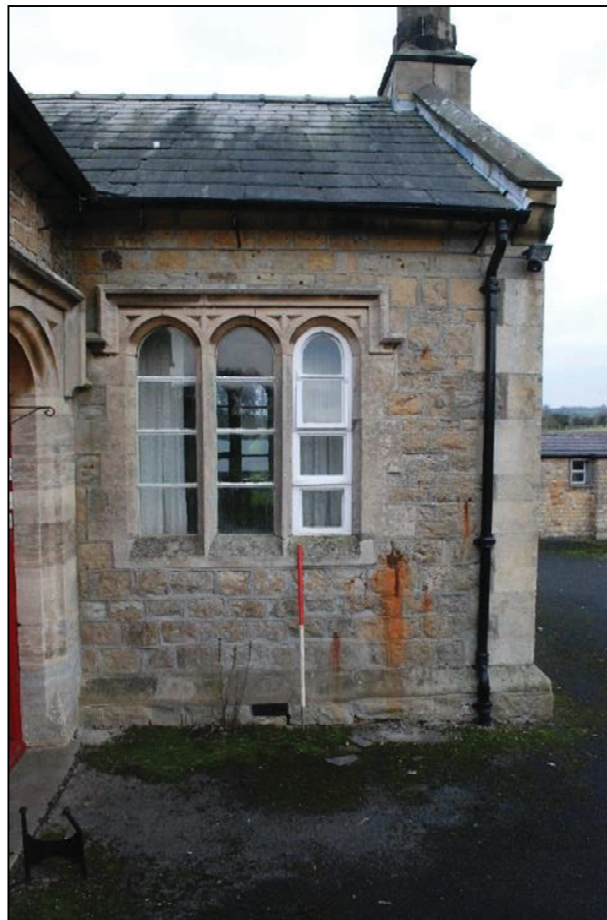
- 6.2 The building is constructed of coursed limestone rubble with limestone ashlar dressings. The building is typical of a 19th century school building, being of one, tall storey with windows placed high into the walls, and skylights (Plate 1). The roof is slate with ashlar coping stones along the ridges. The gable ends project up and outwards from the main building, are sealed with lead flashing and are again topped with ashlar stones (Plate 2).

Plate 2 (shot 100): End of the second classroom showing the projecting gable ends and lead flashing, looking northeast, scale 1m

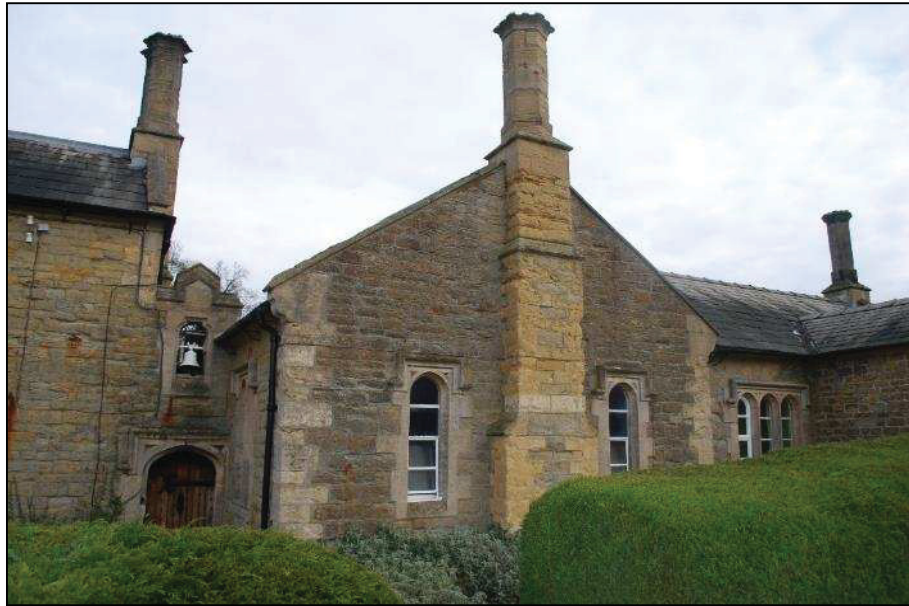
- 6.6 The original building is now largely obscured from the exterior by the more recent extensions. The southwest gable (Plate 3) has a refurbished chimney stack projecting beyond the gable end leading up to a tall hexagonal ashlar shaft with a moulded cornice at its peak. Two windows pierce the gable end, each with a single light and of four panes with pointed heads, of a style which is consistent across the building. These are set into ashlar mouldings with chamfered mullions and hood mould heads.

Plate 3 (shot 142): Gable end of the original school building, with the schoolmaster's house to the left and the extensions to the school to the right, looking east

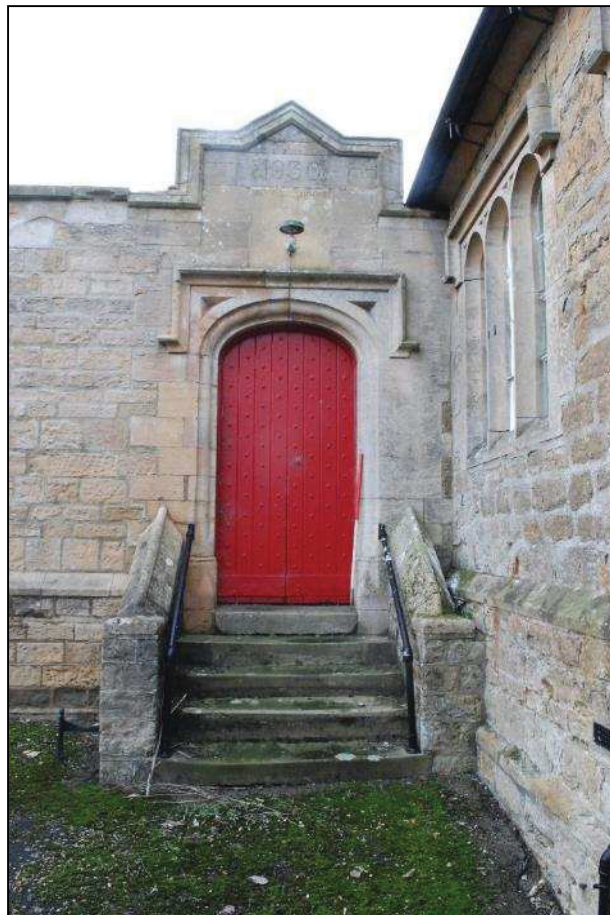
Plate 4 (shot 115): New entrance to the building, constructed in 1930 and now a toilet block, looking southwest, scale 1m

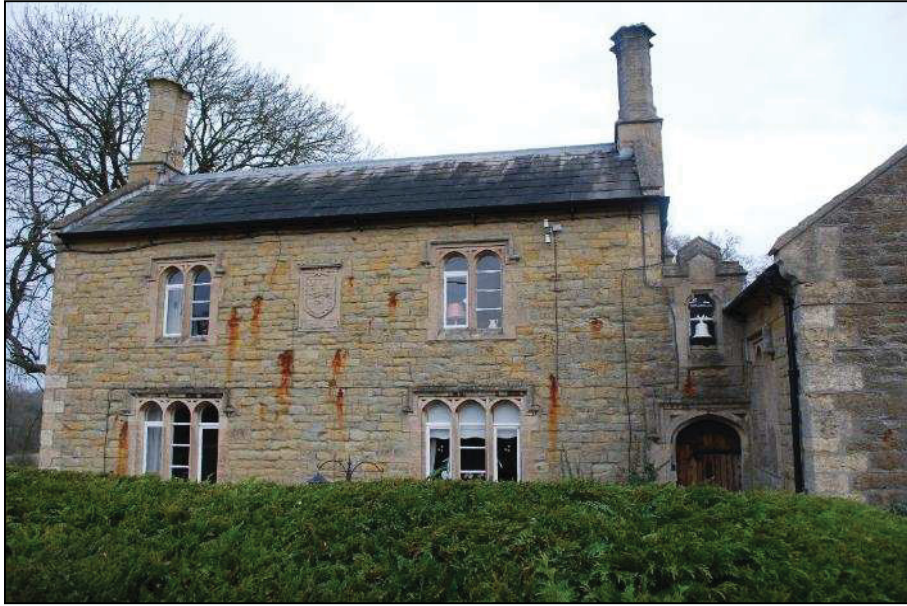
- 6.7 Two light windows of the same style are also present in the northwest facing elevation at this southwest end, adjacent to where the schoolmaster's house meets the elevation. The two buildings are joined by a passage which on the southwest facing elevation consists of a four centred arch, hood mould and plank door with a small gabled bellcote above with a bell opening with Caernarvon head and bell (Plate 5).

Plate 5 (shot 141): Schoolmaster's house adjoining the school, looking northeast

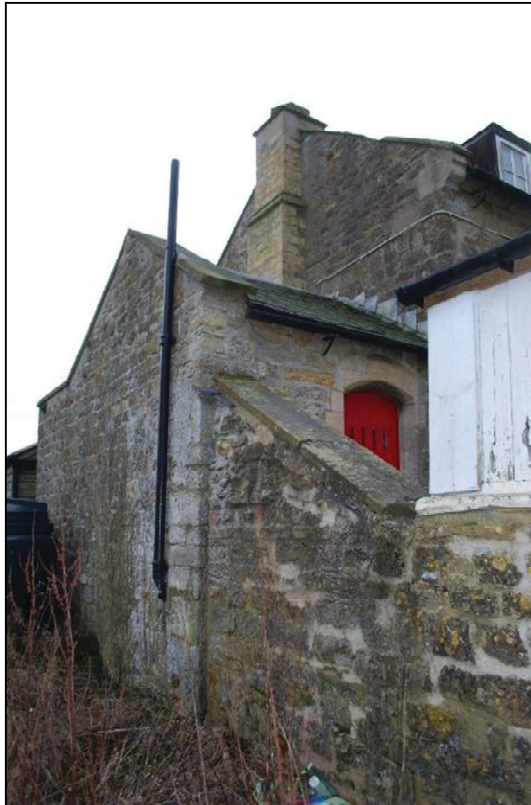
- 6.10 The outbuilding is a single storey extension attached to the main building and sealed with lead flashing (Plate 7). It has no roof to the southeast and a pitched roof of tiles to the northwest (Plate 8). There are entrances to the building from both the school and the schoolmaster's house, through single centred arch doorways of ashlar stone. From the school side, entrance is through an empty doorway into the unroofed area before a second door leads into the roofed part of the extension.

Plate 7 (shot 134): Outbuilding entrance from the schoolmaster's house, looking southeast

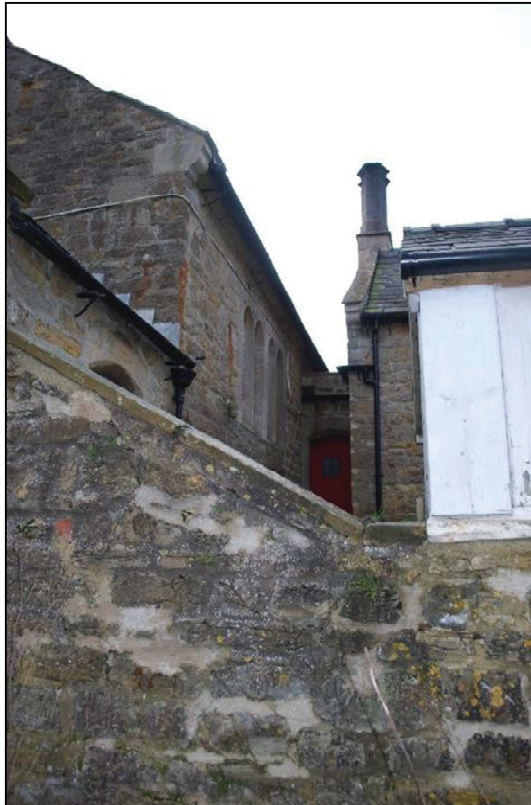
- 6.11 The northwest elevation is largely obscured from the northern end by the schoolmaster's house and garden. Two, two light windows can be seen in this elevation, which also lack the projecting mouldings seen to the south (Plate 9).

Plate 9 (shot 132): Northwest elevation, looking south

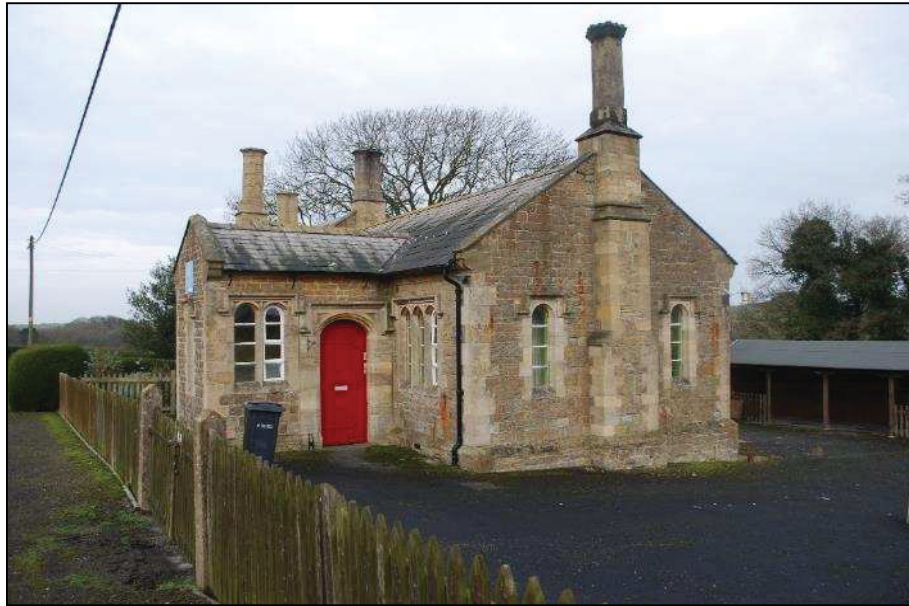
- 6.14 The southwest elevation is primarily occupied by the porch, but also has three light windows to the southeast (Plate 11) and northwest of the porch (Plate 3). The southwest elevation of the porch has a single light window and its southeast elevation a two light window and a door with moulded four centre head with rectangular hood mould. The pitch of the roof of the porch is lower than the main roof but of the same material (Plate 11).

- 6.15 The southeast gable has a central refurbished chimney stack, the same style as the original building, with single light windows to either side (Plate 11).

Plate 11 (shot 145): Porch projecting from the second classroom, looking north, scale 1m

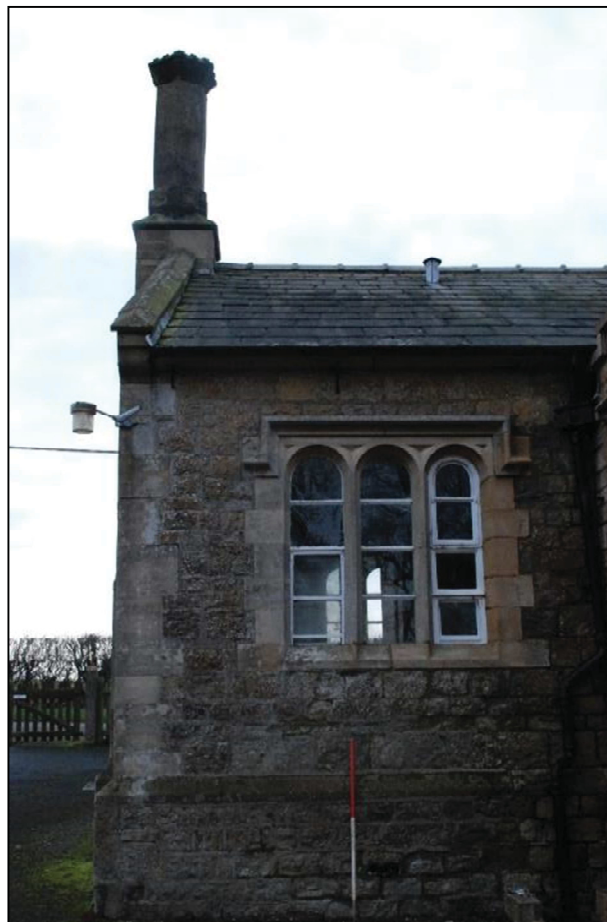
- 6.16 Looking southwest, the northeast elevation is only visible at its southeast extent due to the addition of the later toilet block. Here, a three light window pierces the elevation with a small, modern, metal chimney visible in the roof above the window. A modern light has also been added to the end of the building on this elevation (Plate 12).

Plate 12 (shot 111): Only section of the northeast-facing elevation of the second classroom that is visible, looking southwest, scale 1m

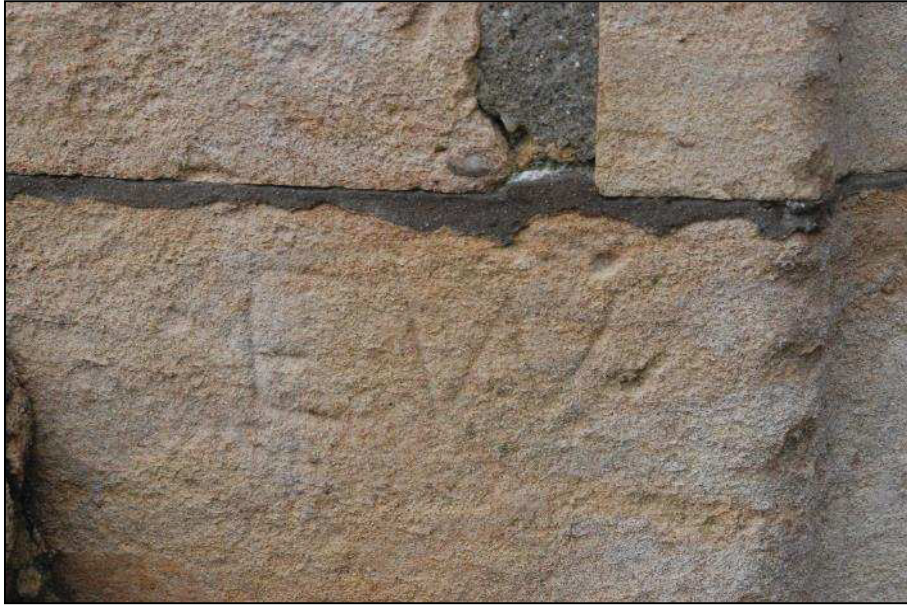
- 6.18 A single piece of graffiti was noted to the left of the doorway into the toilet block reading E.W (Plate 13).
- 6.19 The building is set within a tarmac playground, which has fallen into disrepair. There are two structures within the playground; a weatherboarded timber framed shelter (Plate 14) and a toilet block built of brick with limestone cladding (Plate 15).

Plate 13 (shot 117): Graffiti located to the left of the entrance into the toilet block, looking southwest

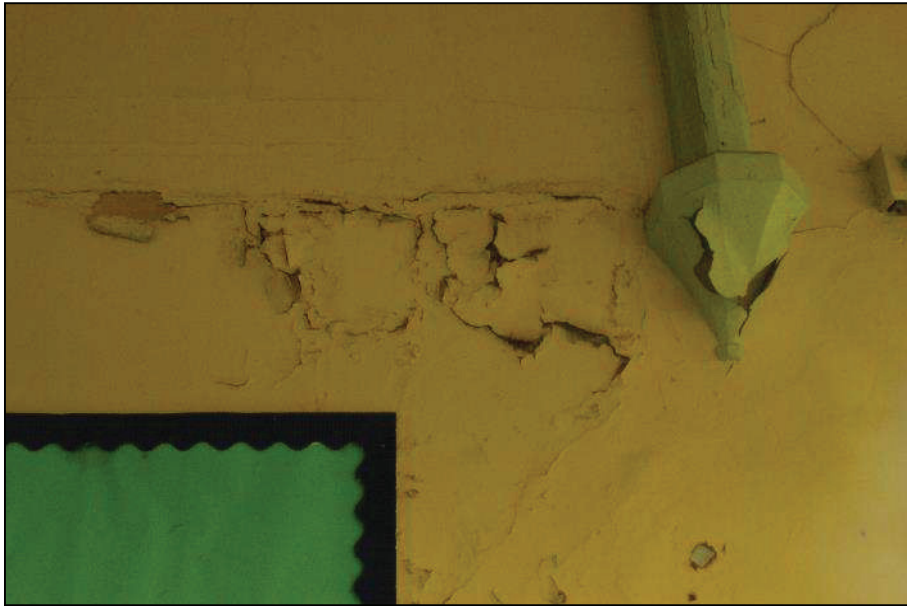
- 6.23 The fireplace to the southeast has been covered over and a cupboard inserted into the southern corner of the room. The style of the windows are consistent across the room: rounded head with three rectangular panels below. Another window has been blocked up on the northeast elevation opposite the door (in the middle bay). Here the paintwork is in particularly poor condition (Plate 21). This is likely to have occurred when the toilet block extension was added.

Plate 21 (shot 26): A blocked up window can be made out by the remaining lintel which has been painted over, looking northeast

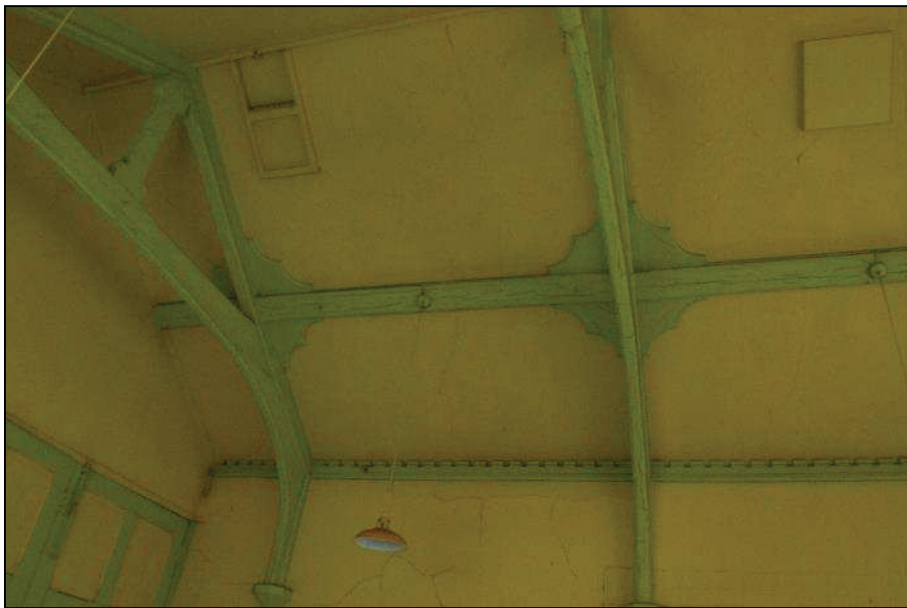
- 6.24 Two skylights in the roof have been boarded up, these were likely to have been original features. Nineteenth century school houses were lit largely using natural light and, as such, skylights and windows placed high in the walls were common features (Baker, Fanchiotti and Steeners 2015: 1.9) (Plate 22).

Plate 22 (shot 18): Blocked skylight in the first classroom, looking north

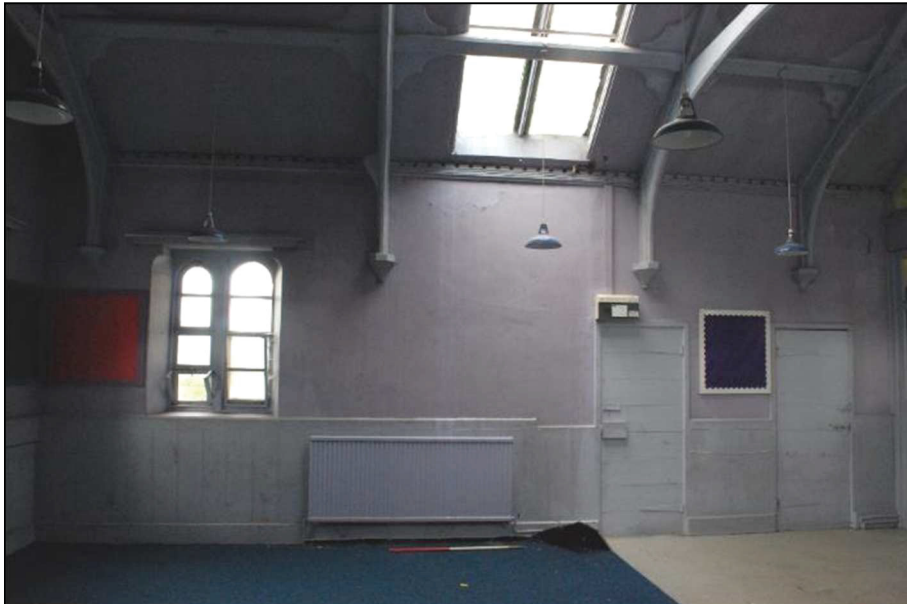
- 6.29 There are two doors in the northwest elevation. These would have led through into the school masters house but are now sealed (Plate 30). On the southeast elevation a door provides access to the toilet block (Plate 31).

Plate 30 (shot 32): The northwest elevation, two doors to the north are sealed, looking northwest, scale 1m

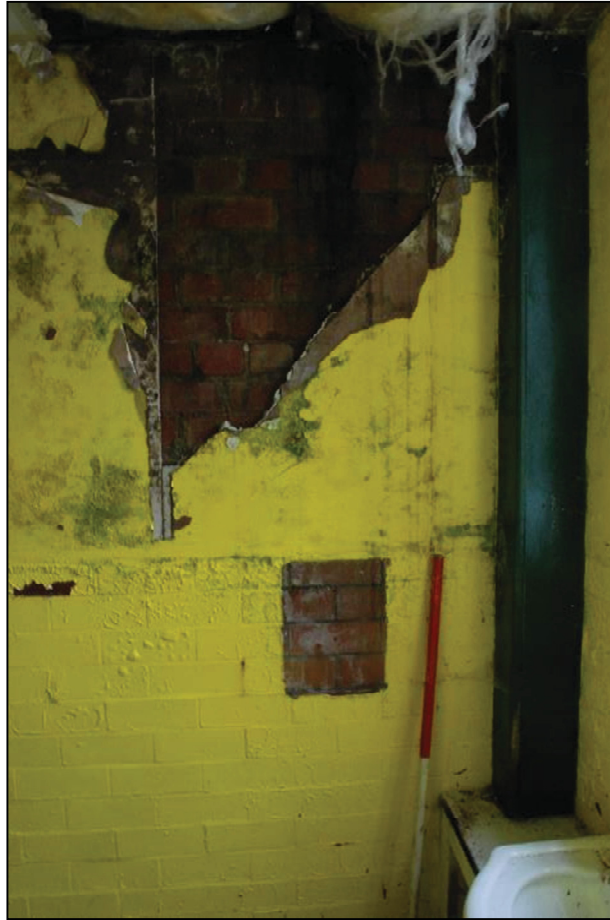
- 6.35 The room is in the worst state of repair of the building, areas of damp are particularly prevalent to the southeast corner of the space (Plate 43).

Plate 43 (shot 78): Area of damp in the toilet block, looking northeast, scale 1m
