HISTORIC BUILDING SURVEY:
LAND ADJACENT TO ST MARYS FARM, KINGSLAND, HEREFORDSHIRE

Planning Reference: N120678/F
NGR: SO 44936 61368
AAL Site Code: KIST16
OASIS Reference Number: allenarc1-242060

Report prepared for Corporate Architecture Limited

By
Allen Archaeology Limited
Report Number AAL 2016027

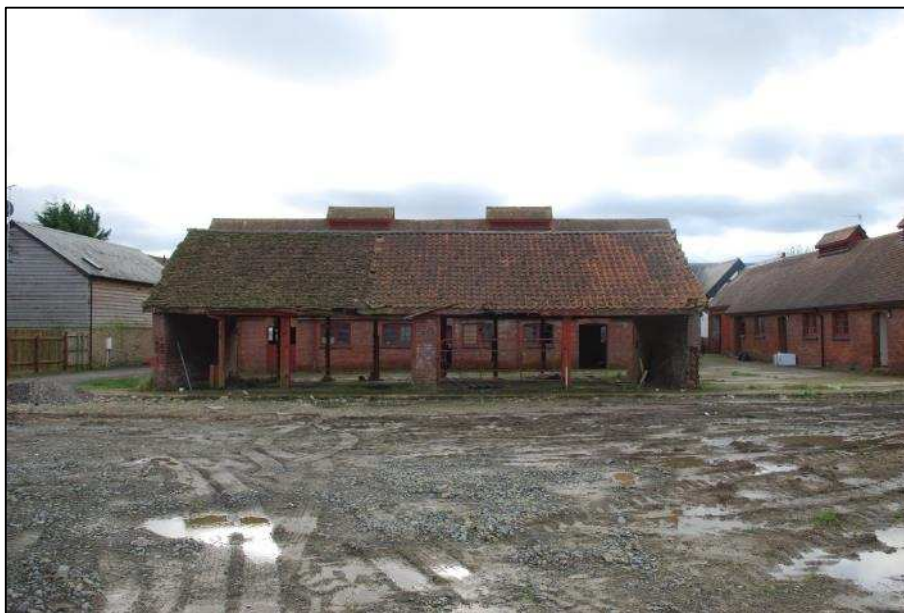
- 6.2 Building B is a timber framed shed or shelter orientated broadly east-west. The building is open along the north and south elevations (Plate 1) and enclosed by brick walls to the east and west (Plate 2). The walls are in a raking English Garden Wall Bond variant of two courses of stretchers to each course of headers in the lower part of the walls, changing to three courses above this, with an irregular bond near the apex of the roof.

- 6.3 The roof is a double pitched gabled roof which has largely been retiled in red ceramic tiles, however about one third of the north facing roof to the east is of older more weathered plain tiles. The ridge line is of black tiles (Plate 1).

Plate 1 (Shot 64): Building B, a shelter or stable, open to the north and south, looking south

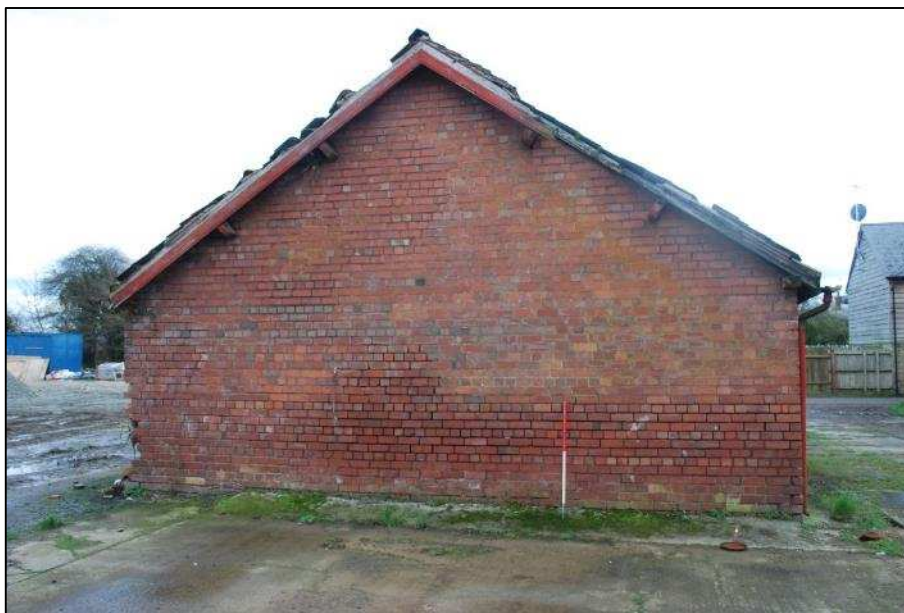
Plate 2 (Shot 63): Red brick western elevation, looking east

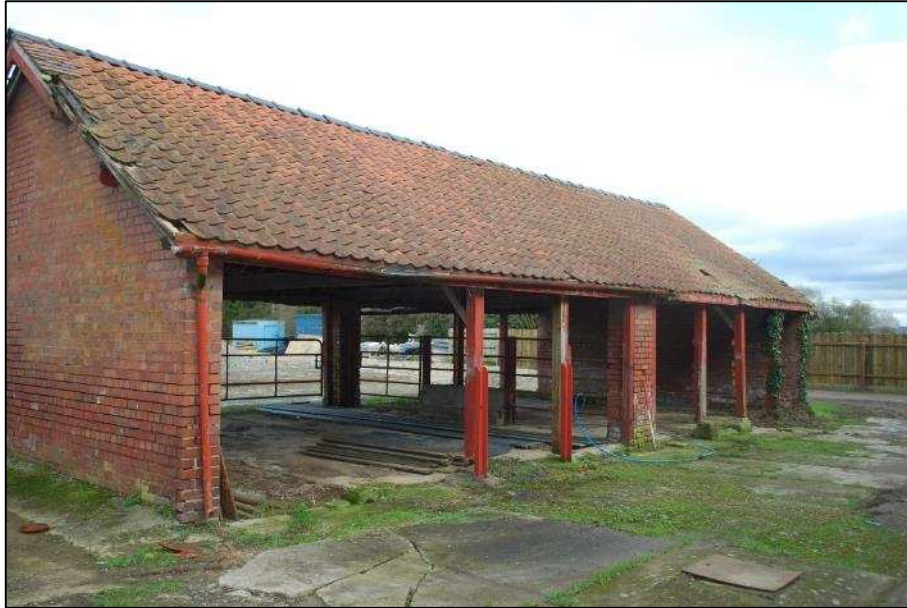
- 6.5 The south facing elevation has nearly a full complement of posts (only the most westerly post is missing). The posts on this elevation are supported on concrete blocks to the east, the two posts to the west have been reinforced with metal posts. A gutter has been removed from the eastern wall plate, but is still in place to the west, a drainpipe descending at the end of the building (Plate 3).

Plate 3 (Shot 70): South facing elevation of the building, looking northeast

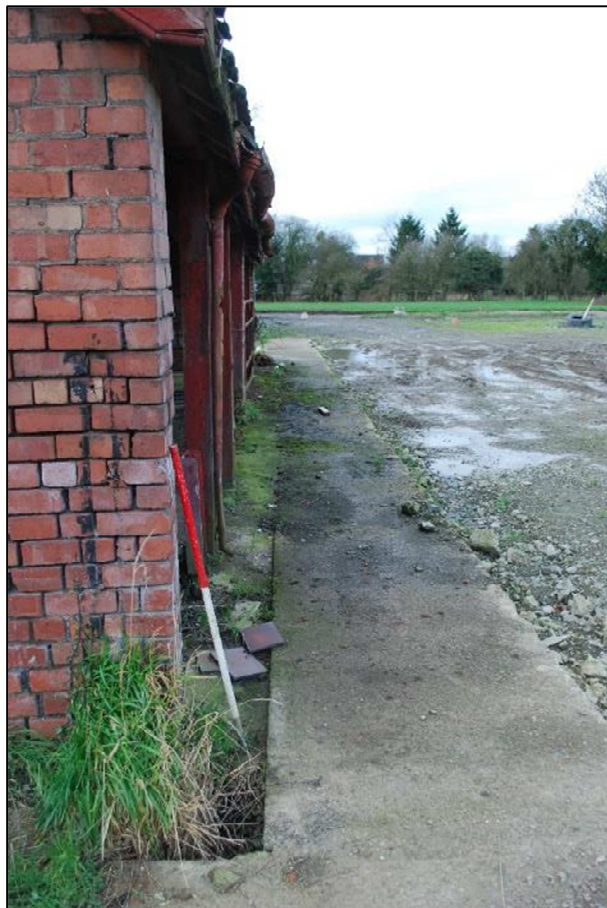
- 6.6 The floor of the building is of concrete, and extends to form a skirt around the exterior of the building (Plate 4). The building is divided into two by metal gates and a trough, which has been built into the floor (Plate 5).

Plate 4 (Shot 66): Concrete floor and drainage along the northern elevation, looking northwest

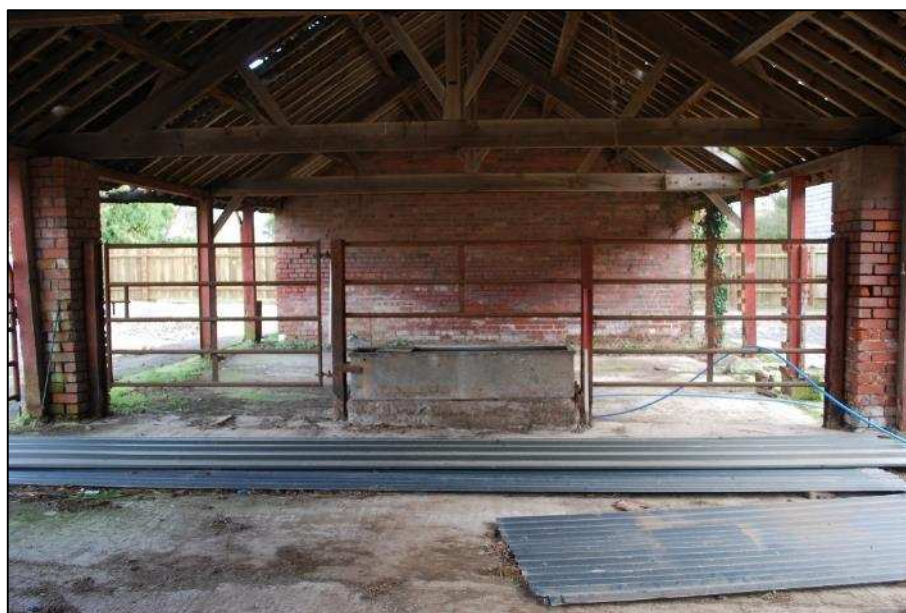
Plate 5 (Shot 83): Gates and trough dividing the room, looking east

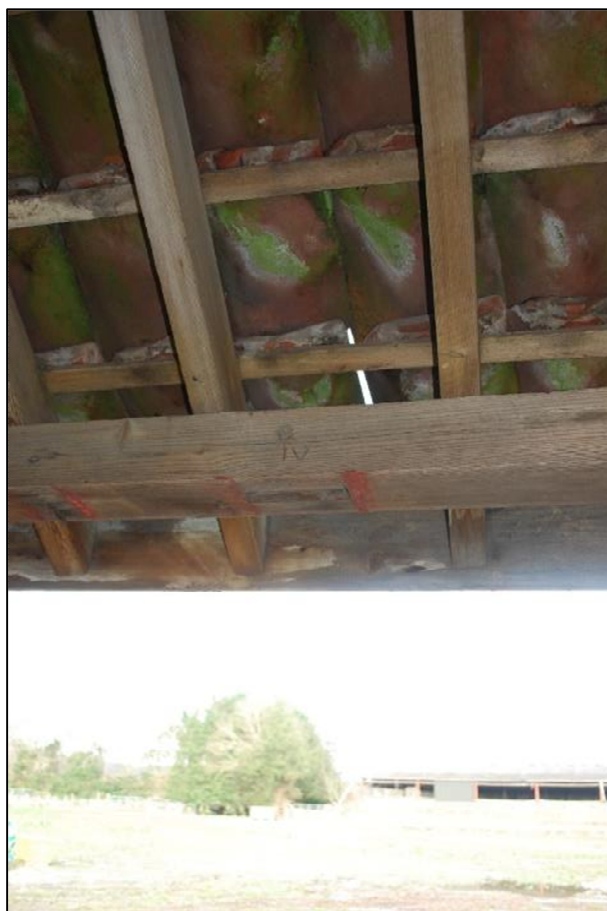
- 6.7 On the interior the building appears to be of just four bays, as only three trusses support the ceiling, however, all of the posts are labelled (Plate 6). The roof trusses are king posts with two sets of struts: one set jointed from the king post and another further along the tie beam. All of the timber is machine sawn. The purlins are further supported by purlin cleats. The bays are not equally spaced therefore the number of common rafters present is also unequal (Plate 7).

Plate 6 (Shot 87): Marking and position of, the now missing, post IV, looking north

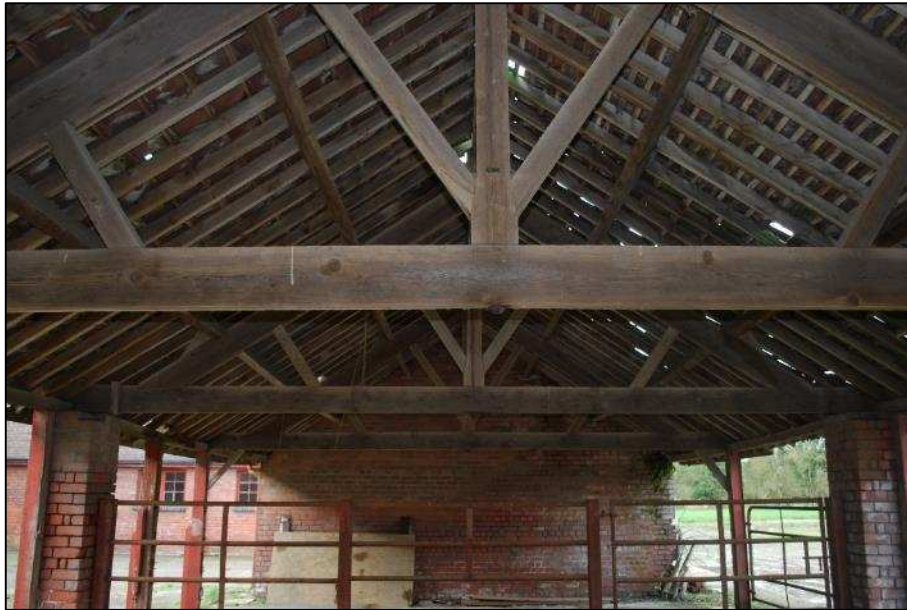
Plate 7 (Shot 73): Roof structure of Building B, looking west

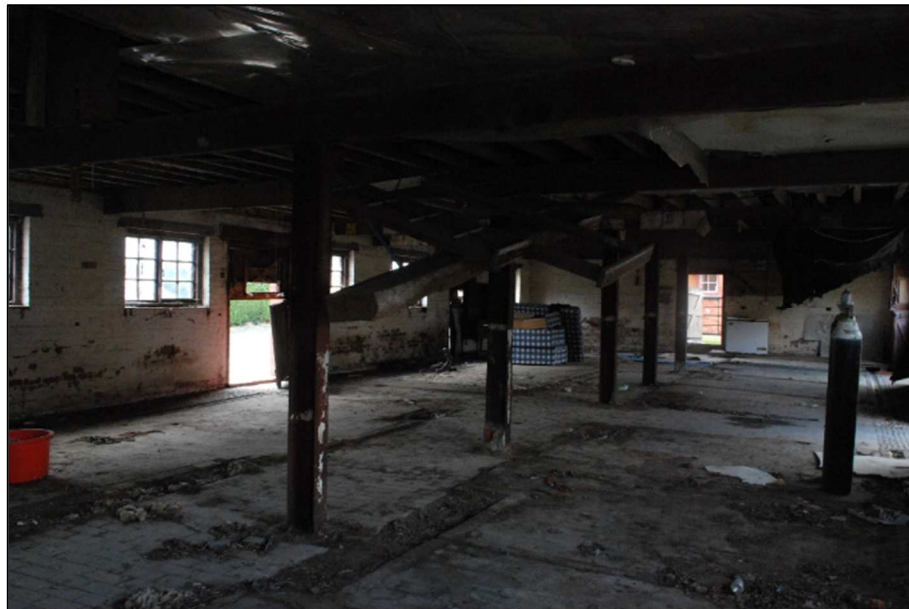
- 6.12 The ground floor has been used as cattle housing. The floor itself has inbuilt drains and evidence of dividers which are no longer in place (Plate 11).

- 6.13 Internally it is apparent that the ceiling supporting the first floor is in a poor condition (Plate 11). The floor itself consists of tie beams supported by steel girders, painted red, which are now rusting. The brick walls have been whitewashed (Plate 12). The building is divided into eight bays, with the fourth bay from the east being larger than the others.

Plate 11 (Shot 59): Ground floor of building C, evidence of dividers can be seen breaking of the room. Looking southwest

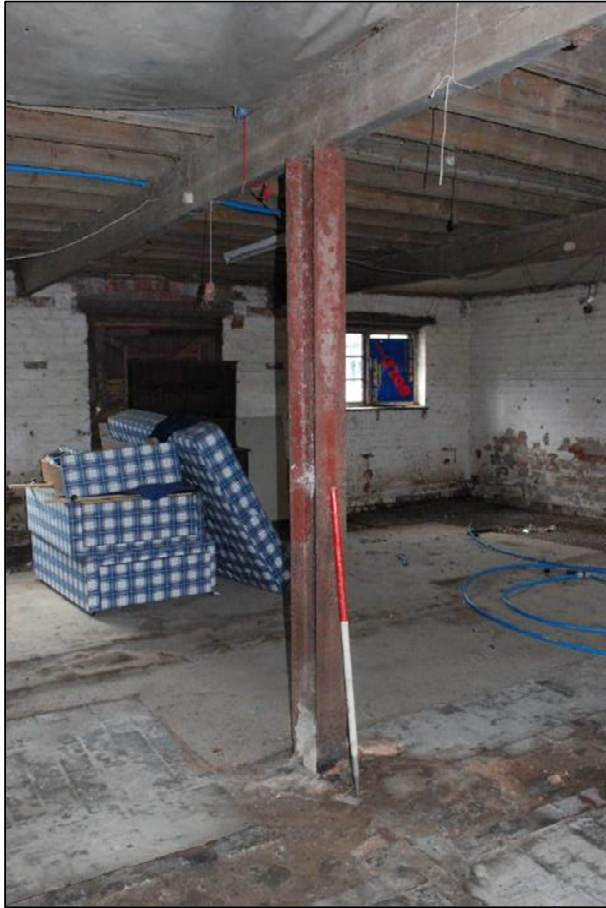
Plate 12 (Shot 39): Metal posts supporting the roof, looking southwest

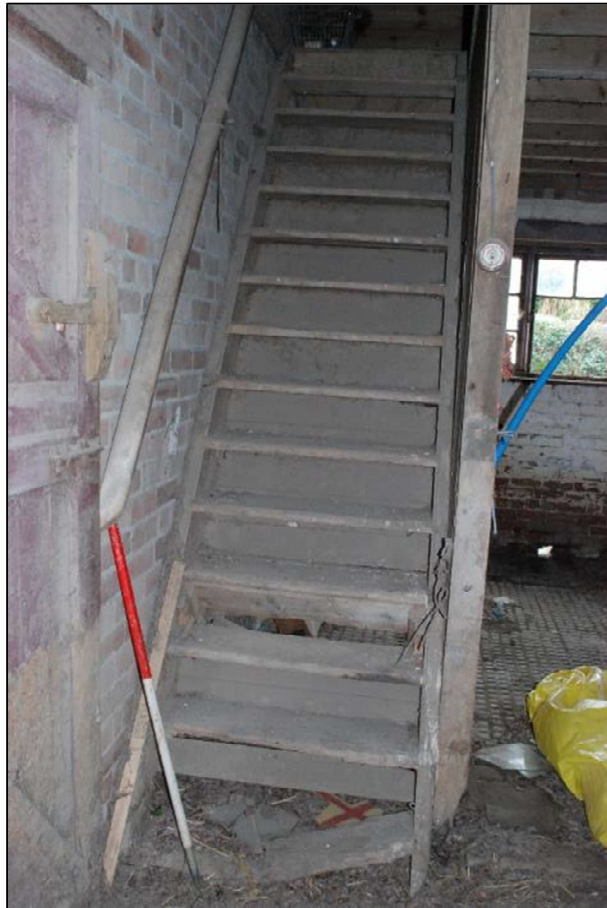
- 6.15 A wooden staircase is in place at the eastern end of the building leading up to the first floor. The staircase is broken in places and runs straight down to the central doorway (Plate 14).

Plate 14 (Shot 48): Staircase at the eastern end of Building C, looking south

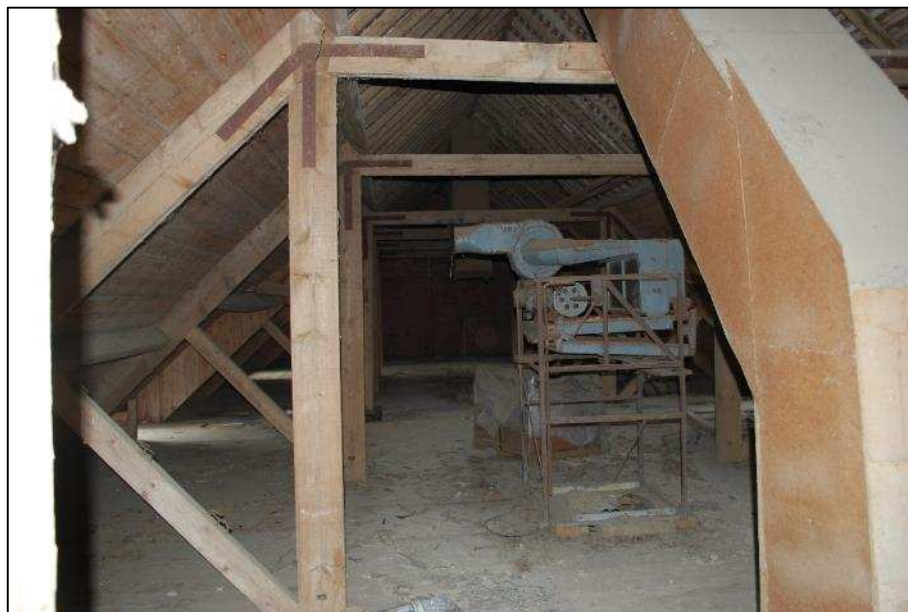
- 6.16 It was not possible to safely undertake a thorough survey of the first floor of the building as the floor had rotted through in a number of places. From the stairway it was possible to see that the roof is of queen post construction, with steel braces. The roof below the straining beam has been panelled with wood, above the common rafters and roof battens are visible (Plate 15).

Plate 15 (Shot 2): First floor of Building C, looking west

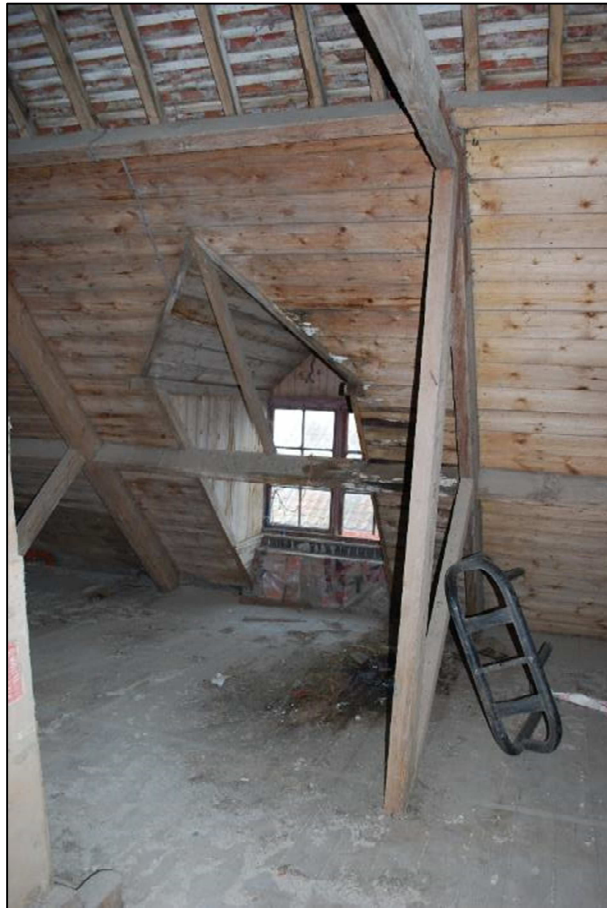
- 6.17 The larger bay is noticeably different at first floor level as the lower purlin which connects to an outward facing strut has been raised to allow the central dormer window to be used as a doorway (Plate 16 shows the north facing, eastern window for comparison). Unfortunately this could not be photographed, but is visible on the plans provided by the client.

Plate 16 (Shot 3): North facing dormer window at the eastern end of building C. The central window differs from this as the lower purlin, which currently blocks the window has been raised to allow access to the door, looking north

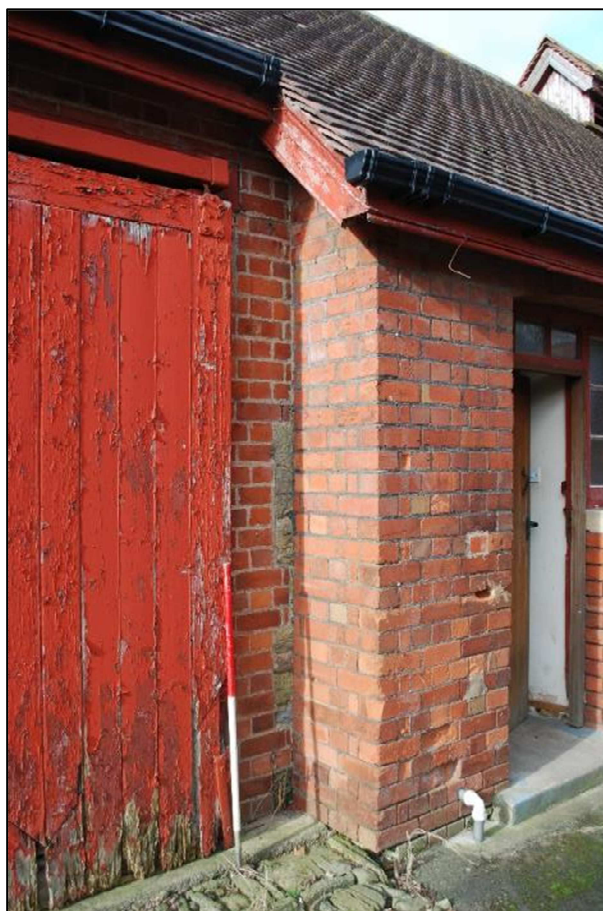
- 6.21 At the southern extent of the building part of the elevation is set back slightly and the join between brick courses is not even, suggesting that the southern end of the building is of a separate build (Plate 19). From the rear (west) of the building it is apparent that the southern extent was earlier and the rest of the building attached, based on the distinctive change in building material (Plate 20).

Plate 19 (Shot 115): Join on east facing elevation of Building D, looking northwest

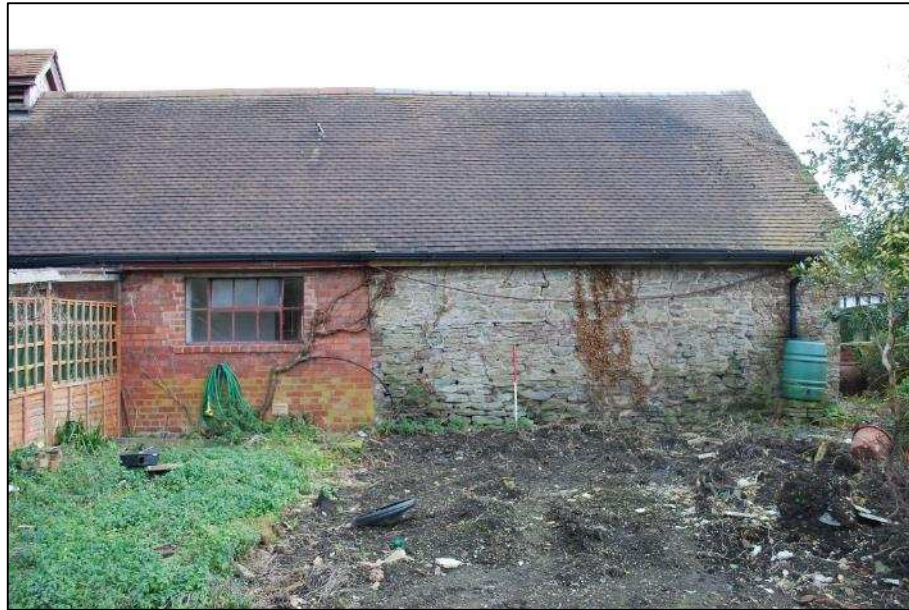
Plate 20 (Shot 103): Southern extent of Building D, the change in building material shows that the building has been extended, looking east

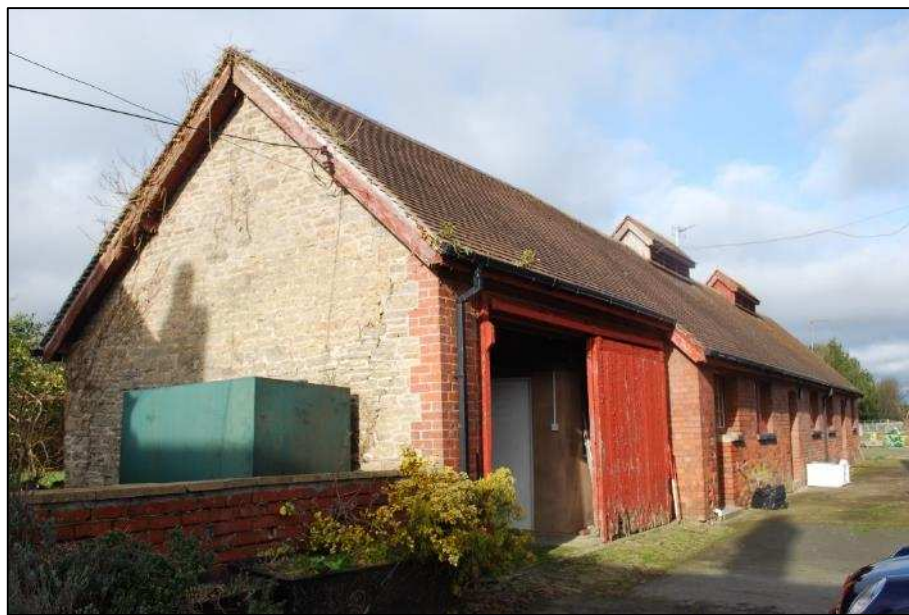
- 6.22 The original building is of stone rubble which has been replaced with red brick to face the courtyard to the east. The roof has been replaced to conceal any join, but the ridge tiles are red on the new part of the building and black over the older part. The building is clearly designed to face the other farm buildings due to the lack of cladding to the rear of the building and there is a lack of windows and doors in the rear elevation (Plate 21). A single window in the west elevation is a later insertion (Plate 20).

Plate 21 (Shot 117): Southern extent of Building D, the interplay between the red brick and stone rubble is clear, looking northwest

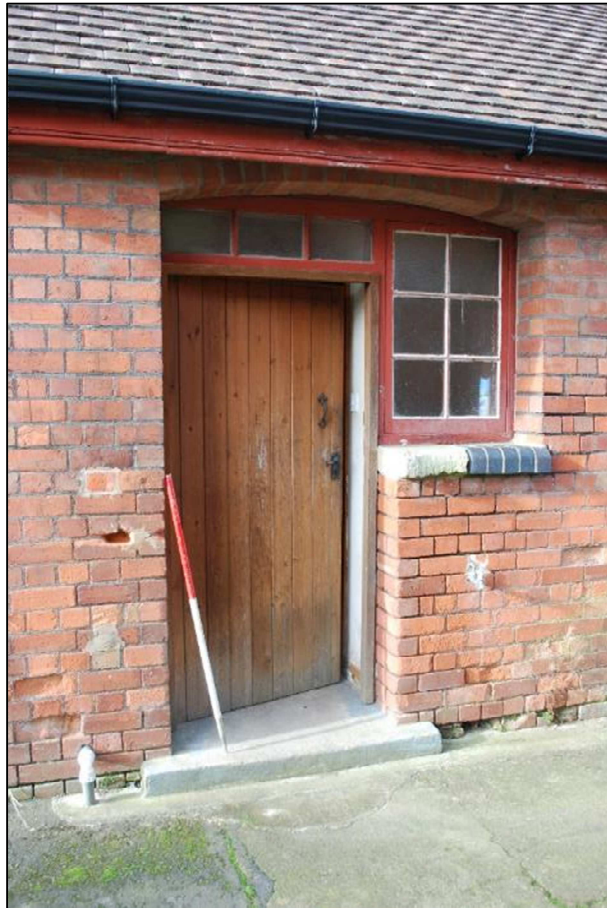
Plate 24 (Shot 113): Irregular window and door on the east facing elevation of Building D, looking west

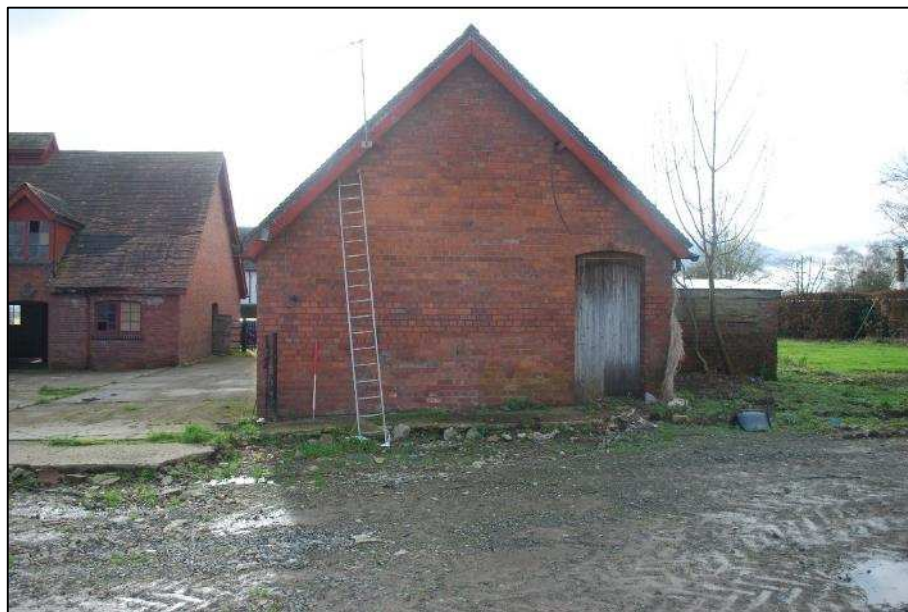
- 6.26 There is a single doorway towards the west side of the north elevation. This is now just boarded wood, internally the doorway has been blocked and there is no evidence for its presence (Plate 25).

Plate 25 (Shot 90): North facing elevation of building D, looking south
