1.0 Introduction

- 1.1 Allen Archaeological Associates was commissioned by Mr Atkinson and Miss Harrison to undertake a photographic survey of a barn prior to its modification to allow access to a residential development on land to the rear of 16 Silver Street, Winteringham, North Lincolnshire.
- 1.2 The methodology conforms to a specification prepared by this company (Allen 2007), and the recommendations of the North Lincolnshire Sites and Monuments Record Office.
- 1.3 A full report and photographic archive will be submitted to North Lincolnshire Museum for long-term storage.

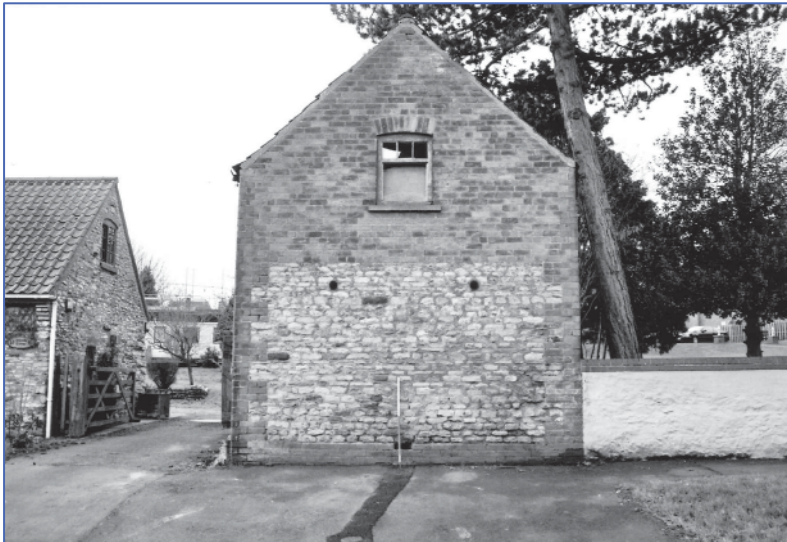
- 5.4 The north and west elevation of the building is constructed of both brick and limestone. On the north elevation, the stonework begins four courses of brickwork above the existing road surface, and comprises coursed, irregular stones set in a grey mortar. The area of stonework is of equivalent height to 27 courses of the surrounding brickwork, and has been tied into the brickwork with sawtooth quoins of three courses in height. This suggests that the stonework represents an original decorative feature, contemporary with the brickwork, which is reflected in a number of buildings of similar period along Silver Street. Two circular openings in the stonework are likely to represent ventilation for the barn.

Plate 2: North elevation, looking south-south-west

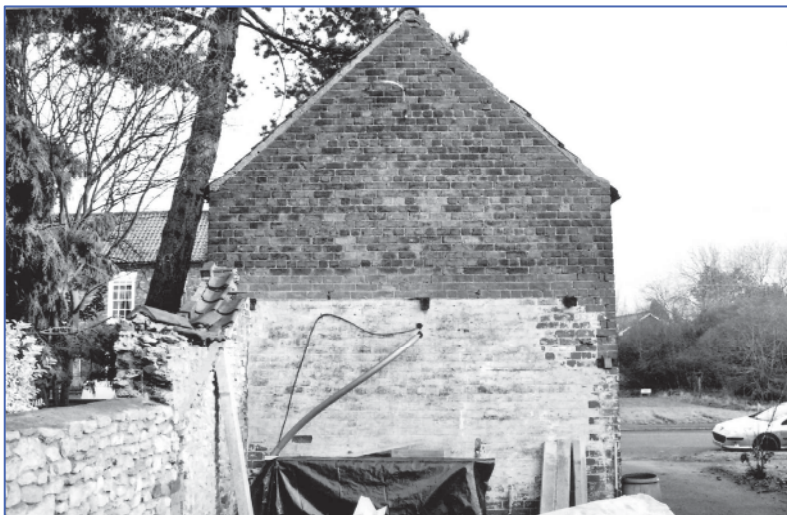
- 5.6 The south elevation is abutted on its west side by a boundary wall, the top of which is capped by tiles and slopes downwards to the south. The lower portion of the wall of the building has been whitewashed, and has the ends of three wooden timbers protruding. This suggests that a single pitched roof outhouse was formerly attached to the south elevation of the barn. The protruding timbers and the whitewashed area of the wall suggest that the outhouse was 2.75m high. A fragmentary course of brickwork in the ground to the south of the barn suggests that the outhouse extended 2.5m southwards from the barn.

Plate 3: South elevation, looking north-north-east

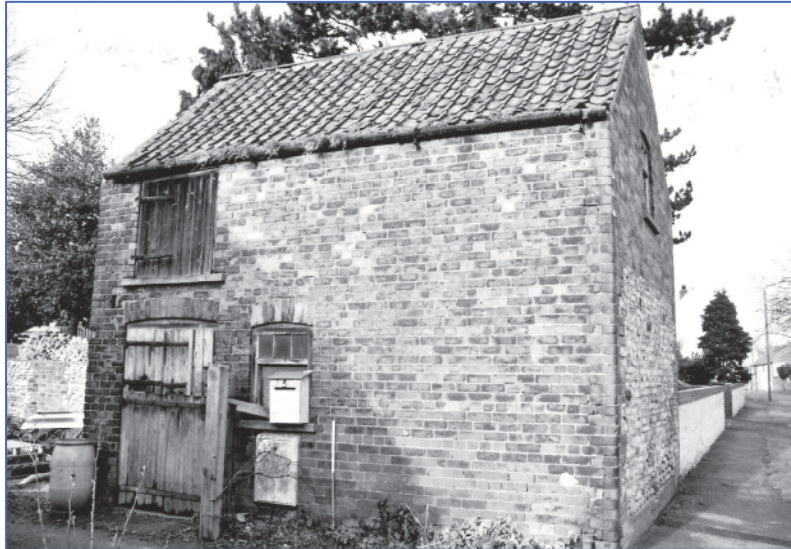
Plate 4: East elevation, looking west

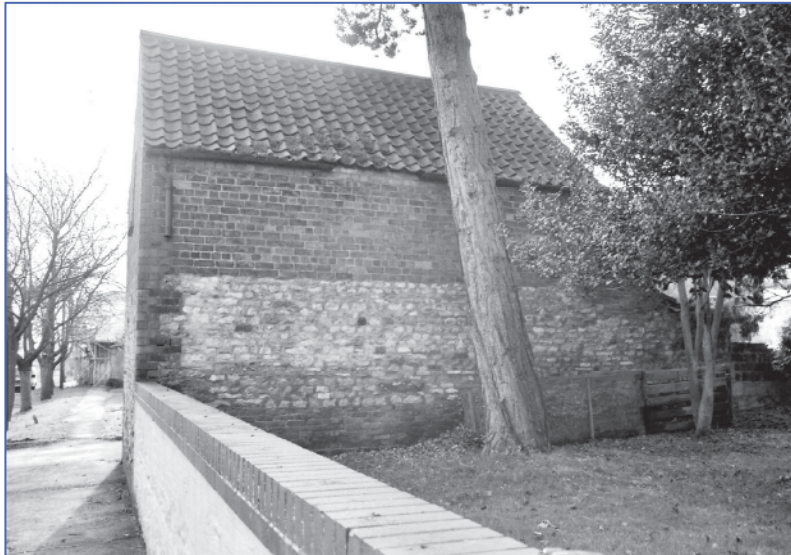
- 5.5 The stonework in the west elevation begins eight courses of brickwork above the ground surface, and has a height equivalent to eighteen courses of brickwork. Again, it is tied into the brickwork at the north end with sawtooth quoins. At the south end of the west elevation, the stonework is bonded into the boundary wall running between the properties of nos. 14 and 16 Silver Street.

Plate 5: West elevation, looking east-south-east

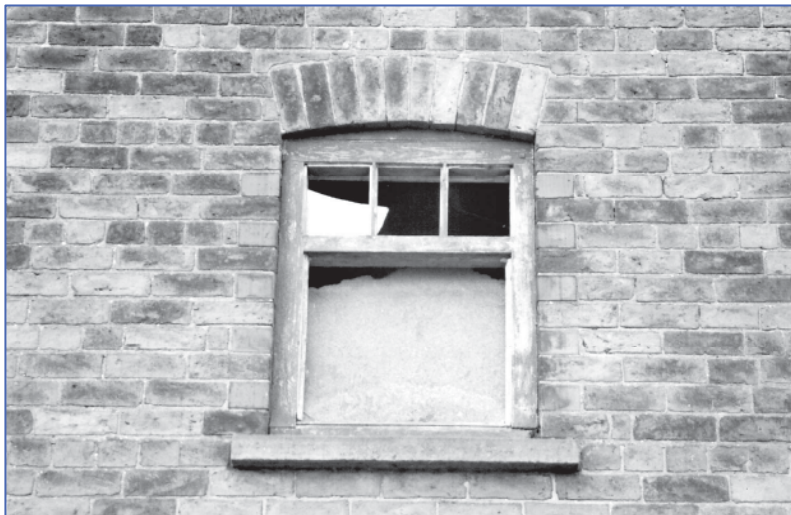
Plate 6: Window in upper storey of north elevation, looking south-south-west

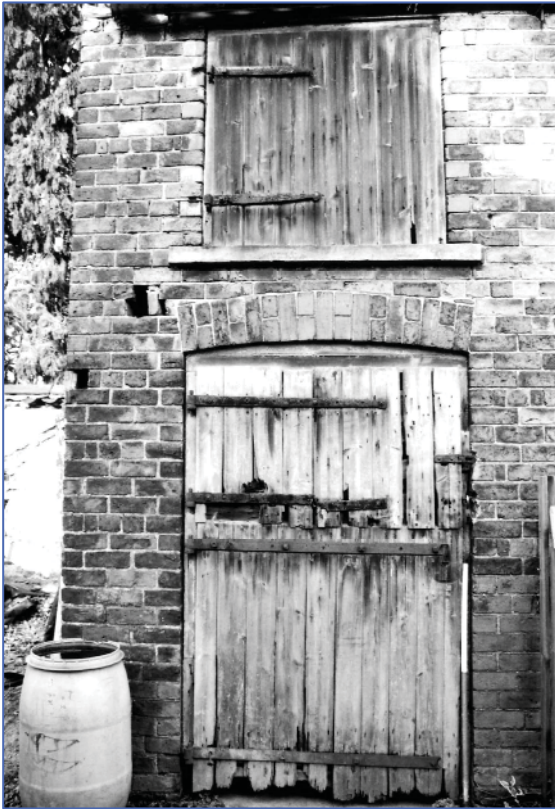
- 5.9 The east elevation also had two doors, towards the south end of the elevation, immediately adjacent to the window. The doorway in the lower storey was capped by a

segmental arched formed of a soldier course alternating between a single stretcher and two headers. The doorway or hatch in the upper storey was a simple square opening with a stone lintel.

Plate 7: Doors in the lower and upper stories of the east elevation, looking west-north-west

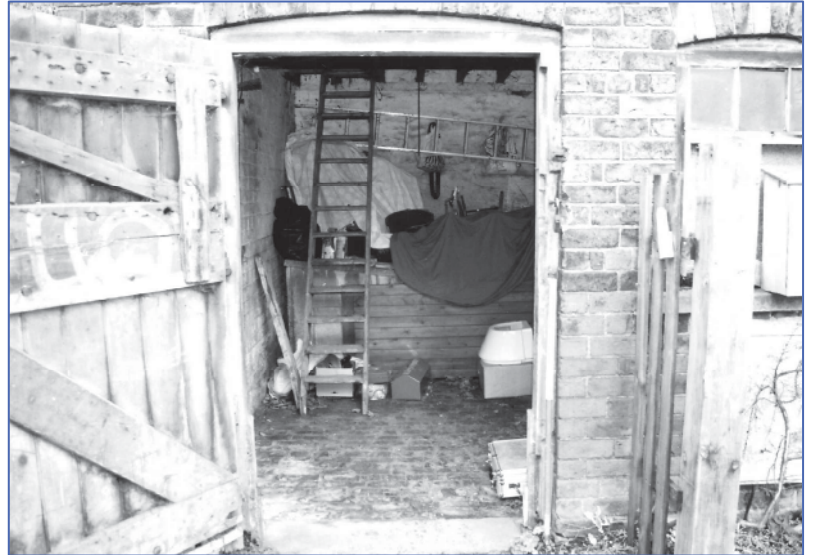
- 5.10 The interior of the building comprised two rooms, over two floors (ground floor and first floor). The walls had been whitewashed throughout, and both floors were filled with large amounts of building materials and household junk. The ground floor was largely of brick, but covered in places by concrete. Two square holes in the north wall related to the circular vents noted in the exterior north elevation. Bull nose bricks had again been used around the interior of the doorway, which was capped by a stone lintel.

Plate 8: Interior view of the lower storey of the barn, looking west-north-west through the door towards the staircase to the upper storey.

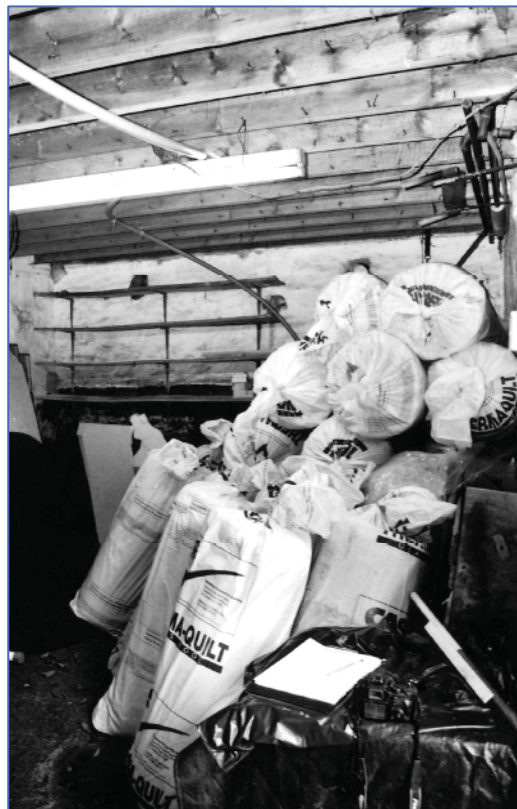
Plate 9: Interior view of the lower storey of the barn, looking north from the door

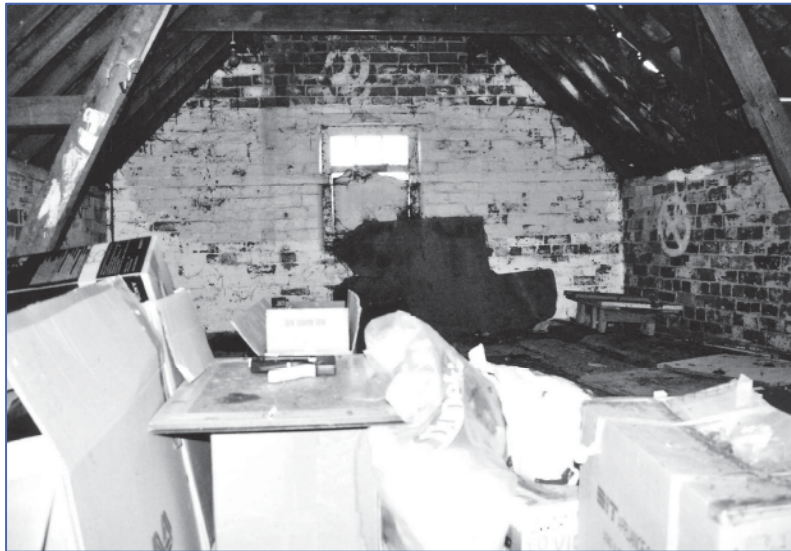
- 5.11 The upper storey was accessed by a wooden ladder through a small hatch. Due to the state of the floor timbers it was not possible to access the upper storey. There were no architectural details of note, other than bull nose bricks framing the window in the north elevation.

Plate 10: Upper storey of the barn, looking north-north-east.

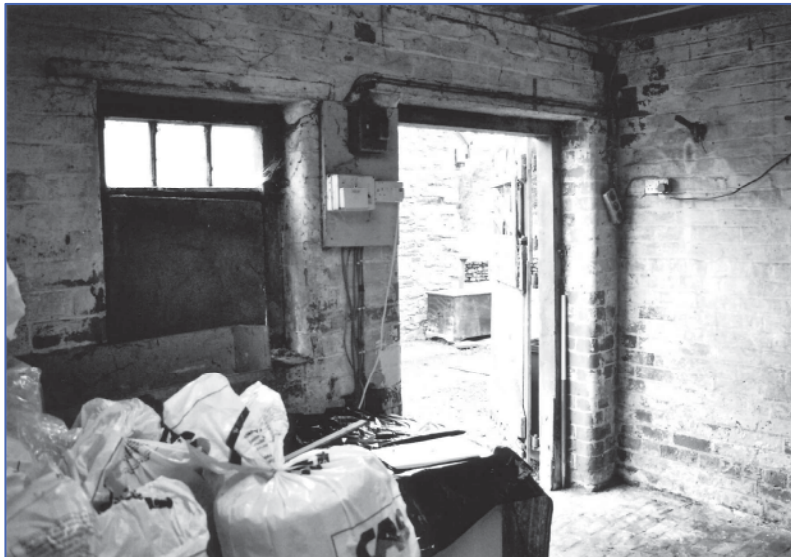
Plate 11: Interior view of the door and window in the lower storey of the east elevation, looking south
