- 1.1 Allen Archaeological Associates was commissioned by Mr Garry Cooper to undertake a photographic survey of two barns that are being converted to residential use at Highcliffe Farm, South Cliff Road, Kirton in Lindsey, North Lincolnshire.
- 1.2 The methodology conforms to a brief provided by the North Lincolnshire Sites and Monuments Record Office, a specification prepared by this company (Allen 2006), and the English Heritage guidelines in *Understanding Historic Buildings: A Guide to Good Recording Practice* (English Heritage 2006).
- 1.3 A full photographic survey report and project archive will be submitted to North Lincolnshire Museum for long-term storage, and will be stored under the Museum Site Code KLAV.

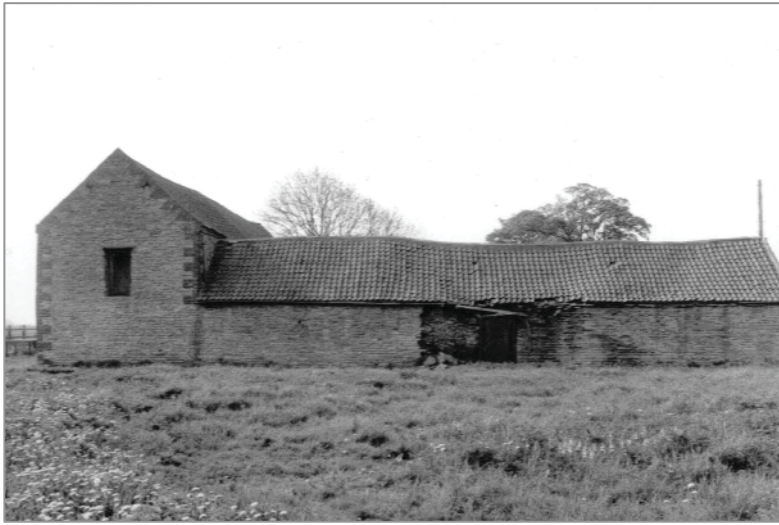
- 5.1.2 *North exterior elevation:* The north elevation has a single door, around which substantial collapse of the walls and part of the roof has occurred, exposing a partial rebuilding in brick to the east of the doorway. Two X-shaped scars either side of the door indicate the location of former steel ties. Two possible former windows were observed towards the west end of the elevation that have been filled in with stone. At its east end, the elevation abuts the north gable end of Barn 2.

Plate 1: Northern elevation, looking south, showing the area of collapse around the central door of Barn 1, and the northern gable end of Barn 2.

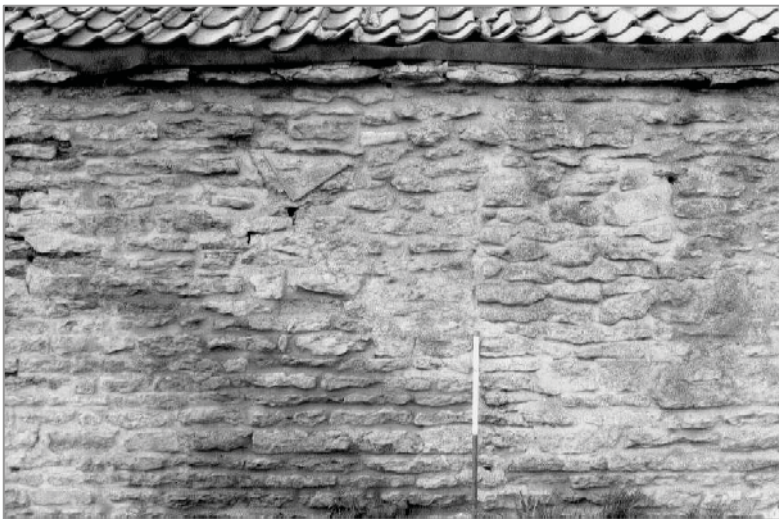
Plate 2: Detail of the north elevation of Barn 1, showing a blocked window and a scar indicating a former X-shaped tie (scale 1m).

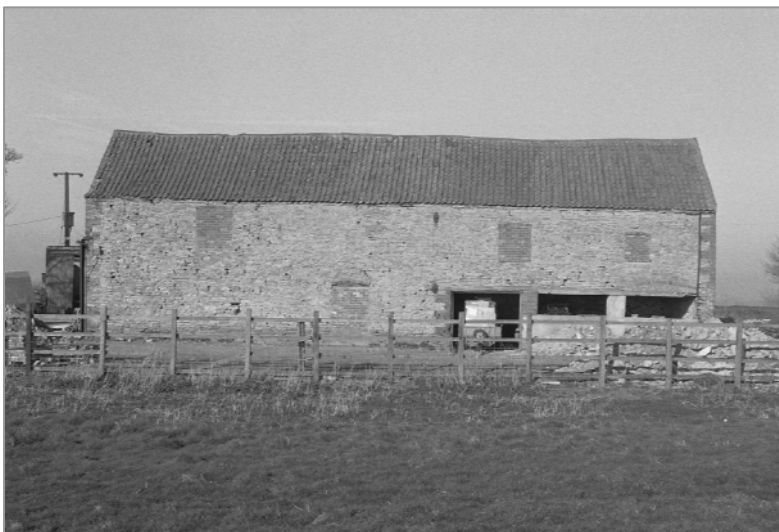
- 5.2.3 *East exterior elevation:* This elevation also has brick sawtooth quoins at each corner. There are three openings in the upper storey that have been filled in with brick. Each opening is also capped with a segmental arch of a single soldier course of brick headers. There is a blocked doorway at ground level, approximately half way along the elevation, also capped with a brick segmental arch. Two oval metal plates denote probable tie-beams.

Plate 3: Eastern elevation of Barn 2, looking west.

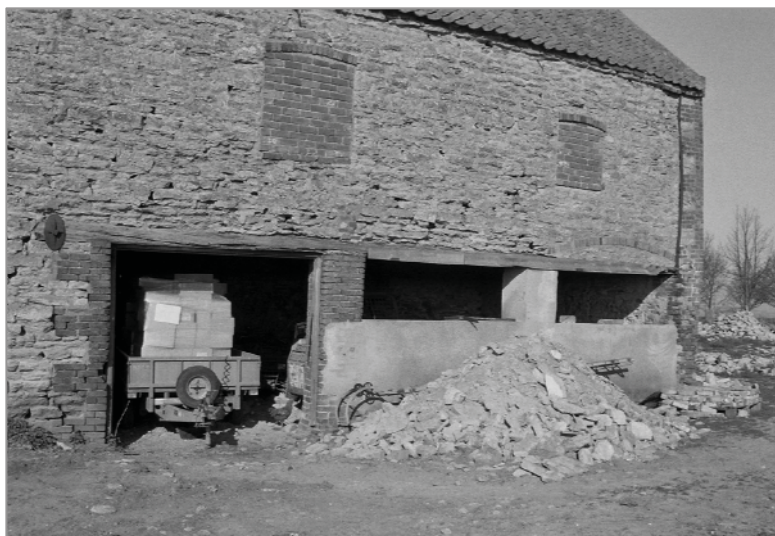
- 5.2.4 At the north end of the elevation, there is an opening in the ground floor divided into three bays, allowing access into a room the width of the building and c.8.8m long. The southern bay is open, with a brick pier on its north side, and bull-nose bricks on each corner. The central and northern bays are blocked by a concrete wall to a height of c.1.5m, and divided by a square pier that has an external concrete face; the composition of the core being unknown. The opening itself appears to be an original feature as the brick sawtooth quoins that decorate the corners of the barn are evident on the south edge of the opening, although the piers may be later additions. Wooden beams run along the top of the opening, but there is a brick segmental arch above the eastern bay that is blocked with stone. This suggests the pier faced with concrete originally formed a bay with the arch above, or has replaced an earlier pier of brick or stone.

Plate 4: Detail showing the three bay opening (possible former cartshed) at the north end of Barn 2. Looking north-east.

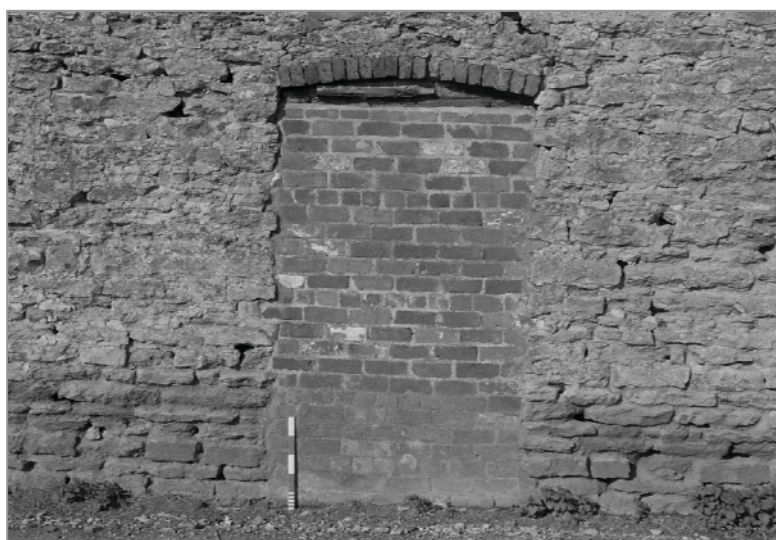
Plate 5: Detail showing blocked doorway in the east elevation of Barn 2. Looking west (scale 0.5m)

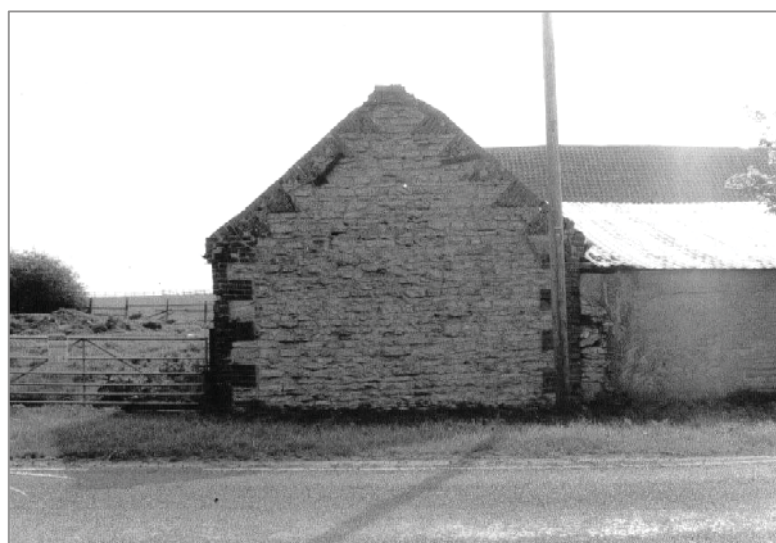
- 5.1.3 *West exterior elevation:* The west elevation fronts onto South Cliff Road, and is adjoined to the south by a boundary wall running parallel to the road. The elevation exhibits tumbling in brick, and sawtooth brick quoins.

Plate 6: Western gable end of Barn 1 fronting South Cliff Road. Note the brick sawtooth quoins and tumbling. Looking east.

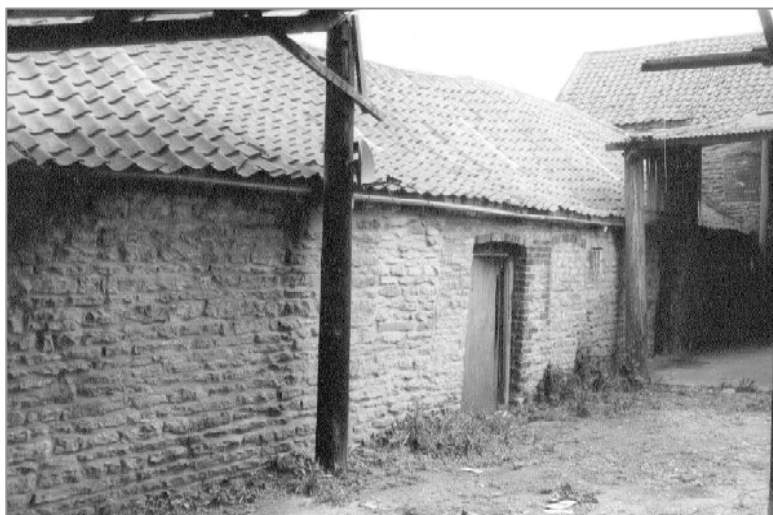
- 5.1.4 *South exterior elevation:* This elevation has four doors and a single window. The door at the west end of the elevation is in a simple wooden frame, while the remaining three doors have wooden frames and are capped by a brick segmental arch. The westernmost of these three doors has further brickwork along its east side. A window has been filled in with stone to its west, with a second blocked window to its east, which also has a segmental arch in brick, and further rebuilding in brick along its west edge.

Plate 7: South elevation of Barn 1, looking east-north-east from the west end of the building.

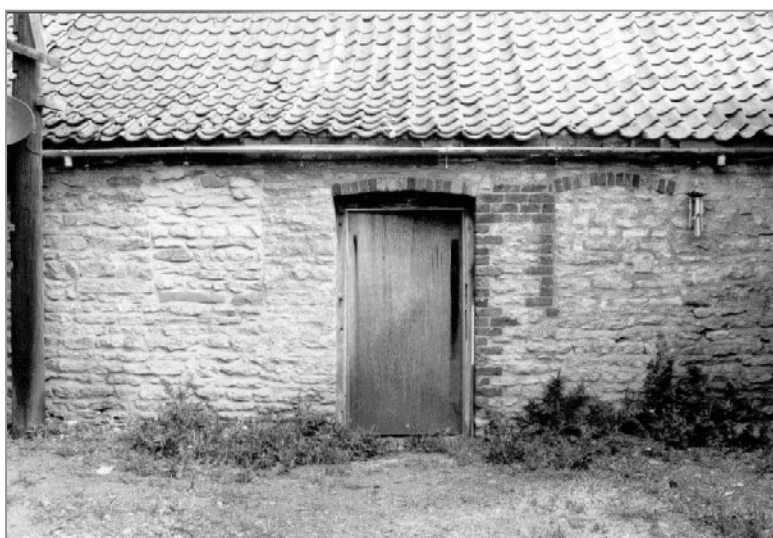
Plate 8: Detail of door and blocked windows in south elevation of Barn 1, looking north (scale 1m).

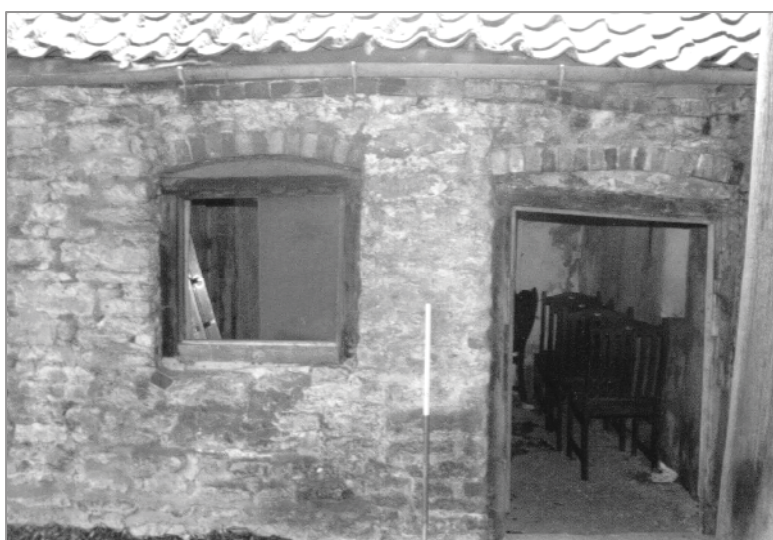
- 5.1.5 The door at the east end of the elevation has a single window immediately to its west, with a brick segmental arch and a wooden frame. Above the door and window is a single course of brickwork directly below the roofline, evidencing a localised repair.

Plate 9: Detail showing door and window at the east end of the south elevation of Barn 1, looking north (scale 1m).

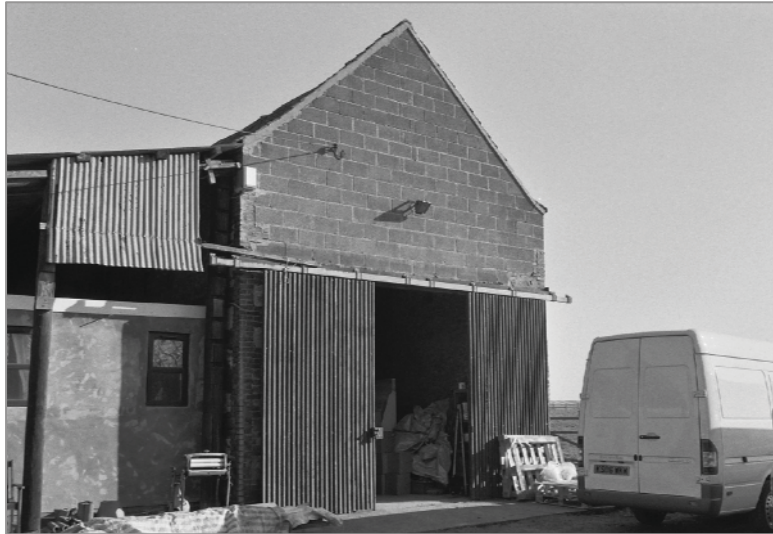
- 5.2.6 *South exterior elevation:* This elevation appears to have been almost entirely rebuilt during the later 20th century. At ground floor level, the corners of the elevation exhibit the typical stone build, with brick sawtooth quoins. Much of the elevation is taken up with large sliding corrugated steel double doors however. The upper portion of the wall is constructed of breeze blocks.

Plate 10: South elevation of Barn 2, looking north-east.

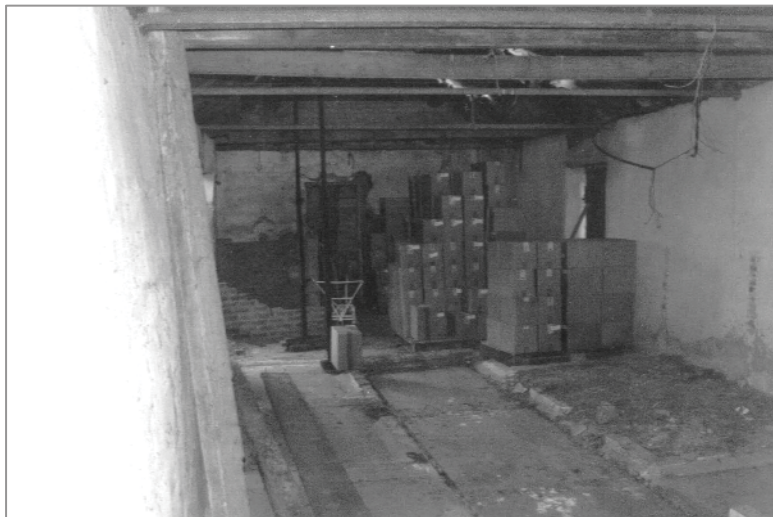
- 5.1.9 The large room at the west end of the building has been used as a pig-shed, the brick bases of individual sties survive to either side of a central walkway. A door at the east end of the room has a wooden frame with modern concrete rebuilding around it. This suggests that the door may be a later insertion into the wall, although this was not certain.

Plate 11: General view of large room at the west end of Barn 1. Looking east-south-east from the north-west corner. The brick foundations of the pig sties are clearly visible as are the wooden and steel tie beams in the roof.

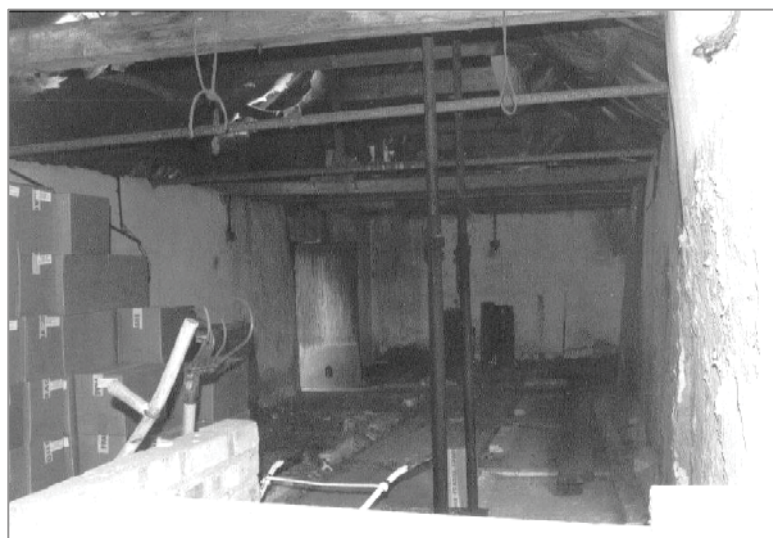
- 5.1.8 The roof has been subject to several ad hoc repairs and alterations in the past, using both wood and metal tie-beams, leaving little indication of its original form.

Plate 12: General view of large room at the west end of Barn 1. Looking west-south-west from the north-east corner. Again, the former pig sties and the roof supports are visible.

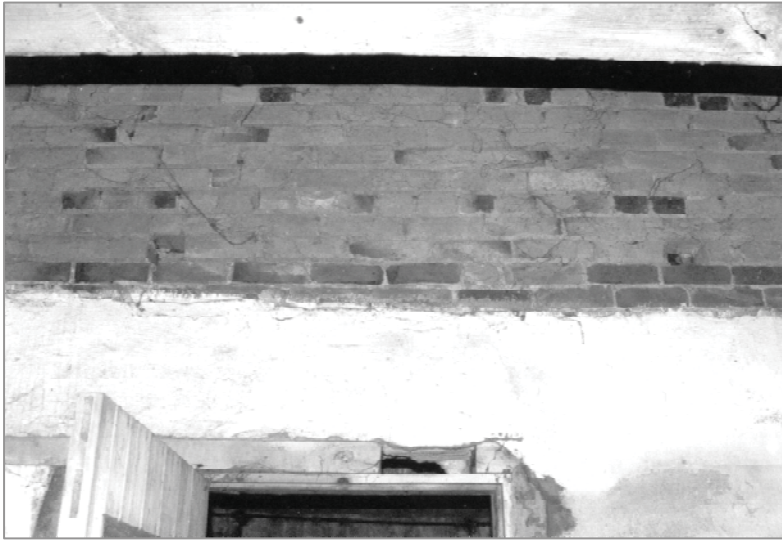
Plate 13: Detail showing the brickwork of the dividing wall between the two rooms at the east end of Barn 1, looking east. A number of 'airholes' are also visible.

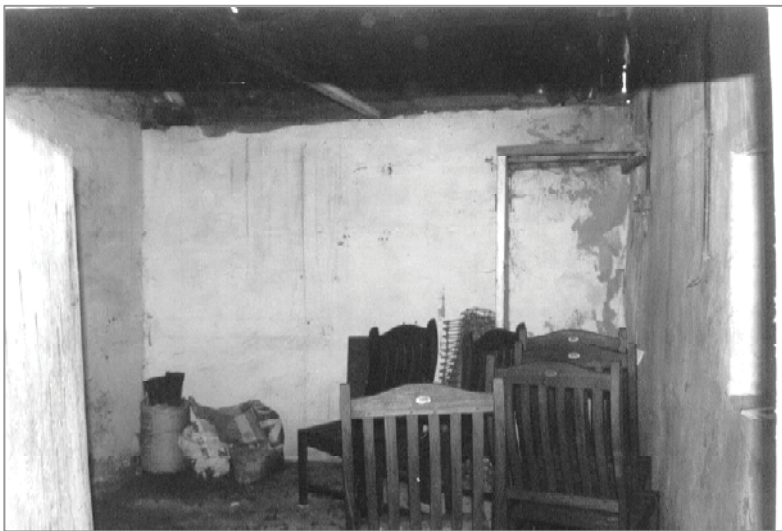
- 5.1.11 The room at the east end of the barn was similarly lacking in architectural detail. It had a door and window in its south wall, and a door in the west wall, which appears to be a later insertion. A blocked recess in the east wall may have been a former window, looking into the attached two storey barn.

Plate 14: General view of room at the east end of Barn 1, looking north-north-west from the south-east corner.

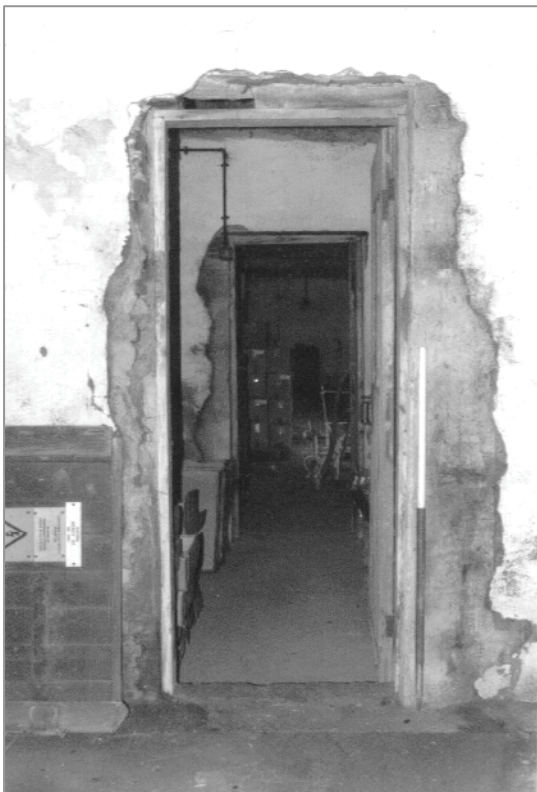
Plate 15: View of the doorway in the west wall of the room at the east end of the barn. The modern concrete around the door frame suggests that it is a recent addition or alteration. Looking west (scale 1m).

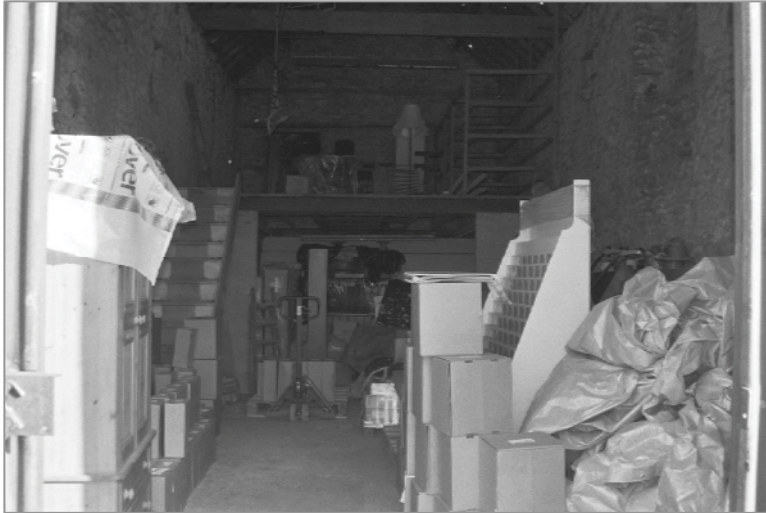
Plate 16: Interior of Barn 2, looking north. The workshop area is visible in the background, with the former hayloft above.

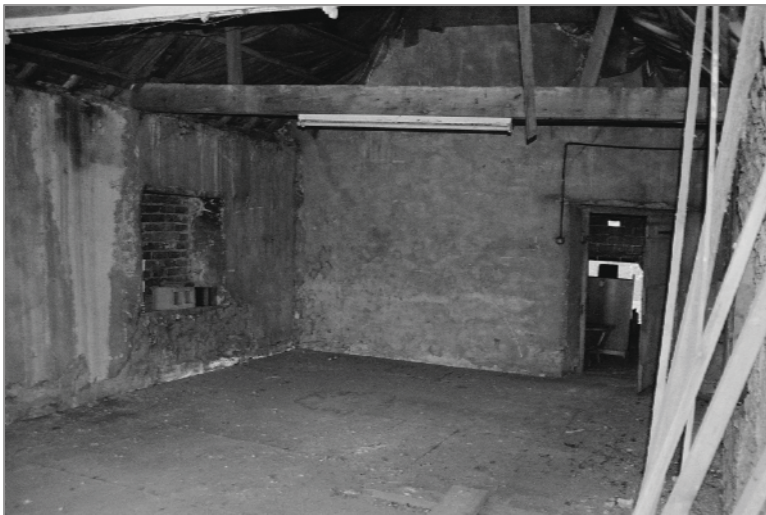
Plate 17: First storey room at the north end of Barn 2, looking south-south-east towards the doorway and a blocked window.

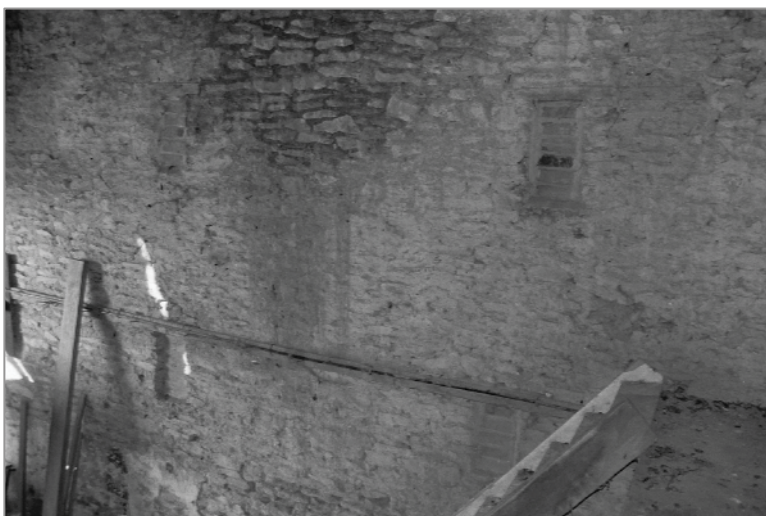
- 5.2.10 There is a single blocked window in the upper part of the east wall, also visible externally. A number of small recesses were evident in both the east and west walls that have been blocked with brick and are likely to have originally served as ventilation, to aid the drying out of stored crops.

Plate 18: Interior east elevation of Barn 2, showing blocked ventilation holes. Looking south-west.

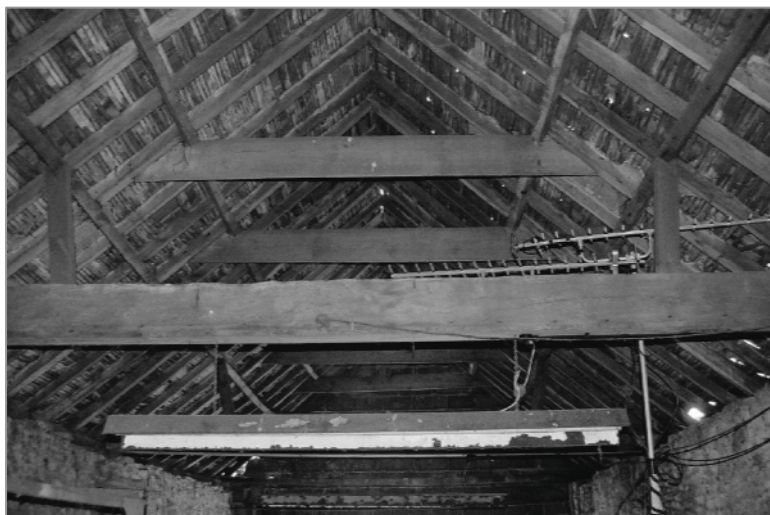
- 5.2.11 The roof structure is clearly visible in this part of the barn. It is a form of double rafter roof, with the rafters supported by two purlins on each side of the roof. There is no visible wall plate to receive the rafters. The upper purlins are supported by collar beams between every third or fourth rafter and the lower purlin rests on queenposts attached to tie beams. Above the purlins is a coverage of thin wooden slats running longitudinally along the roof.

Plate 19: Roof structure of Barn 2, looking south from the hayloft/mezzanine.

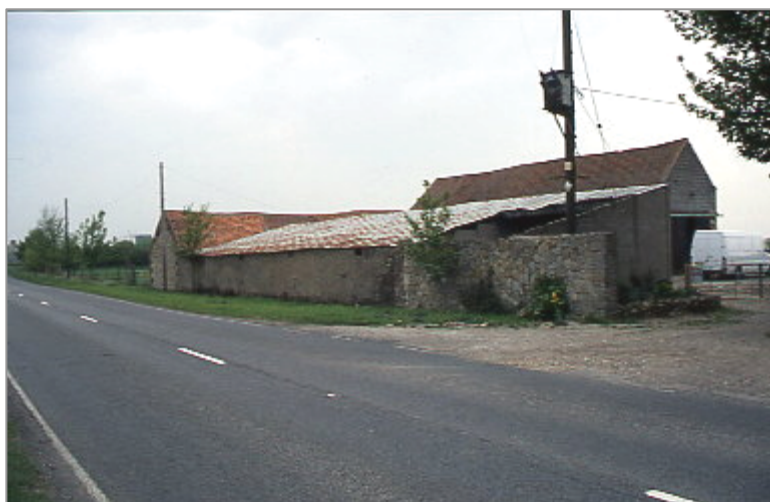
Plate 20: General view of the site, looking north-north-east. The west end of Barn 1 fronts onto the road. Barn 2 is in the background. The building in the foreground is a modern breeze block pig shed, due for demolition.

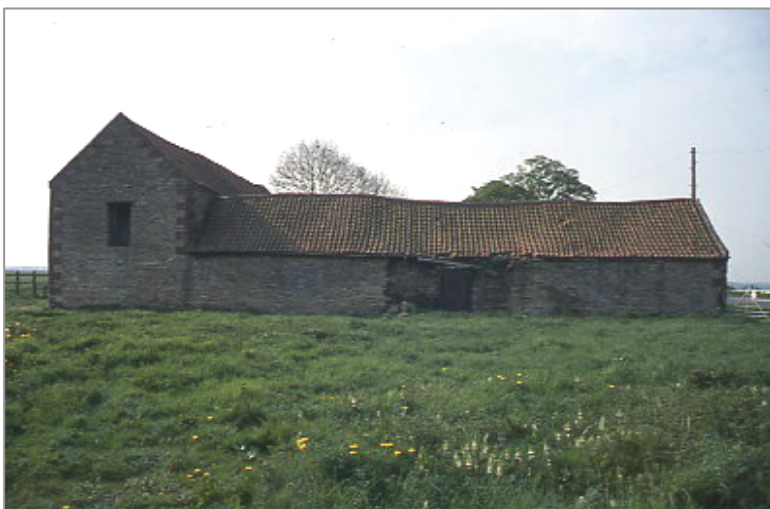
Plate 21: North elevation of the barns, looking south.

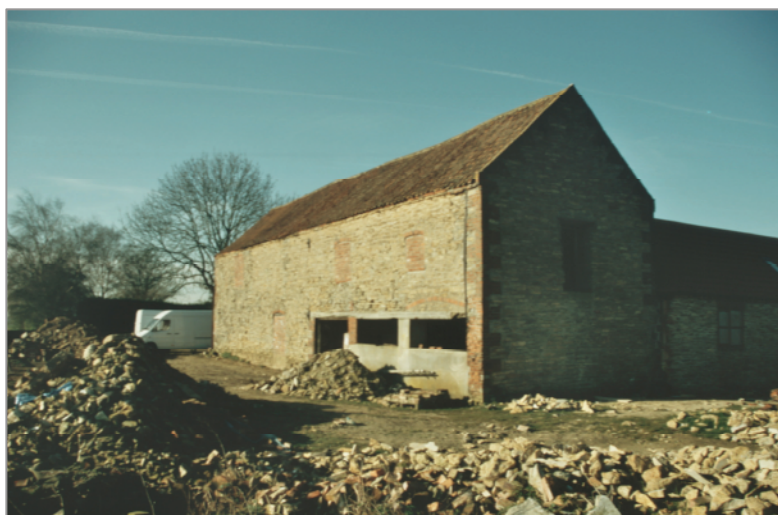
Plate 22: Barn 2, looking south-west. Part of Barn 1 is also visible extending to the west.

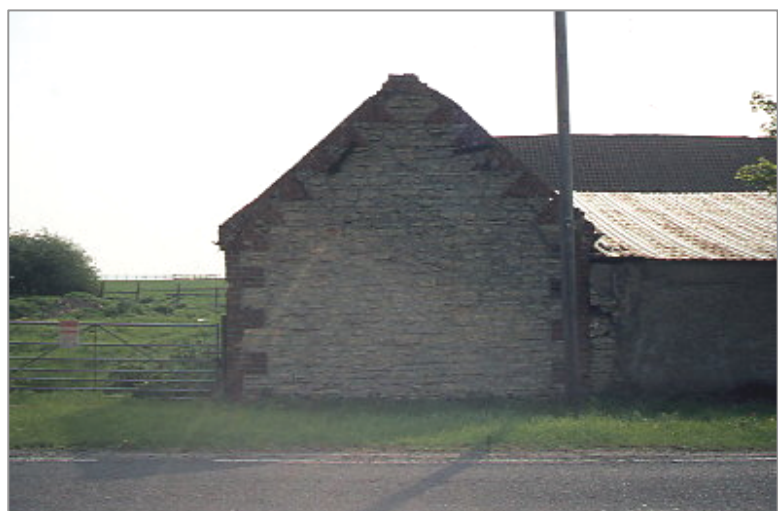
Plate 23: West gable end of Barn 1, looking east from South Cliff Road.

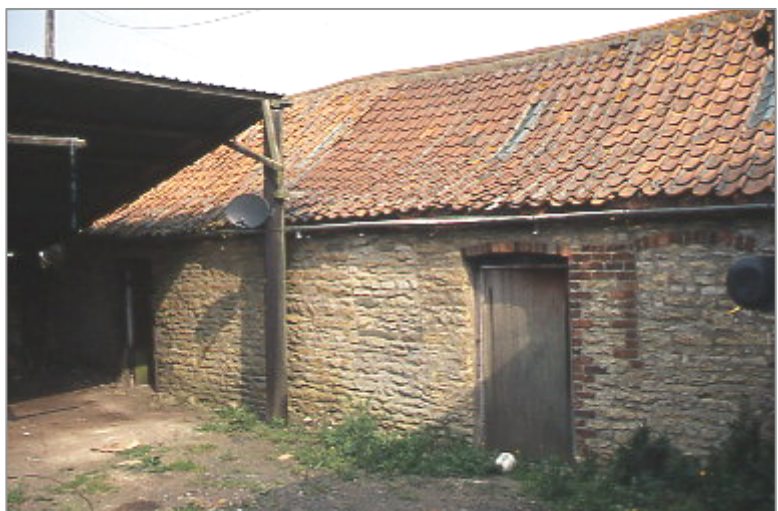
Plate 24: South elevation of Barn 1. Looking north-west, showing the two doors and the blocked windows.
