**HISTORIC BUILDING SURVEY REPORT:
WINDMILL HOUSE FARM, FOREST ROAD, WARSOP, NOTTINGHAMSHIRE**

Planning Reference: 2016/0050/NT
NGR: SK 5823 6628
AAL Site Code: WAFR16
Museum Accession Number: MASMG 2016-489
OASIS Reference Number: allenarc1-265135

By
Allen Archaeology Limited
Report Number AAL 2016158

October 2016

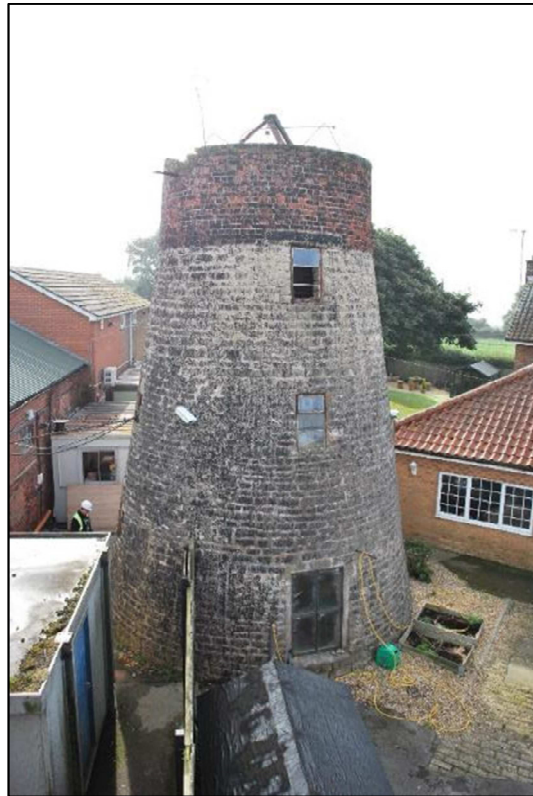
- 6.2 The windmill is located to the southwest of Bowrings Transports main yard (Plate 1). Directly to the east a brick building of a probable 19th century date, presumably associated with the mill, has been altered and reroofed in subsequent years (Plate 2).
- 6.3 The existing mill building is mainly of coursed stonework, with 19 courses of red brick in English Bond above, and it rises to three storeys (Plate 1). The building has been tarred, a common practise in brickwork mills of this age, to prevent water eroding the mortar (Freese 1957); although the tar has now largely weathered away.

- 6.6 The surviving windows are three-light casements with the exception of the ground floor northwest window, which is a four-light casement and the southwest ground floor window, which has had the glass removed to fit a modern steel exhaust pipe (Plate 7). They all have metal frames and the second floor windows have tarred, cut stone lintels (Plate 1).

Plate 1 (Shot 17): Warsop mill, looking southeast

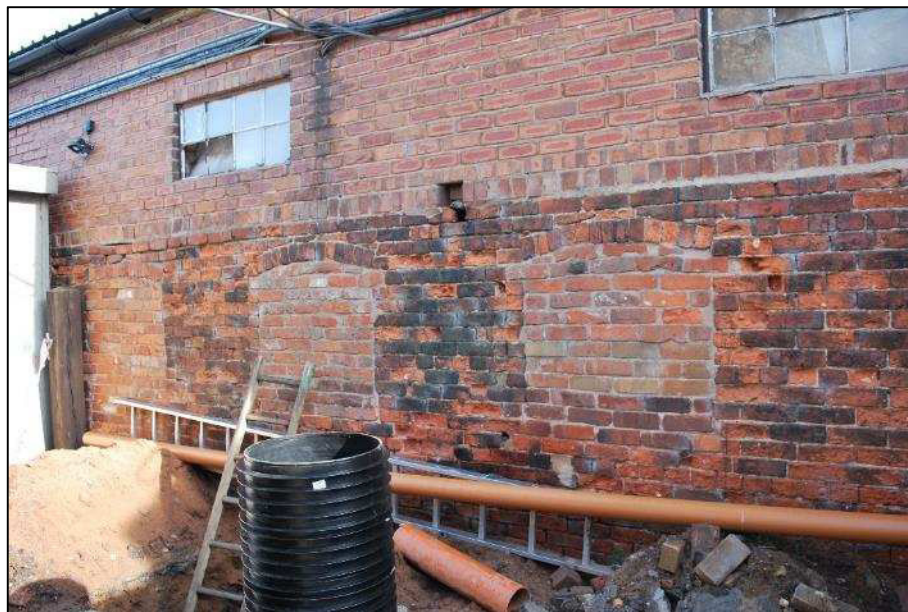
Plate 2 (Shot 85): 19th century building to the northeast of the mill, looking north

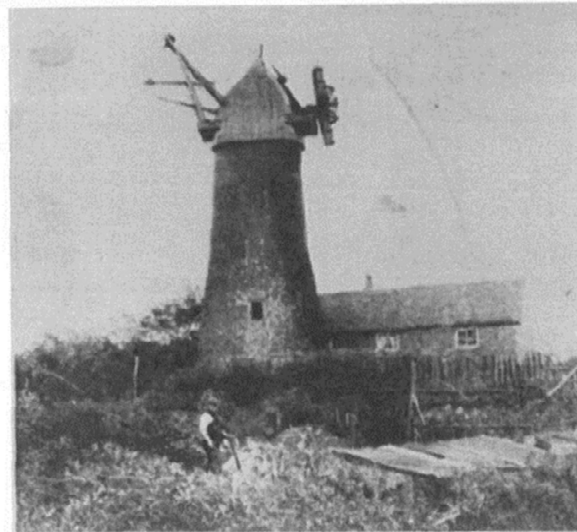
- 6.4 A photograph of Warsop windmill in the early 1900s shows that the machinery at the top of the windmill was once concealed in an ogee cap (Plate 3), which was gone by 1931 (<https://catalogue.millsarchive.org/forest-mill>). The same image shows the extant outbuilding to the rear of the windmill. All that remains on the building now is part of a winch mechanism to the lower floors (Plate 4).

Plate 3: Warsop Mill in the 1900s, image kindly supplied by Denise Varley, conservation officer for Mansfield District Council

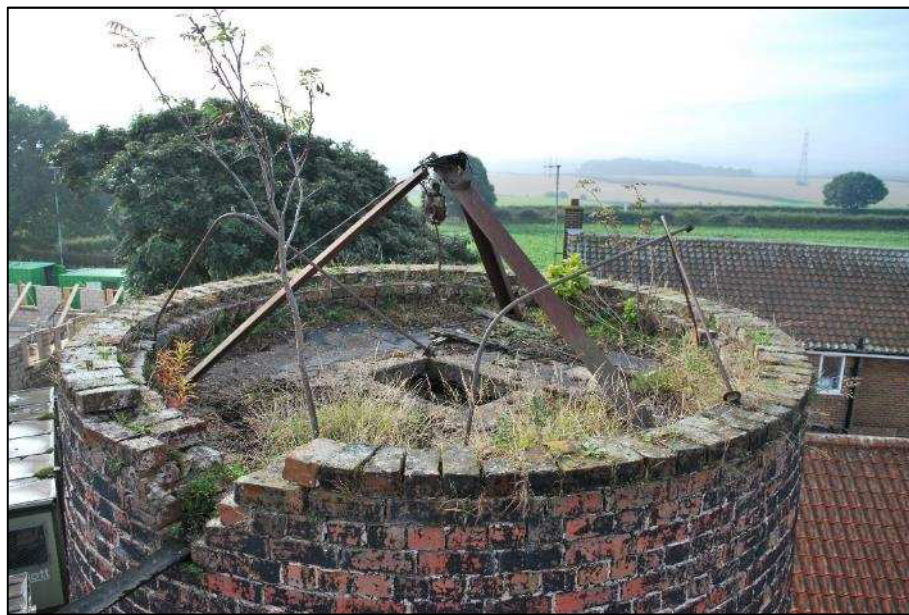
Plate 4 (Shot 1): The top of the windmill, looking southeast

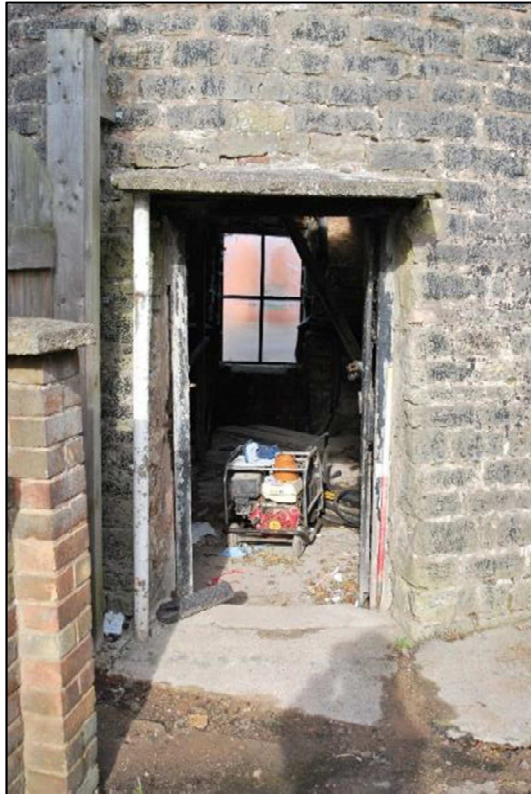
- 6.5 There is a single doorway into the building from the southeast (Plate 5). However, a large window on the ground floor to the northwest is likely to have been another doorway prior to conversion (Plate 6). There are four windows and doors regularly spaced out on the ground floor and first floor at the four intercardinal directions (Plate 1). The southwestern ground floor window has had a modern steel exhaust pipe inserted through it from a boiler inside the building (Plate 7). The second floor has windows on the southeast and northwest elevation (Plate 1) and a blocked opening on the northeast elevation (Plate 8). The early photo is not clear, but only appears to show a single window on the southwest elevation at first floor level (Plate 3), suggesting that the upper window may have been bricked up by this time.

- 6.7 The door is set back from the face of the wall and appears to have been replaced as it does not fit the frame properly (Plate 9). A concrete porch projects over the doorway and is supported by a metal pole on one corner (Plate 5).

Plate 5 (Shot 30): Entrance to the mill, looking northwest (1m scale)

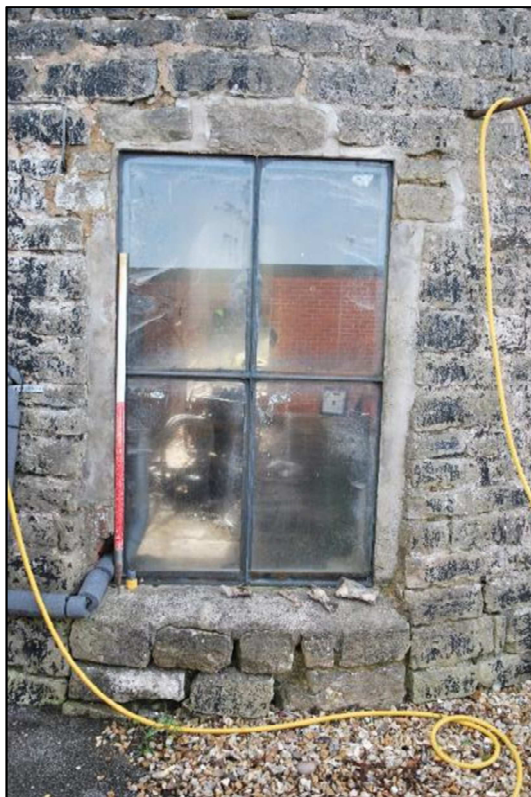
Plate 6 (Shot 21): Large four-light casement window inserted in place of a door, looking southeast (1m scale)

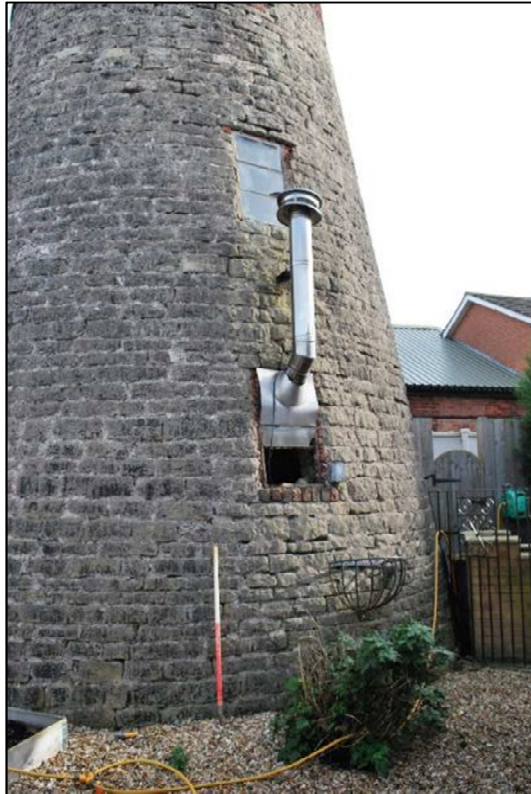
Plate 7 (Shot 23): Southwestern ground and first floor windows, looking east (1m scale)

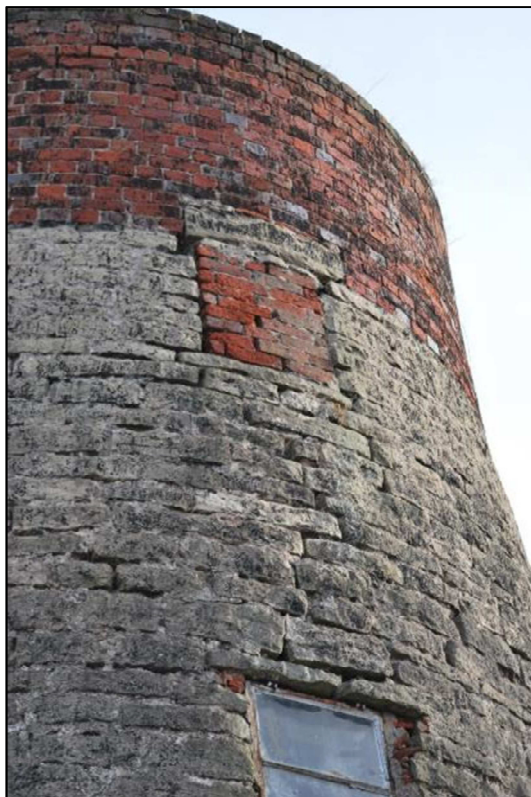
Plate 8 (Shot 24): Blocked second floor window, looking east

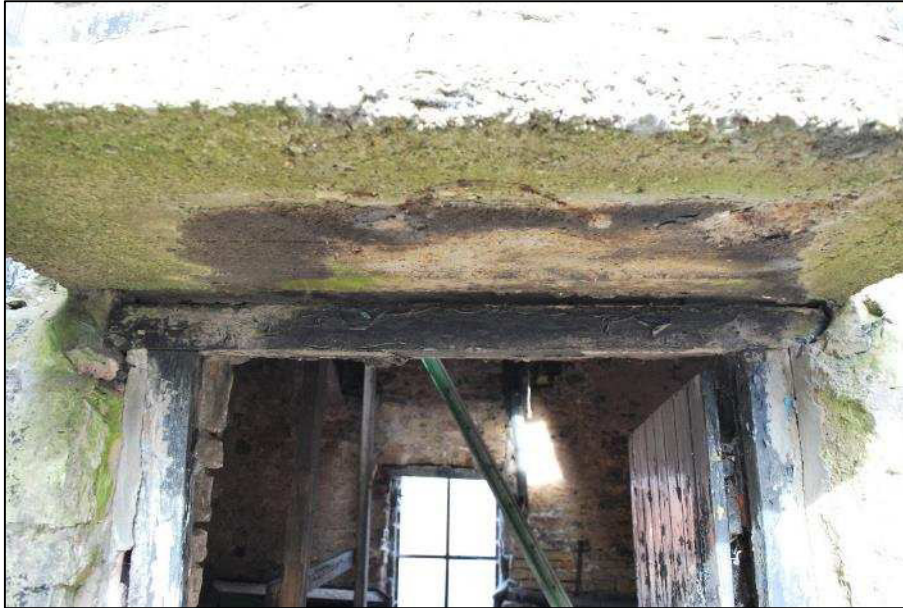
Plate 9 (Shot 37): Detail of the concrete porch and wooden door frame, looking northwest

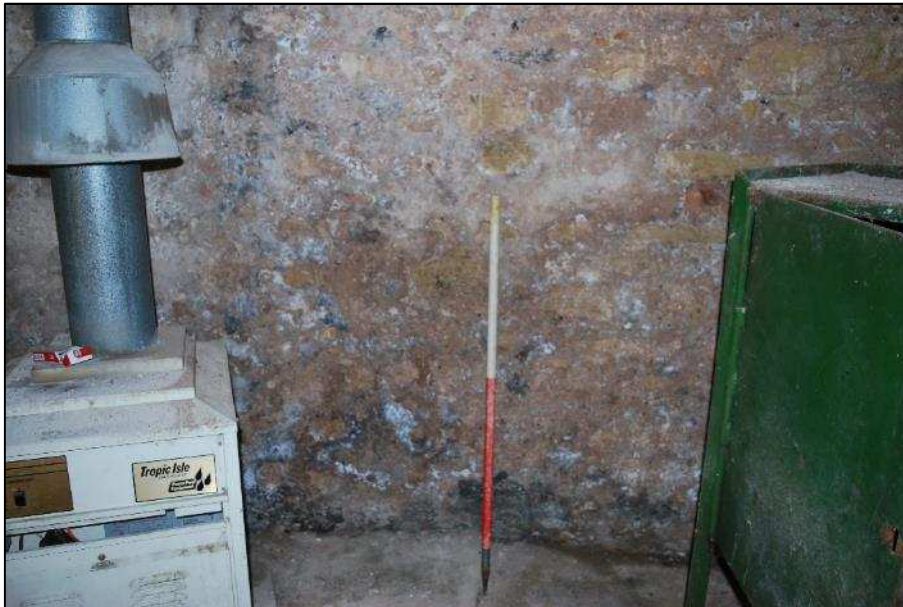
- 6.8 Internally, the walls have been plastered, but the plaster is now falling away and the underlying stonework is visible (Plate 10). The ground floor surface is composed of a patchwork of irregular stone and concrete blocks, reflecting the *ad hoc* repair and maintenance of this area of the building (Plate 11). There was also a burnt area on the northern wall, possibly the site of a former fireplace (Plate 12).

Plate 10 (Shot 75): Plasterwork falling away on the ground floor, looking southwest (1m scale)

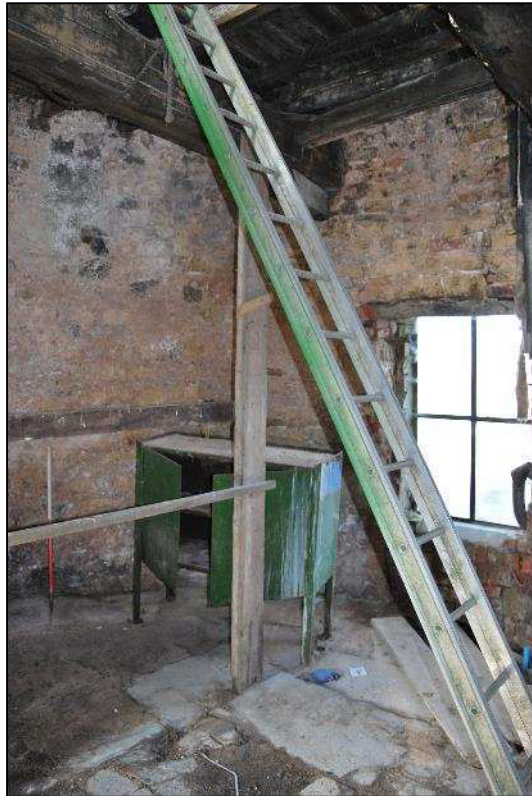
Plate 11 (Shot 70): General view of ground floor interior, showing patchwork of repairs to floor, looking east-southeast (1m scale)

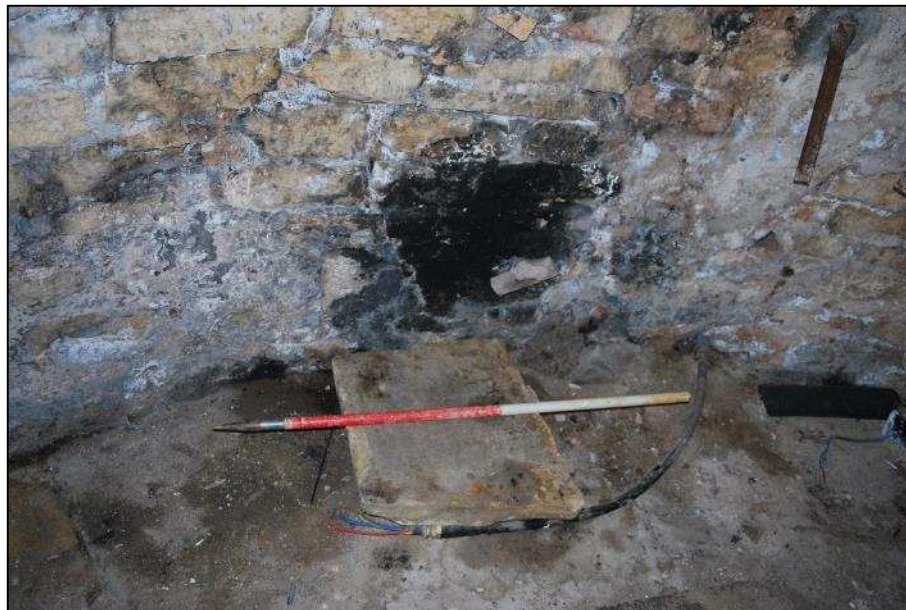
Plate 12 (Shot 67): Burnt area on ground floor, looking north (1m scale)

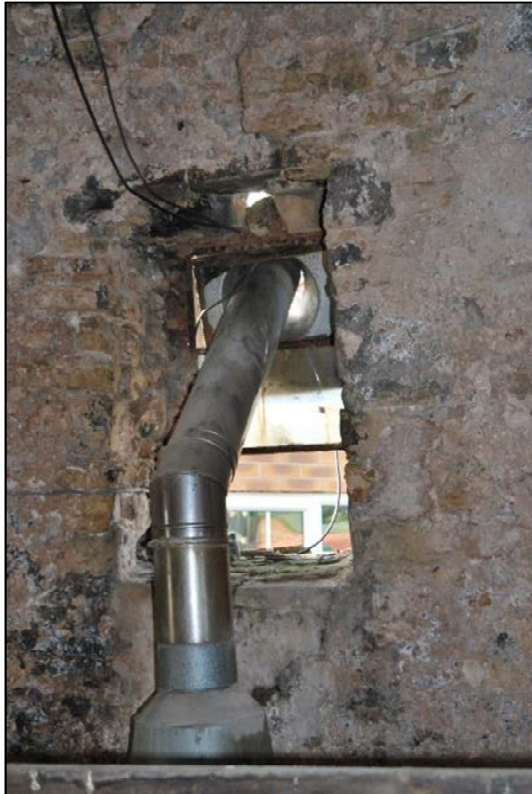
- 6.9 The ground floor room contains a number of features associated with recent reuse of the building; including a modern gas boiler, the exhaust pipe for which has been inserted through one of the windows (Plate 13). Another of the windows has been blocked with breeze blocks (Plate 14), although the glass remains on the exterior. Pipework and cables protrude through the floor relating to the installation of modern services in the building (Plate 12 and Plate 15). Some timber supports have been added to one of the beams but these do not appear to be supporting any weight in the ceiling and are more likely part of an internal partition (Plate 16).

Plate 13 (Shot 69): Chimney from the boiler going through a ground floor window, looking southwest

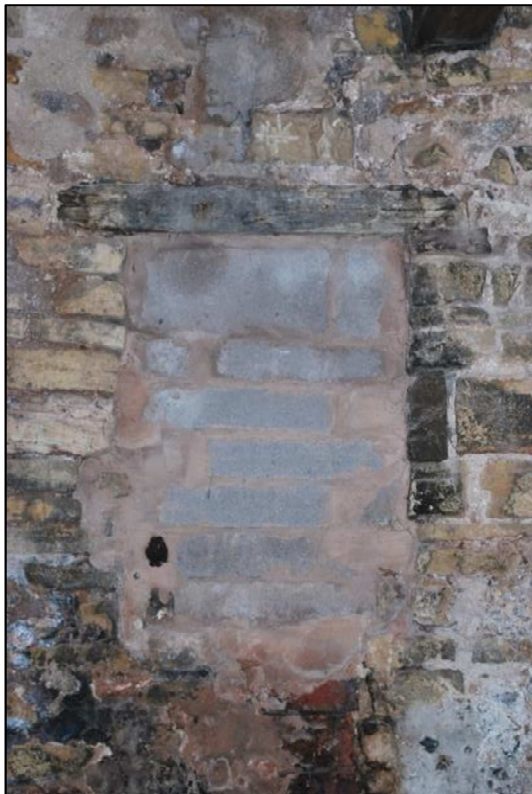
Plate 14 (Shot 64): Ground floor window bricked up from the interior, looking northeast

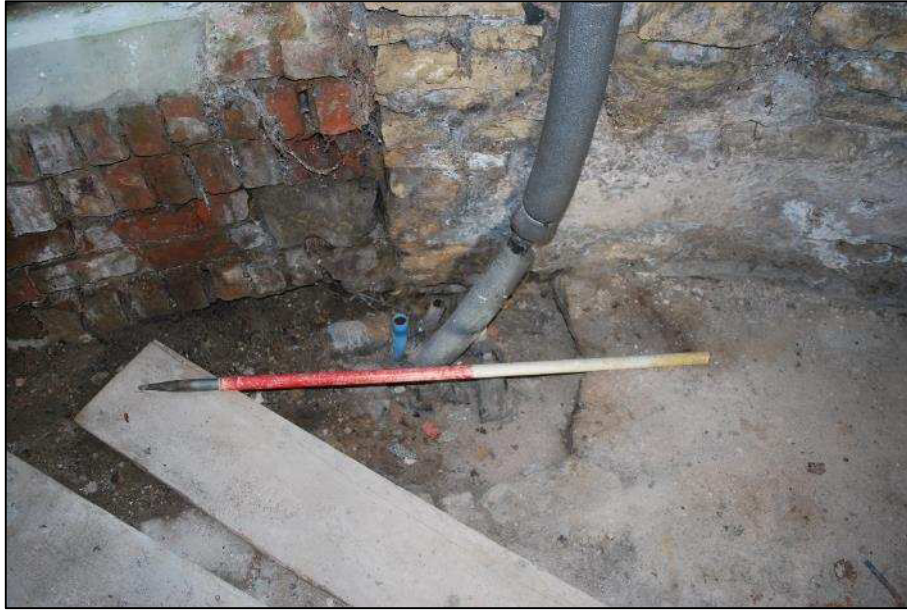
- 6.10 The entrance to the building is from the southeast (Plate 17). On the opposite side of the building a doorway to the northwest has been removed and a modern four-light window inserted. The brickwork below the window is clearly later and has not been plastered (Plate 15).

Plate 15 (Shot 66): Pipework coming through the floor and brickwork below inserted window, looking northwest (1m scale)

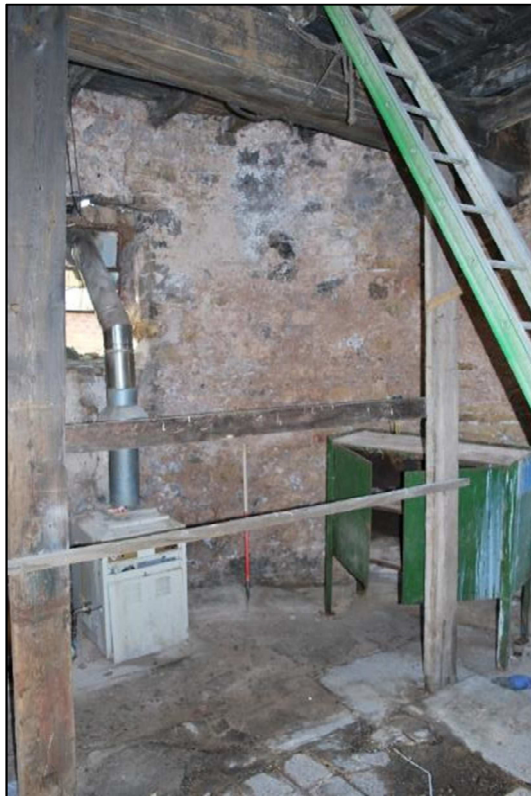
Plate 16 (Shot 76): Supports added to the principal beams, looking west (1m scale)

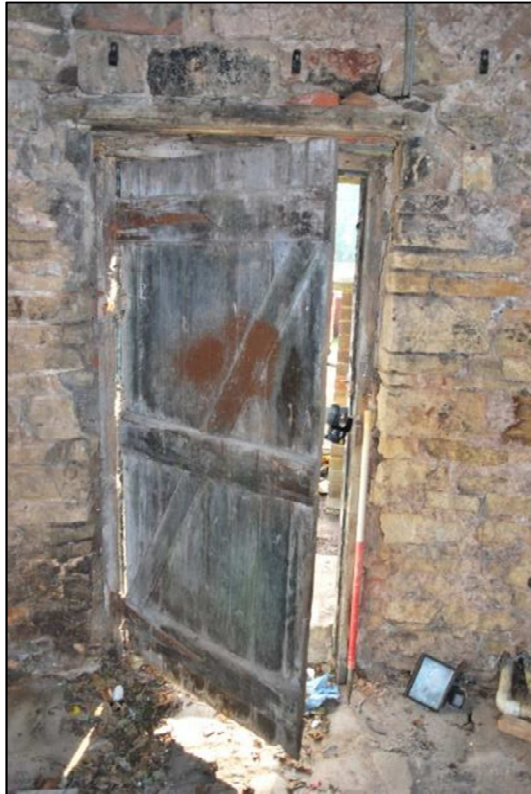
Plate 17 (Shot 81): Ground floor entrance, looking southeast (1m scale)

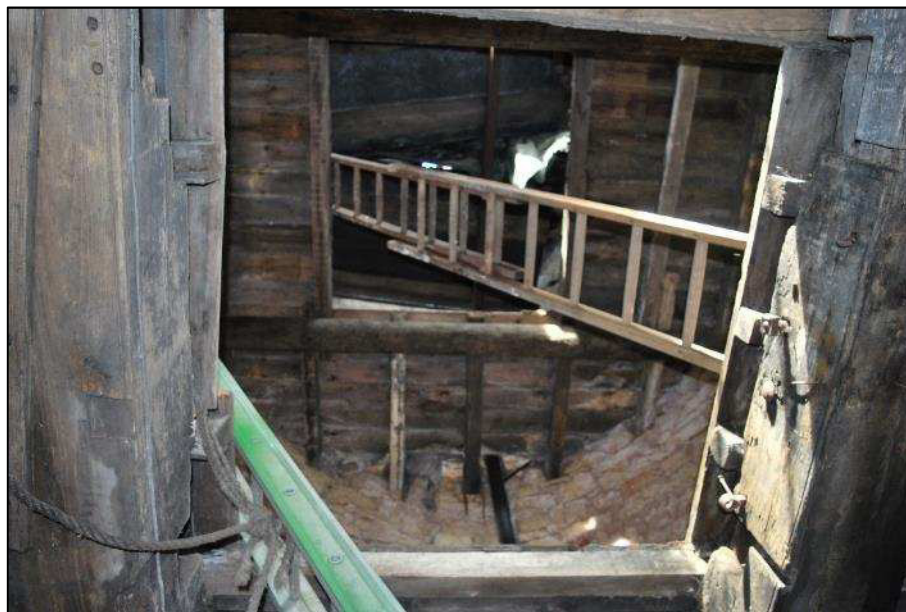
- 6.11 Access to the upper floors is currently via ladders through a central opening where the lifting mechanisms for the mill would originally have raised and descended (Plate 18).

Plate 18 (Shot 86): Access to the upper floors, looking northwest

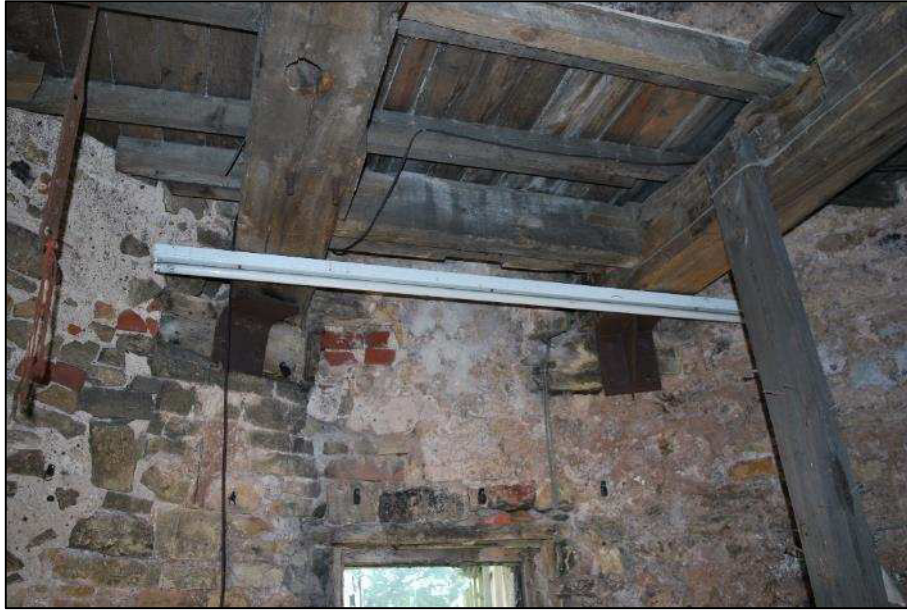
- 6.12 The first and second floors are wooden planking supported by joists and two principal beams (Plate 19). The beams are lodged into recesses in the wall, made for the purpose and resting on large wooden blocks. These are further bracketed with iron supports (Plate 20). A number of other supports have been added to the joists including metal and wooden brackets (Plate 21). The floor

joists rest on top of the supporting beams, and have mostly been doubled in the gap between the two principal beams (Plate 19). There are no visible peg marks and the timber is all machine sawn. Machine-sawn timber comes into use in the mid-19th century, suggesting that these floors may have replaced the original floors, the building being of a probable late 18th or early 19th century date. The ground floor principal beams have a number of unused sockets and an assembly mark is visible on one of the beams, but there are no other marks across the rest of the building (Plate 22). These suggest that either the beams are reused from an earlier building on the site, or that they have been removed and repaired or replaced, possibly in the mid-19th century.

Plate 19 (Shot 68): Ceiling support; beams supporting joists and planks, looking southeast

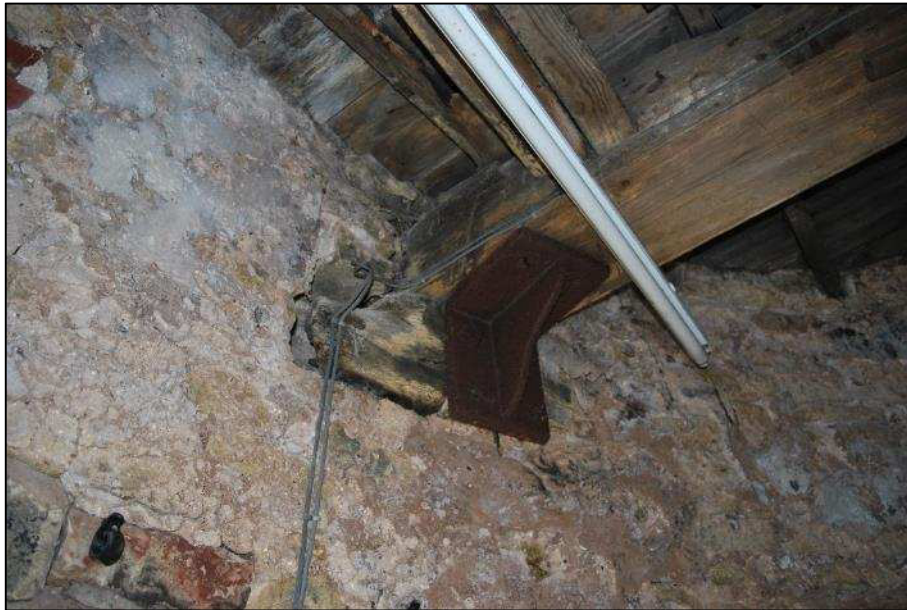
Plate 20 (Shot 72): Principal beam recessed into the wall, looking southeast

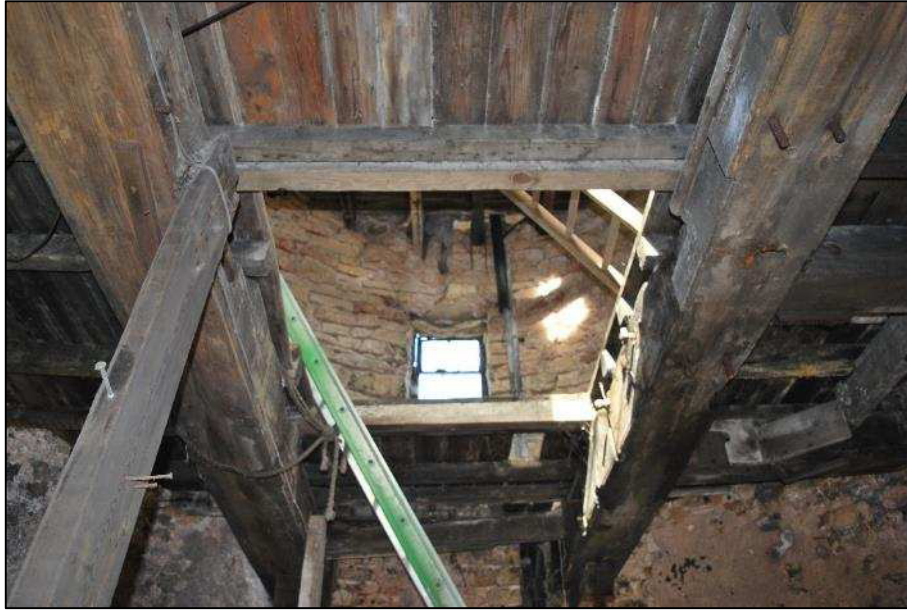
Plate 21 (Shot 71): Various additional supports to the first floor, looking northwest

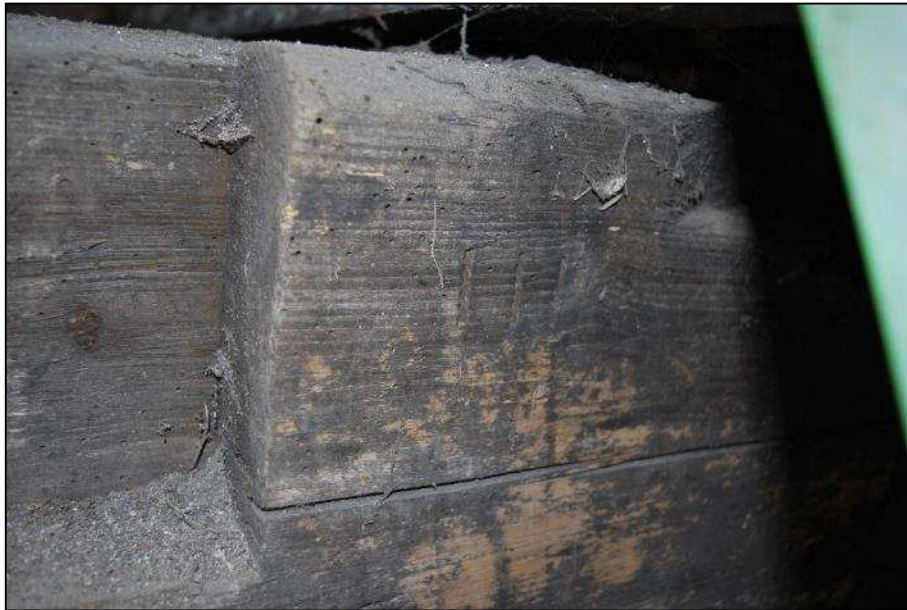
Plate 22 (Shot 59): Unused socket and assembly mark on the principal beam (looking southwest)

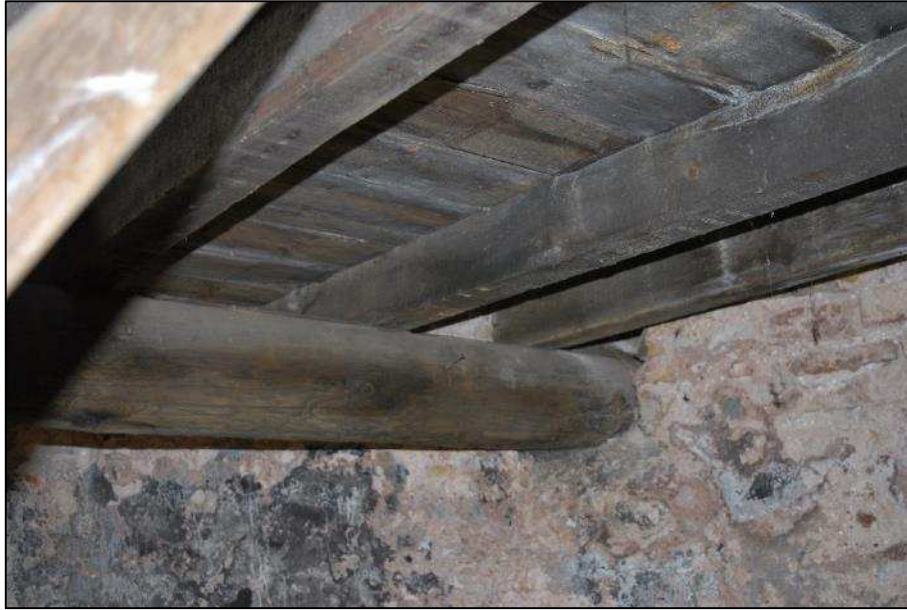
- 6.13 The second floor beams are not of cut timber, instead whole trunks have been used, the reason for which is unclear (Plate 23). The joists still rest on top of these, however, fewer additional supports have been added.
- 6.14 Access to the first and second floors was extremely limited as the floors no longer safely bear weight. The first floor does not appear to have been used as extensively as the ground floor since its disuse as a windmill and no features of historic interest survive. The second floor was not accessible internally, but a cherry picker was used to examine the space through a window. A large, steel water tank has been inserted into this floor and occupies most of the space. This is supported by iron joists, in turn supported on the window ledges (Plate 24).

Plate 23 (Shot 44): Trunk used for a beam on the second floor, looking southeast

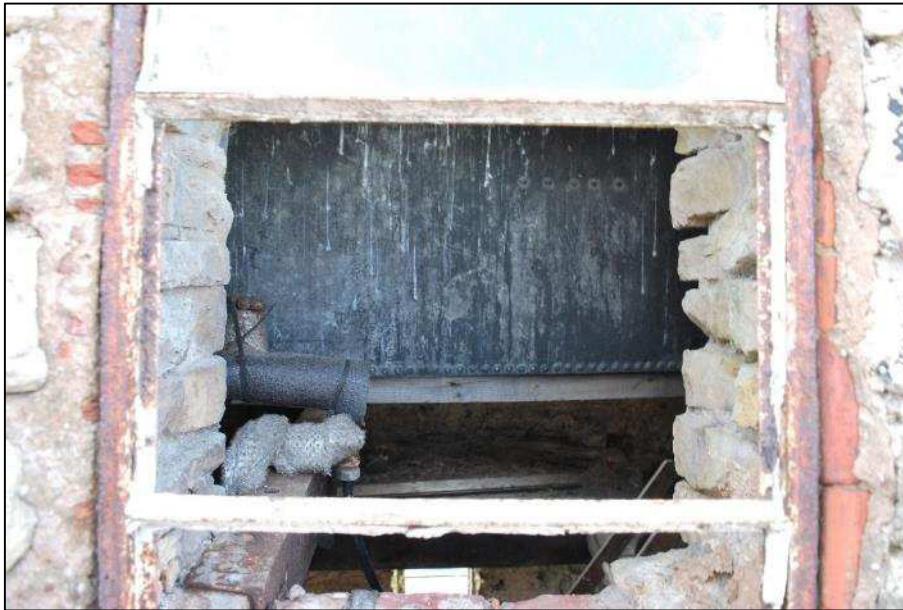
Plate 24 (Shot 9): Second floor of the building, viewed from the exterior, showing the inserted water tank and its supporting joists, looking southeast
