- 1.1 Allen Archaeological Associates was commissioned by Christopher Press Architect, on behalf of their clients, Mr and Mrs Smith, to undertake a building survey of two ranges of barns that are being converted into self contained holiday accommodation at The Grange, Yarburgh Road, Alvingham, Lincolnshire.
- 1.2 The methodology conforms to a specification prepared by this company (Allen 2007), and the English Heritage guidelines in *Understanding Historic Buildings: A Guide to Good Recording Practice* (English Heritage 2006).
- 1.3 A copy of the building survey report and the full project archive will be submitted to The Collection, Lincoln, for long-term storage, and will be stored under the Museum Accession Number 2007.97.

- 2.1 Alvingham is situated in the administrative district of East Lindsey, approximately 5km north-east of the centre of Louth. The Grange is to the north-west of the village, on the east side of Yarburgh Road. The barns that are the subject of the building survey form part of a complex of agricultural buildings, to the south of the farmhouse. The site centres on NGR TF 3596 9153.

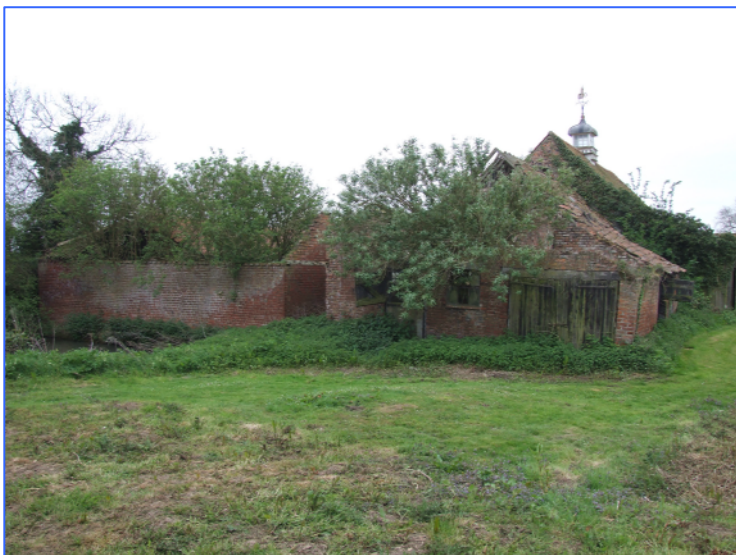
- 5.1.2 At the east end of the range there is a derelict outbuilding (Building 1), the roof of which has collapsed. Much of the brickwork above the wall plate on the south, east and west elevations has also collapsed. The east elevation has a set of double doors with a wooden lintel, and the north elevation bows out to the north with a large crack running top to bottom across the centre of the wall. The position of the double doors, pointing away from the crew yard, suggests that it served as a cart shed allowing access directly to the fields; a common architectural addition during the 19<sup>th</sup> century (Pickles and Lake 2006).

**Plate 3:** East elevation of the north range, showing the derelict stable and cartshed with the double wooden doors. Looking south-west.

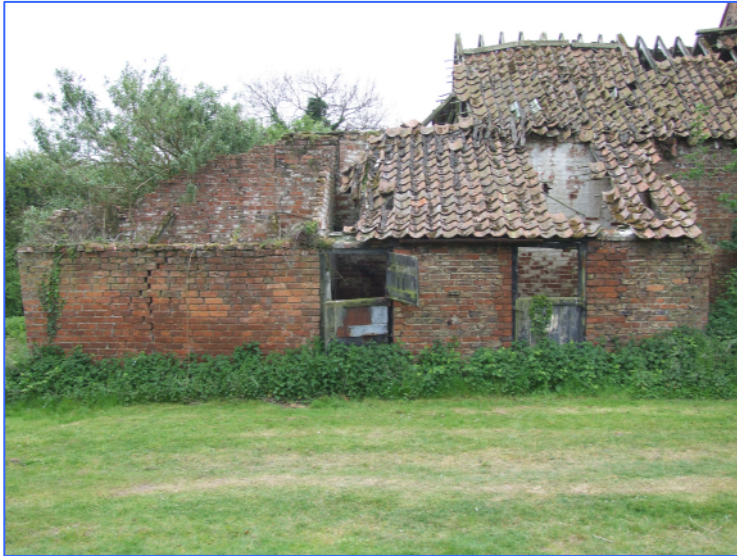
- 5.1.4 Attached to the east end of the outbuilding/cartshed is another range of three stable blocks (Building 3), with a mono pitched pantile roof. All three are in poor condition, but the two best preserved have a wooden door on their north elevations, while the north elevation of the western block has almost completely collapsed, and its west elevation has been built into the adjacent lean-to.

**Plate 4:** Stable block and cartshed at the east end of the north elevation of the north range. Looking south-south-east.

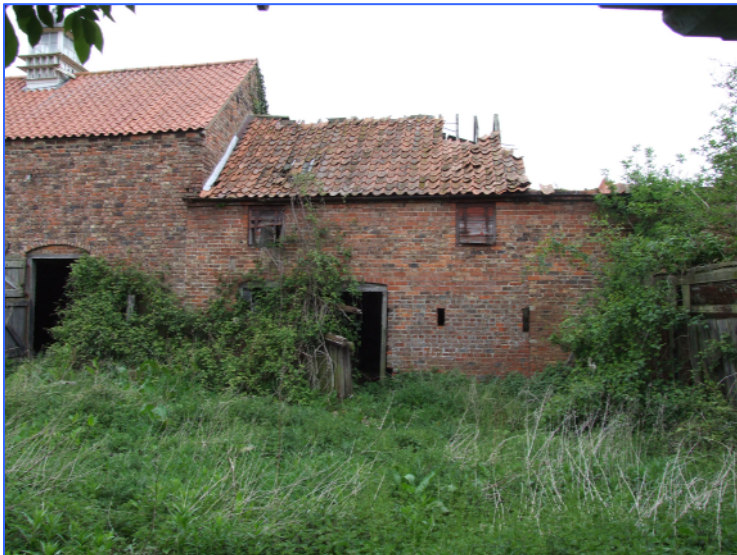
- 5.1.5 Another stable block with a hayloft in the upper storey is located to the south of the above (Building 4), with a wooden door with a segmental arch overlooking the crew yard. There is a small window to the west of the door, with two air vent holes and a possible blocked doorway to its east. Internally, the ground floor is divided into three bays by two timber partitions, with the ground sloping downwards to a timber gully which runs out into the pond to the east, to carry away animal waste. The upper floor is unsafe to enter, but is accessed by a timber ladder and a door in the west elevation. It is divided into bays by a series of low wooden partitions, which are attached to large timber verticals that support the roof purlins and tie beams. There are two shuttered pitching holes in the south elevation for the loading and unloading of animal feed or crops directly to/from the crew yard. The east end of the double pitched pantile roof has completely collapsed.

**Plate 5:** Stable block and hayloft in the south elevation of the north range. Looking north-north-west.

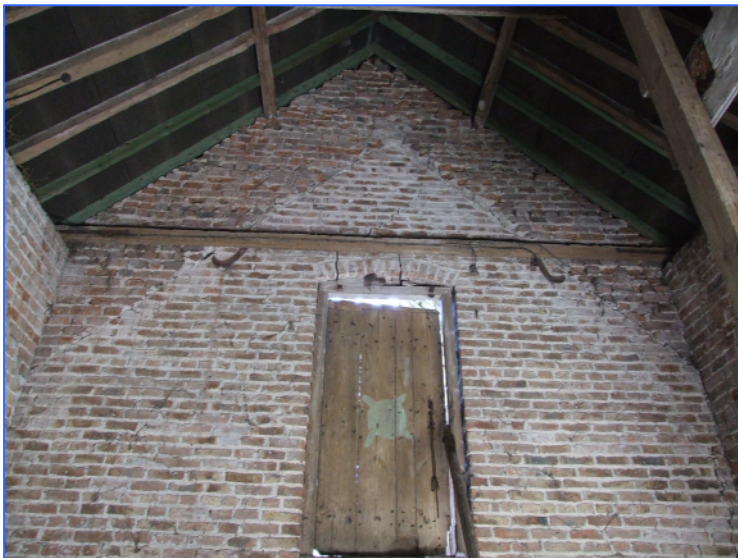
- 5.1.7 The above group of buildings appear to represent the earliest phase of construction of the barns. To the west, they are attached to a large three storey barn (Building 5), measuring approximately 11m by 5m. The east wall of this later barn has been built upon the west wall of the earlier stable/granary block, as shown by the line of the double pitched roof in the internal east elevation of the three storey barn (plate 8). The brickwork of the barn is a very irregular form of English Garden Wall Bond, mainly using four or five courses of stretchers to each header course, although occasional headers are visible in no obvious pattern in some of the stretcher courses. This suggests the building was built for purely functional reasons with very little interest paid to decorative aspects. The roof is a double pitched pantile roof that appears to be a relatively recent repair.

**Plate 8:** East internal elevation of the three storey threshing barn, showing the roof line of the adjacent stable/hayloft. Looking east-north-east.

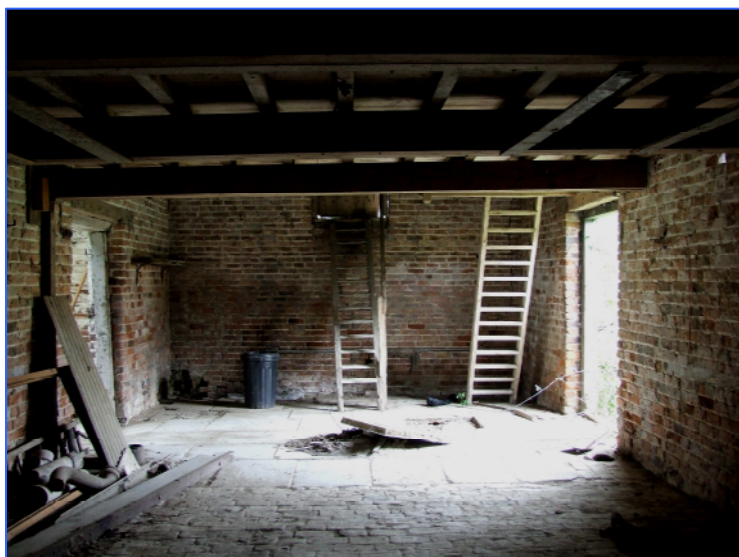
- 5.1.11 The ground floor of the barn comprises a single room, with a flagstone floor at its east end. This probably served as a threshing floor, with the opposing doors allowing a through flow of air to carry away the chaff. A loose flagstone exposed an earlier floor of compacted chalk gravel and soil beneath the probable threshing floor. The western portion of the room has a brick floor and was probably used to store the threshed crop.

**Plate 11:** Ground floor of the threshing barn, looking east-north-east towards the flagstone threshing floor, with the large doors at either side allowing the through-flow of air to carry away the chaff.

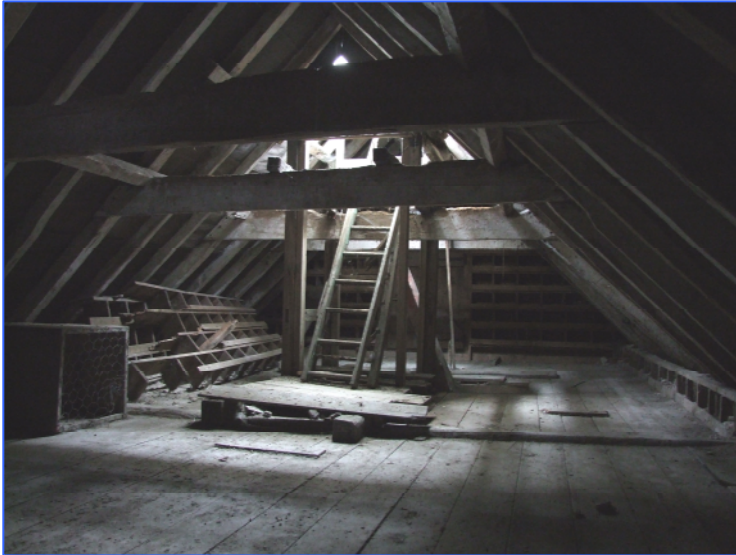
- 5.1.13 The second storey, which was used as a pigeon cote, is also accessed by a wooden ladder and a hatch in the north-west corner of the floor. It is slightly larger than the first storey, measuring 8.3m by 5m, and overhangs the lower storey at its east end. There was a curious feature attached to the floor rafters of this storey at its east end, comprising two steel supports holding a wooden timber with a small wooden box attached. A possible interpretation for this feature is as a roost and feed box for the pigeons. The room has a series of pigeon boxes around the walls, and a hatch in the centre of the roof allowing access to a glazed cupola. The cupola has a series of flight holes for the pigeons, glazed windows of six lights in each side, and a lead roof topped with a wind vane in the design of a Viking ship.

**Plate 13:** Pigeon cote in the second storey of the threshing barn. Note the pigeon holes at the far end of the room and along the right hand side of the shot, and the ladder allowing access to the cupola above. Looking west.

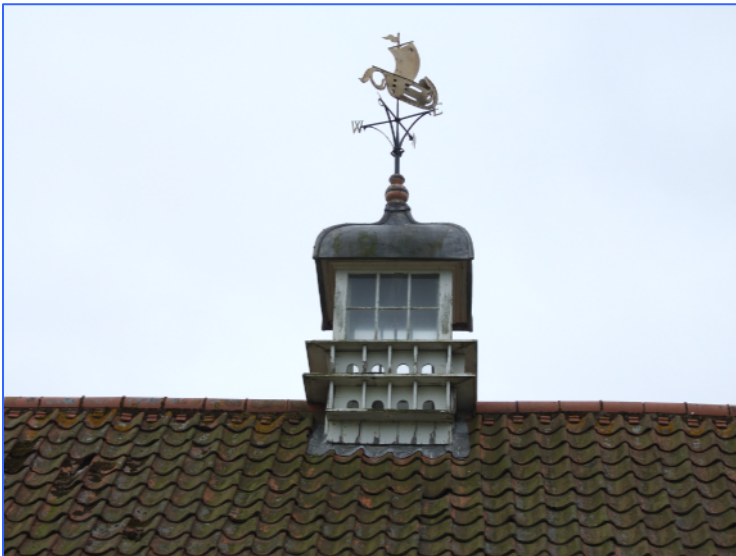
- 5.1.14 The pigeon cote and cupola appear to represent a later addition to the barn, as part of a major phase of redevelopment. The floor of the first storey, the wooden partition wall at its east end,

and the pigeon cote itself all appear to be of one build. The construction of the pigeon cote would have required the cupola to be built at the same time as it has flight holes for the pigeons, and it follows that the barn was also re-roofed at this time.

**Plate 14:** The glazed cupola on the roof of the three storey barn, with the wind vane and flight holes for pigeons. Looking south-south-east.

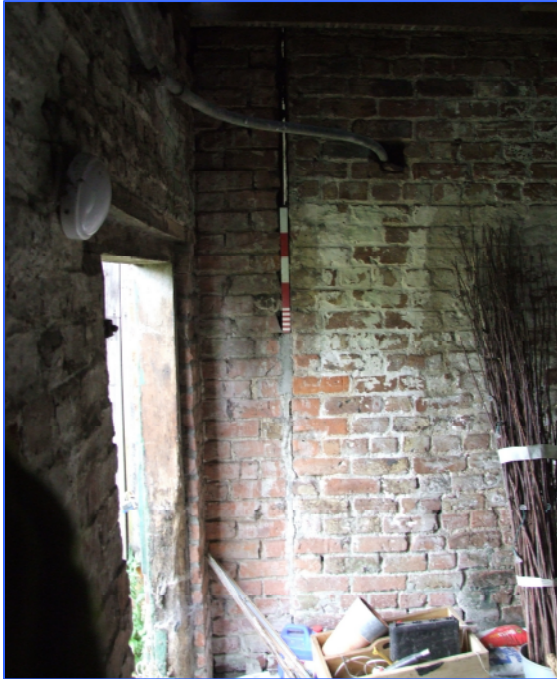
**Plate 16:** Internal east elevation of barn showing the relationship between the two phases of walls. Looking east-north-east.

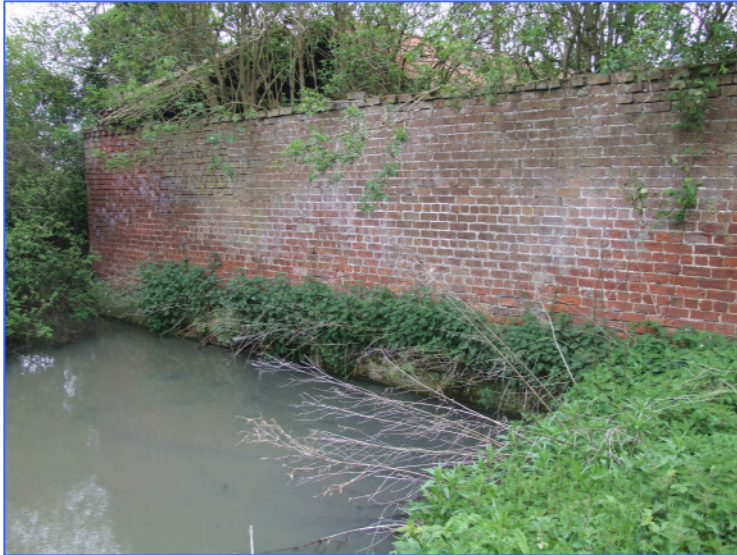
**Plate 19:** East elevation of the derelict barn at the east end of the south elevation. Looking south.

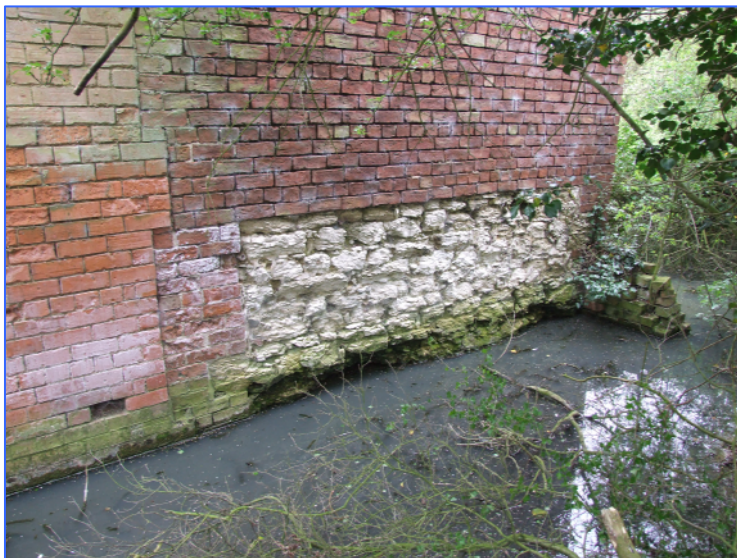
- 5.2.1 The south range comprises two buildings arranged in an L-shaped plan. The earliest building is at the east end of the range (Building 10), and extends northwards to within 1.5m of the north range. The gap between the two ranges appears to have had wooden doors at each end, of which only the western door survives. The building measures 11.5m by 4.2m and had a double pitched roof that has completely collapsed. The south end of the building extends into the adjacent pond, which runs along the south side of the south range. The east and south elevations are in English Garden Wall Bond (three stretchers to each header course), with a dentil course below the roofline. At the base of the east corner of the south elevation is a small area of dressed chalk blocks and a stub of a brick wall extending southwards. The chalk blocks may have been robbed from nearby earlier buildings. A second, less plausible possibility, is that they represent the in situ remains of an earlier stone wall.

**Plate 21:** Chalk blocks in the south-east corner of the south range. Looking north. Note also the difference in brickwork at the left of the shot.

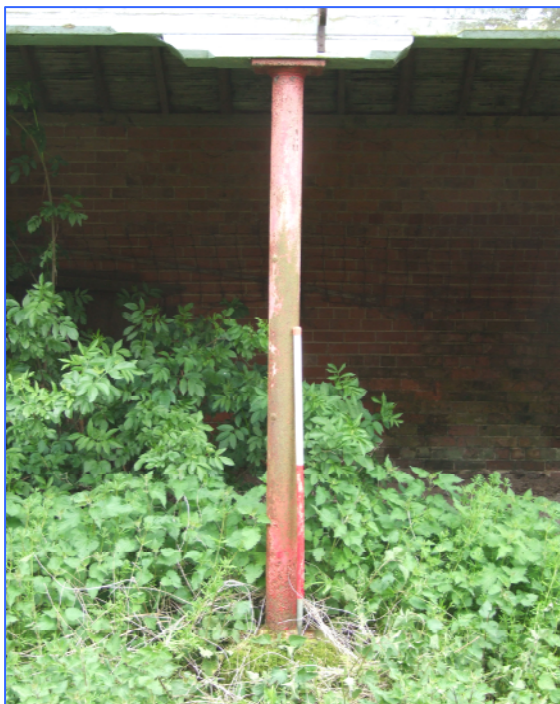
- 5.2.4 The second building in the south range (Building 11) is a single storey brick structure with a double pitched pantile roof, probably a cow shed. It measures 35m by 5m, and is divided into three uneven bays, open on their north elevation and facing into the crew yard. The three bays are divided by two brick walls, each fronted by a brick stanchion with bull nose bricks on the corners. The brick stanchions support a large wooden lintel, which is also supported by eight cast iron stanchions, each of which is set on a stone pad, with a timber pad below the lintel.

**Plate 25:** Detail of one of the cast iron stanchion on the north elevation of the south range.
