- An archaeological scheme of works was undertaken in advance of the conversion of an existing building, and the construction of a new block of retirement flats, on land at the Old Cornmill, South Street in Bourne, Lincolnshire.
- The existing cornmill was subject to a programme of building survey prior to conversion, detailing all external elevations and internal shots of original features, fixtures and fittings.
- A programme of archaeological trial trenching was also carried out, in advance of the construction of a new block of flats adjacent to the existing building. Two trenches were excavated, exposing a late medieval, several undated linear features, and a large late medieval pit.

- 1.1 Allen Archaeological Associates was commissioned by Quadrant Surveying Limited on behalf of their client, Mill Developments (UK) Limited., to undertake a programme of building survey and archaeological trial trenching in advance of development at The Old Cornmill, South Street in Bourne, Lincolnshire.

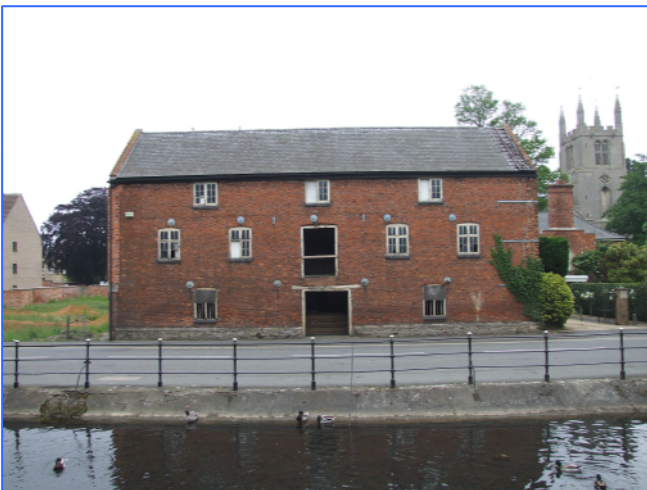
- 7.3 The south end of this elevation has a series of metal ties inserted, which appear to have been necessitated by subsidence of the south gable end. There has also been extensive rebuilding at the north corner of this elevation, probably occasioned by the demolition of the formerly adjacent warehouse building. There are a number of circular steel plates along the elevation indicating the position of tie rods.

**Plate 2:** West elevation, looking east.

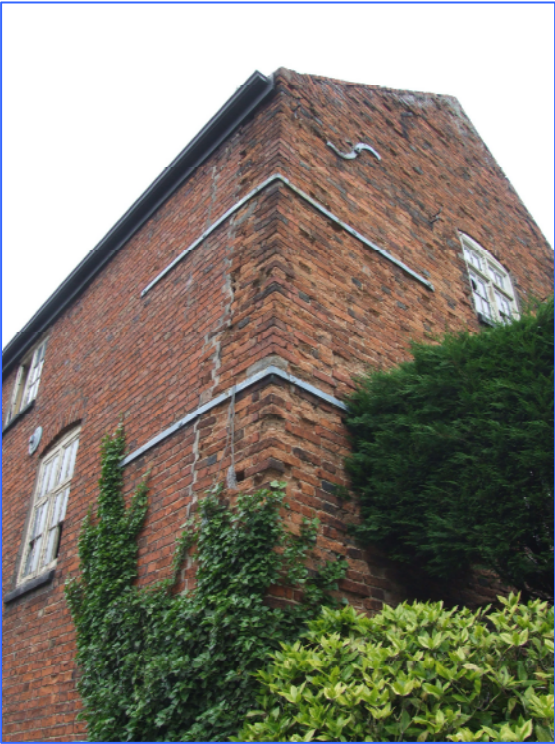
**Plate 4:** Detail of south-west corner, showing steel ties and the cracking and subsidence of the wall. Looking north-east

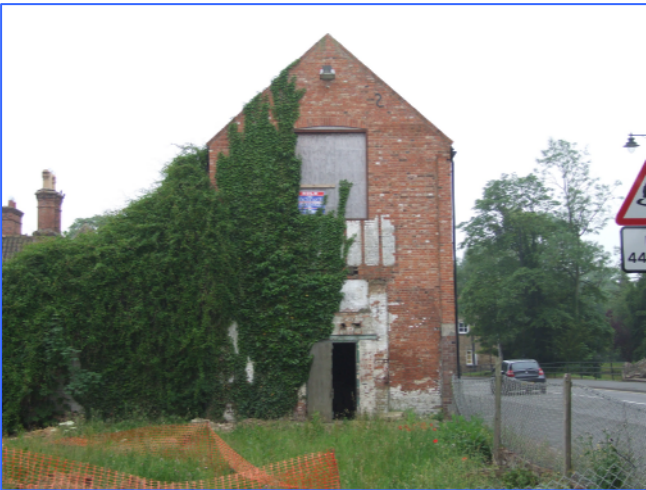
- 7.6 The north elevation was also partially obscured by vegetation. It had a single door at ground floor level, and a set of double doors at second storey level. Areas of white washing and occasional small gaps in the brickwork indicate structural features related to the warehouse building formerly attached to this elevation.

**Plate 5:** North elevation, looking south

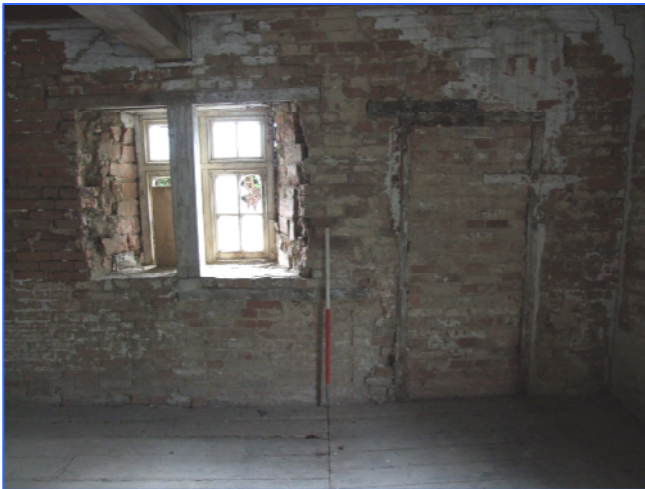
- 7.10 The brickwork in the south wall is in a poor state, with a number of cracks evident. The opening for the window is recessed into the wall and supported by a wooden beam with a wooden lintel over. To the west of the window is a blocked doorway, the wooden frame of which has been left in situ.

**Plate 11:** South wall of the first floor, showing the window and blocked doorway, looking south.

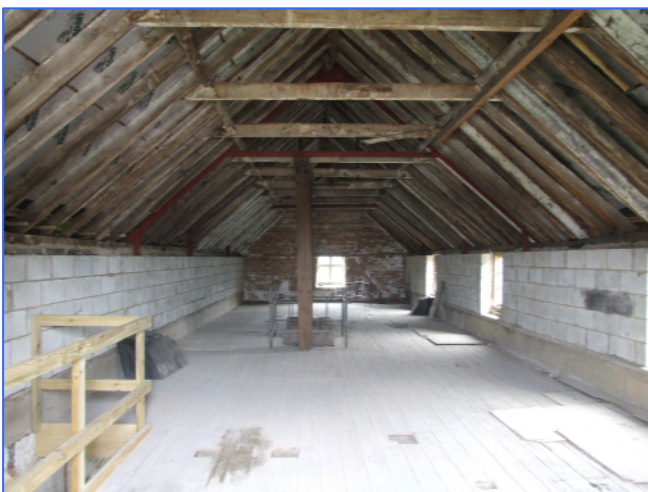
- 7.12 The most extensive evidence of recent repairs is visible on the second storey. Breeze block walls have been added along the north, east and west elevations, and the building has a new roof with asbestos insulation.

**Plate 12:** Second floor, looking south

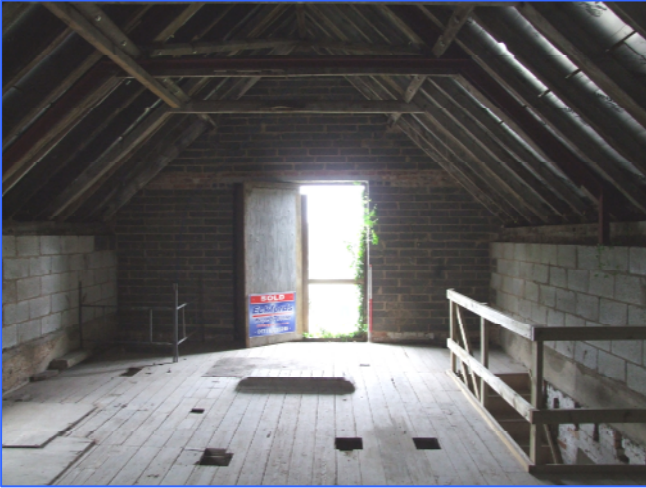
- 7.11 The north wall on this floor also exhibits a recent breeze block repair, again likely to have been occasioned by the demolition of the adjacent building, and reflected by an external brickwork repair.

**Plate 13:** North end of the second floor, looking north to the door and repaired north wall.

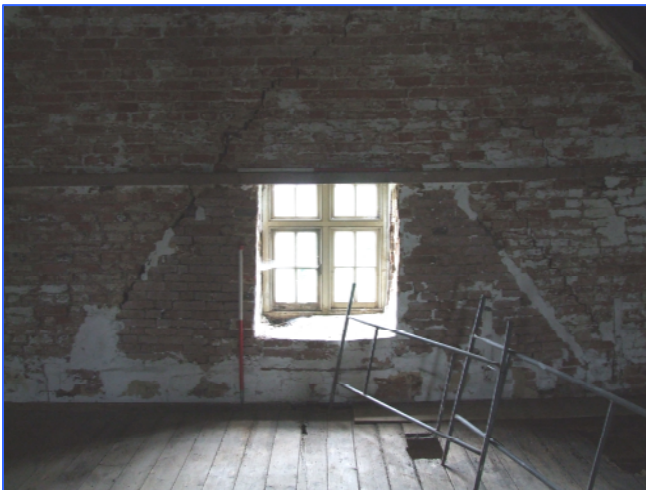
- 7.13 In the south wall of the building, there is slight evidence that the building has been increased in height at some time, as evidenced by a possible roof scar flanking the window in the south elevation. There is however no matching roof scar on the exterior of this elevation, and it may merely be a crack caused by subsidence of the wall, already noted externally, where metal ties have been used to hold the south wall to the west wall.

**Plate 14:** Window at the south end of the second floor, showing the cracks evidencing the subsidence of the south wall. Looking south.
