**ARCHAEOLOGICAL ASSESSMENT REPORT:
CHURCH OF SAINT MARGARET, HAWERBY CUM BEESBY,
NORTH-EAST LINCOLNSHIRE**

NGR: TF 26082 97596
AAL Site Code: HASM 13

By
Allen Archaeology Limited
Report Number AAL2014118

October 2014

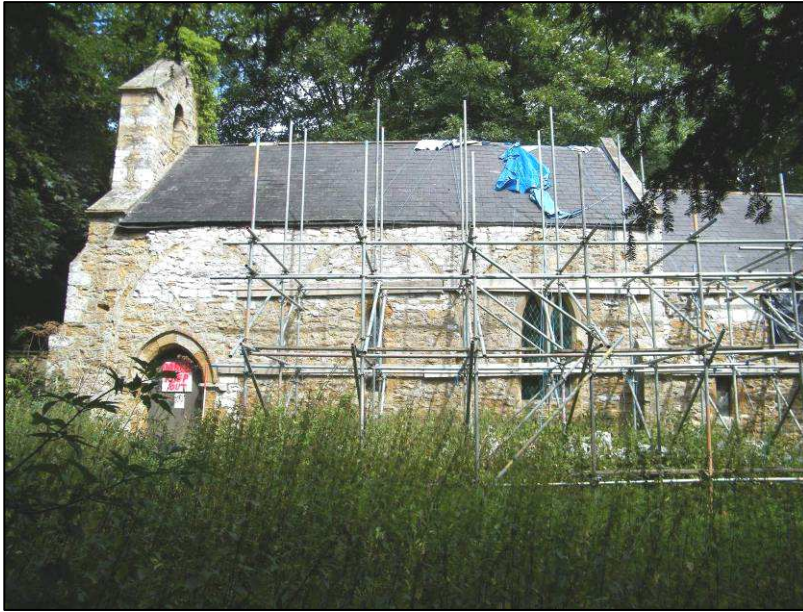
Plate 1 (shot 6): South elevation of the nave

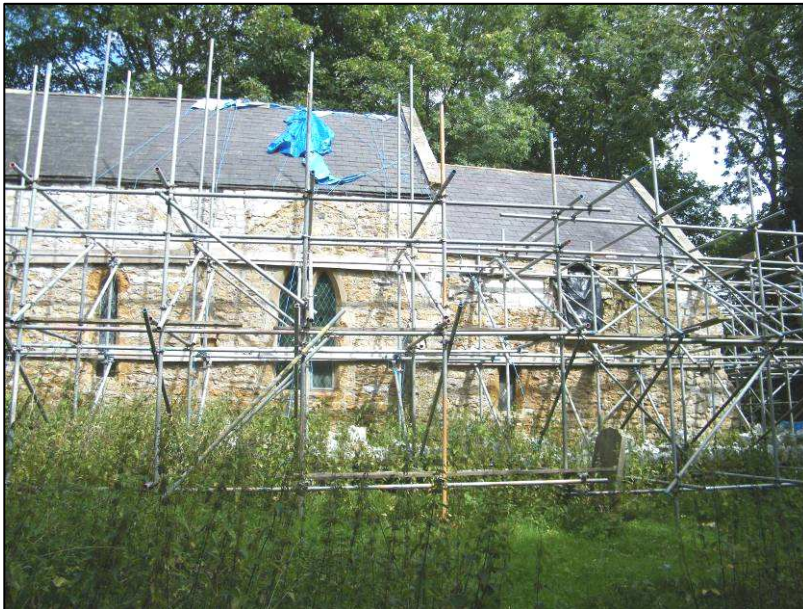
Plate 2 (shot 8): South elevation of the chancel

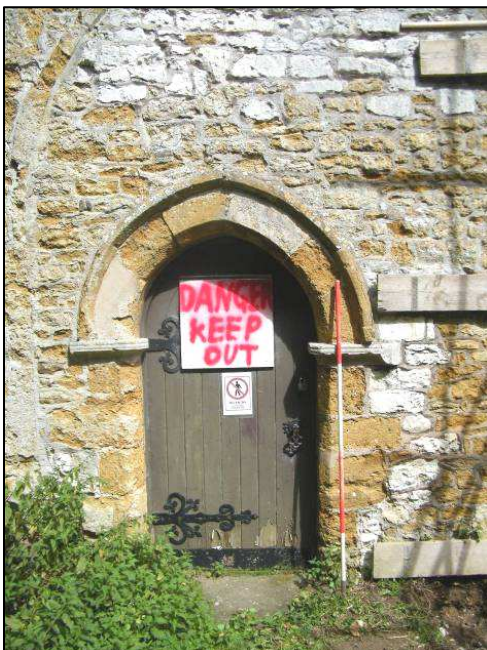
- 7.2 In the nave there are two pointed arched windows of different sizes. The western is a narrow lancet window and the easternmost has 19th century Y-tracery, and is probably part of the 1846 restoration of the church. These windows are situated in the centre of two blind arches which represented the former arcade, infilled when the south aisle was removed, presumably due to a diminishing congregation (Proctor 2012). The chancel has only a small, narrow two-pointed arched window with simple glazing (Plates 1 and 2).
- 7.3 The main entrance is located toward the southwest end of the south elevation, off centre from the infilled arcade arch and has been decorated with a hood mould, simple impostes and ironstone quoins. These elements are likely to be re-used masonry from the church’s earliest phase. The plank door has decorated scroll strap hinges and is of a later date (Plate 3).

Plate 3 (shot 10): Door with hood mould, 2m scale

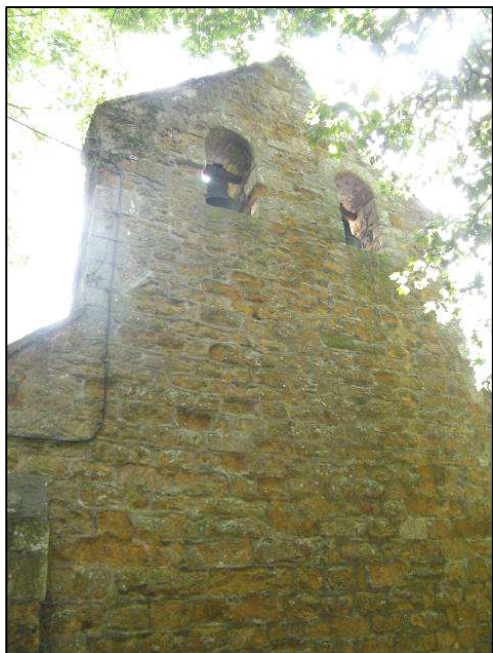
- 7.4 The bell-cote or bell-gable holds two bells within round headed arches, and is likely to date to the 17th century renovation of the church (Proctor 2012). The interior of the arches has been

built or repaired with bricks. The elevation also has two stepped and shallow buttresses, offering some limited support to the wall (Plates 4 and 5).

Plate 4 (shot 15): West elevation bell-cote

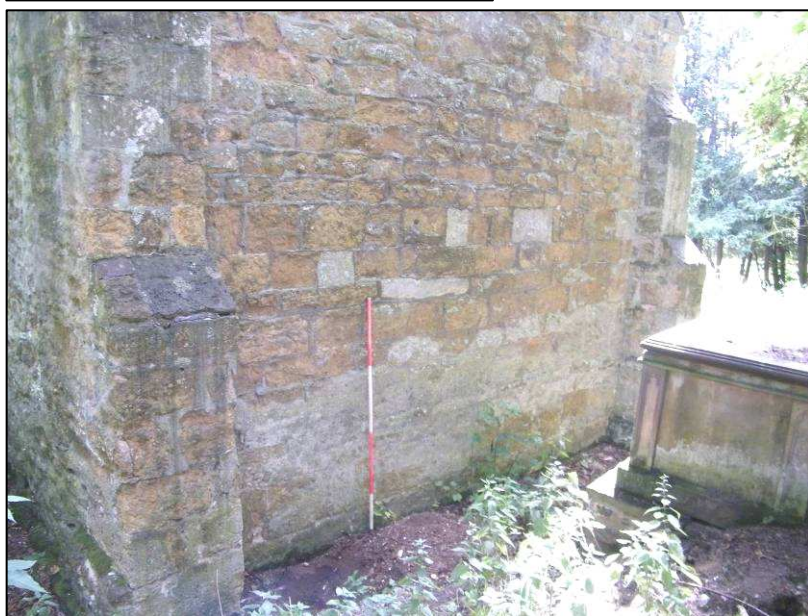
Plate 5 (shot 14): West elevation buttresses, 2m scale

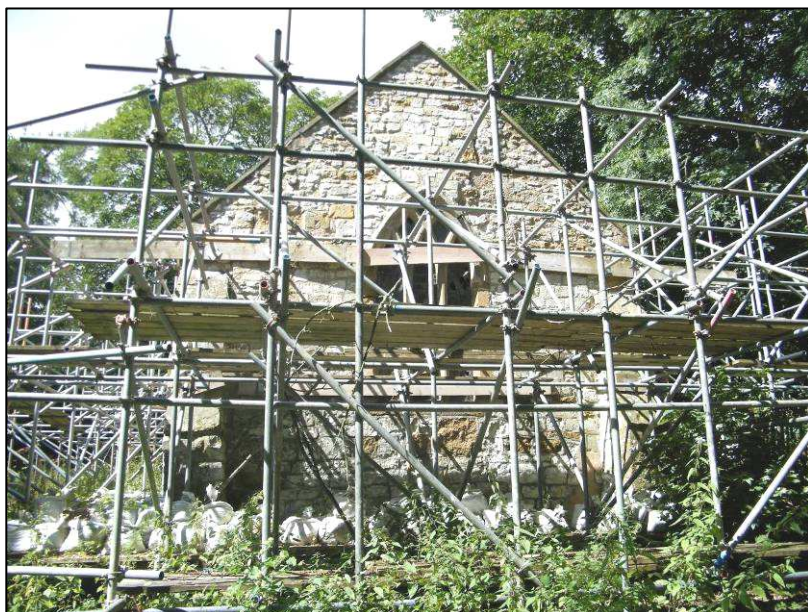
- 7.5 The buttressed east elevation has a large arched window with intersecting tracery, and is likely to be an addition of 1846. There is a large crack in the gable that extends through to the window (Plates 6 and 7). There is a stained glass window of 1912 in the east window, that has been badly vandalised.

Plate 6 (shot 51): East elevation behind scaffold

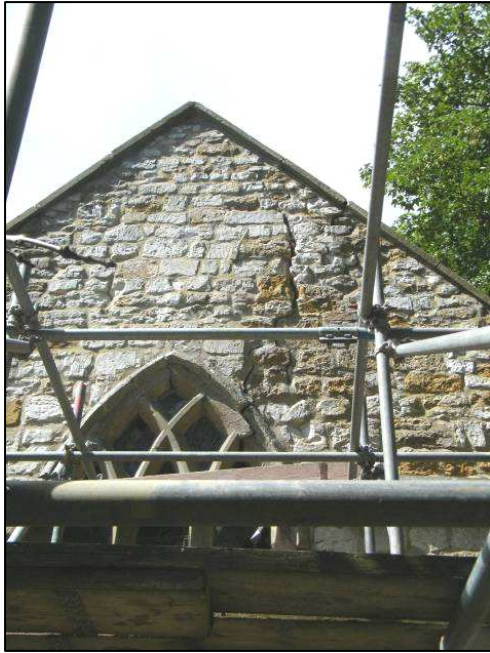
Plate 7 (shot 54): Crack through masonry wall and tracery window, east elevation

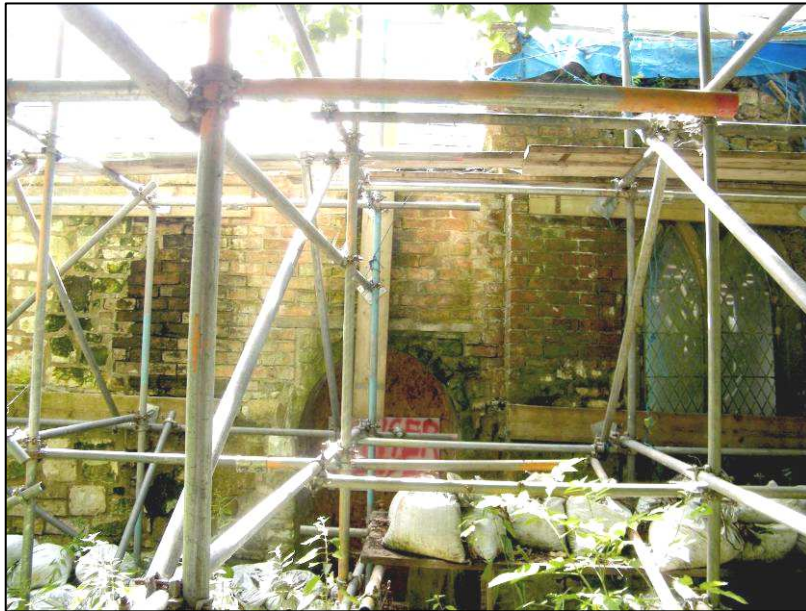
- 7.6 Large parts of the north elevation of both the chancel and nave have been repaired with simple stretcher bond brickwork (Plate 8). This also extends into the east gable of the nave, above the roofline of the chancel. Stretcher bond was in common use during the later part of the 19th century (Brunskill 2009, 53), and these repairs are likely to date to the 1846 renovation of the church. This elevation has a similar layout of windows to the south elevation, with a narrow lancet and larger window with Y-tracery, and a blocked doorway into the chancel.

- 9.5 In 1846, the church was restored as is reflected in the Y-shaped tracery windows, plain glazing, and probably the brickwork repairs on the north elevation. These restorations are of moderate interest to the church itself, as part of the story of the use and adaptation of the structure, although the brickwork is now in a very poor state of repair due to recent deterioration of the structure, and does not add to its amenity value.

Plate 8 (shot 43): North elevation showing repair work in brick and boarded up doorway

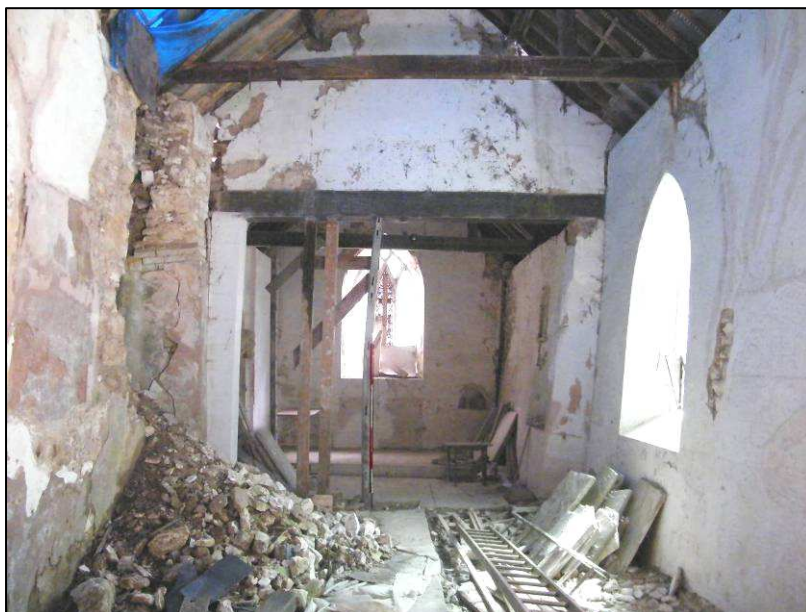
- 7.7 Much of the interior has been stripped out and all the 19th century pews, fitted during the 1846 renovation have been removed (Plate 9). However, the 19th century raised tiled floor has been left in situ. The flagstones around the outer walls in the nave have been lifted.

Plate 9 (shot 24): General view of the interior, looking east towards the chancel, 2m scale

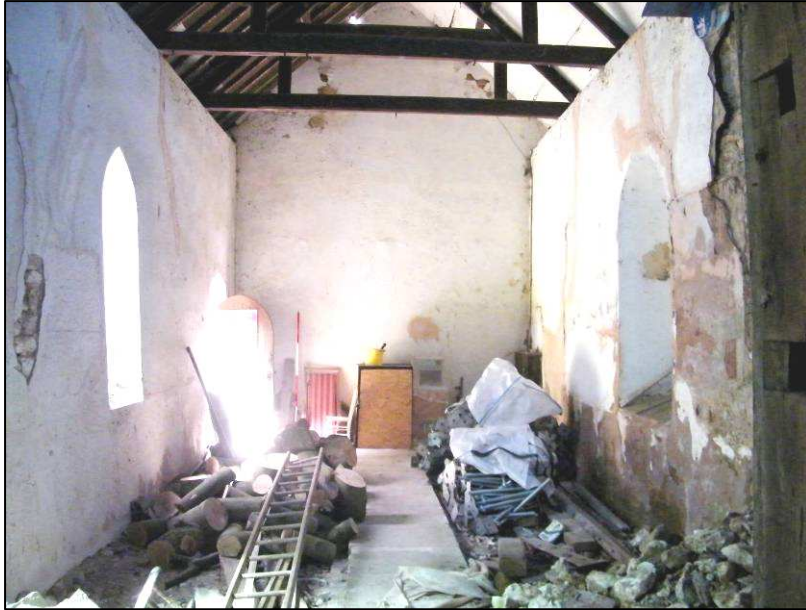
- 7.8 The walls have been rendered and lime washed, mostly obscuring the masonry and brickwork behind. As a result of the recent re-roofing, both the north and south elevations have spread and are now bowing out dangerously; cracks have formed between the nave and chancel. Three supports have been arranged to hold up the timber bressumer between the nave and chancel. Part of the north elevation has collapsed allowing the rubble core to spill out in to the church and also allowing water ingress. It appears that in this area the previous owner has intended to fit a rooflight but this work was never completed and temporary sheeting covering the opening has long since deteriorated, further adding to the structural problems.

- 7.9 The squared 19th century timber roof uses queen post trusses. Above the collapsed wall section, roof rafters have been removed or collapsed and the roof is in need of repair (Plates 10–12).

Plate 10 (shot 28): General view of the church looking west across the nave, 2m scale

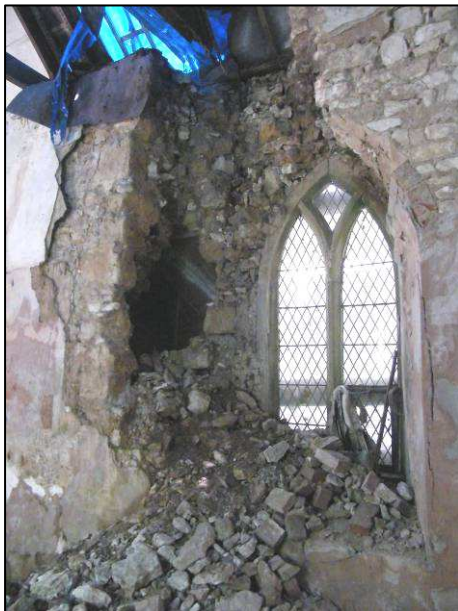
Plate 11 (shot 30): Collapsed rubble core within the south elevation, looking north-northwest

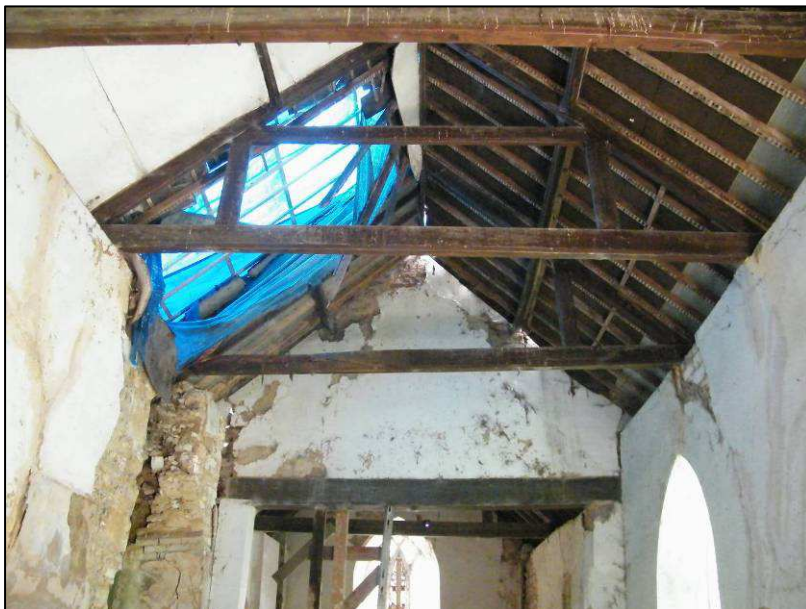
- 9.7 In 1978 the church became redundant and was sold to a private owner. The slate roof was added after this date, and has no architectural significance; indeed the recent repairs to the roof have resulted in a significant proportion of the damage to the building.

Plate 12 (shot 37): Queen post roof structure, looking east

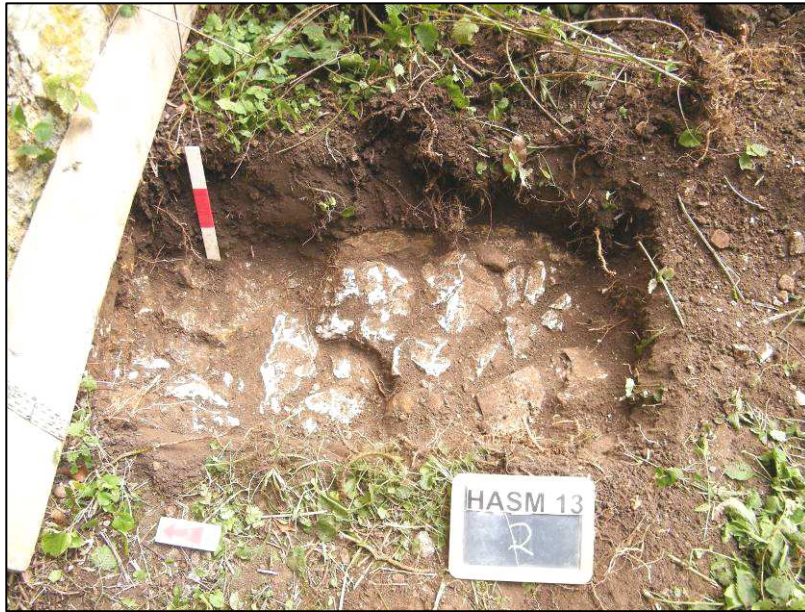
- 8.1 Test Pit 1 abutted the south elevation, east of the main entrance. The topsoil 101, measured approximately 0.20-0.30m in thickness and sealed a north to south aligned cut [104], likely to represent a foundation trench cut for the wall infilling the former south aisle arcade. This was cut through a probable north – south aligned wall, 103, which comprised angular chalk rubble with possible facing stones to the east. This appeared to run beneath and therefore predate

Plate 13 (shot 2): West facing section of Test Pit 1 showing possible wall 103, 0.3m scale

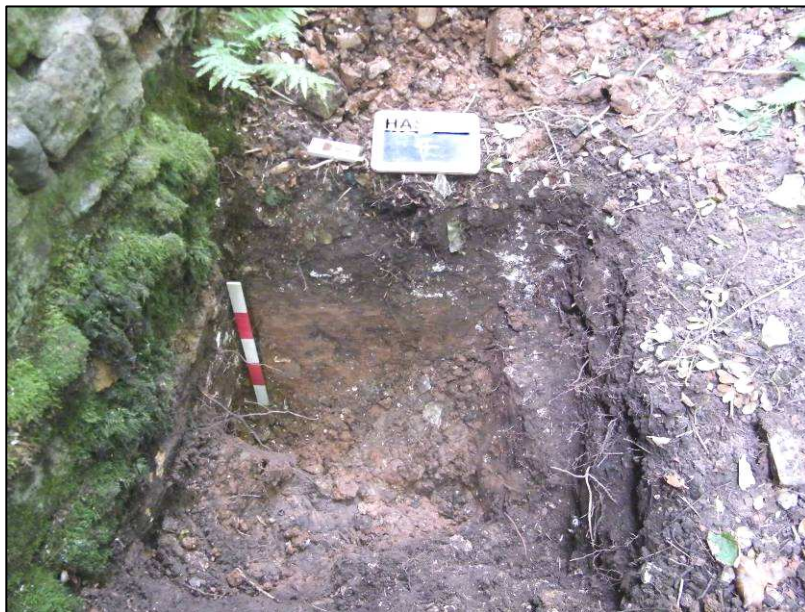
Plate 14 (shot 4): West facing section of Test Pit 2, 0.5m scale

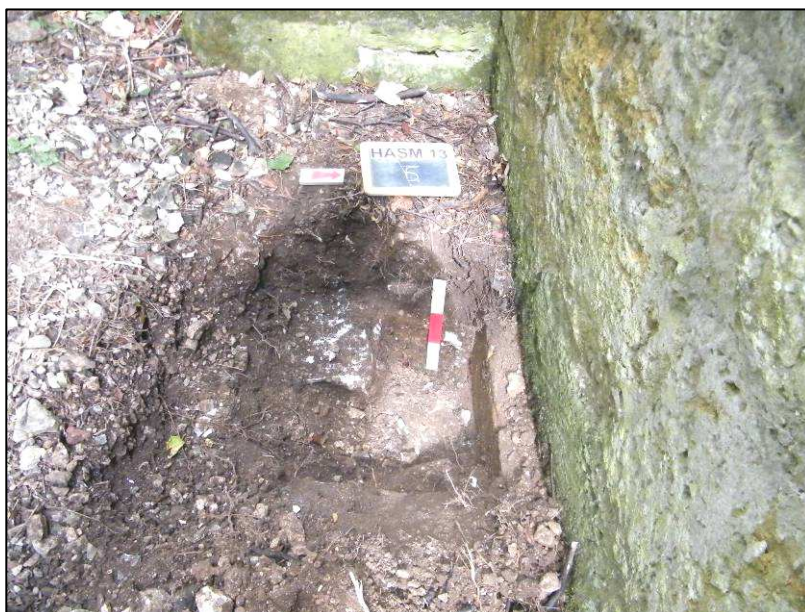
- 8.3 Test Pit 3, located against the west elevation revealed a deposit interpreted as a foundation trench backfill, 301 with frequent large dressed stone fragments. This was sealed by a 0.20m thick topsoil 300 (Plate 15).

Plate 15 (shot 5): South facing section of test pit 3, 0.3m scale
