HISTORIC BUILDING SURVEY REPORT:

NOS 113 AND 115 HIGH STREET AND DOBB'S YARD, CHATTERIS, CAMBRIDGESHIRE

Planning Reference: F/YR16/0247/F
NGR: TL 3909 8660
AAL Site Code: CHHD 17
CHET Event Number: ECB5436
OASIS Reference Number: allenarc1-324532

By
Allen Archaeology Limited
Report Number AAL 2018135

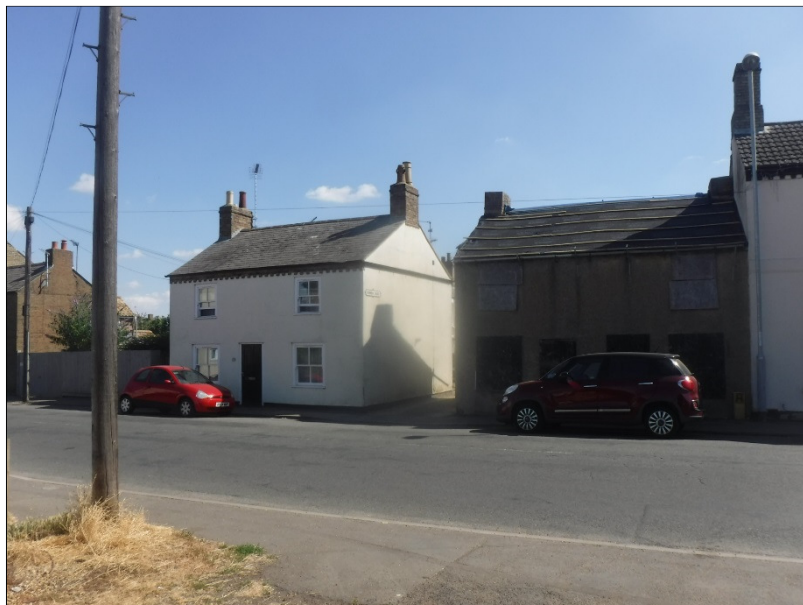
- 7.2 The two narrow fronted two storey cottages measure approximately 7.3m x 6.7m in plan, with each property measuring c.6.6m x 3m (Plate 1). They front on to High Street with two boarded up entrances facing the road. Each cottage has a window on the ground floor and first floor that have also been boarded up. It has a double pitched gabled roof from which the tiles have been removed. A dentil cornice is visible under the eaves. A chimney in red brick protrudes through the apex of the roof on each gable. These may be of later date as the bricks appear to differ from those bricks exposed behind the otherwise rendered façade on the northwest corner of cottage No 115 (Plate 2 and Plate 3).

Plate 1 (shot 40): General view of 113 and 115 to the right of shot, also showing 117 to the left. Looking northeast, 1m scale

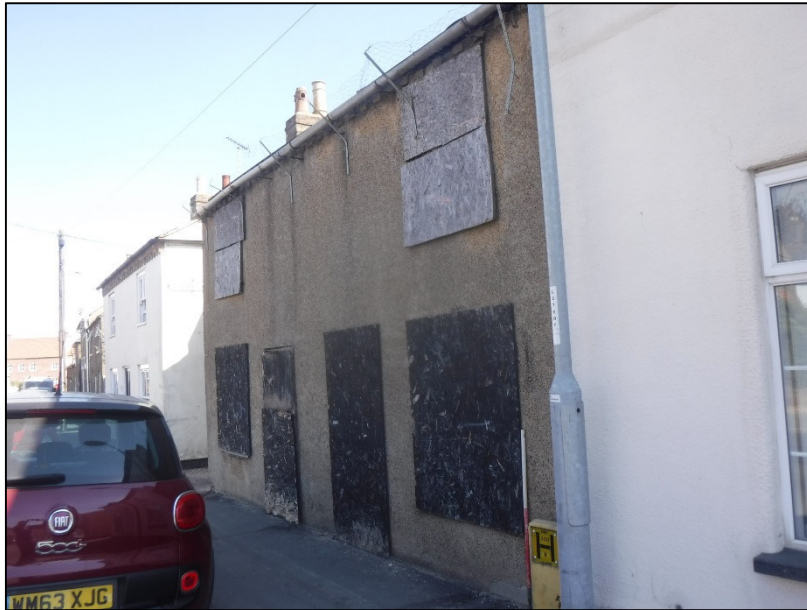
Plate 2 (shot 43): Southwest elevation. Looking northeast, 1m scale

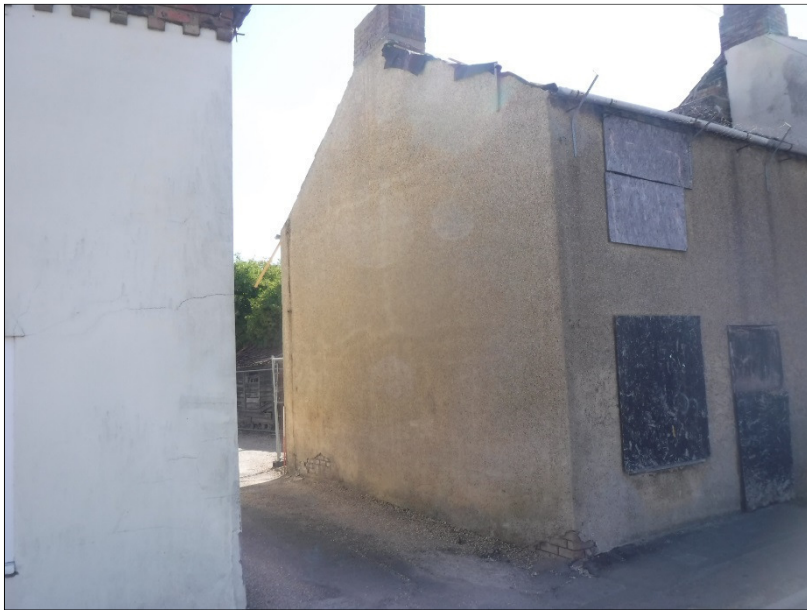
Plate 3 (shot 45): Northwest gable end of 115. Looking southeast, 1m scale

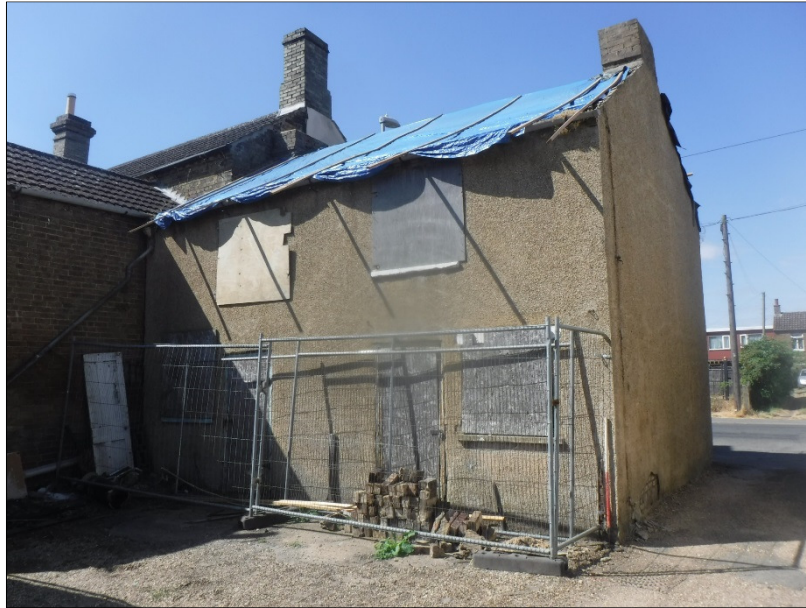
- 7.4 To the rear of the property are a further two entrances and a window to each floor, all openings have been boarded up, hiding any details (Plate 4). The northwest elevation is blind.

Plate 4 (shot 46): Rear, northeast-facing elevation. Looking southwest, 1m scale

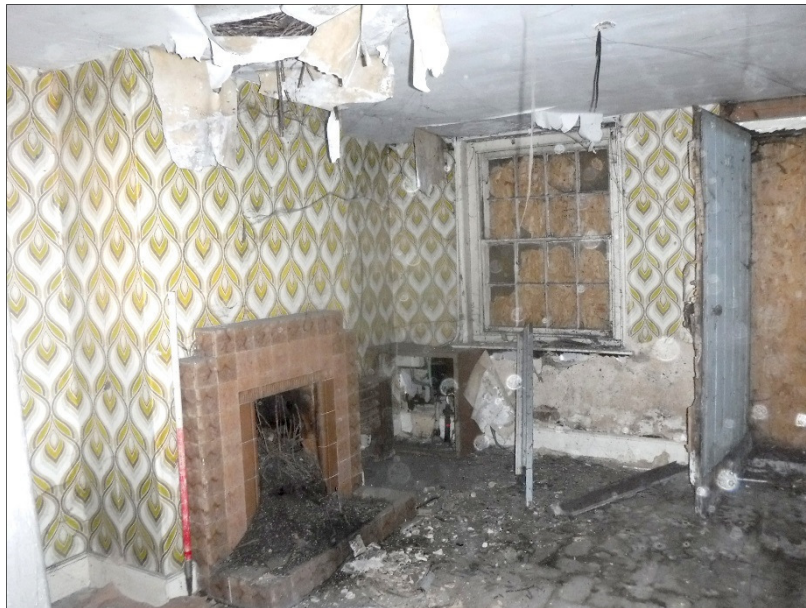
Plate 5 (shot 56): Interior view of No 113 living room. Looking south, 1m scale

- 7.6 The living room (originally the front room), in 113 has retained its pre-1980s décor with a fireplace and chimney breast on the southeast wall (Plate 5). The fireplace has a glazed tile surround of light brown tiles. The openings, both on the southwest elevation consist of a square vertical 8 over 8 sash with thin glazing bars, probably original to the cottage, and a plank and batten door hung on strap hinges (Plate 6). The exterior door is braced but not ledged and therefore shows some wear and tear to the base of the planks. A small hole in the ceiling reveals

what appear to be reeds above the plaster rather than a layer of laths. This is likely to be an original feature. The floor is covered in wooden planks.

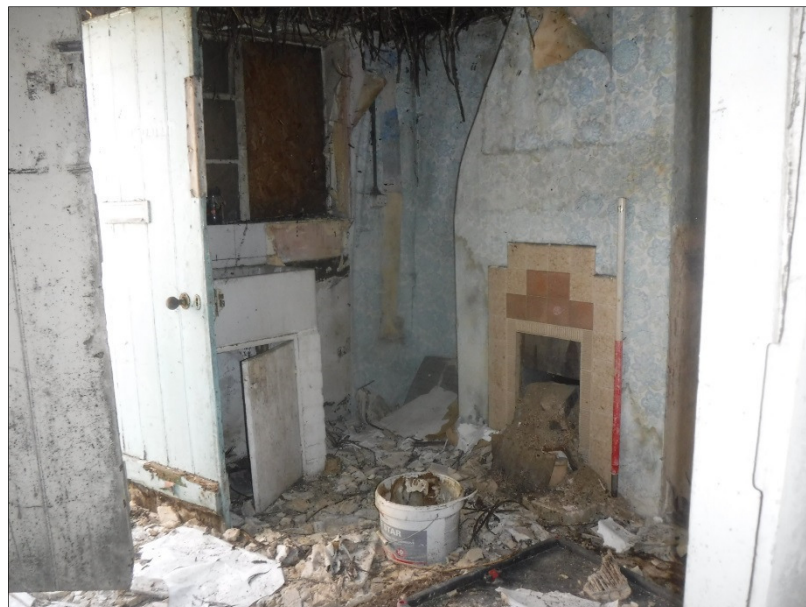
- 7.7 The kitchen, originally the living room, contains a fireplace with cream coloured tile surround on the southeast elevation. A later Belfast sink has been fitted on the northeast elevation and there appears to have been room for an electric cooker (Plate 7). A hole in the ceiling reveals the same reed construction as that in the living room. The staircase is encased by white painted wooden plank panelling with an under stairs cupboard, a plank and batten door is fitted in the access to the stairs (Plate 8).

Plate 7 (shot 51): General view of the kitchen in 113. Looking southeast, 1m scale

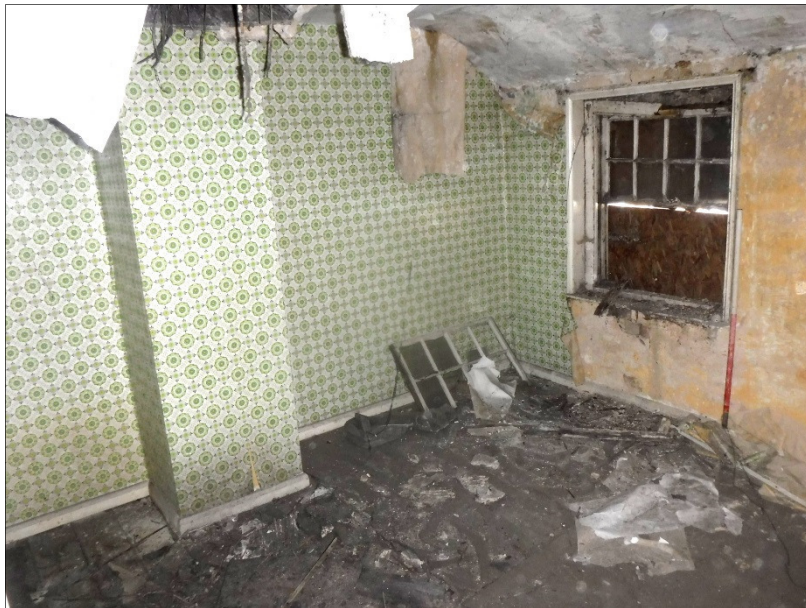
- 7.8 On the first floor are two bedrooms. Beneath the flaking wall paper in the bedroom facing the High Street are plastered walls (Plate 9). The room has a window following the same style as the living room, and it has a plank floor. There is no evidence for a brick or stone hearth near the chimney stack, suggesting this room was unheated and that there was never a fireplace.

Plate 9 (shot 62): Bedroom fronting the High Street in 113. Looking southwest, 1m scale

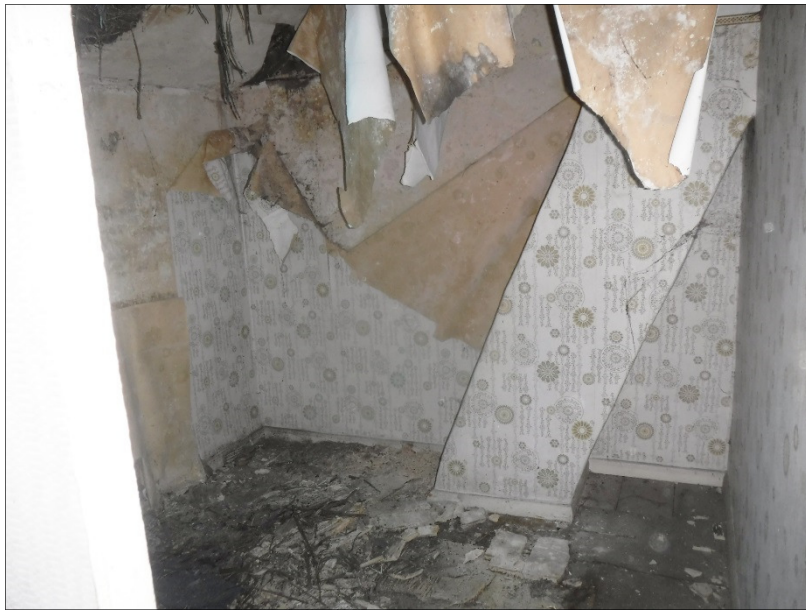
- 7.9 The room to the rear of the property is in a very dilapidated state with wallpaper hanging from the ceiling obscuring much of the view but revealing a further layer of reeds (Plate 10). The plaster has been directly applied to the reeds which are held in place by vertical laths nailed into the rafters.
- 7.10 Rotten floor boards hindered any closer examination of the room. The window differs from that to the front bedroom in being a side-hung casement window with six panels between glazing

Plate 10 (shot 59): Small bedroom to the rear in 113 showing chimney flue. Looking southeast

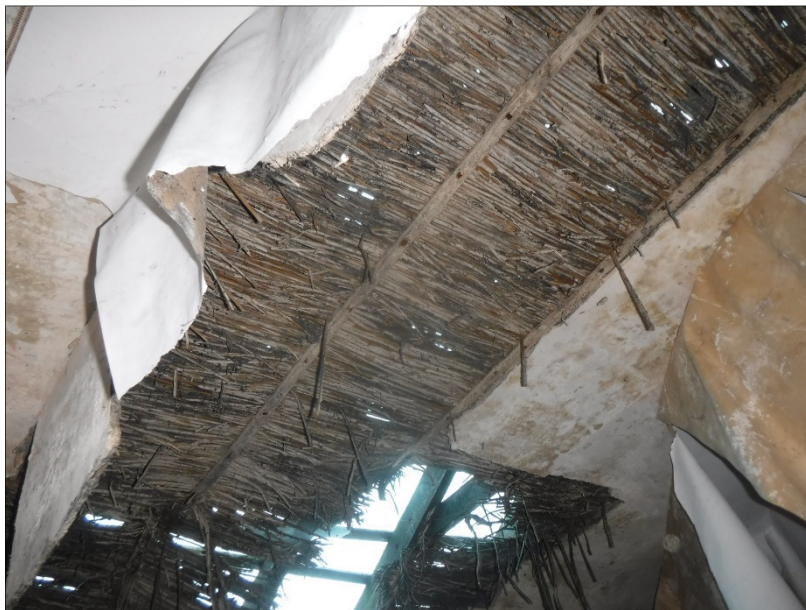
Plate 11 (shot 63): Reed filling above the laths in 113. Looking southeast

- 8.4 Although, 'long straw' has been the tradition of thatching in the east of England (Slocombe 2012), the organic material found in the ceilings above the vertical laths have been interpreted as reeds, as their stems appeared much thicker than that of any straw. As William Millar describes in his book from 1897 'Plastering, plain and decorative', this method of applying plaster to reeds was used in both Lincolnshire and the Cambridgeshire fens for plastered floors in the upper storeys. Gauged plaster was laid on reeds instead of laths as there was plenty of material around (Millar 1998). It is therefore more likely that this is an original feature.

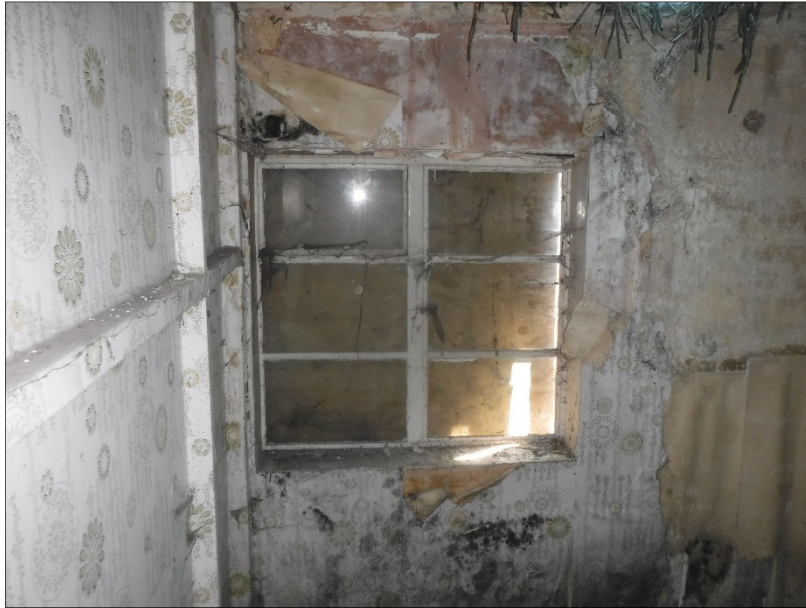
bars, that to the left being fixed, with a top panel opening (Plate 12). The stud wall of the staircase is exposed to the northwest although covered in wall paper. The angled chimney stack again shows no evidence for a former hearth.

Plate 12 (shot 60): Rear bedroom window in 113. Looking northeast

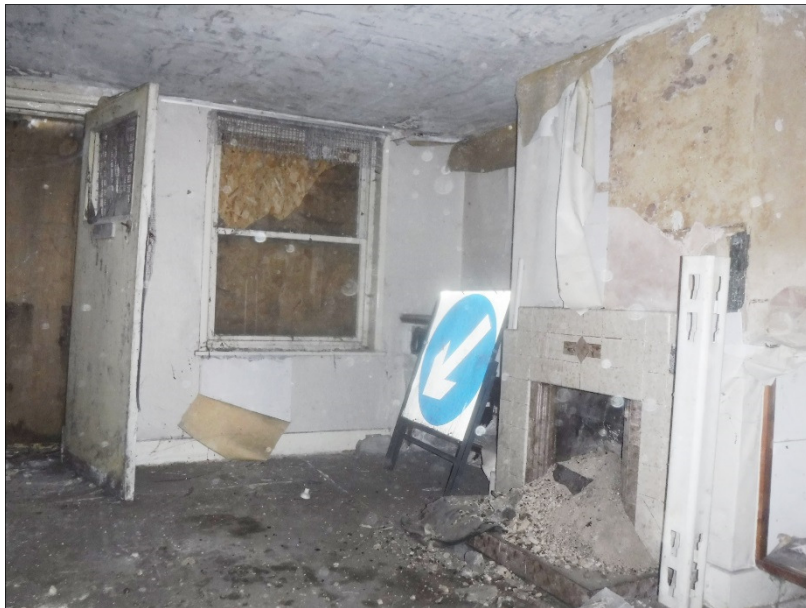
- 7.11 The living room of cottage 115 has a glazed tile surround to the fireplace in art deco style (Plate 13). The tiles are a mix of off-white and brown with a geometrical embellishment to the front. The sash window with large panes and the wooden door on the northwest elevation are later replacements. An inspection hole in the ceiling again reveals reeds above the plaster.

Plate 13 (shot 66): Living room of No 115. Looking northwest

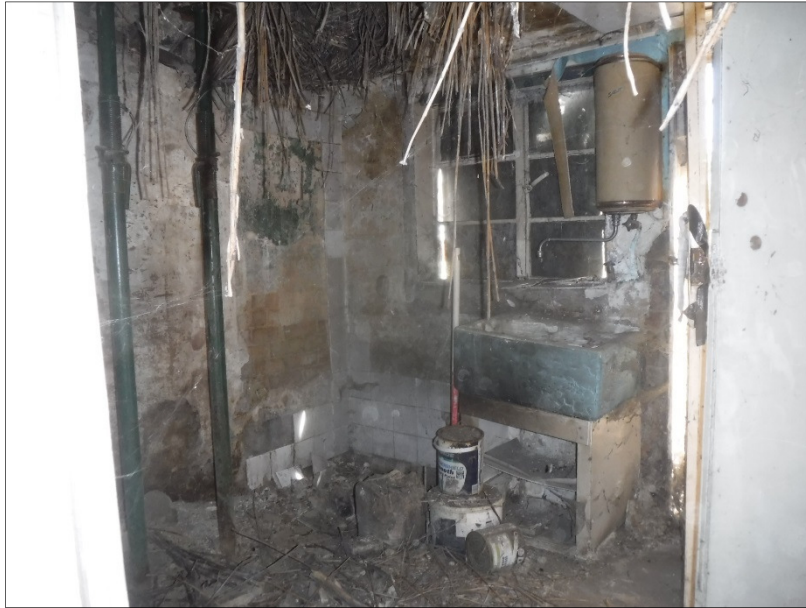
- 7.12 The kitchen is in a very dilapidated state and the upper floor is partially upheld by acrow props (Plate 14). The only features present are a kitchen sink and a water heater: the original fireplace has been removed. Some modern tiles are still attached to the lower part of the northwest and northeast walls. The casement window above the sink is identical to that found in the rear bedroom of 113.

Plate 14 (shot 65): Dilapidated kitchen of No 115. Looking north, 1m scale

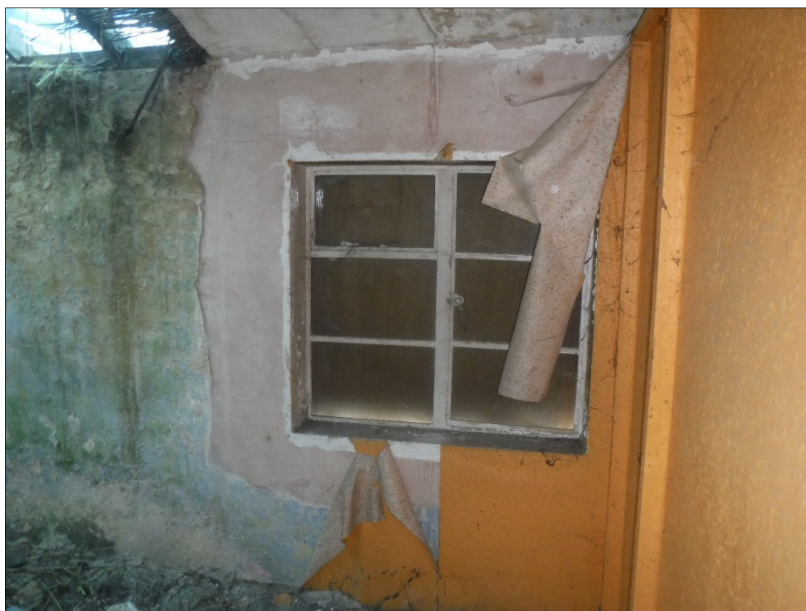
- 7.13 The same style window as in the kitchen is also found in the first floor bedroom to the rear of the property (Plate 15). A hole in the plastered ceiling and roof exposes a part of the wall plate and some common rafters with collar beams (Plate 16). As the floor has been exposed to the weather, the floor boards are in poor condition and the room is not safe to access. The angled chimney breast consists of light red coloured machine-made bricks of a kind also exposed on the interior-facing northwest gable. Again there is no evidence for a fireplace, suggesting the room was always unheated.

Plate 15 (shot 69): Rear bedroom and window. Looking northeast

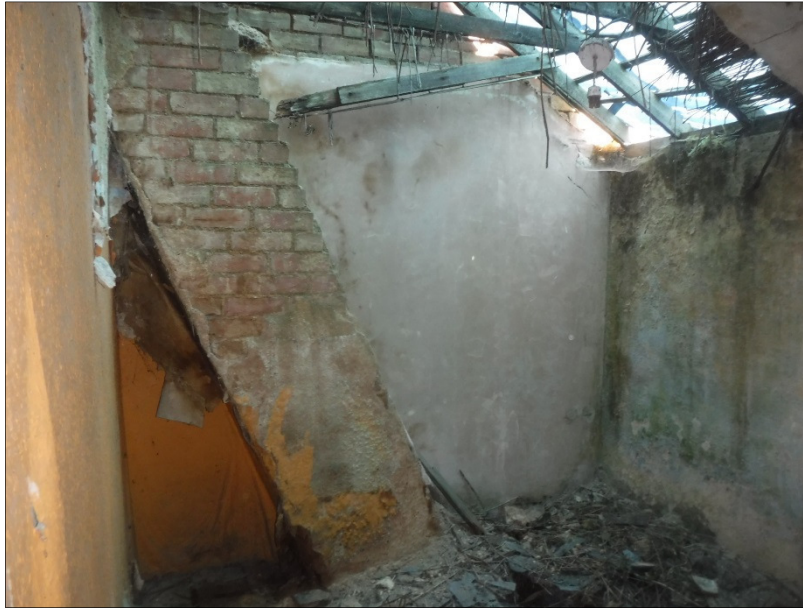
*Plate 16 (shot 68): Dilapidated roof and ceiling. Chimney breast in light red coloured bricks.
Looking north*

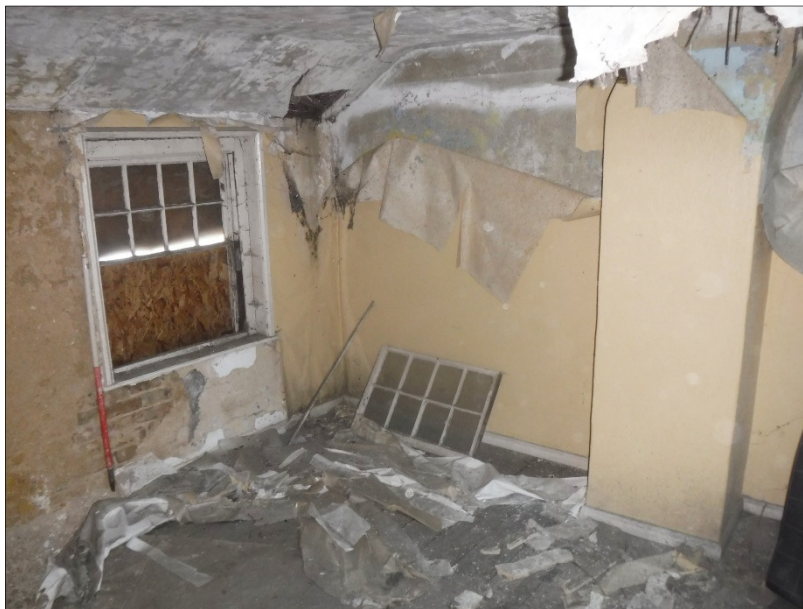
- 7.14 The bedroom fronting the High Street is also in a poor condition. A sash window of the same style as in 113 is only partially in situ, half has been removed and is leaning against the wall (Plate 17). Bricks exposed below the window appear to be cream coloured with a red tinge.
- 7.15 Once again the chimney breast does not appear to have had a fireplace showing no visible hearth within the plank floor, so the room is likely to originally have been unheated.

Plate 17 (shot 71): Bedroom fronting High Street. Looking northwest, 1m scale

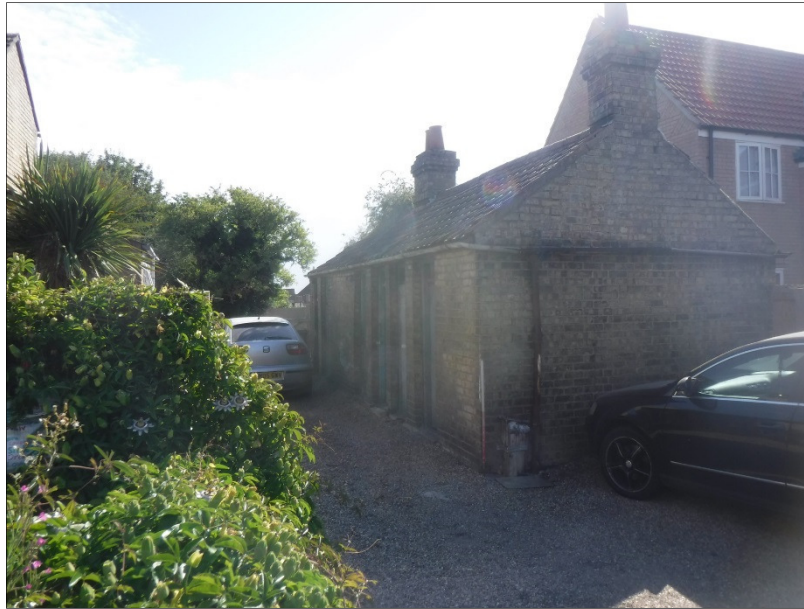
- 7.16 At the northeast end of the site lay a brick outbuilding (Plate 18). The structure is single storey, built in cream coloured bricks with some red and black varieties. It is built in an irregular

Plate 18 (shot 2): General view of the brick outhouse. Looking east, 1m scale

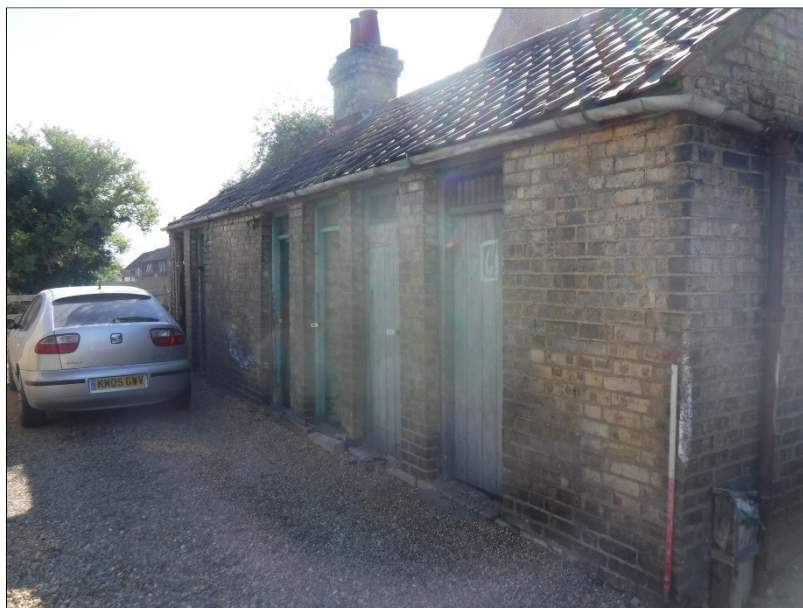
- 7.17 The northwest corner of the structure displays a regular monk bond where the header clearly forms a straight line and is repeated twice (Plate 19). Such regularity is not observed elsewhere. There are six entrances from this elevation leading into six cells/rooms, all fitted with braced plank and batten doors.

Plate 19 (shot 3): Northwest-facing elevation. Looking east, 1m scale

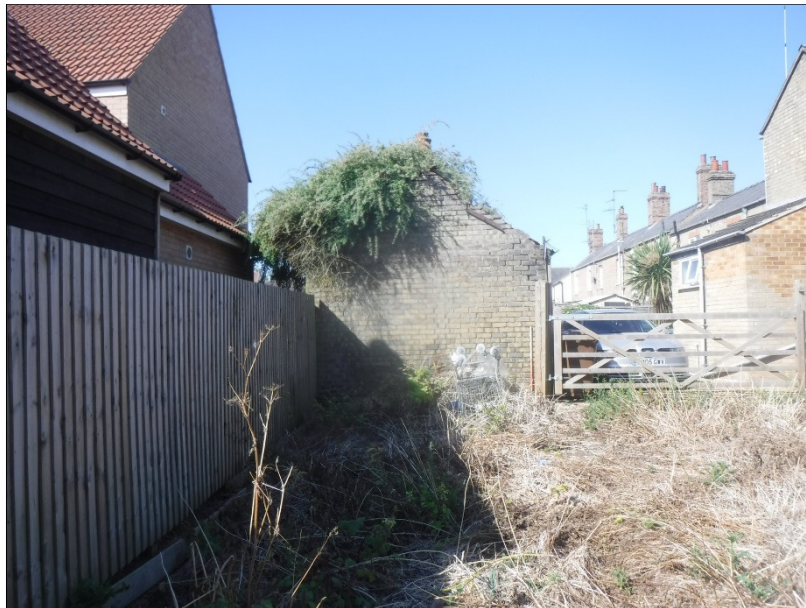
- 7.18 The northeast elevation is partially covered by vegetation that extends through the roof, and by debris on the ground. Apart from one vertical section of headers, the majority of the wall again displays an irregular stretcher bond with occasional header.

Plate 20 (shot 5): Northeast elevation partially covered by vegetation. Looking southwest, 1m scale

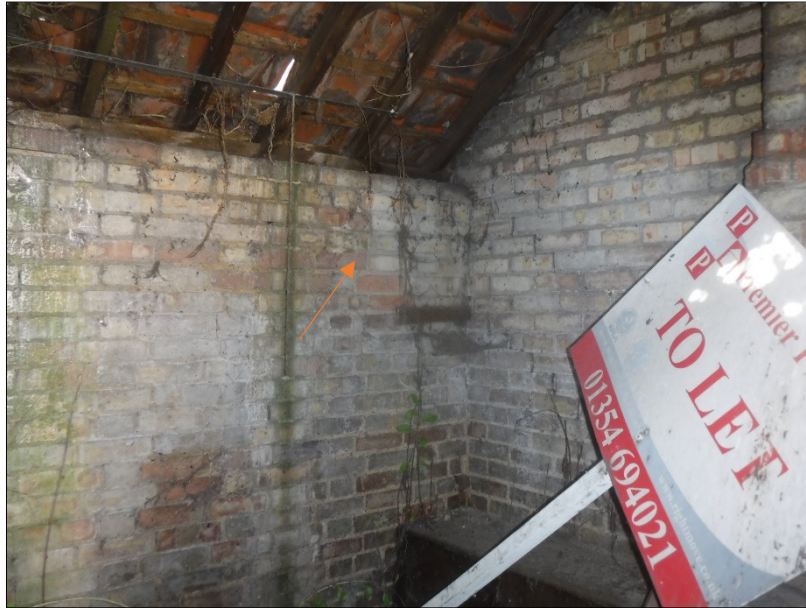
Plate 23 (shot 11): Southeast elevation with monk bond and arrow pointing to possible bricked up opening. Looking south

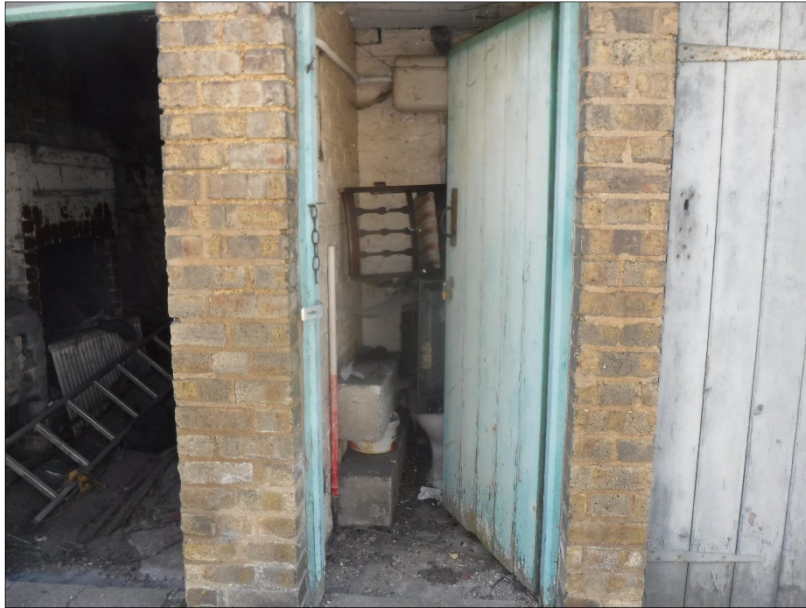
- 7.22 Next to the washhouse is a toilet, there was potentially another toilet next to it, but the room is inaccessible (Plate 27).

Plate 27 (shot 16): Small toilet next to the washroom. Looking southeast, 1m scale

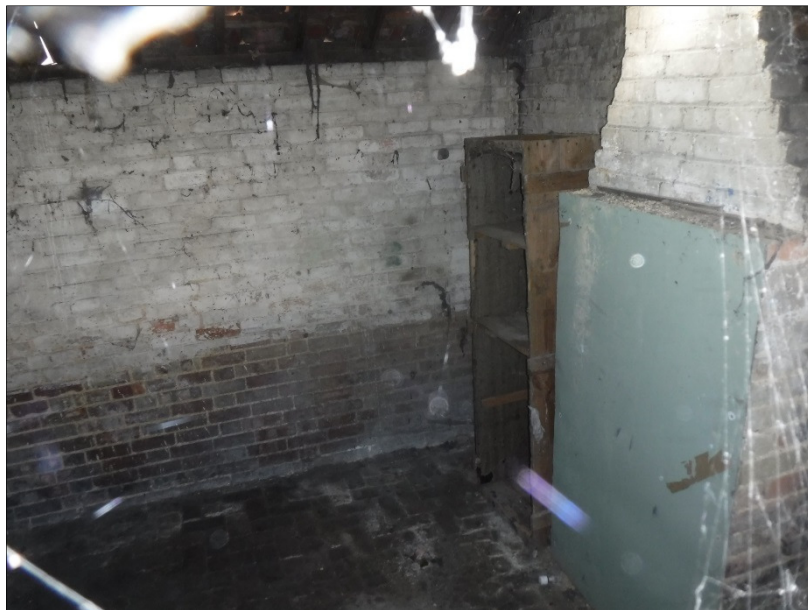
- 7.23 The southernmost room also contains a fireplace, although boarded up, suggesting this room perhaps also functioned as a washroom, but there is no copper visible (Plate 28). The door into this room was jammed which only provided limited views through the ventilation holes at the top of the door. It has a brick floor laid out in a 90^o herringbone style.

Plate 28 (shot 17): General view of the southernmost room. Looking south

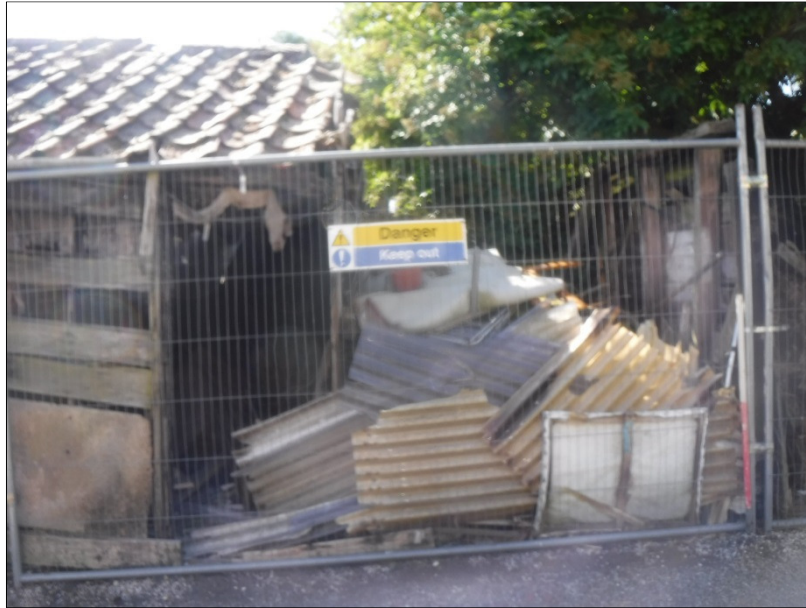
Plate 31 (shot 27): Collapsed area in centre of sheds. Looking southeast, 1m scale

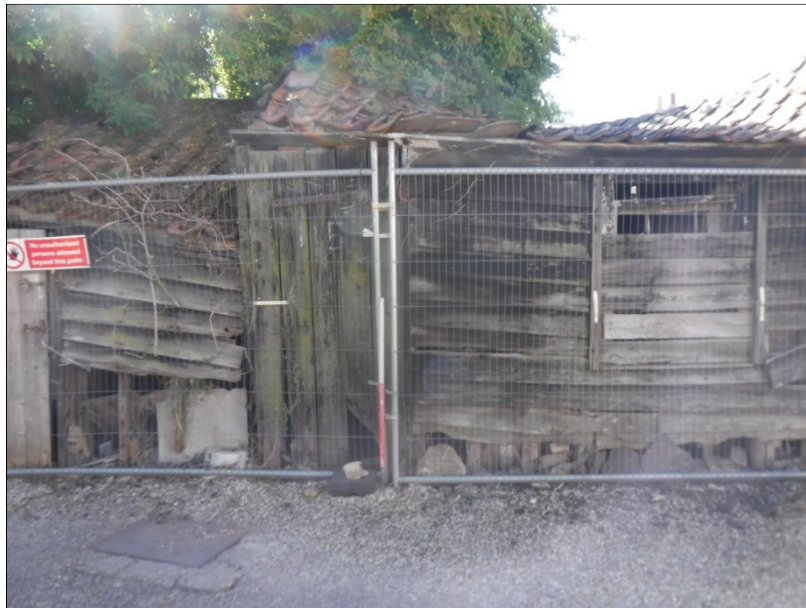
Plate 32 (shot 29): General view of southwestern part of northwest elevation showing poor condition. Looking southeast, 1m scale

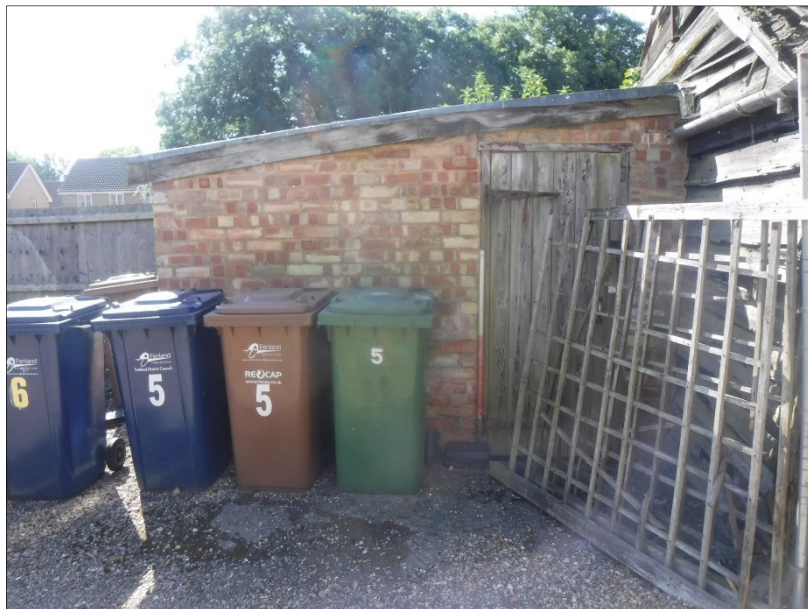
- 7.29 A small brick lean-to in stretcher bond is attached to the northeast end of the wooden sheds, it too is full of assorted rubbish and was not fully accessible (Plate 36 and Plate 37). The lean-to structure has a mono-pitched roof covered in corrugated sheets. A window facing northeast is boarded from the outside. A plank and batten door on strap hinges on the northwest elevation provides the only access. The interior walls are painted, the amount of items stacked in the store offer limited views of the interior.

Plate 36 (shot 22): Brick lean-to. Looking southeast, 1m scale
