**HISTORIC BUILDING SURVEY REPORT:  
MANOR TOP FARM, LACEBY, NORTH EAST LINCOLNSHIRE**

Planning Reference: DM/1028/18/FUL  
NGR: TA 2275 0536  
AAL Site Code: LATF 19  
North-East Lincolnshire Museum Service Accession Code: GRIMS:2019.006  
OASIS Reference Number: allenarc1-351121

By  
Allen Archaeology Ltd  
Report Number AAL 2019064

May 2019

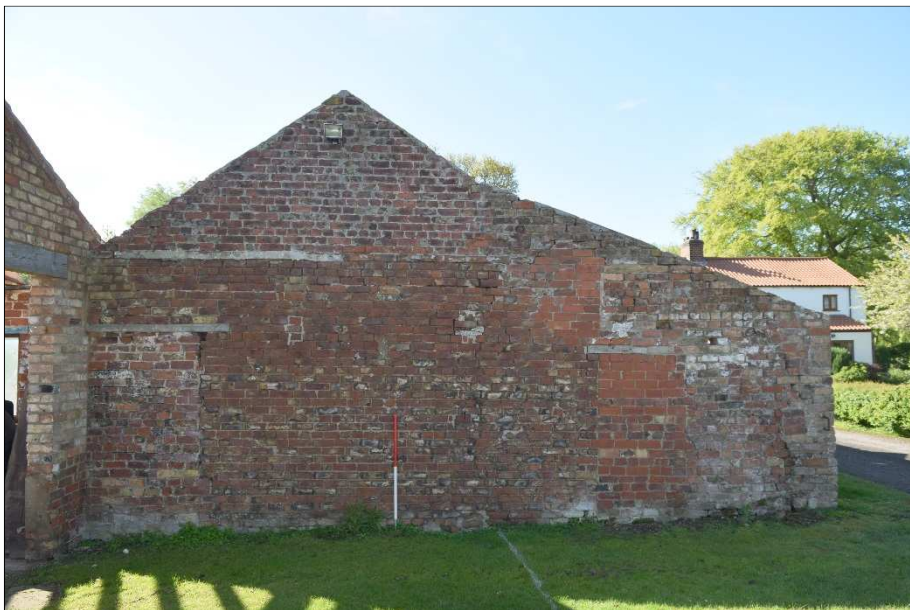
*Plate 3 (shot 4): North-facing elevation showing blocked openings. Looking south, 1m scale*

- 7.3 The north elevation has two blocked up doorways, the one to the east once led to the stable and the west opening into the tack-room situated in the lean-to extension. Between the two blocked up doorways are smaller blocked up ventilation holes or former joist/fixture holes. Concrete rendering may be associated with removed northwest structure.

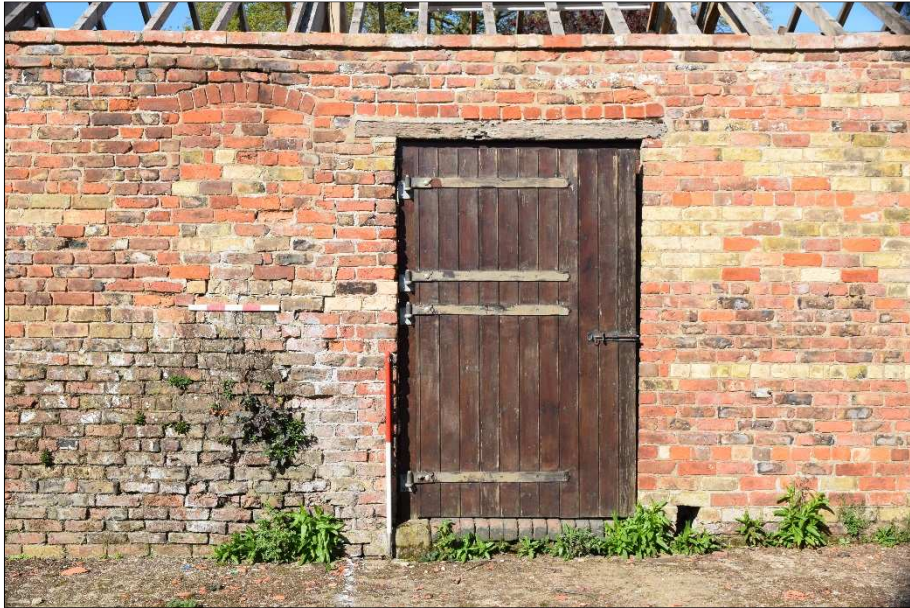
- 7.5 The northernmost stable door has an adjacent blocked up window with segmental arch above, similar to the extant window in the south bay (Plate 5 and Plate 6). The north stable bay also has a drainage hole towards the ground surface, north of the stable door. None was observed on the south side of the door, despite the presence of an internal drainage channel.

*Plate 5 (shot 15): Representative shot of stable door, showing blocked window to the left and a small drain on the right hand side of the door. Looking west, 1m scale*

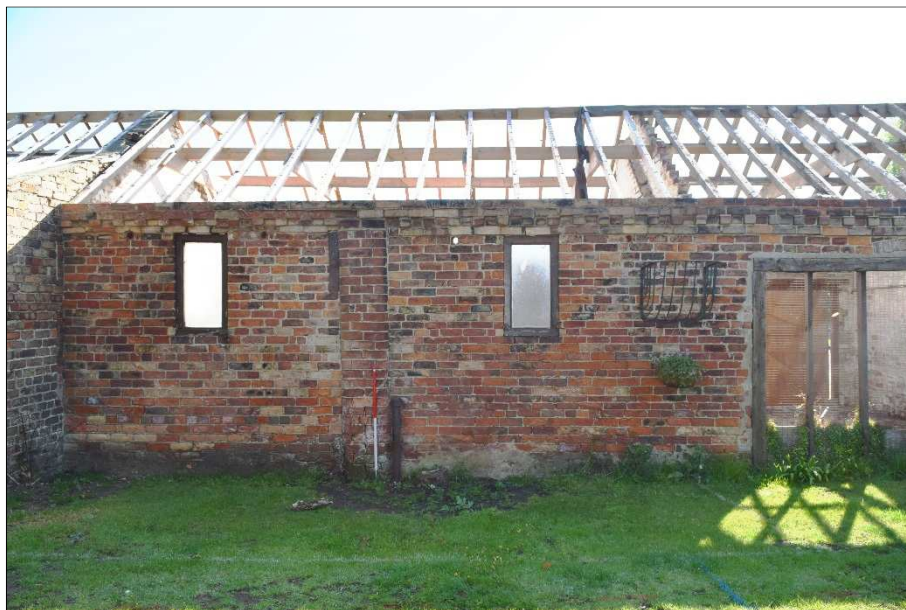
- 7.7 Under the eaves on the west-facing elevation is a dentil course which was not present on the east elevation. The original opening for the potential harness room was originally smaller judging by the segmental arch above the existing opening, which has been widened and fitted with a four field timber frame and netting (Plate 8, Figure 4). A bullnose pilaster is positioned in the centre of the north central bay. The long windows on either side of the pilaster are modern additions and likely to be contemporary with the doors on the structure.
- 7.8 An iron manger north of the large opening was most probably used elsewhere on the farm, it is unlikely to be in situ.

*Plate 8 (shot 7): Former harness room to the right with modified opening and later windows to centre bays. Looking east, 1m scale*

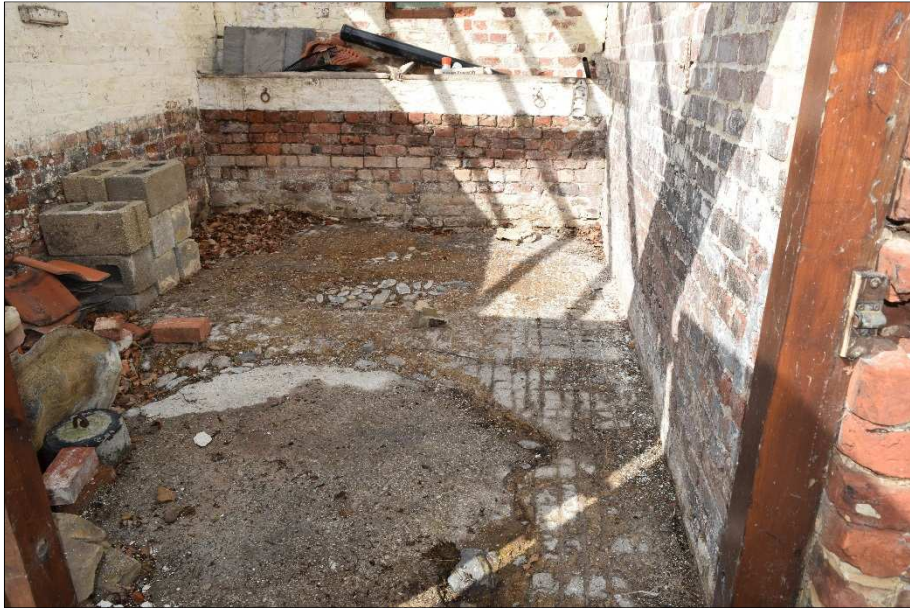
*Plate 19 (shot 46): Worn floor surface in the northern stable box. Looking west*

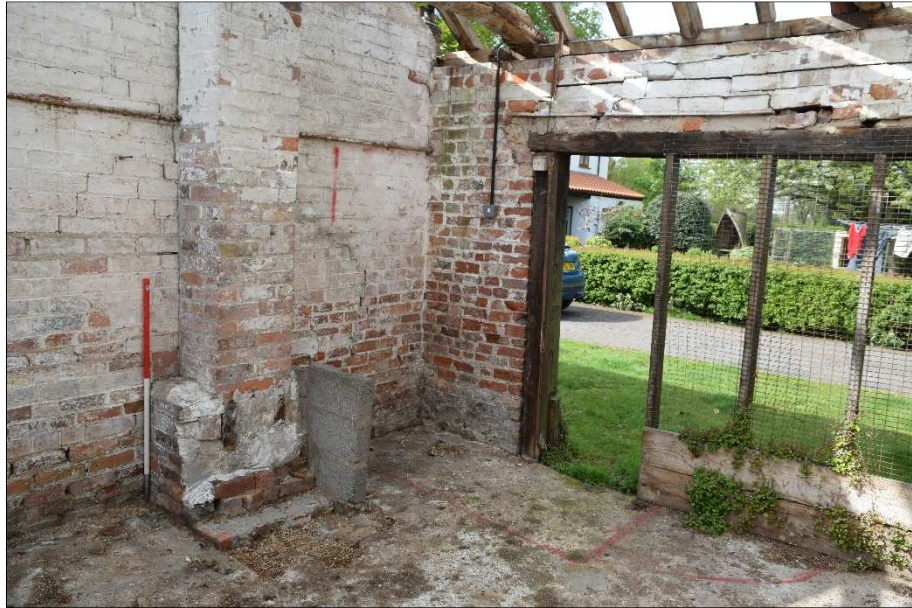
- 7.15 Within the second bay to the south is a room containing a partially demolished fireplace (Plate 23). The fireplace was a feature part of the harness room during the Victorian era, which suggests that was the original function of this room (English Heritage 2013, 36). Apart from a few nails fixed to the wall, there are no saddle-trees as in the tack room in the northwest extension. With the wall to the north being partially rendered it was impossible to judge whether there were traces of any removed fittings on this wall (Plate 24).

*Plate 23 (shot 43): General view of former harness room with partially removed fireplace. Looking southwest, 1m scale*

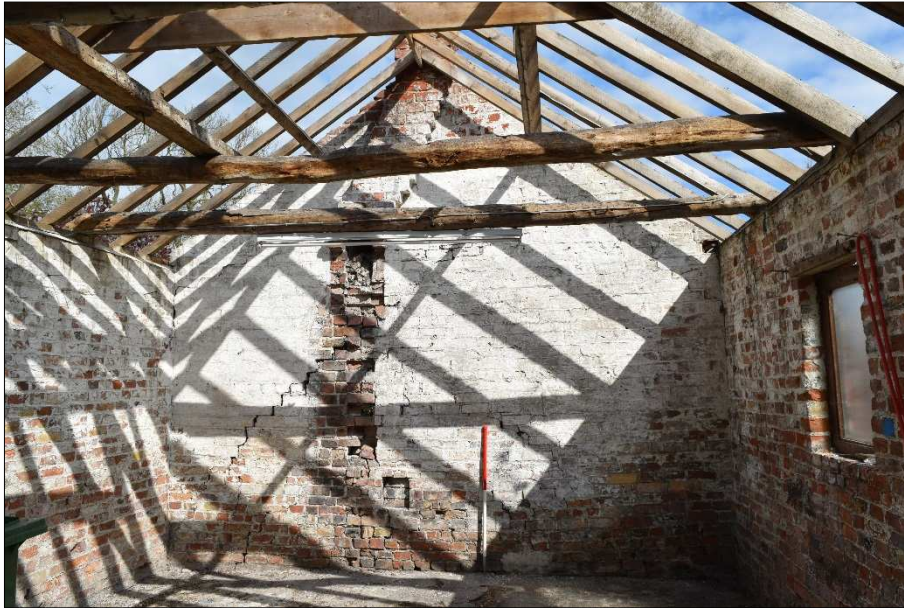
*Plate 25 (shot 47): General view of the southern bay showing partially removed chimney flue.  
Looking north, 1m scale*

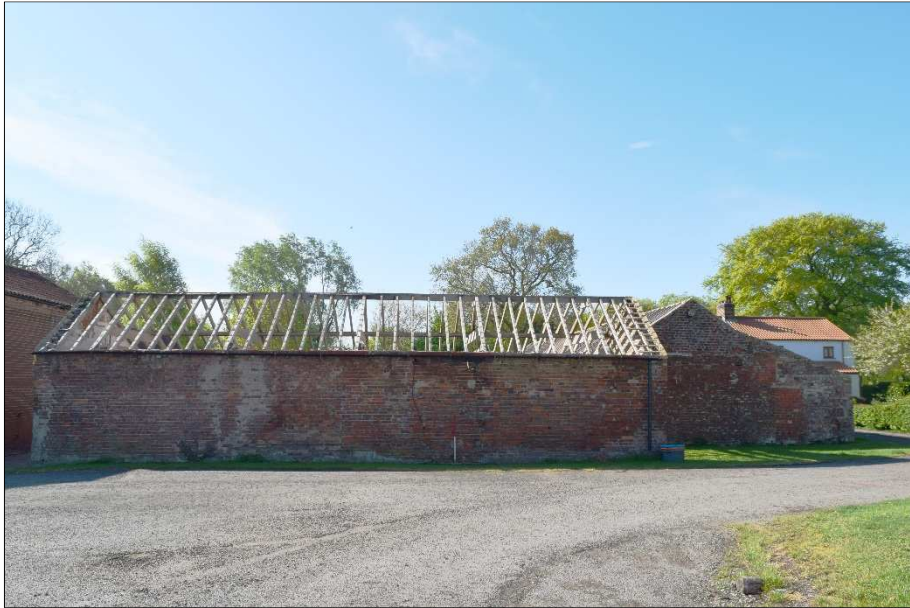
- 7.17 Building B measures approximately 14m long and 5.5m wide. It has a double pitched roof, although any roof covering had been removed prior to the survey. The north-facing elevation largely follows an English Garden Wall bond with three rows of stretchers between each row of headers (Plate 26). Large areas of repair or rebuilding is visible on this elevation. On the south elevation the pattern follows five rows of stretchers between the headers (Plate 27). The bricks on this elevation, again indicate that the structure may have been rebuilt at some point in the history, with worn handmade bricks in the lower part of the wall, and machine-made bricks above.

*Plate 26 (shot 3): North elevation of Building B. looking south, 1m scale*

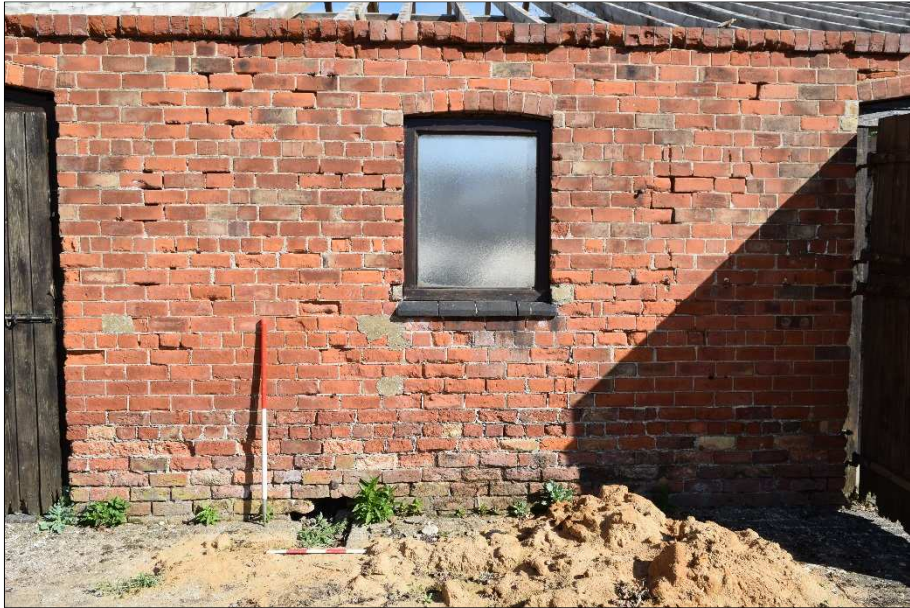
- 7.18 The south elevation has two stable doors with three evenly spaced windows, all in the same style as those on Building A and have retained their original segmental arches. A drainage hole/outlet can be found below the centre window, coming from an internal drainage channel (Plate 28).

*Plate 28 (shot 20): Close up of window and outlet of drain from the stable. Looking north, 1m scale*

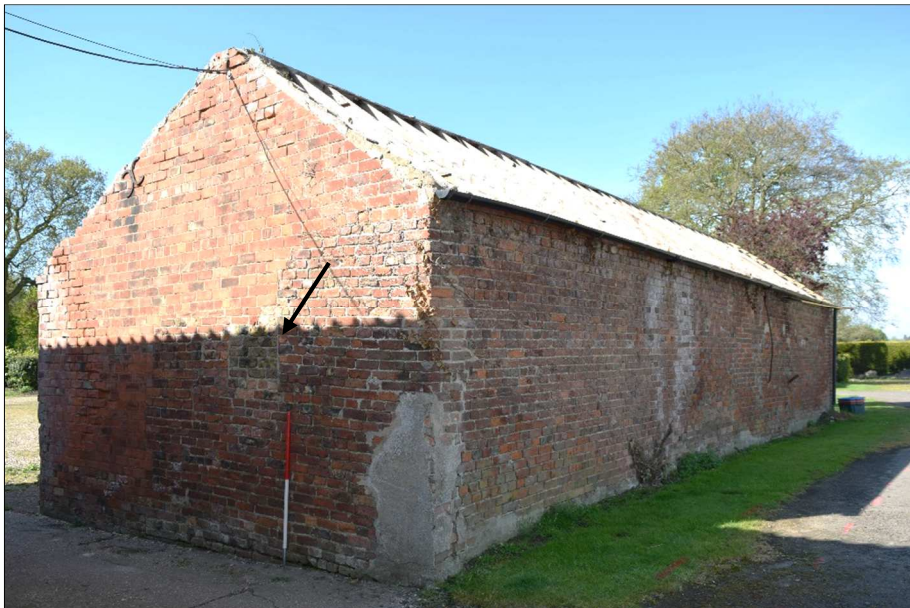
- 7.19 The east elevation also show large areas of repair, as well as evidence for a possible blocked up window (Plate 29).

*Plate 29 (shot 22): East elevation of Building B, with arrow pointing to possible blocked window. Looking southwest, 1m scale*

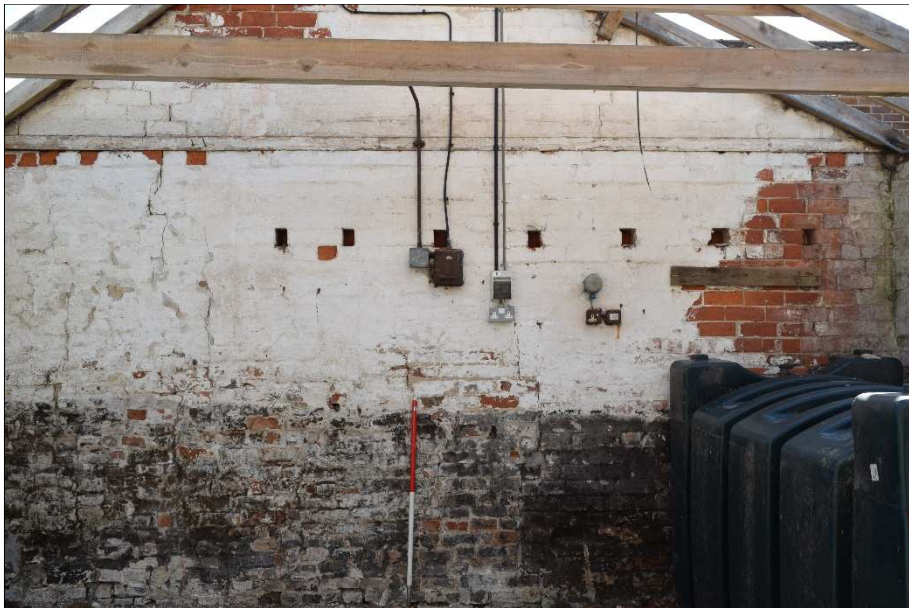
*Plate 31 (shot 24): Holes on the east wall from removed fixtures*

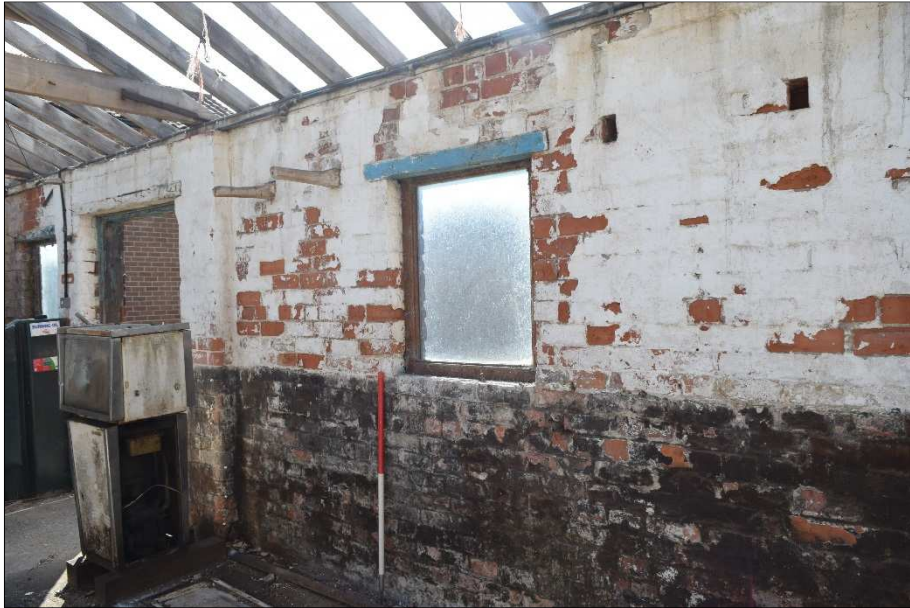
*Plate 32 (shot 26): Saddle-trees on the south wall, notice the holes to the right where these have been removed. Looking southeast, 1m scale*

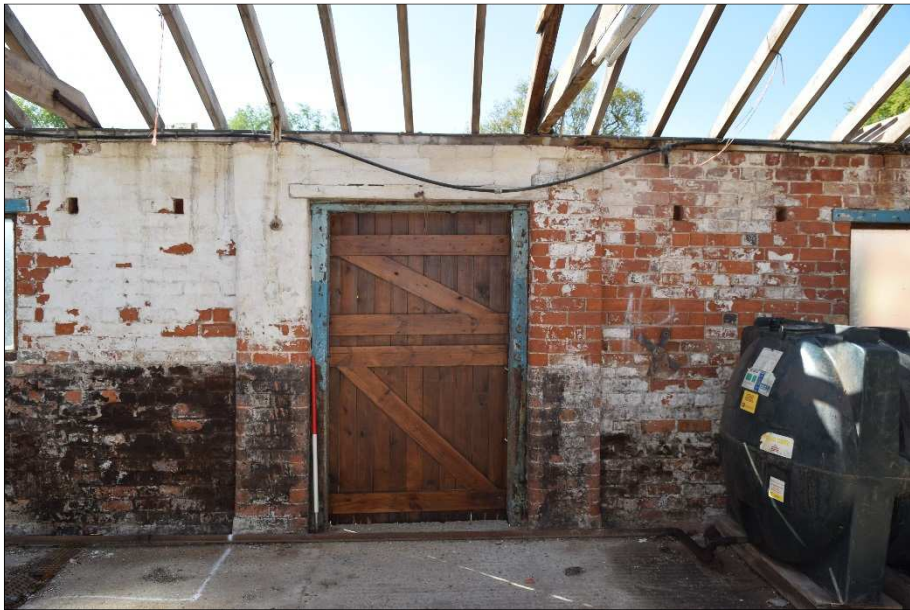
*Plate 33 (shot 27): Representative stable door and removed saddle-tree fixtures on the wall. Looking south, 1m scale*

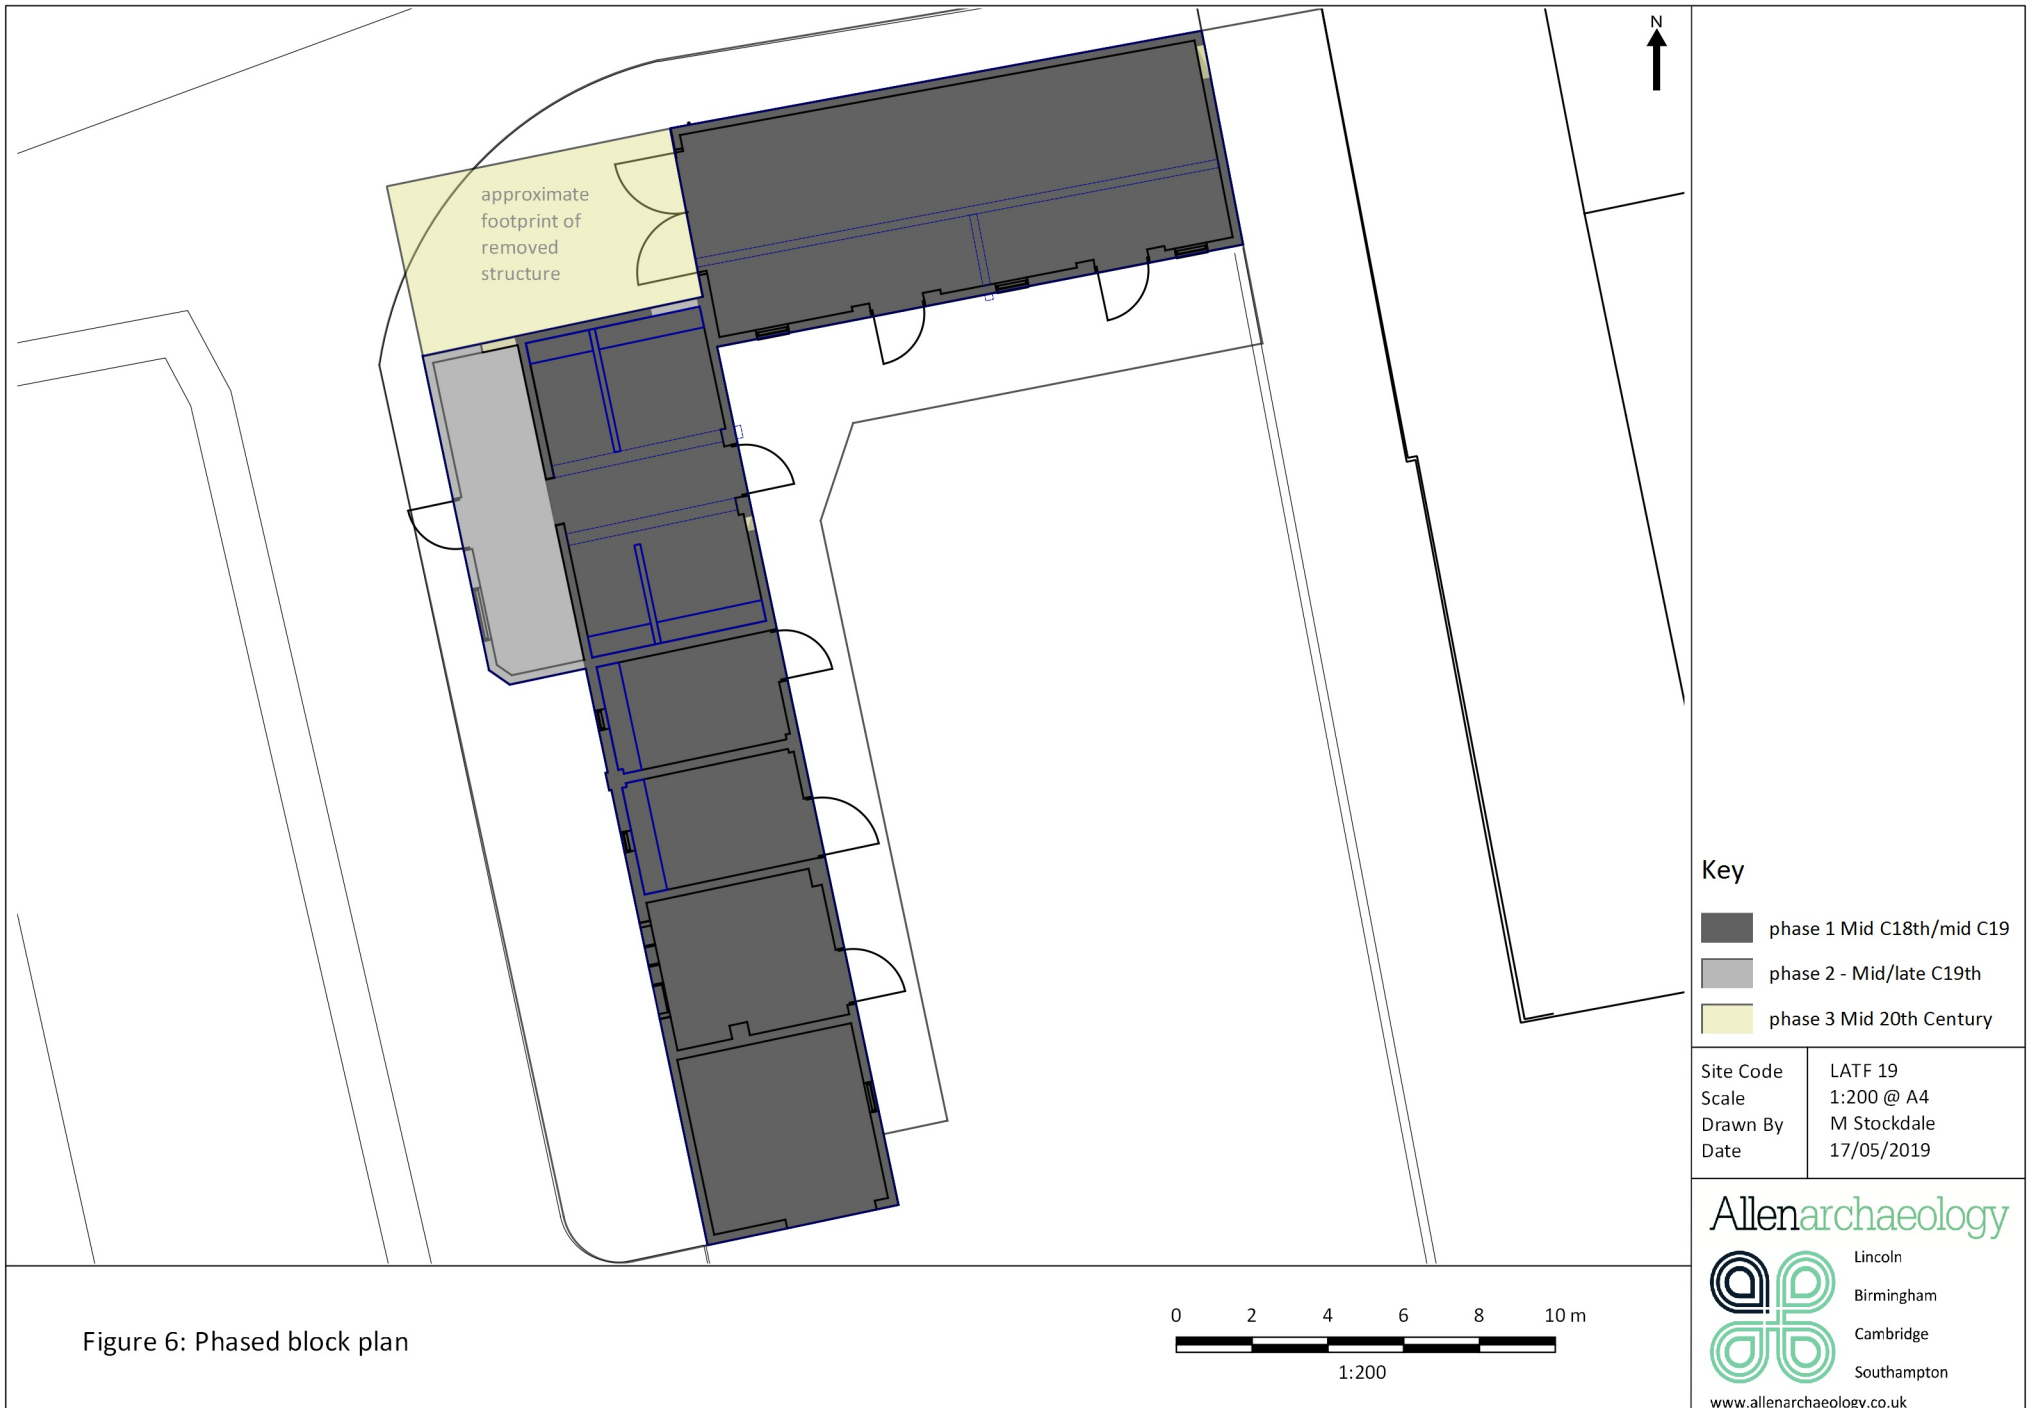
Figure 6: Phased block plan

8.1 The survey suggested three phases of development for stable buildings A and B (Figure 6). The first phase relates to their construction in the mid-18<sup>th</sup> to mid-19<sup>th</sup> century. All structures are visible on the Ordnance Survey map of 1887 (Figure 7). The stables were usually built close to the farmhouse as the horse was a most valued possession. In the early 17<sup>th</sup> century the stables usually abutted the barn or was part of a combination barn (Wade Martins 1991, p35). The survey structures are in close proximity of the farmhouse to the southwest but are set apart from the barn (not part of this survey). Although no stalls were

- 8.3 The second phase in the later part of the 19<sup>th</sup> century relates to the construction of the tack room and northwest extension (Figure 7). According to Mrs Beeton's *Book of household management* from 1861, the harness-room should be kept dry, airy and furnished with a fireplace and boiler, to be able to protect the harness, as well as prepare the mashes for the horses. For this purpose the centre bay would have been ideal. Why a further extension was needed is unknown, perhaps to allow for the tackle to be stored closer to the horses and/or create a larger workspace in the centre bay. It is not impossible that the northern bay was transformed at the same time, creating the stalls along the north and south walls by blocking the doorway to the structure once situated to the north.

- 8.4 The Phase 1 north structure was demolished during the mid-20<sup>th</sup> century (Phase 3), disappearing from the maps between the mid-1950s and the late 1960s. This may have been the point when the large opening on the west elevation of Building B was constructed and potentially when the north doorway of the tack room was blocked and other repairs were made to the façade by partially using later machine-made bricks as opposed to the earlier handmade bricks.
