1.0 Introduction

- 1.1 Allen Archaeological Associates was commissioned by Claystone Developments Limited to undertake a building survey of two ranges of barns that are being modified for residential use at Crossholme Farm on Well Street in Bishop Norton, Lincolnshire (Planning Reference M03/P/1003).
- 1.2 The methodology conforms to a specification prepared by this company (Allen 2007), and the English Heritage guidelines in *Understanding Historic Buildings: A Guide to Good Recording Practice* (English Heritage 2006).
- 1.3 A copy of the building survey report and the full project archive will be submitted to The Collection, Lincoln, for long-term storage, and will be stored under the Museum Accession Number 2007.245.

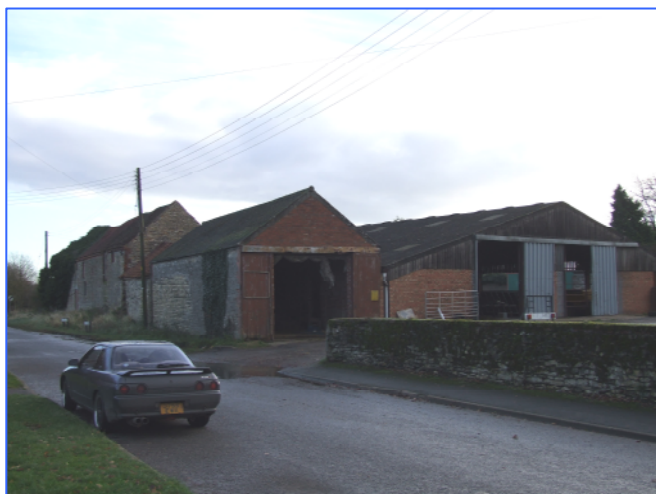
- 5.1.2 **Building 1 (19th to 20th century):** At the west end of the range there is brick and limestone built single storey barn, with a 3.2m wide entrance with a corrugated steel double slide door to the west (plates 1 and 2). The northern external elevation is of bonded limestone and is probably original, while the interior is faced with brick. The southern and western walls are also of English Garden Wall bond brickwork and are likely to be later modifications of 20th century date. The double pitched roof is a modern alteration, being constructed of corrugated asbestos sheeting and incorporating four sky-lights along its southern side. The south elevation has two doorways inserted that give access to a later breeze block building (Building 1b). The original function of the building is not clear, as the west and south elevations have been completely replaced, although it may have been used as a store.

Plate 1: The north range of buildings, and the covered crew yard, looking south-east.

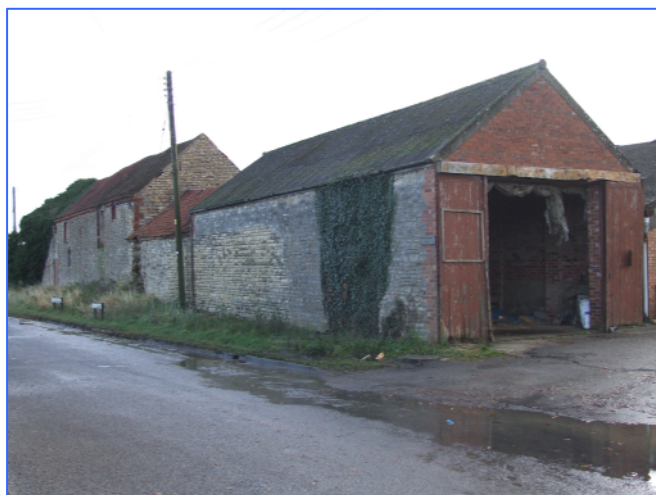
Plate 2: The north range of buildings, looking south-east from the west end of Building 1.

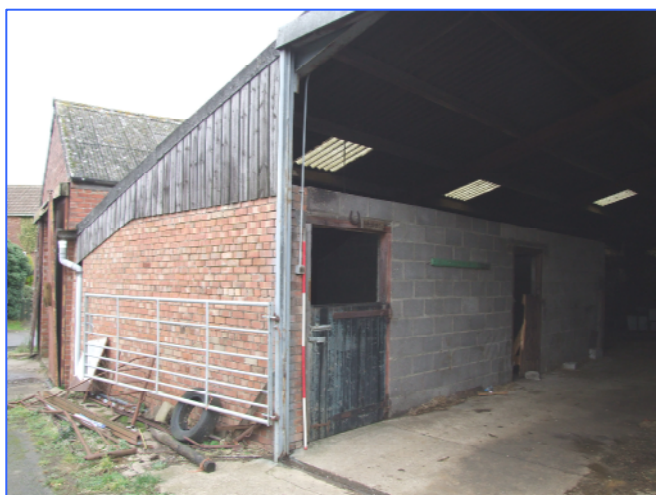
- 5.1.3 The stables (Building 1b) are of 20th century construction (plate 3). The walls of the stables are of breeze block construction. They do not have their own roof, but are covered by the corrugated steel roof of the covered crew yard, and as such may be contemporary with the roofing of the crew yard. The western-most stable measures 5.8m by 4.2m, and the eastern stable measures 5m by 4.8m. Each stable has access to the crew yard by doors on their south-west corners, and each has access to Building 1a to the north through a wooden door.

Plate 3: Stable block 1b, on the southern elevation of building 1. Looking north-north-east.

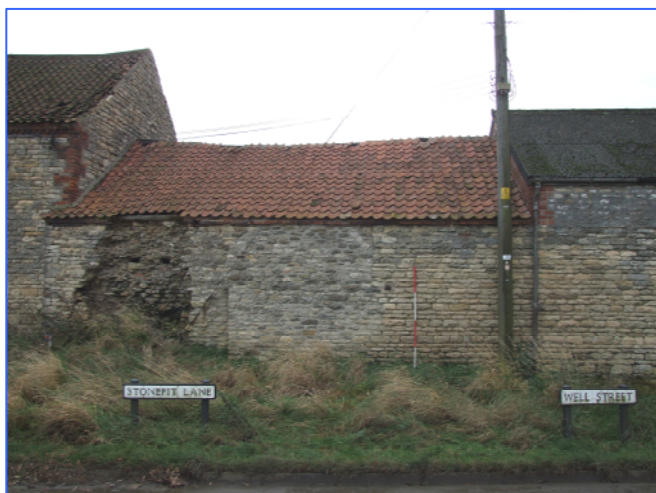
Plate 4: North elevation of Building 2, showing exposed rubble core and blocked doorway. Looking south.

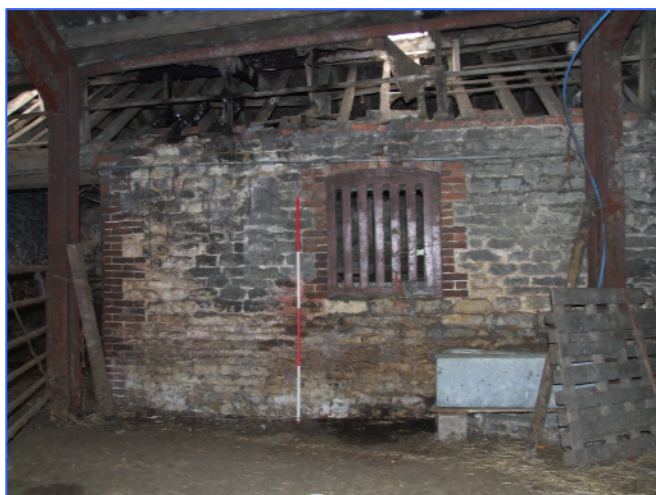
- 5.1.5 Access to the barn is gained through a 2.50m wide entrance in the south elevation, with decorative saw tooth brickwork along both sides. It is opposed by a doorway in the north elevation, blocked in with stone. There is a single vented window measuring 1m wide and 0.98m high located 2.2m to the east of the entrance in the south elevation. The window has a wooden lintel on the internal elevation with a tile inset at its base. Externally, the window is framed by saw tooth brickwork and a brick segmental arch. The window itself has a wooden frame enclosing five vertical wooden slats. The saw tooth brickwork around the window and entrance is likely to be an original decorative feature of 19th century date (plate 5).

Plate 5: South elevation of Building 2, showing the window and part of the entrance to the west. The saw tooth brickwork is likely to be an original feature.

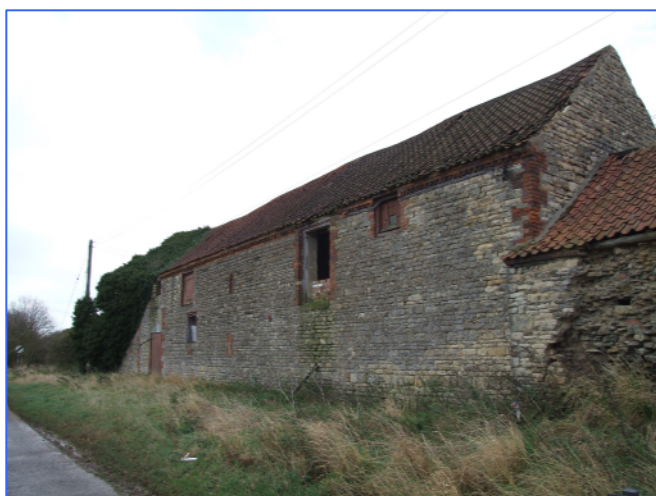
- 5.1.7 **Building 3 (late 18th to 19th century):** This is the largest of the buildings surveyed, measuring 27.2m east to west and 6.8m north to south. The barn is of limestone with saw tooth brick quoins and brick doorway and window surrounds. There are ventilation slits framed in brick at both ground floor and first floor level, several of which have been blocked, which suggests the building was used in the storage and processing of crops. The double pitched pan tile roof is supported by a course of dog tooth brickwork directly below the roof line (plate 6). There are a series of doorways, windows and pitching holes in the north and south elevations, representing changing functions of the building over time.

Plate 6: North elevation of Building 3, looking south-east.

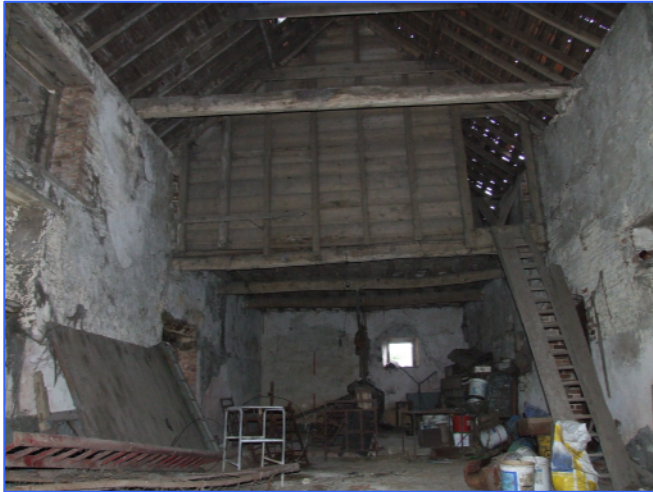
- 5.1.8 The ground floor is divided into two bays, 3a and 3b. 3a is the larger area at c.17.4m by 5.8m, with a wooden hay loft with ladder access (plate 7) at its eastern end. The two bays are divided by a brick partition wall in English Garden Wall Bond, which is a probable later addition. The brick partition wall incorporates a wide and low brick arched doorway 3m wide and 1.75m high at its highest point. The width of the arch is likely to have been to allow access for carts. There is a ladder providing access to the upper storey to the west of the partition wall (plate 8), although the hayloft was not safe to enter.

Plate 7: East end of Building 3, showing the wooden hayloft. Looking east.

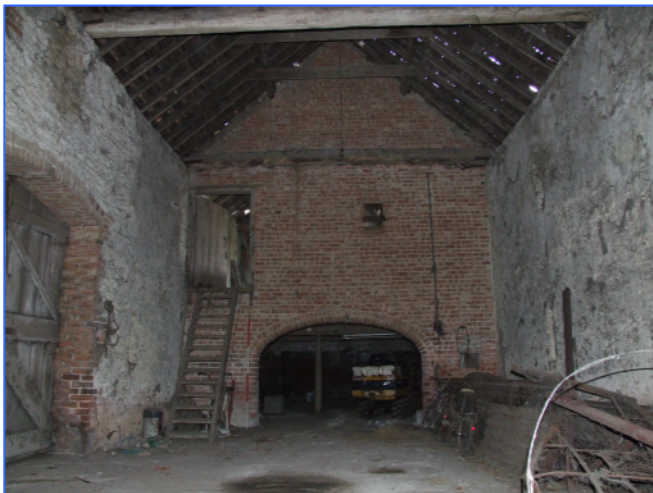
Plate 8: Brick partition wall in Building 3, looking west.

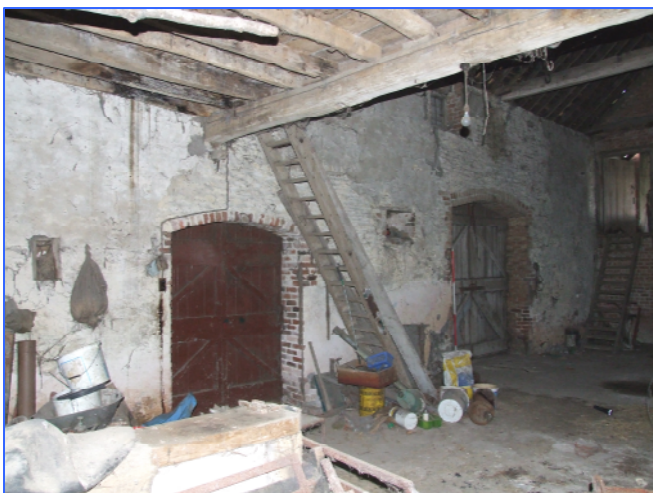
- 5.1.9 3a has two doors in its southern elevation, one c.2.6m wide and one 1.45m wide, both set into a brick framed opening with a segmental arch and saw tooth brickwork (plate 9). A wooden lintel towards the east end of the elevation may define another blocked doorway, although the elevation has been whitewashed and is difficult to discern. Its position in the south elevation is mirrored in the north elevation by another blocked doorway, defined by saw tooth brickwork and a wooden lintel, into which a smaller door has been inserted at a later date (plate 10). These two blocked openings may represent original entrances either side of a former threshing floor, suggesting that the existing doorways represent later insertions.

Plate 9: Doors in south elevation of Building 3, looking north-east.

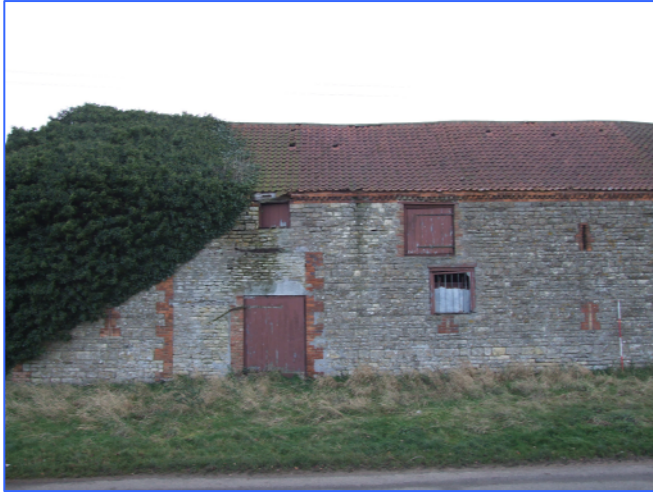
- 5.1.10 There is a window to the west of the blocked doorway in the northern elevation, set in a wooden frame with five vertical steel bars. This is a later insertion of unknown date, as it has truncated a ventilation slit, which is an original feature of the building (plate 10).

Plate 10: North elevation of Building 3, east end. Note the blocked doorway defined by the saw tooth brickwork with smaller door inserted. The window to the west truncates a ventilation slit. Looking south.

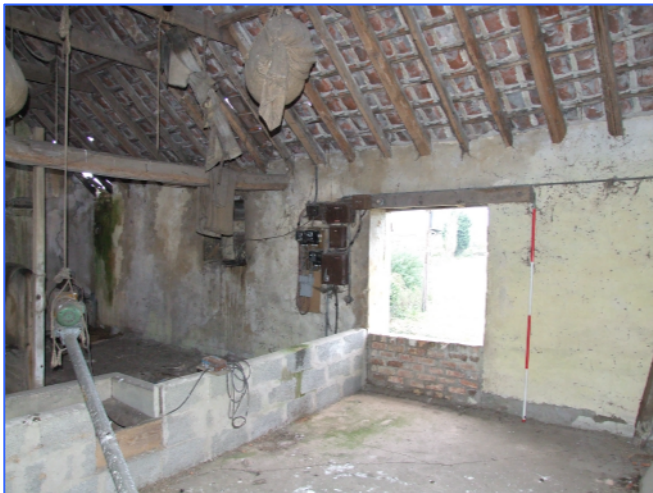
- 5.1.11 The area enclosed by the partition wall (3b) measures 10m long and 5.8m wide. The only access to 3b is by the low arch in the brick partition wall which forms its eastern elevation. There are two opposing openings at first floor height. The entrance in the southern wall has been blocked in with bricks, and the entrance in the north wall has been partially blocked (plate 6), reflecting a change in the function of the building. There is another shuttered pitching hole at the west end of the north elevation. Until recently it appears that grain has been brought into the building through one of the two pitching holes in the north elevation, to be stored in a breeze block bay

in the eastern part of the room, from which it is pumped through an opening to the ground floor where it is put into grain sacks (plate 11).

Plate 11: Loading hatch in north wall of Building 3, and breeze block storage bay. The chute in the middle of the breeze block wall allows grain to poured into sacks on the ground floor. Looking north-west.

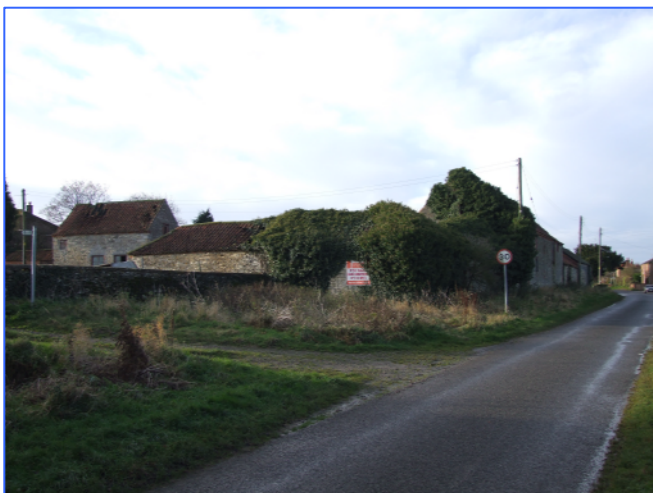
- 5.2.1 **Building 4 (19th to 20th century):** A block of buildings comprising cattle pens and stables enclose the north and east sides of an open yard to the east of Building 3 and the covered crew yard (plate 12).

Plate 12: East range of the barn complex looking west-south-west. Building 4 is in the foreground, and largely obscured by ivy, with Building 5 to the left of the shot in the background.

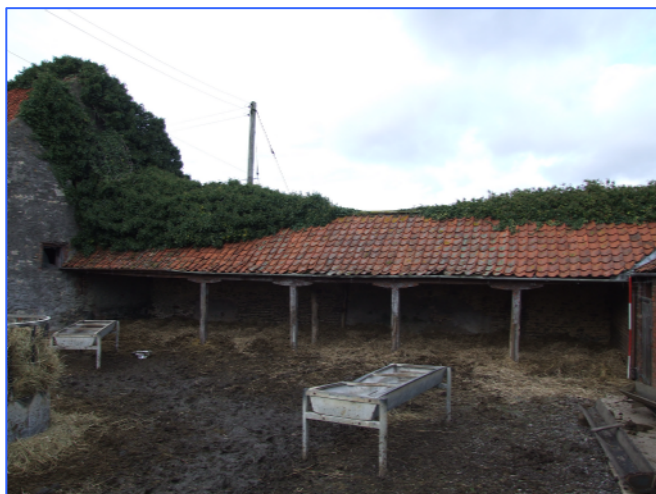
- 5.2.2 On the north side of the yard is Building 4a, a long, narrow building, until recently used as a shelter shed for cattle, which is likely to represent its original function (plate 13) (see Brunskill 2000). The north and east elevations are constructed of bonded limestone, and largely obscured by ivy. The building has a pitched pan tile roof and is supported by wooden beams over four square wooden posts on the south elevation, which is otherwise open. The internal area of the cattle pens measures 14.2m along its east-west axis and 3.2m along its north-south axis. To the east of the brick partition wall is a stable block (Building 4b - d).

Plate 13: South elevation of cattle shed 4a, looking north-north-west. The eastern gable end of Building 3 is visible at the left of the shot.

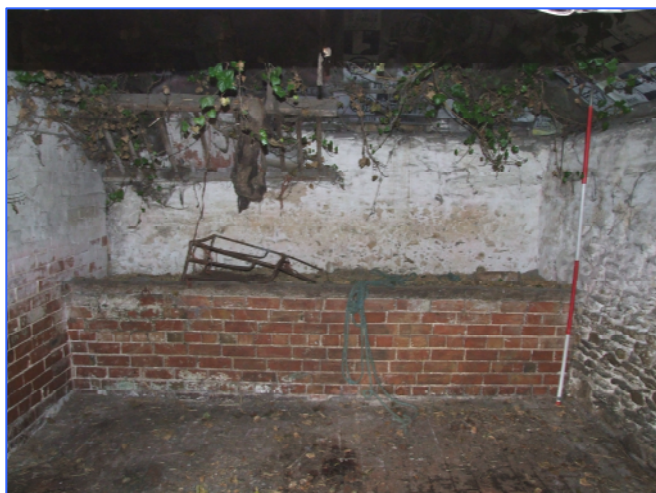
- 5.2.4 The building is divided into three rooms, 4b, 4c and 4d. The northern-most block (4b), has an internal area of 5.4m by 3.8m. A brick trough measuring 3.8m long and 0.80m (up to eight courses) high was recorded against the north wall (plate 16). An east-west aligned brick partition wall bounded a second stable (Building 4c) to the south. The internal area of this stable measured 5m along its north - south axis and 3.4m along its east - west axis. This stable also had a brick trough, on its north wall which measured 3.4m wide and 0.75m (up to six brick courses) high. A third brick partition wall bounded the stable (Building 4d) to the south. This stable has an internal area of 4.6m by 4.3m and did not have a feeding trough.

Plate 16: Brick feeding trough in stable block 4b, looking north.

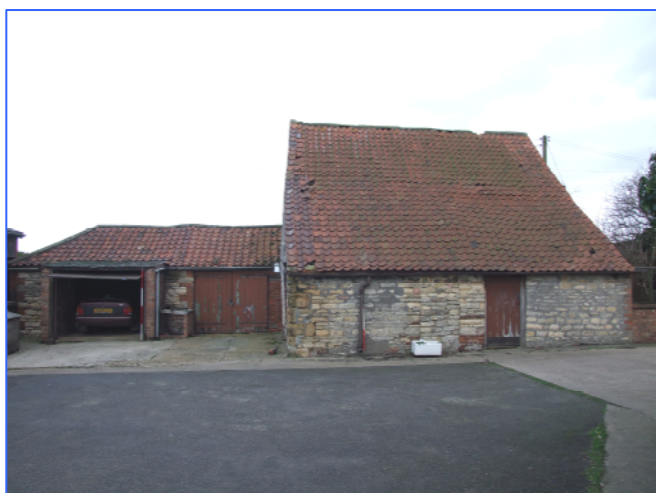
- 5.2.5 **Garage 5a, Barn 5b (18th to 20th century):** A series of buildings extends to the south of the open yard. The first of these (Building 5a) is a brick and limestone structure which has been converted into a garage with two bays, both of which have wooden double doors in their west elevation (plate 17). The east – west width of the two bays has been extended by a brick extension on the west elevation of the north bay, and on the east elevation of the south bay. There is a blocked in doorway in the north elevation which originally gave access to the yard to the north. It is possible that the building originally served as a small cart shed with two bays.

Plate 17: West elevation of garage 5a and stable 5b, looking east-north-east.

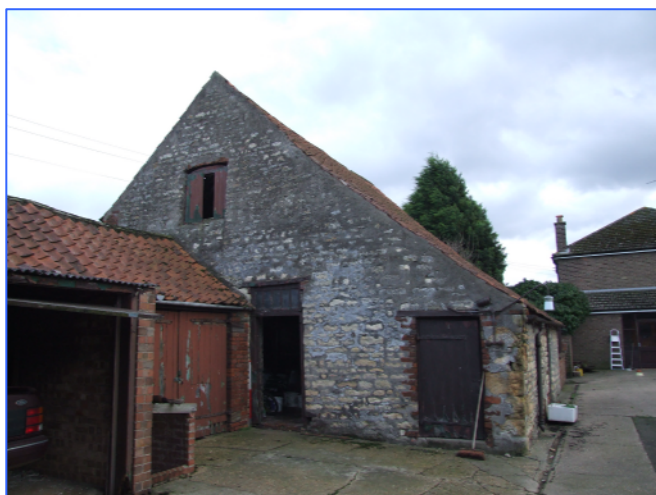
- 5.2.6 To the south of 5a is building 5b, a two storey structure, divided into three rooms on the ground floor. It is of bonded limestone construction, with saw tooth brick work around the doors and other openings. There are two doorways in the north elevation (plate 18), and another in the west elevation, which provide access to each of the three rooms. The west elevation also has a blocked entrance of similar dimensions to the existing door (plate 17). There are no doors in the east elevation, but two windows set in wooden frames (plate 14). Two further windows in the south elevation appear to be later insertions, each with a brick segmental arch (plate 19).

Plate 18: North elevation of building 5b, abutted by garage 5a. Looking south-south-east.

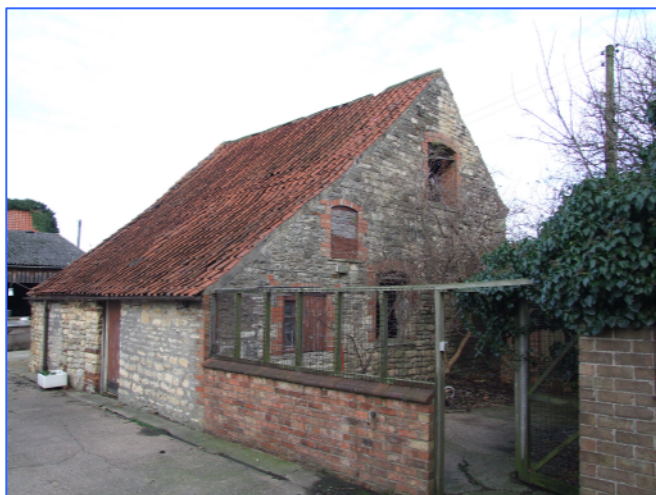
- 5.2.9 Block 5c, to the south of 5b, comprises a group of four small rooms arranged around a small caged yard. The buildings are largely brick built, single storey outbuildings which are largely derelict and overgrown. The eastern wall of 5c is of bonded limestone with a brick repair at the top (plate 19). The buildings are probably of 20th century date, and are likely to have been used as kennels.

Plate 19: South elevation of building 5b, and adjacent yard 5c. Looking north-east.

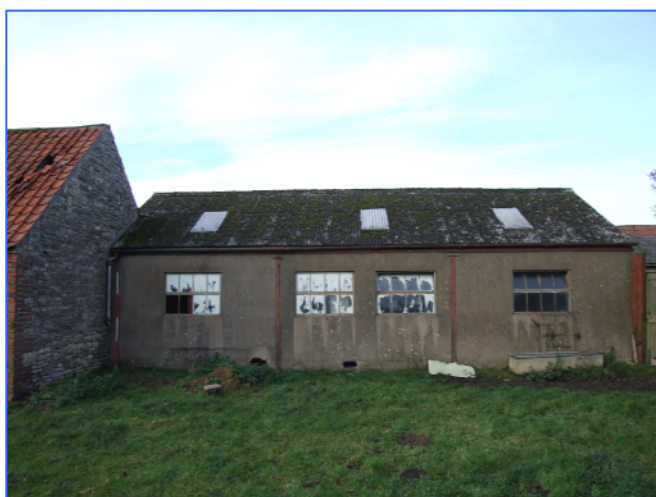
- 5.3.1 **Building 6a (20th century):** Building 6a is a modern, single storey brick, breeze block and limestone construction with a single wide entrance to the east, and a double pitched corrugated asbestos roof. It is aligned east-north-east to west-south-west and measures 11.5m long by 6.5m wide (plate 20). Its northern external elevation is of limestone, its western wall is of breeze block construction and to the west it abuts the cart shed 6b. A short portion of wall extends 1.8m north of the north-west corner of the building. This wall is of brick and limestone construction and stands 1.3m high. To the north of this wall is the access to the existing farmhouse along the south side of the covered yard.

Plate 20: South elevation of building 6a, looking north-north-west.

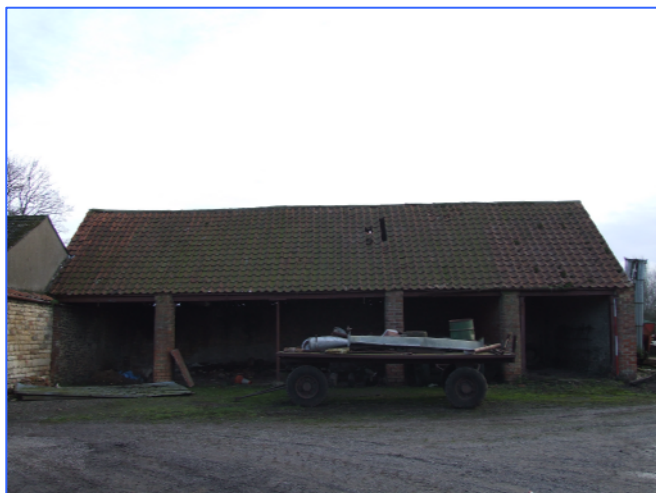
- 5.3.2 **Building 6b (19th century):** Cart shed 6b is open to the north, and the southern side of the building backs onto fields. It is of limestone construction, and has five bays, each 2.5m wide, divided by three brick piers and a single cast iron upright which is likely to be a later repair (plate 21). The westernmost bay also has a brick partition wall dividing it from the adjacent bay. There is a pitching hole in the west elevation, which suggests that the cart shed originally had an upper floor for storing crops (plate 22). The cart shed is probably positioned to allow access to Well Street/Stonepit Lane to the north.

Plate 21: Cart shed 6b, north elevation, looking south-south-east.

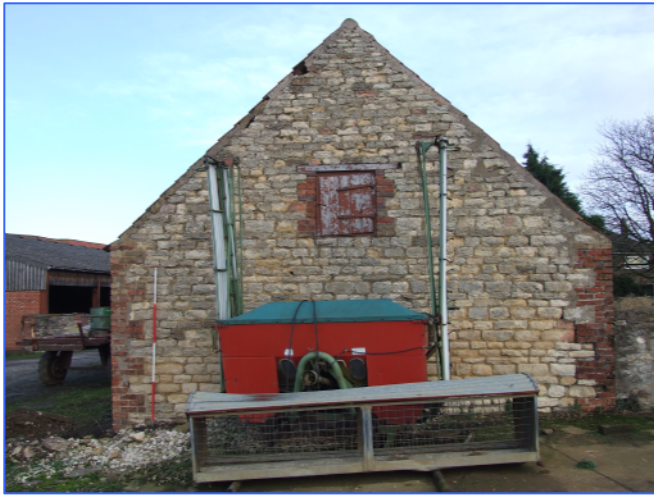
Plate 22: West elevation of building 6b, looking east.
