Appendix 1: Colour plates (Archive shot numbers are in brackets, see Figures 4, 5, and 6 for shot location and direction)

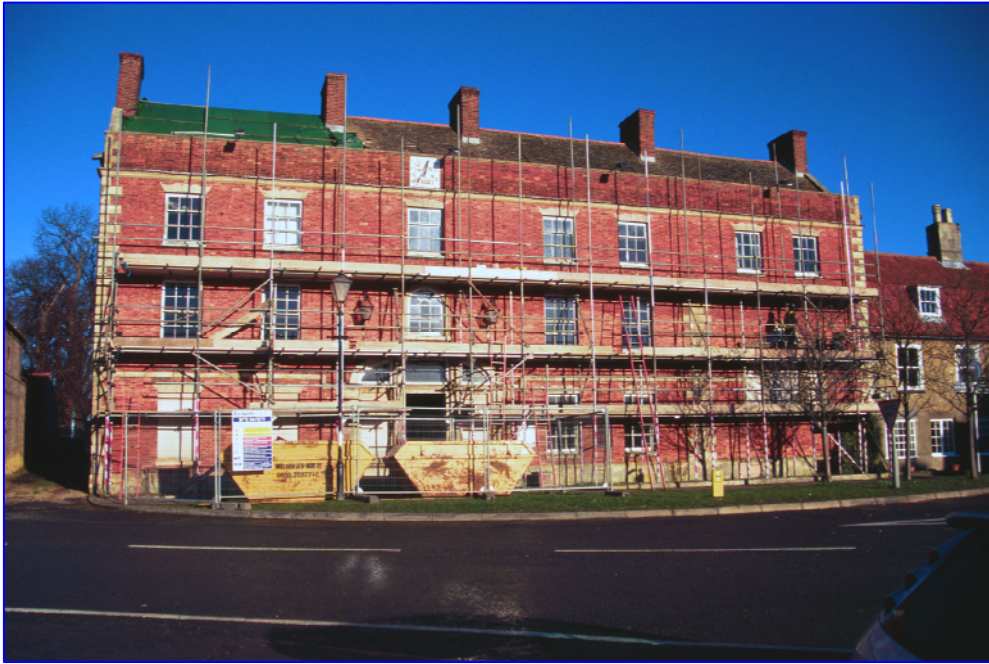
Plate 1: (001) Southern façade of the Greyhound Inn demonstrating the limitations upon photographic recording. Looking north.

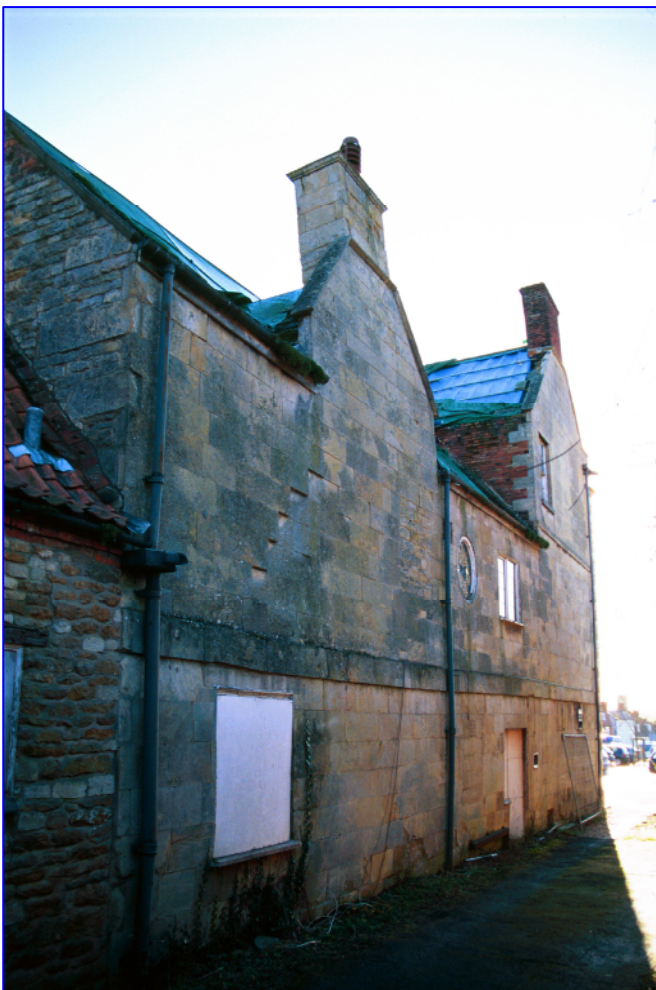
Plate 2: (009) The Western Elevation showing the ashlar cladding. Note the location of the Western Range stack behind the gable coping. The tarpaulin covers fire damage to the second floor. Looking south-east.

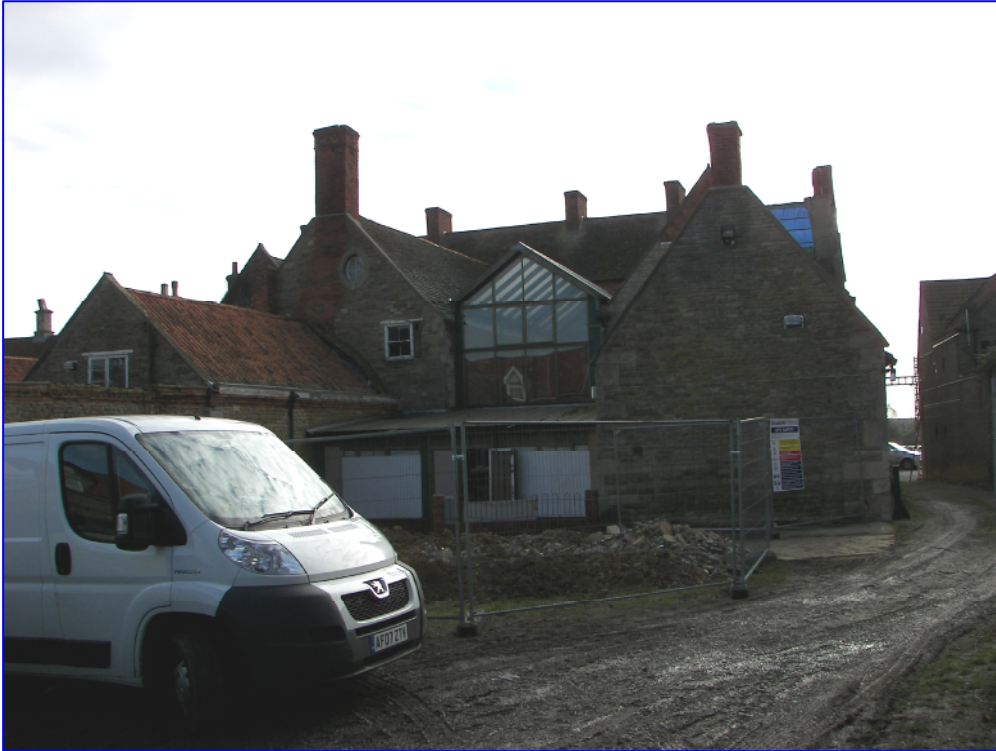
Plate 3: (178) Northern elevations showing the false garret bullseye window in the Eastern Range and the visually intrusive lean to abutting the atrium frame. Looking south-east.

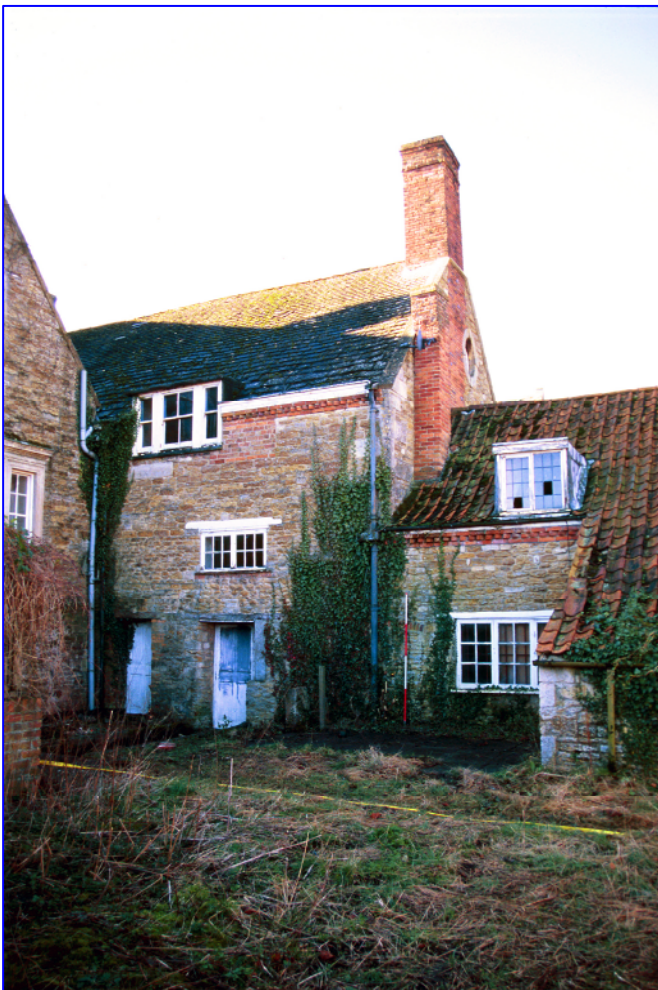
Plate 4: (013) The eastern elevations of the Eastern Range, detailing remodelling at the eaves and the insertion of dormers into the roof. Looking south-west.

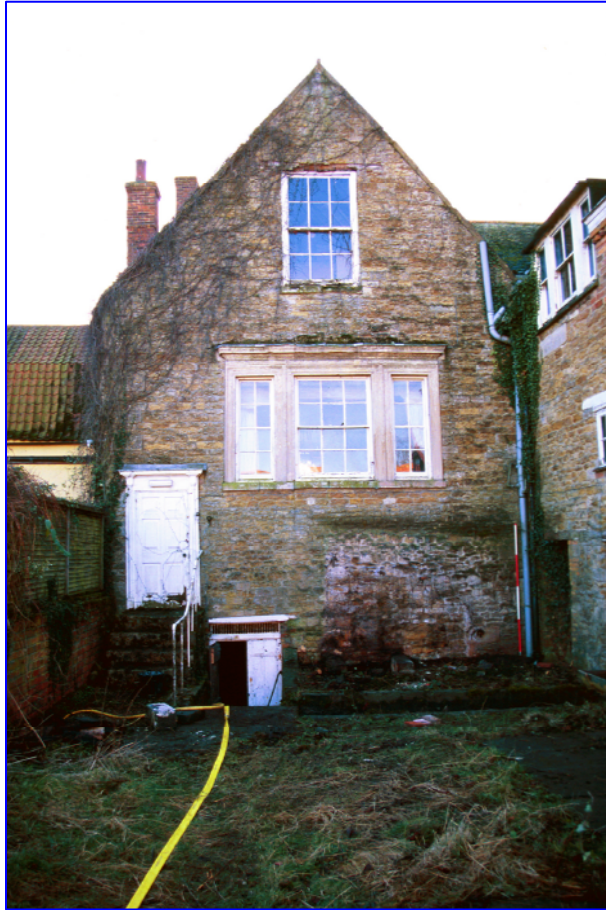
Plate 5: (014) North elevation of the courtroom showing the high level moulded stone window and rear access steps with steps down to the cellar doorway. Looking south

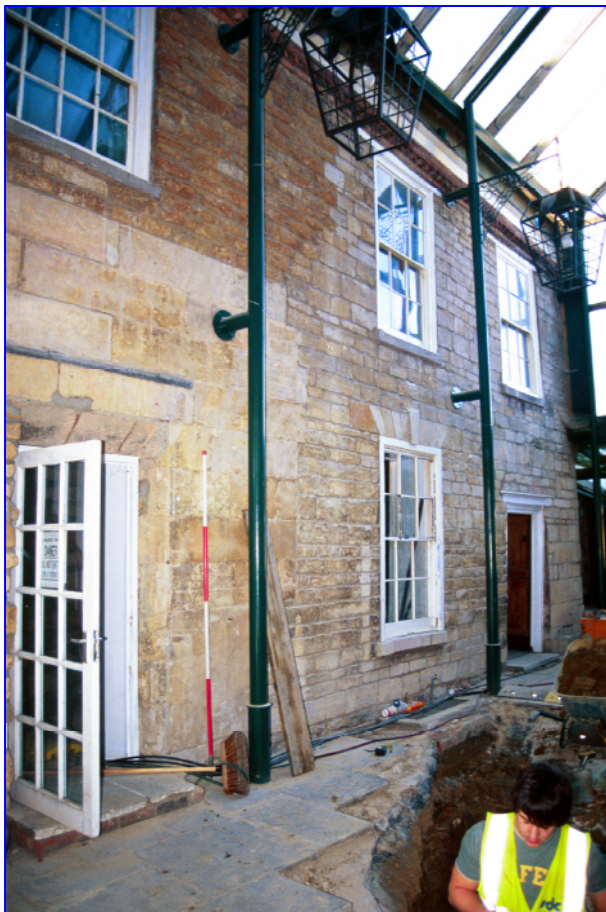
Plate 6: (026) Eastern elevation of the Western Range (South Block) illustrating the changes in wall fabric associated with phases of development. Looking north-west

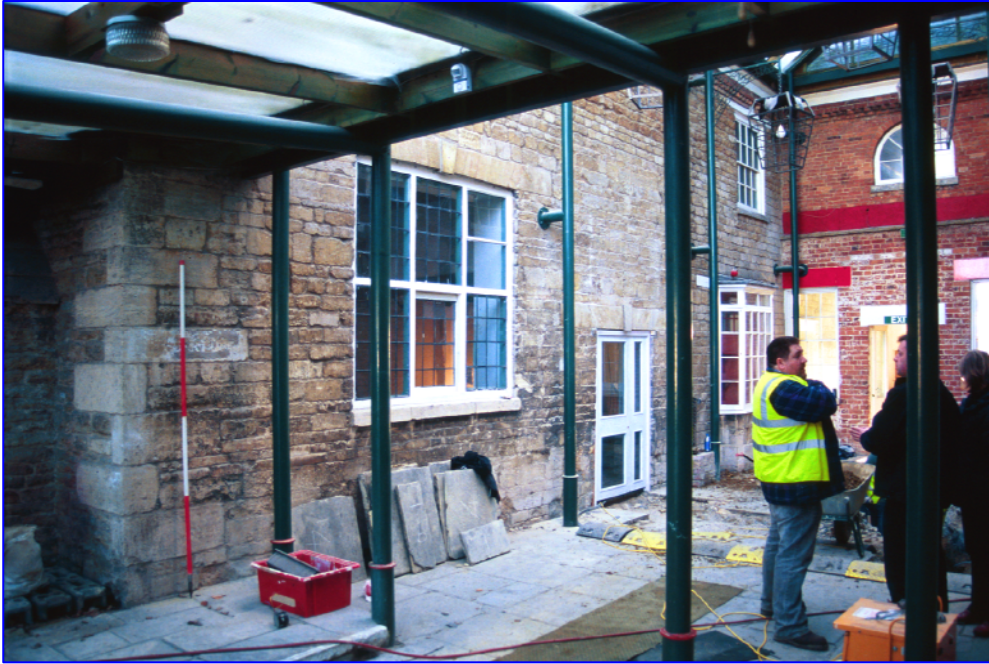
Plate 7: (021) Western (internal) elevation of the East Range (South Block). Looking east.

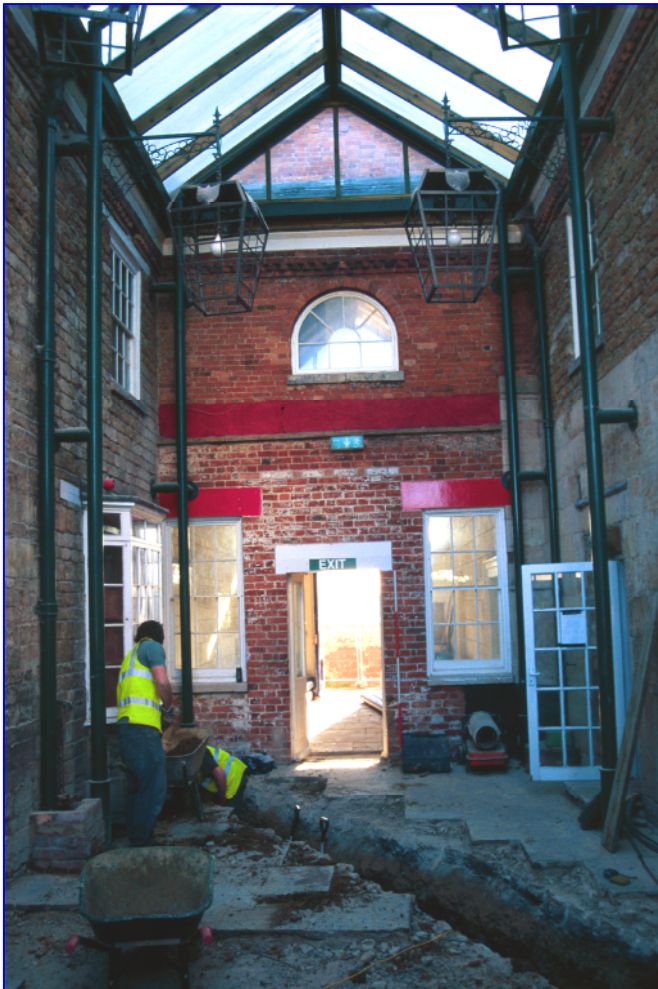
Plate 8: (027) Northern elevation of the carriageway arch with 19th century infilling on the ground floor. Note the offset of the ashlar blockwork facia, in the right hand corner, necessary to correct the alignment between the Southern and Western Ranges. Looking south.
