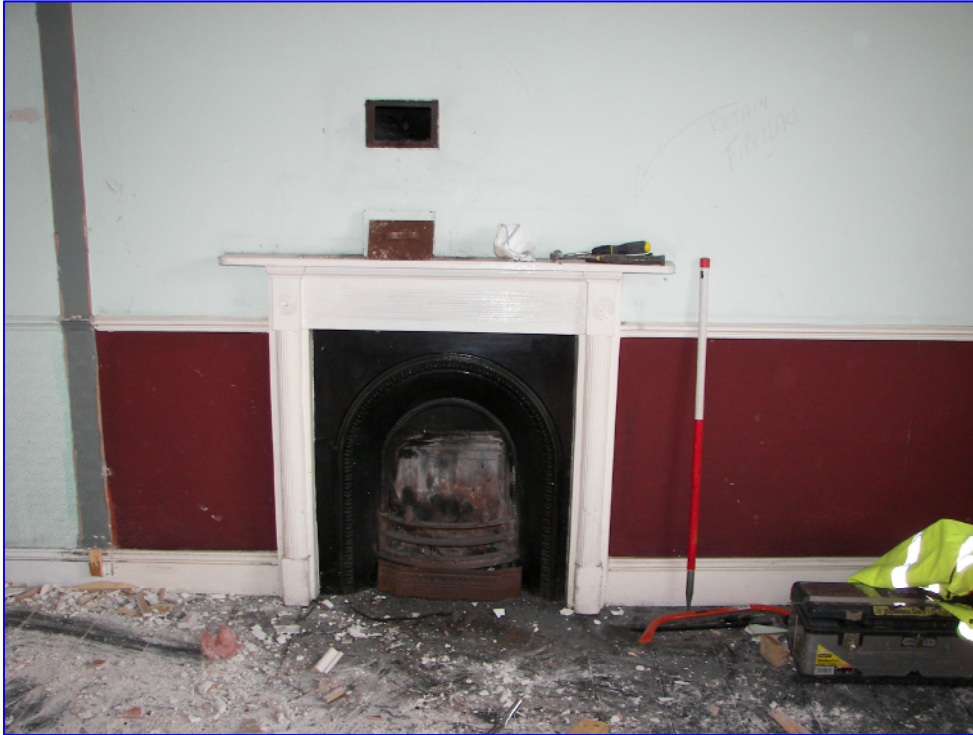
Plate 9: (shot 113) Room 16 retains a mid 19th century cast iron arched register grate that has a Regency style fire surround with concentric bosses and reeded moulding. Looking east.

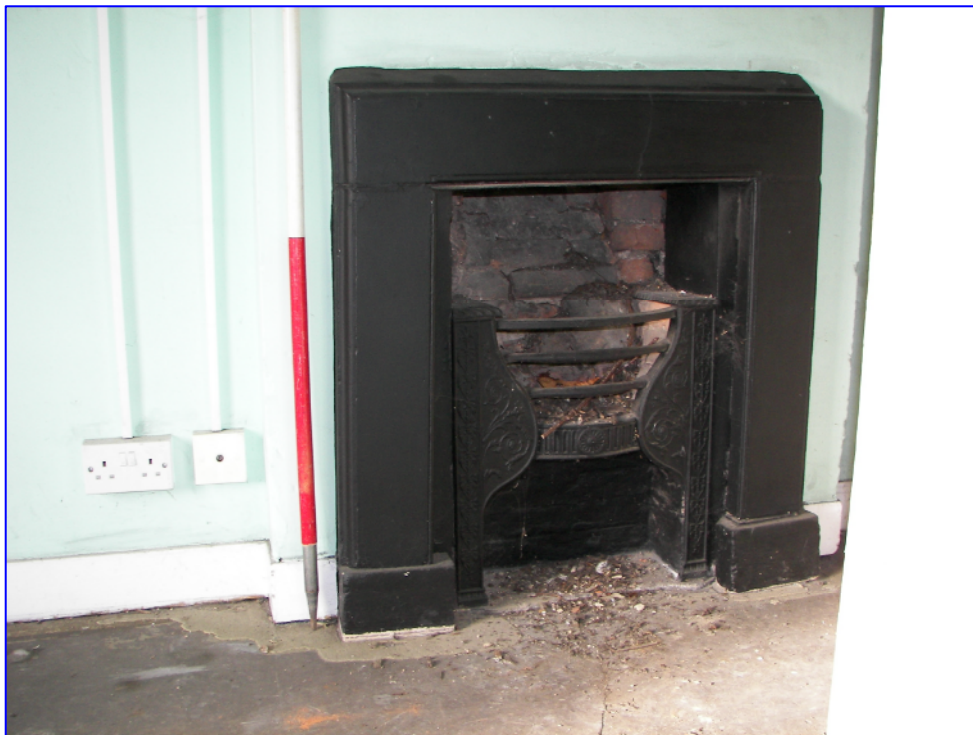
Plate 10: (123) Room 18 retains a late 18th early 19th century cast iron hob grate with a plain stone surround. The same style of fireplace has been retained in rooms 19, 20 and 21. Looking north-north-west.

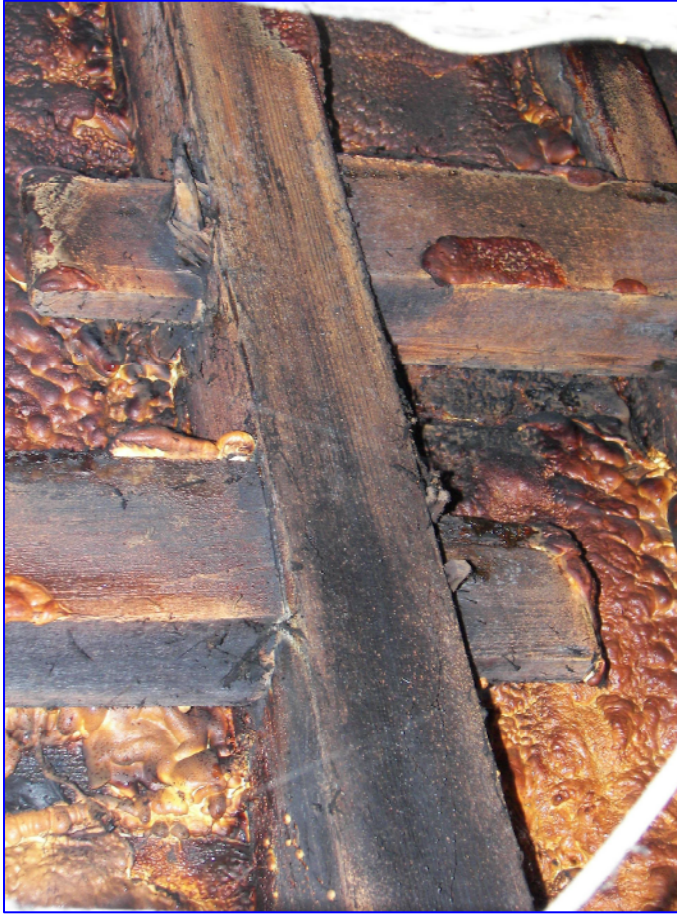
Plate 11: (shot 138) Staggered butt purlins morticed with tenons pegged behind the principal rafters and supporting common rafters. Observed in the fire damaged part of the Southern Range. Shot taken vertically.

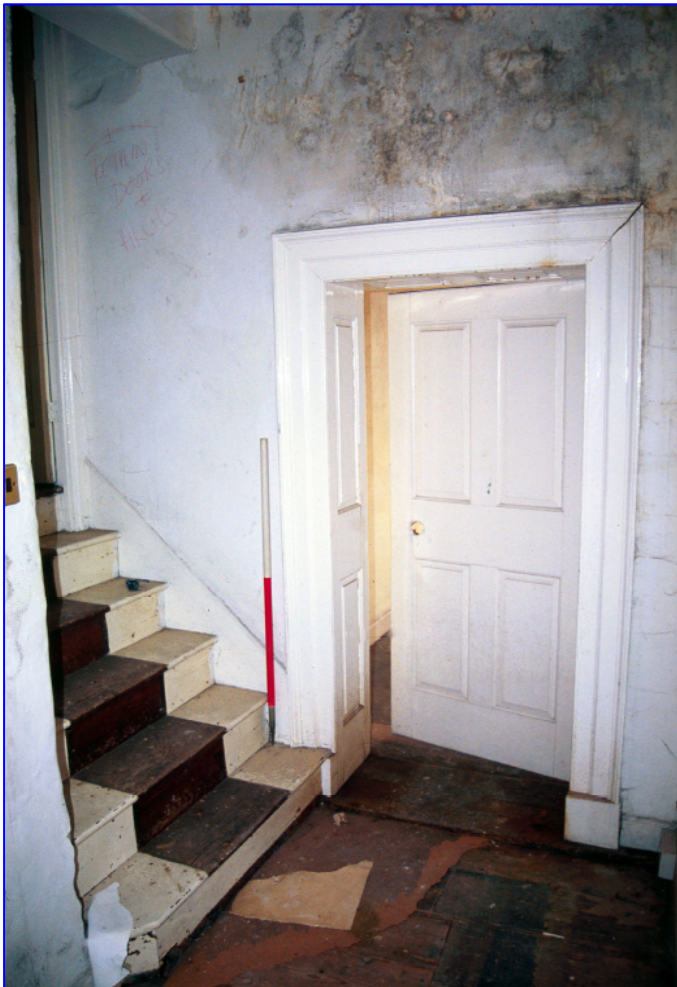
Plate 12: (074) On the first floor, rooms have doors that are four panel raised and fielded within a boxed, panelled frame with architrave. Shot depicts the door of Room 10 taken from the western half landing facing south.

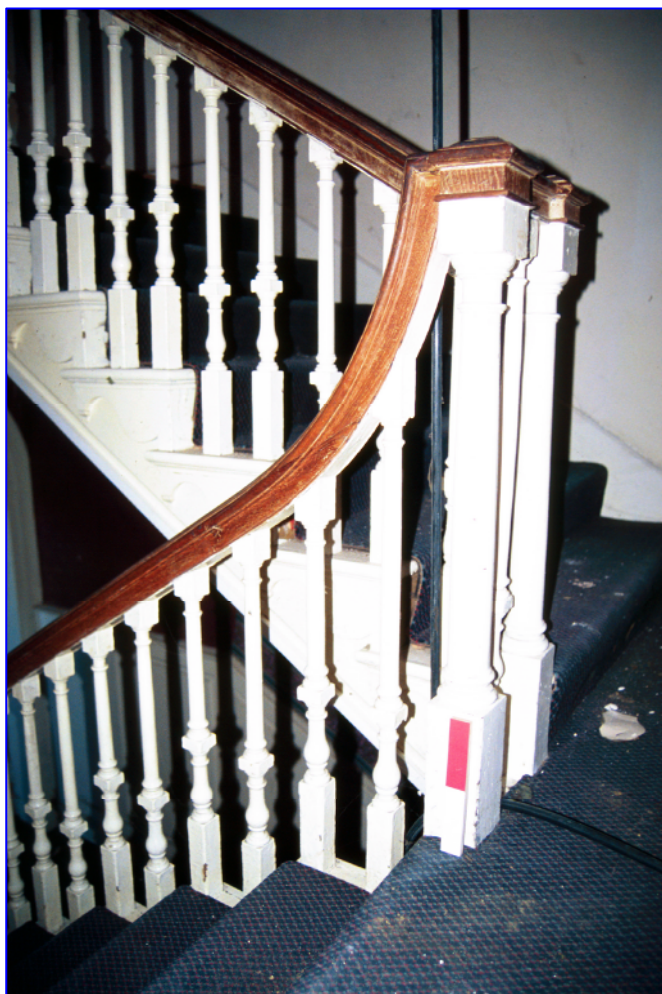
Plate 13: (097) Constructed in an open strung mid Georgian style, the eastern staircase has slender turned balusters standing on the treads with columnar newel posts and ramped handrail. Looking south-west.

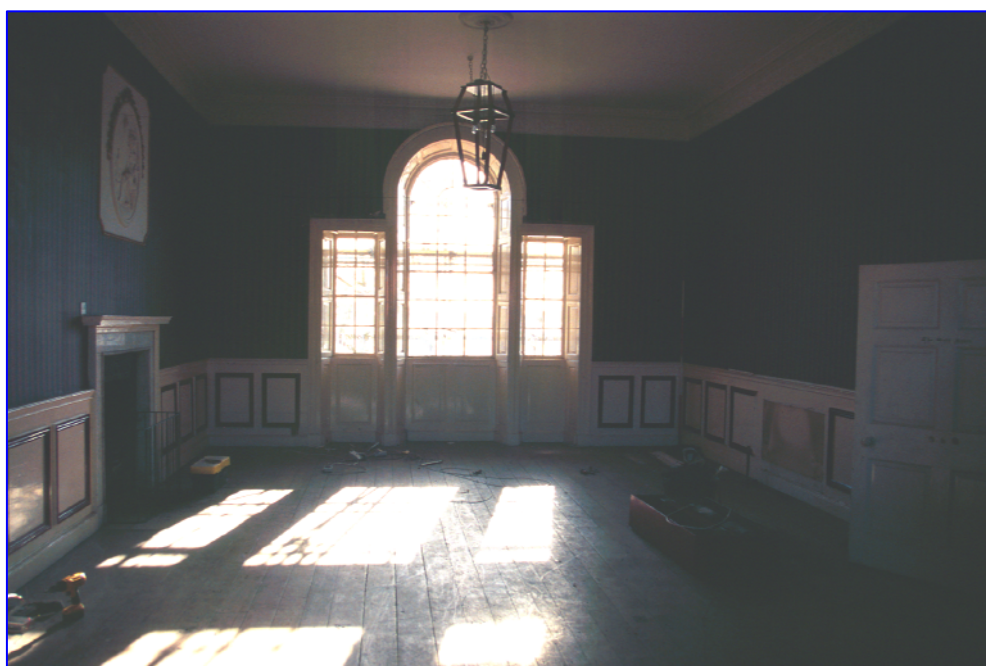
Plate 14: (033) general shot of the courtroom, its panelling and Venetian window. Looking south.

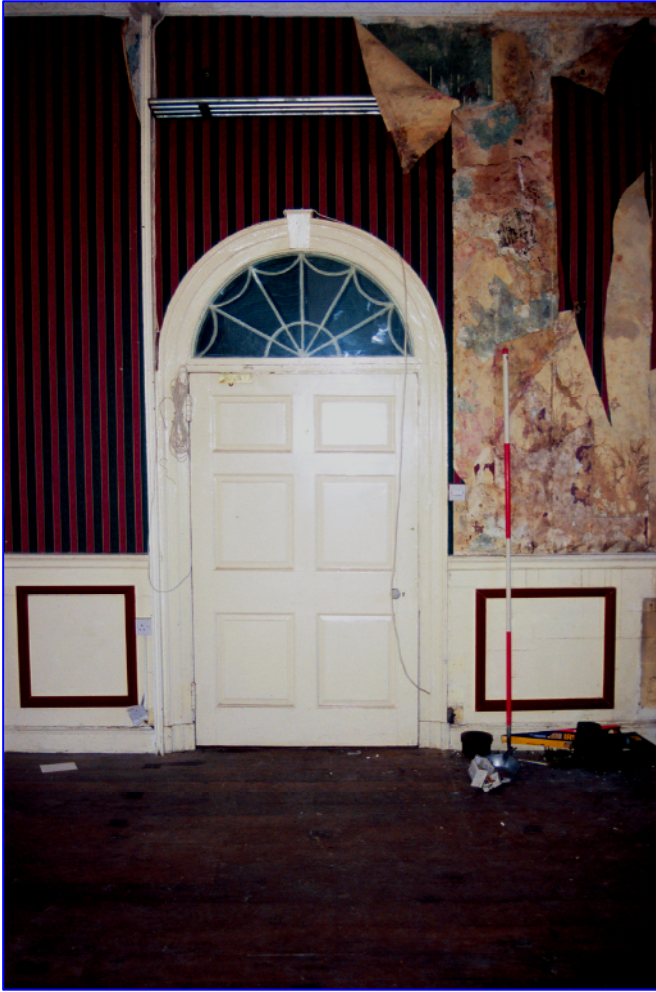
Plate 15: (036) The courtroom is accessed via a six panel door with an Adam Style fanlight header, framed by architrave with keystone detail on both sides of the door frame. This shot also demonstrates the level of water damage to the interior of the building. Looking east.

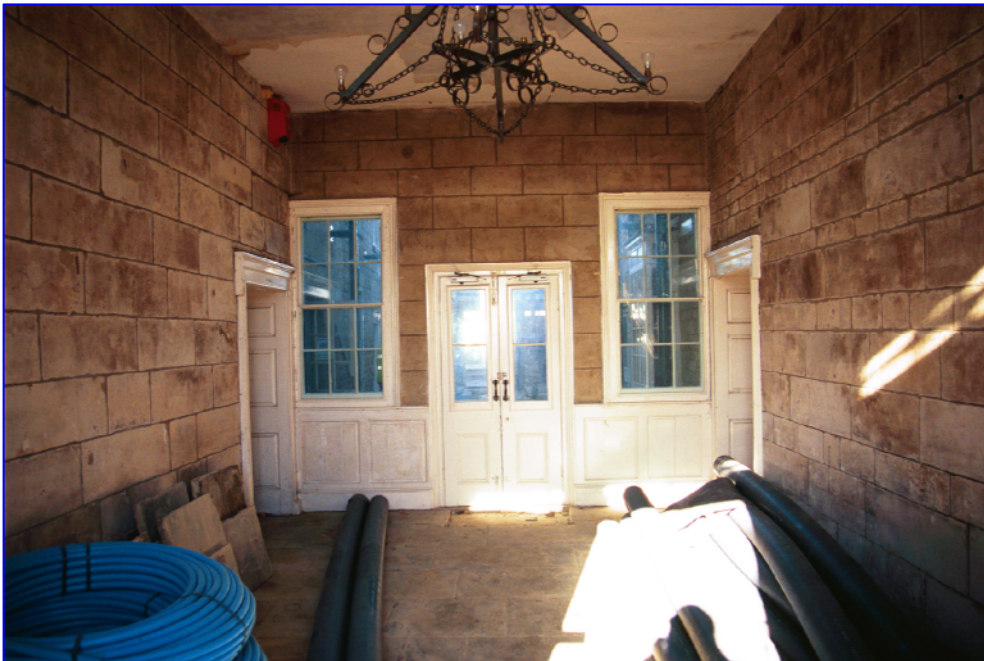
Plate 16: (030) The ashlar lining applied to the carriage arch in 1789. The northern end is filled by a 19th century brick wall, door and windows, with imitation stone dressing over panelling applied the interior wall. Looking south.
