LEVEL 1 BUILDING SURVEY REPORT
WELLWOOD FARM, DIGBY FEN, LINCOLNSHIRE

Planning Reference: N/22/1515/03
NGR: TF 1250 5452
AAA Site Code: DIWF 08
LCCM Accession Number: 2008.128
Oasis reference: Allenarc1_46329

Allen Archaeological Associates
Report Number 2008/045

July 2008

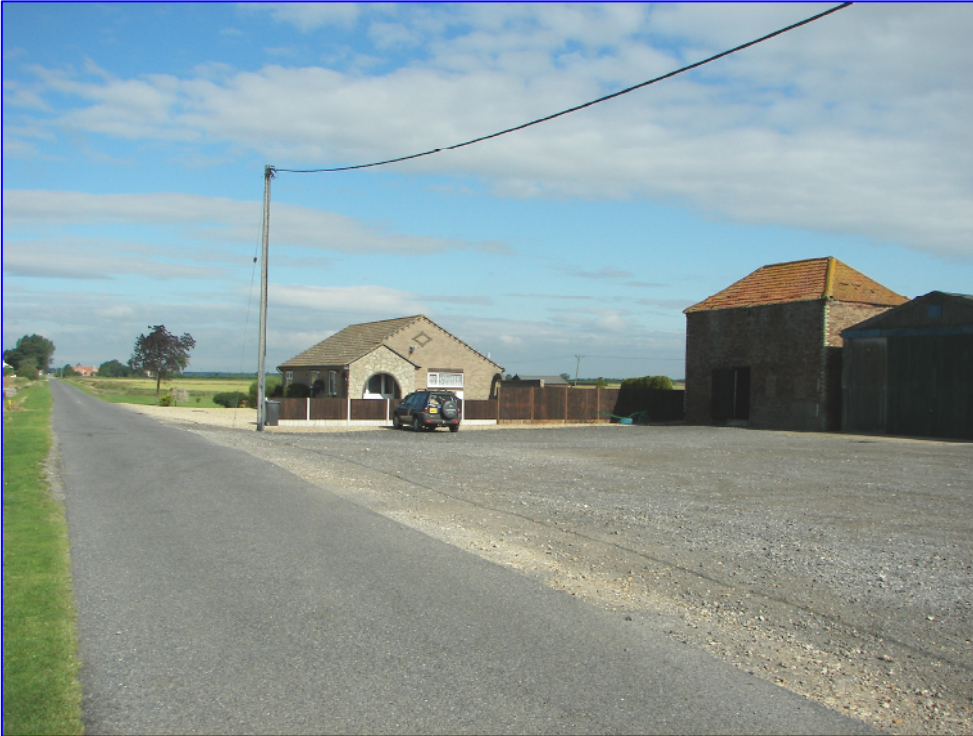
Plate 1 (Shot 2):
The setting of the barn, viewed looking north-west along the adjacent lane.

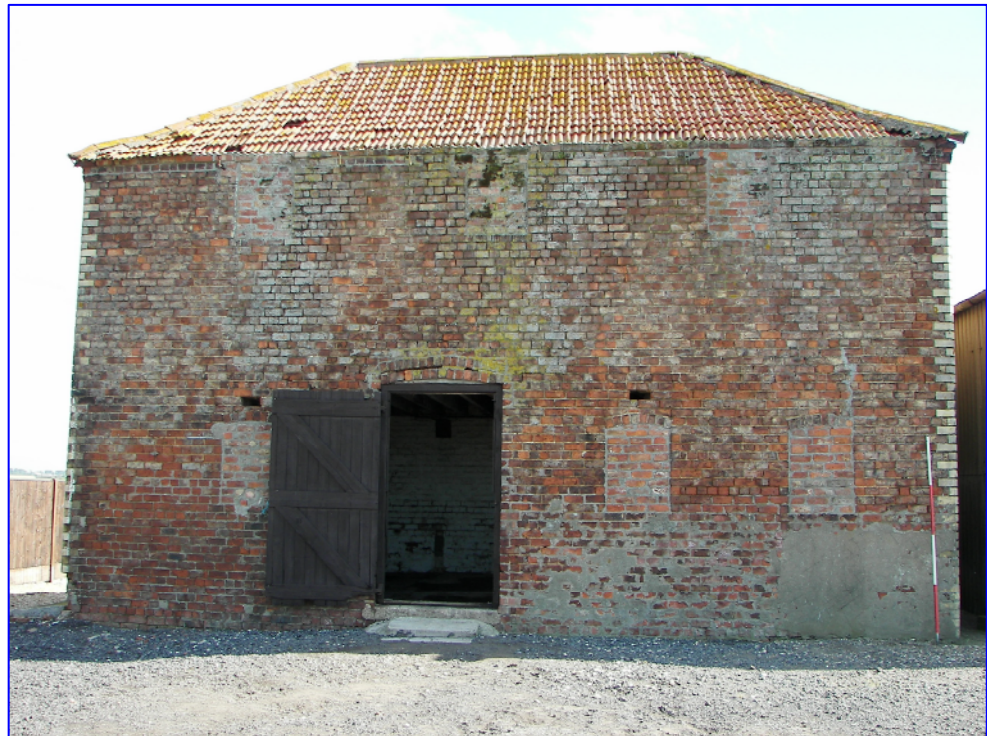
- 5.1.1 The south-west facing elevation has three blocked windows on the ground floor, arranged two to the left and one to the right of the main doorway. Each window aperture is headed by a rough segmental arch of brick headers. The doorway is topped by a double brick arch in the same style over a plain plank door in a timber frame that rests on a stone sill (Plates 2 and 3).

- 5.1.2 The first floor has three small blocked in windows at the eaves (Plate 2). The absence of brick arches over the window heads (as on the ground floor) indicates the lowering of the roof line at some point in the building's development.

Plate 2 (Shot 5): The south-west facing elevation showing the blocked in windows on the ground and first floors. Looking north-east.

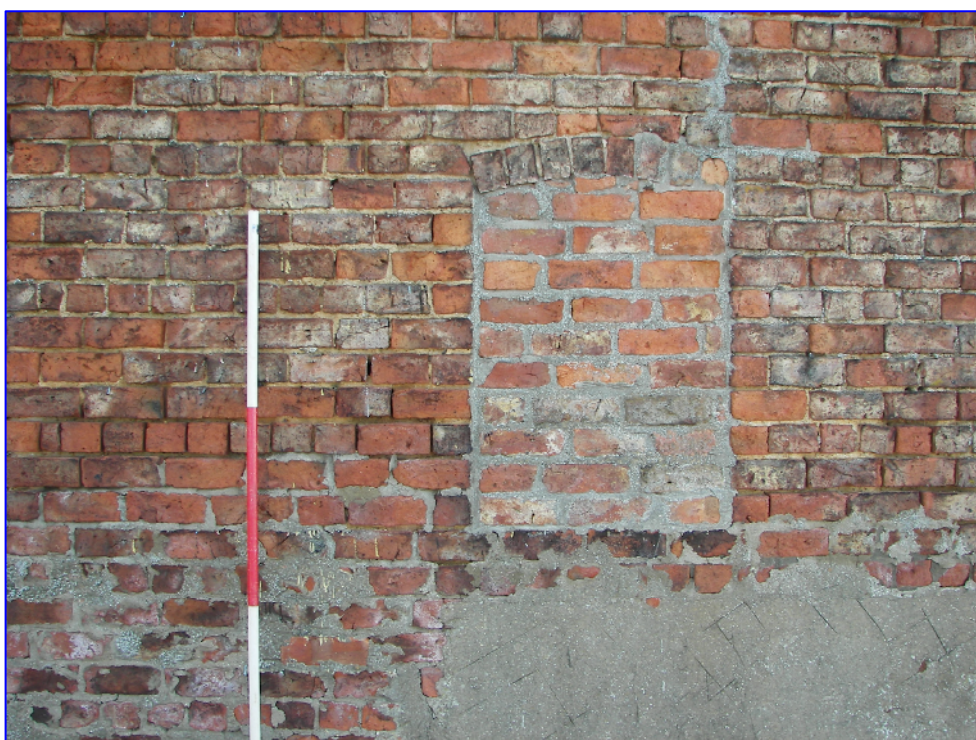
Plate 3 (Shot 6): Detail shot of a blocked in window on the ground floor of the south-west facing elevation, looking north-east.

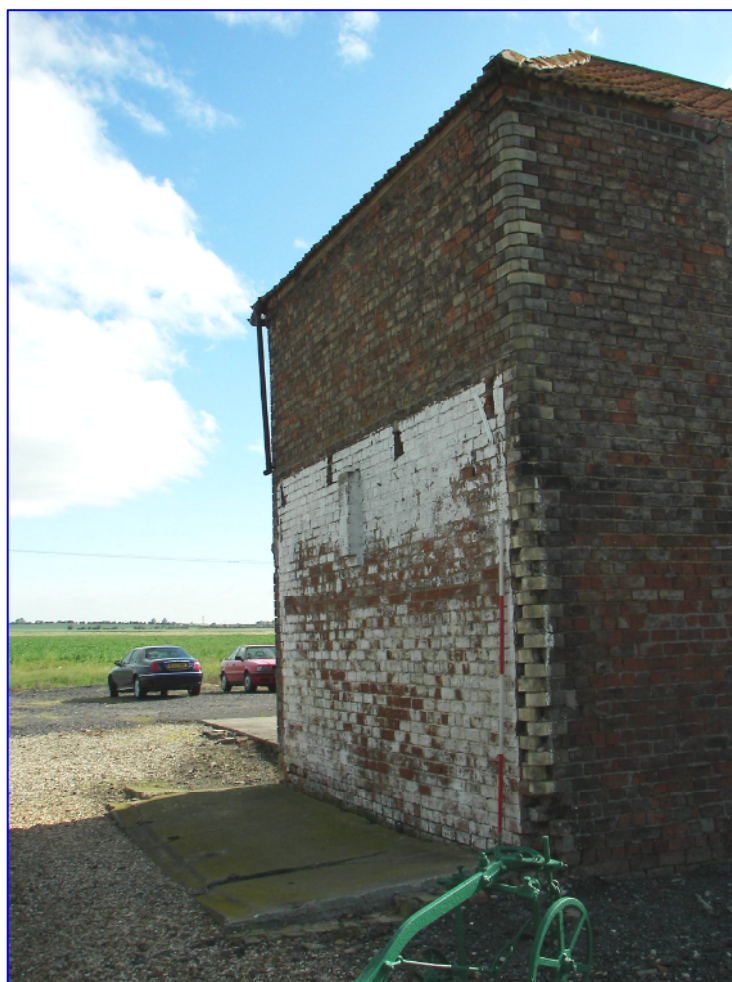
- 5.1.3 The north-west facing elevation (Plate 4) is of plain brick walling with holes at first floor joist level from the removal of roof timbers and projecting brickwork associated with the demolition of an adjoining single storey lean-to building. The concrete base from this building is still in situ, which is also evidenced by the remnants of whitewashing on the extant wall.

Plate 4 (Shot 9): The north-west facing elevation, looking north, showing the scarring from the recently demolished outbuilding and the surviving concrete floor.

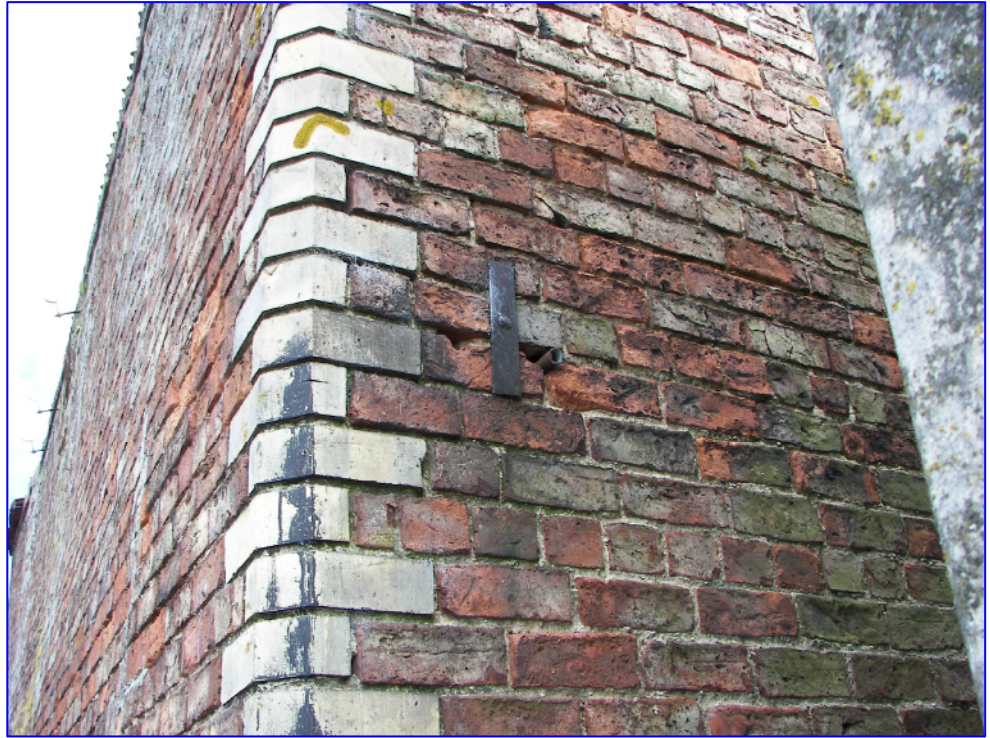
- 5.1.7 The south-east facing elevation is of plain brick walling with a single small blocked window on the first floor. There is a pair of plain strap iron tie plates at joist level at each corner with opposing tie plates located on the north-west elevation (Plate 5). This elevation could not be photographed due to the proximity of an adjacent building.

Plate 5 (Shot 24): Shot taken looking north-east of the south-west corner of the barn showing the polychrome detailing using single cant bricks in a gault fabric at the corners of the barn. To the right is a simple tie plate.

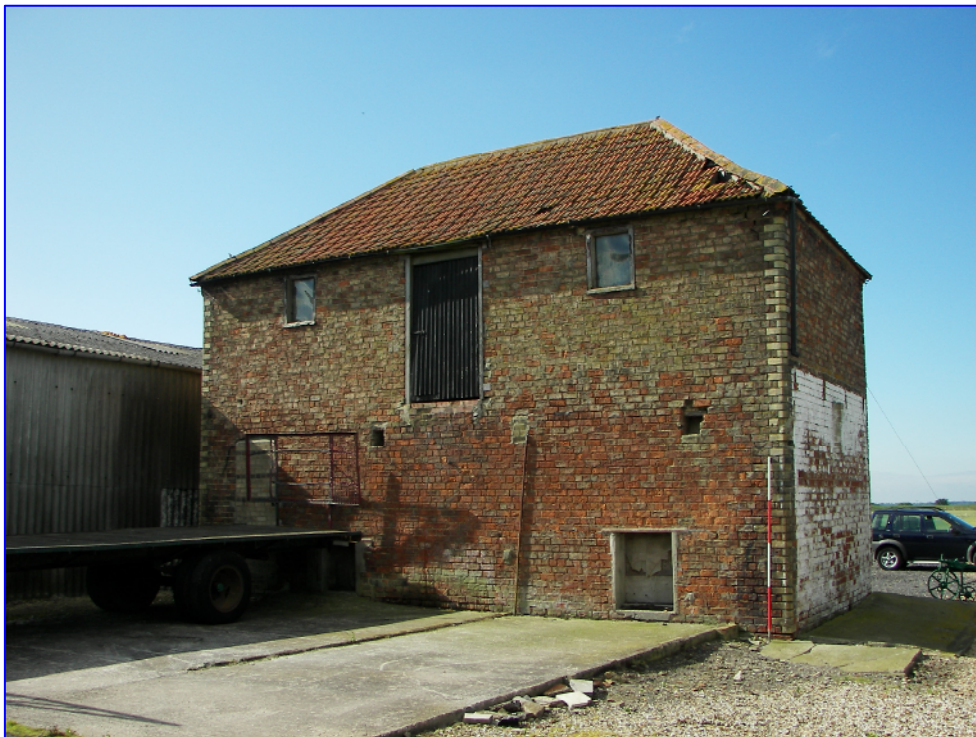
- 5.1.4 The north-east facing elevation (Plate 6) has three openings on the ground floor. Two small doorways set low in the wall (one partially obscured from view by a farm trailer) were associated with the buildings former use as pig sties. A blocked in single doorway at the left side of the façade (Plate 7) is topped by a single segmental arch of brick headers.

Plate 6 (Shot 11): The north-east facing elevation viewed looking south. Note the concrete apron for the pig sties formerly accessed through the small openings in the barn wall.

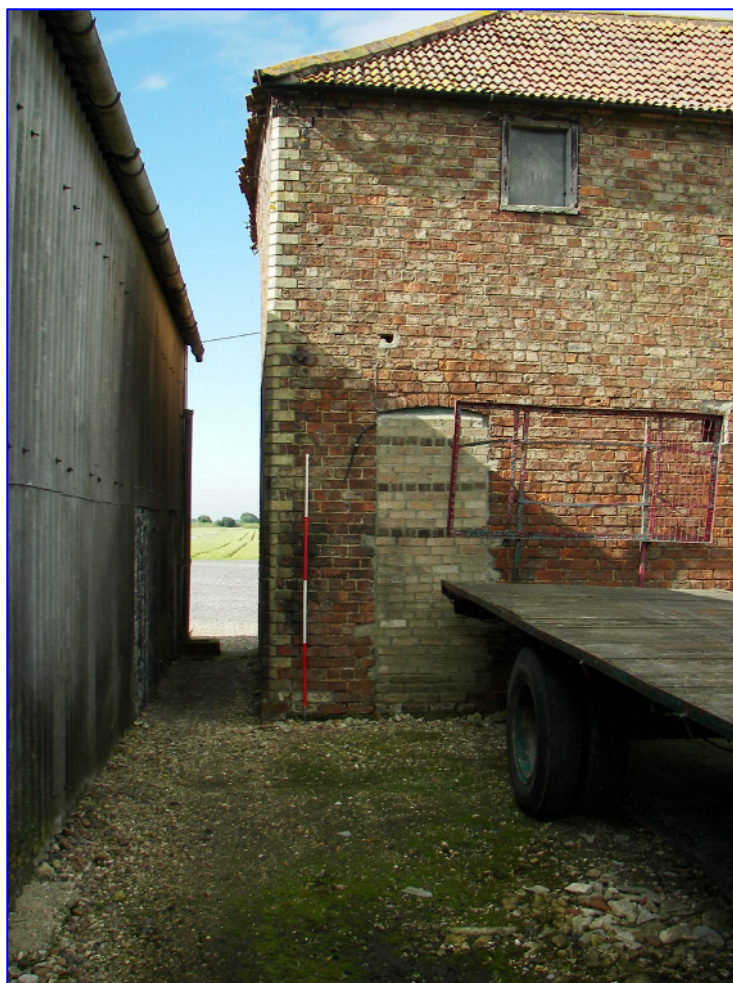
Plate 7 (Shot 15): A shot taken looking south-west showing the blocked doorway in the north-east elevation and the slight outward bow in the wall at eaves level in the south-east facing elevation.

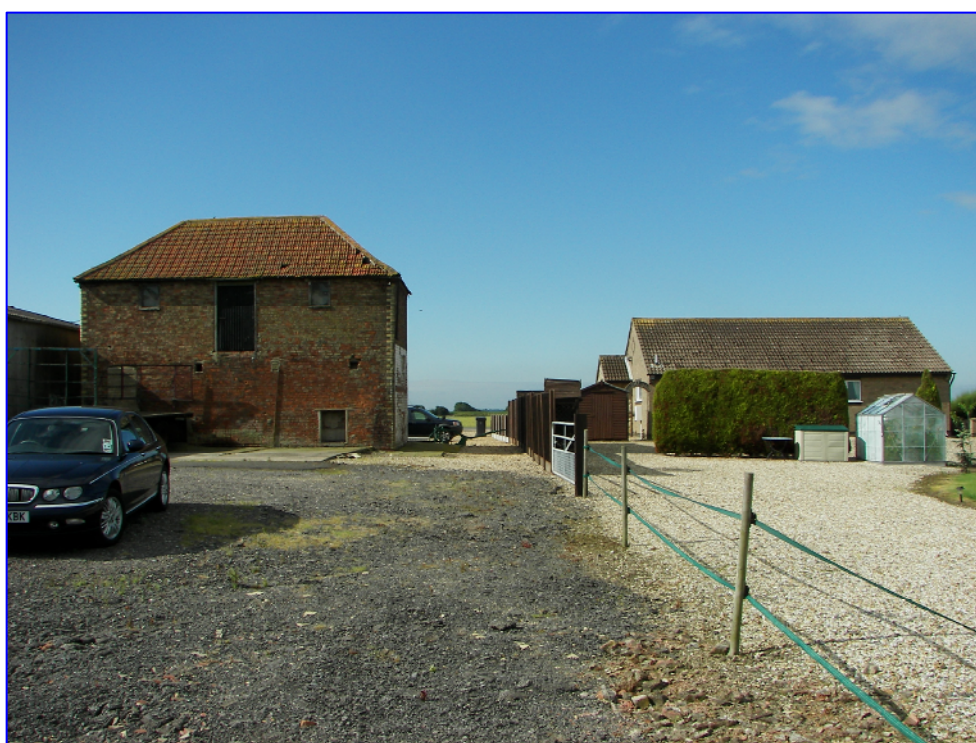
Plate 8 (Shot 13): The north-east facing elevation looking south-south-west and showing the rear aspect of the barn and surrounding buildings.

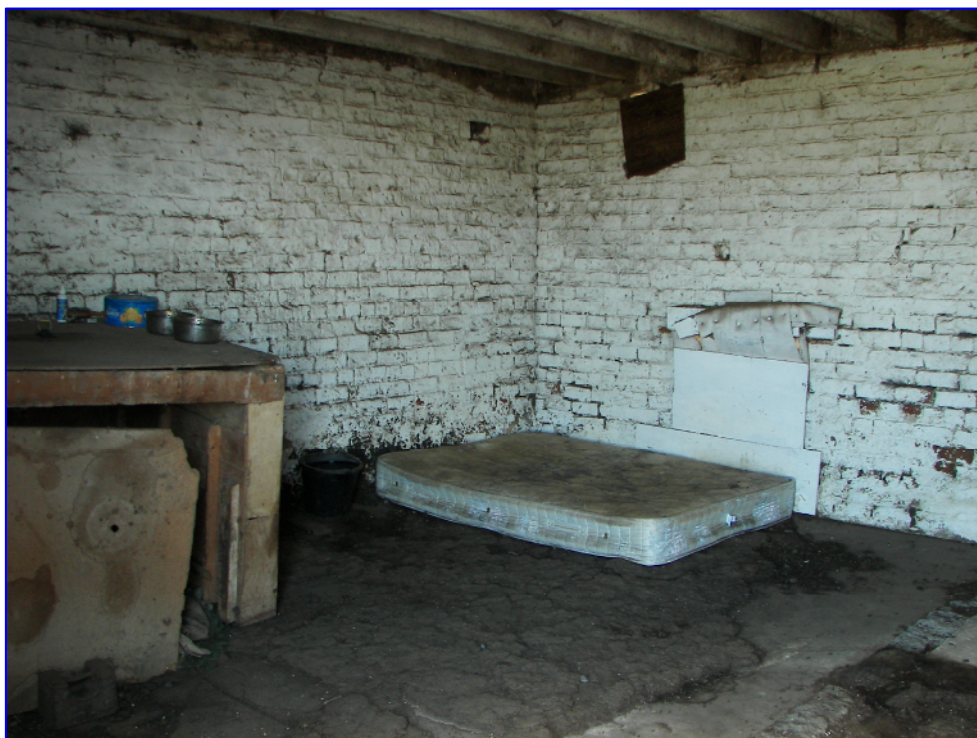
- 5.2 Internal:** Accessed via the main door in the south-western elevation, the ground floor currently consists of a single open space with a concrete floor inset with the remains of cinder block walling associated with its former use as pig sties (Plate 9).

Plate 9 (Shot 17):
The ground floor
interior of the barn,
looking north.

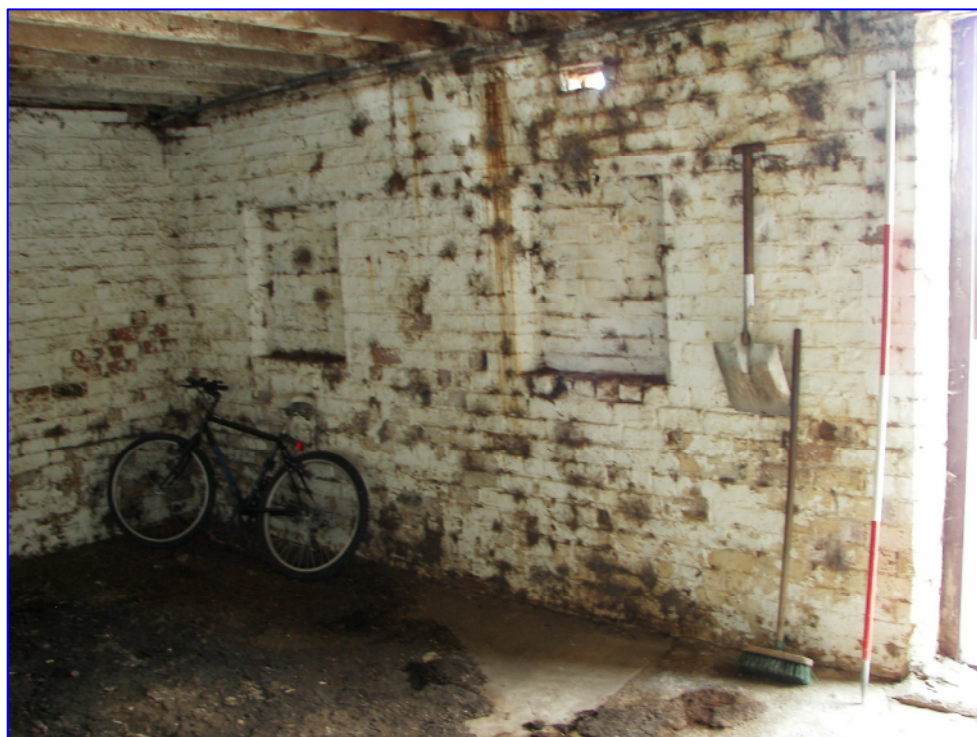
Plate 10 (Shot 20):
The north-east facing
interior ground floor
elevation viewed
looking south.

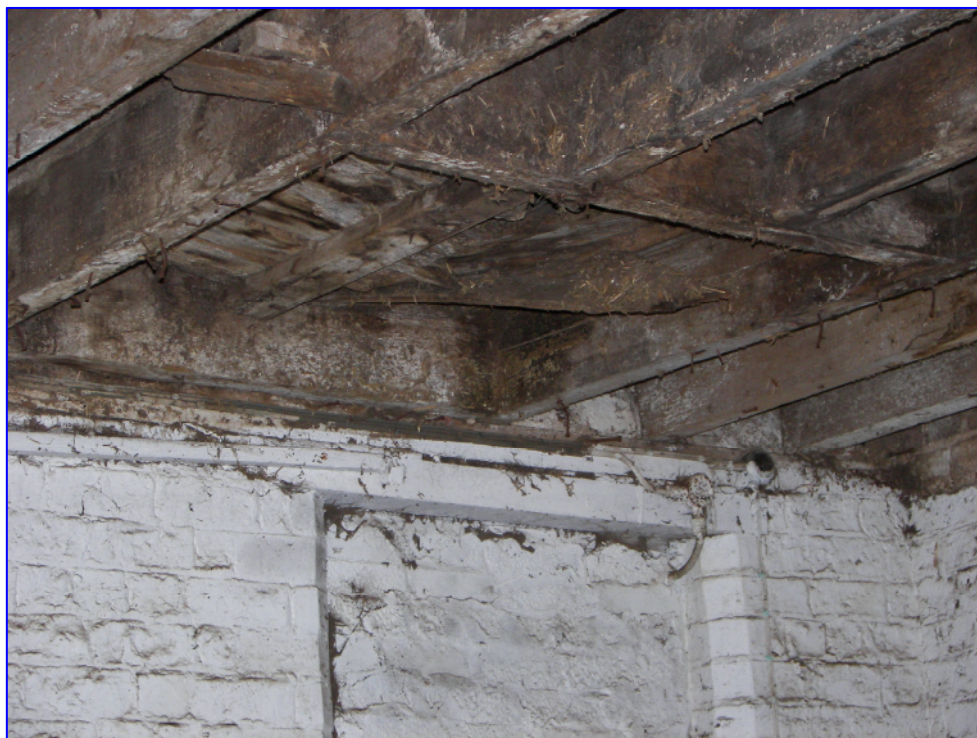
- 5.2.2 The ceiling is open to the joists that are supported by a wall plate set into the double thickness of the wall. A square opening in the joists at the north-east corner of the room (Plate 11) formerly provided access to the first floor via a fixed staircase (now removed).

Plate 11 (Shot 31): A blocked opening in the first floor joists that formerly housed an internal staircase. The opening is located in the north-east corner of the barn over the blocked external doorway, the shot was taken looking north-east.

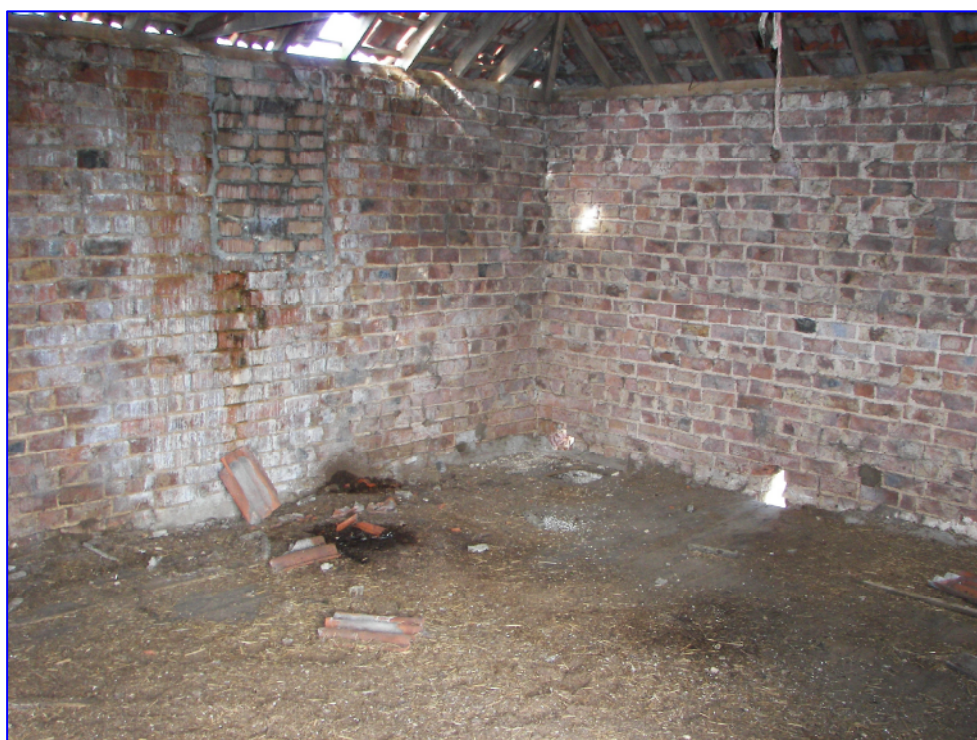
Plate 12 (Shot 28): Internal shot of the empty first floor looking south-west. Note the blocked window in the south-west wall

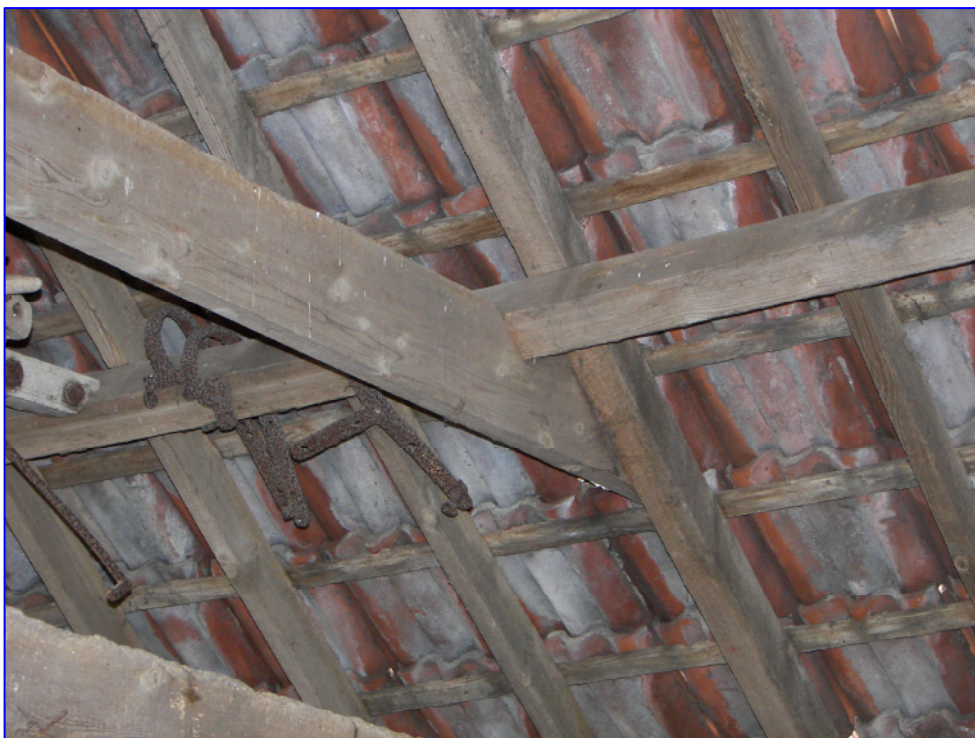
Plate 13 (Shot 30):
Detail of the clasped
purlin construction of
the roof timbers, viewed
looking south.

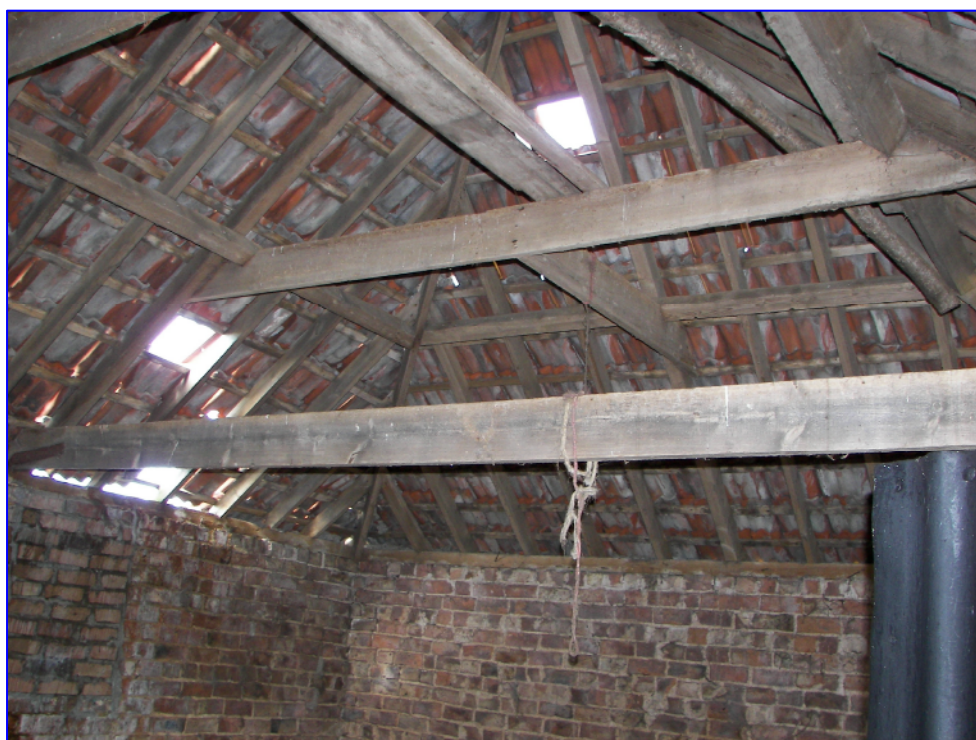
- 6.5 The present roof structure is constructed in light weight sawn timbers covered by 20th century triple ribbed tiles and has completely replaced the original roof structure. This is likely to be an addition which coincided with the lowering of the walls to the level of the first floor window heads.

Plate 14 (Shot 25):
General shot of the
hipped roof construction
looking south-west.
