**HISTORIC BUILDING SURVEY REPORT:  
FORMER BOAR'S HEAD INN, 724 GARSTANG ROAD, BARTON, LANCASHIRE**

Planning Reference: 06/2021/0543  
NGR: SD 51599 37162  
AAL Site Code: BAGR 21  
OASIS Reference Number: allenarc1-504199

By  
Allen Archaeology Ltd  
Report Number AAL 2022019

February 2022

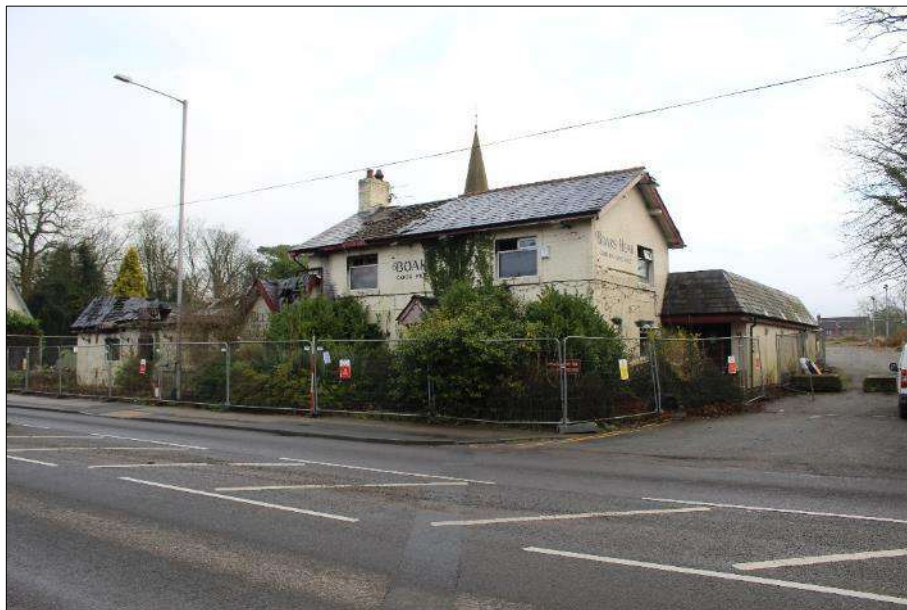
6.2 The original two-storey structure is a rendered brick building of solid wall construction, measuring c.11m x 7m (Plate 1). It is north-northwest to south-southeast orientated and flanks Garstang Road, to the west. It has a double pitched gabled roof covered in Welsh slate with overhanging eaves and protruding purlins on the gables. It has one brick stack, at the north gable, protruding from the apex of the roof, and this has two clay chimney pots. There is evidence of a previous chimney to the south end of the roof that has since been removed.

*Plate 1 (shot 2): General view of the public house from Garstang Road, looking northeast, 2m scale*

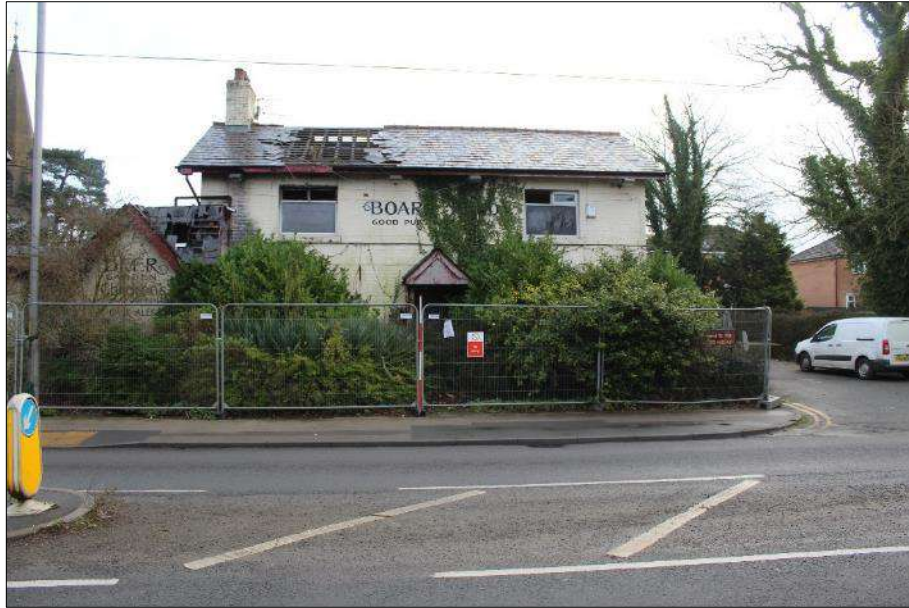
6.3 The front west facing elevation has been built in English Bond, whereas the south elevation displays more irregular spacing with fewer header courses. The walls are painted, and there is a front entrance in the west elevation which is flanked by windows at ground and first floor level on each side (Plate 2). The door in the front entrance is painted timber with a timber canopy, and the windows consist of modern uPVC double glazed units, all of which are modern replacements with stone lintels and sills (e.g. Plate 3).

*Plate 2 (shot 1): General view of the front, west facing elevation, looking east, 2m scale*

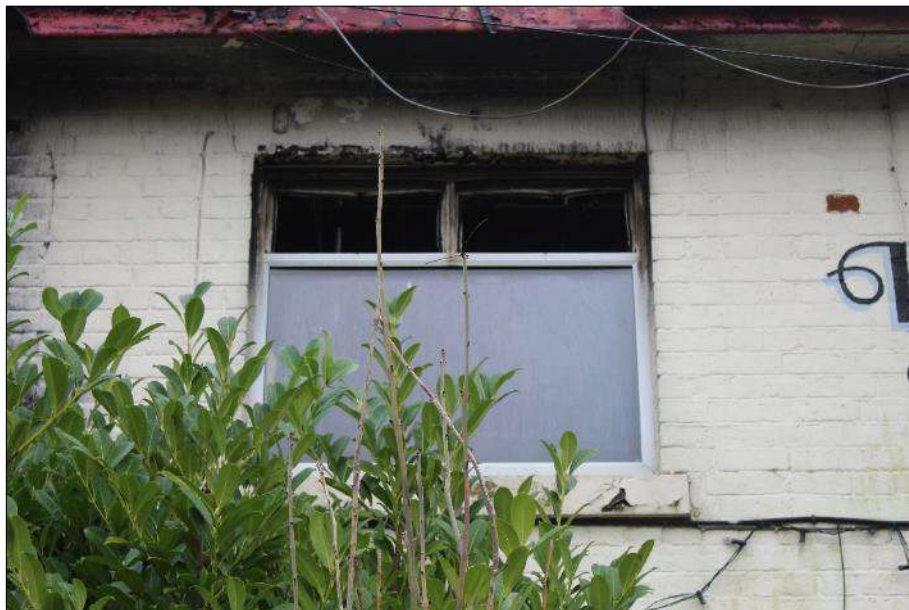
*Plate 3 (shot 6): First floor window in front elevation, looking east*

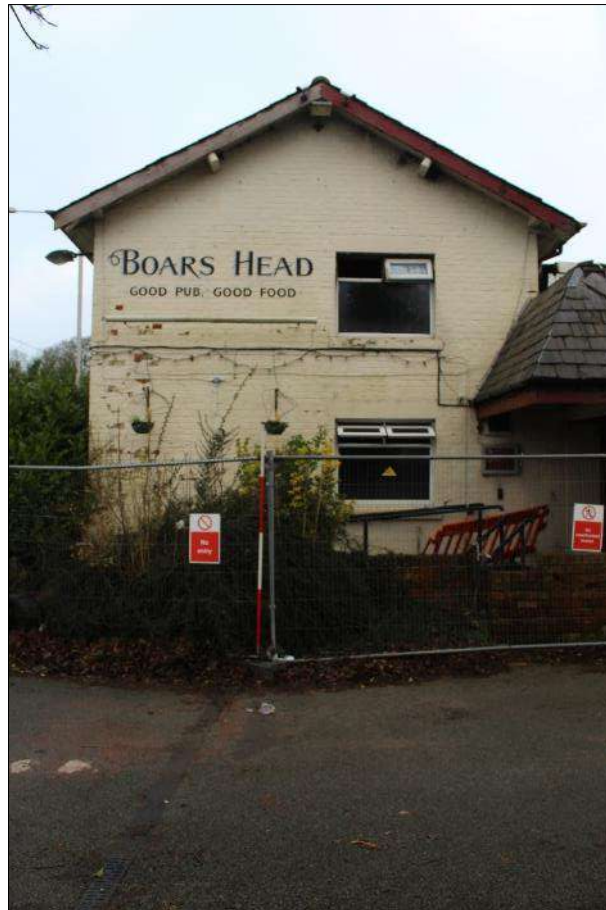
- 6.4 The south facing elevation has two off-centre and modern uPVC windows with stone lintels and sills, one on ground floor and one on first floor (Plate 4). This elevation is abutted by the porch of later Structure C.
- 6.5 The north and east elevations are entirely concealed by both Structure B and Structure C extension to the east, with only the roof visible from the rear.

*Plate 4 (shot 8): South elevation, looking north, 2m scale*

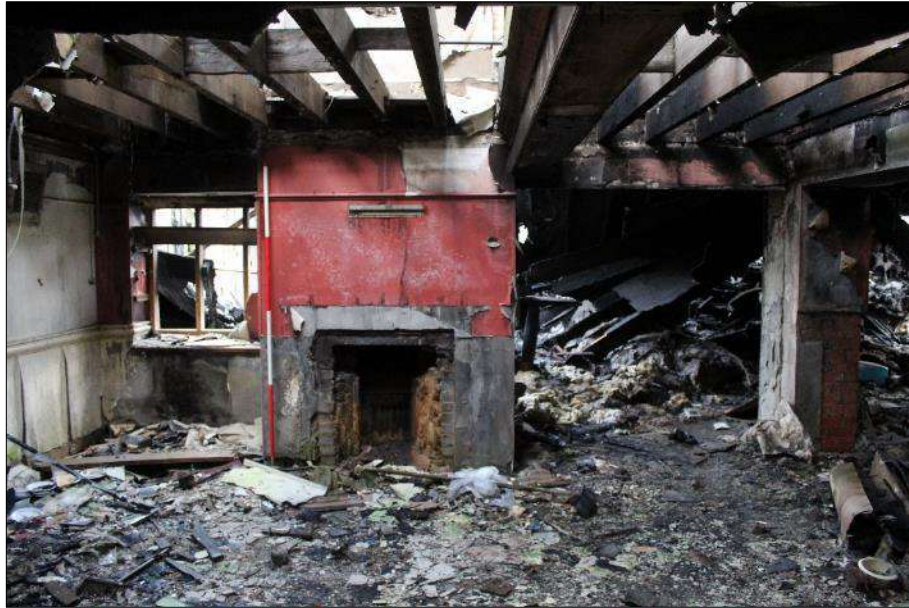
- 6.7 Modern paint and wallpaper cover the walls throughout. The majority of the walls are stained by fire damage, but in places the original colouring can be more easily distinguished, such as the wallpaper surrounding the fireplace (Plate 5).

- 6.8 The large floor joists were scorched by the fire. These were directly fixed into the brick wall and showed traces of laths and plaster from a former ceiling.

*Plate 5 (shot 44): General view of interior of original structure, looking north, 2m scale*

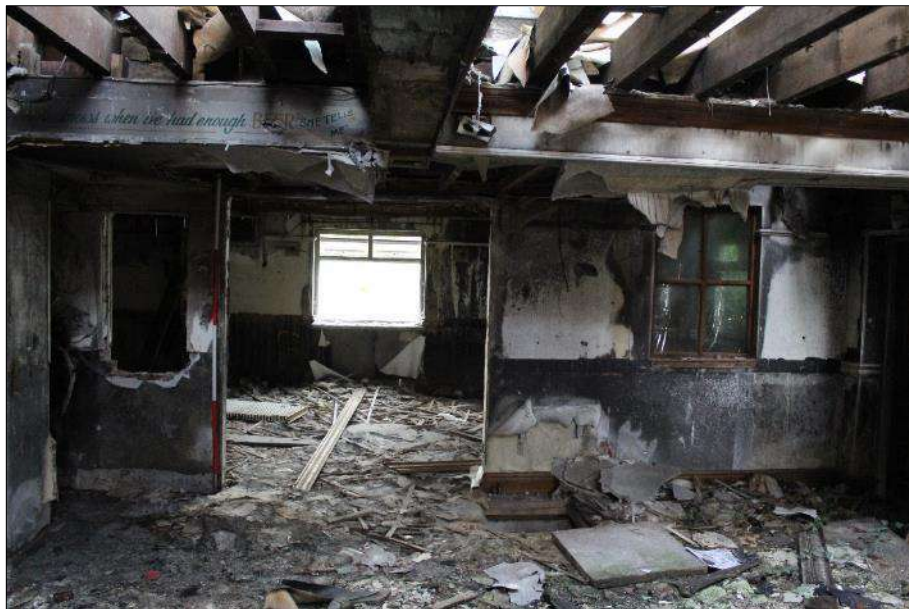
- 6.9 The ground floor is split into two rooms by a thin dividing brick wall containing two windows, though one of these windows is missing and only the window frame remains (Plate 6). The southern room measures c.6m x 4m, and has a modern uPVC window in both the western and southern elevations (Plate 7). The northern room contains the door in the west elevation, leading to Garstang Road, a modern uPVC window c.2m to the north of the door (Plate 8), and the fireplace, shown in Plate 5. The extant remains of the eastern elevation are limited to a few columns, as this wall was removed for accessibility following the erection of structures B and C. Later RSJs support the upper floor.

*Plate 6 (shot 48): General view of the dividing wall of the ground floor of the original structure, looking south, 2m scale*

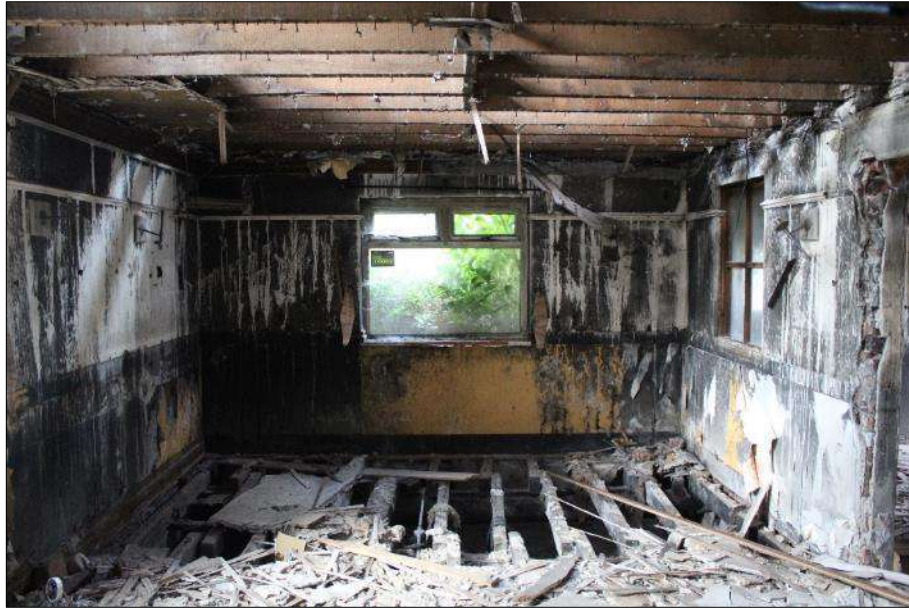
- 6.10 Floorboards were missing towards the west, revealing staggered floor joists (Plate 7).

*Plate 7 (shot 30): General view of southern room with western window, looking west*

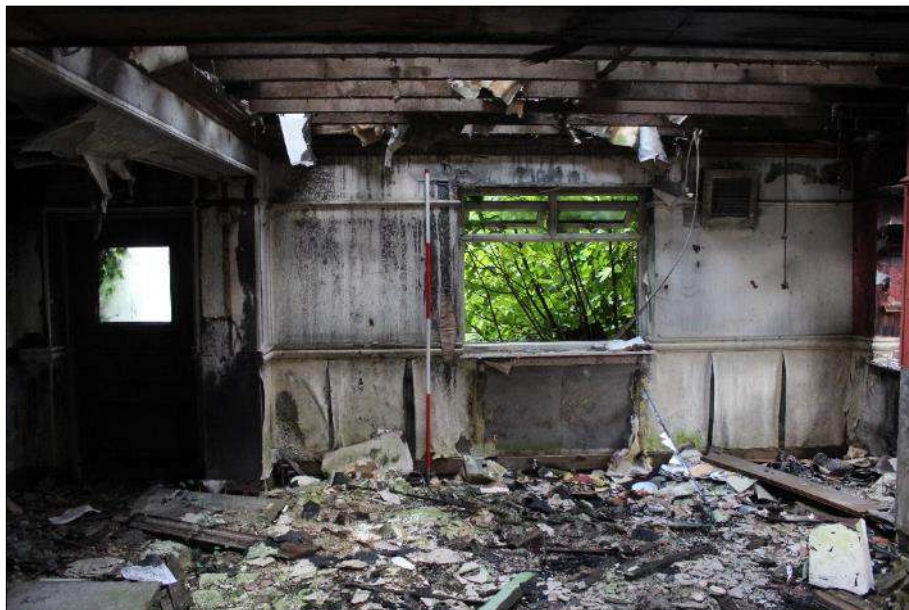
*Plate 8 (shot 46): General view of western elevation of northern room, looking west, 2m scale*

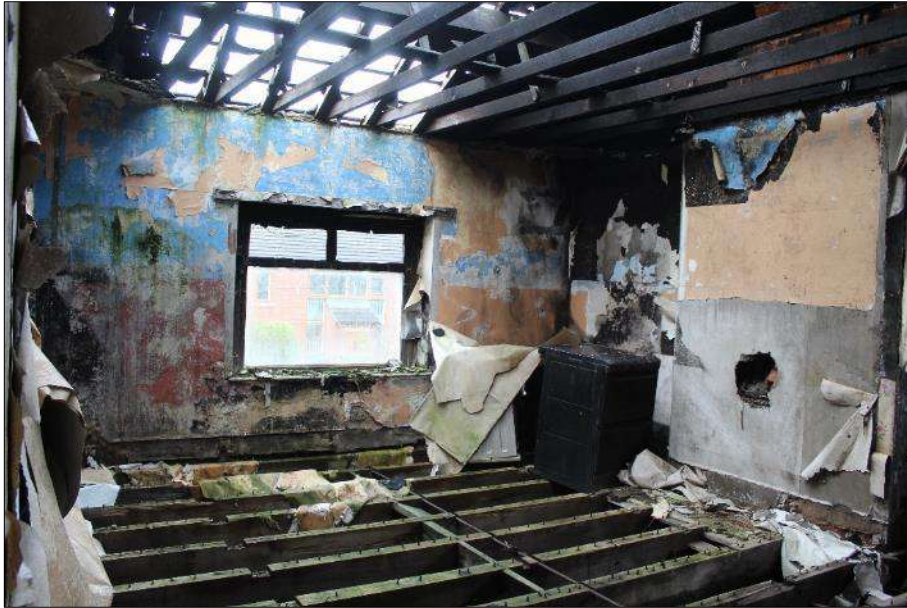
- 6.12 There are three rooms within the footprint of Structure A: one to the north measuring c.6m x 4.5m (Plate 9), one to the south measuring c.6m x 4m (Plate 10), and a small box room and presumably a former landing separating the previous two and measuring c.6m x 1.5m (Plate 11). The blocked up remains of fireplaces were visible in both the northern and southern rooms, and all rooms have been subject to extensive fire damage. This had burnt out all floorboards, greatly limiting access.

*Plate 9 (shot 66): General view of upstairs northern room, looking northwest*

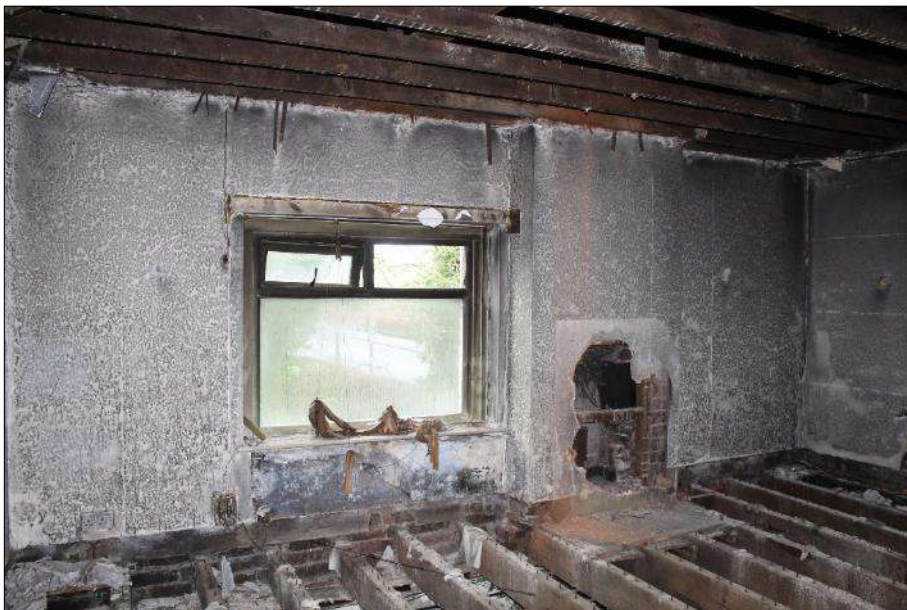
*Plate 10 (shot 69): General view of southern room, looking southwest*

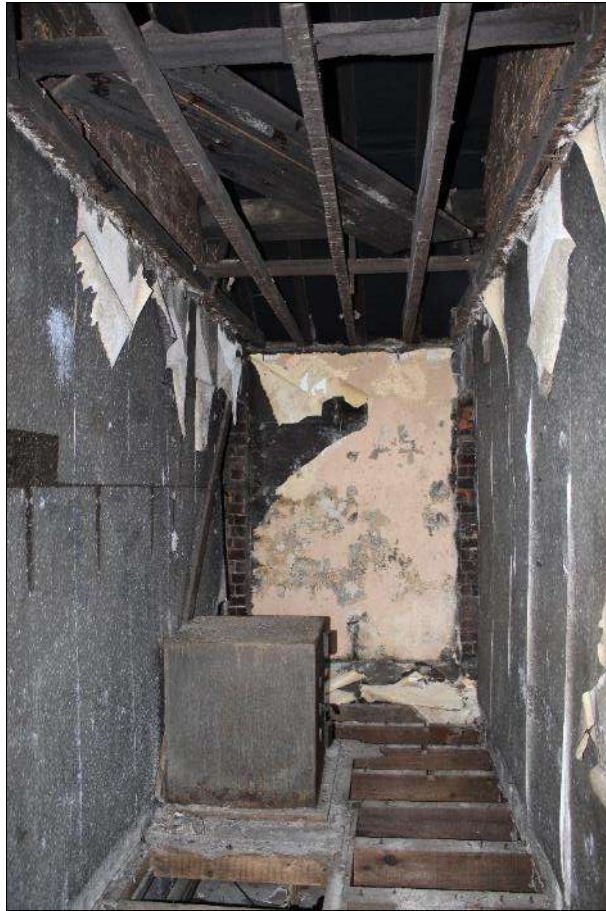
*Plate 11 (shot 68): General view of box room and former landing/hallway with a potential blocked window, looking west*

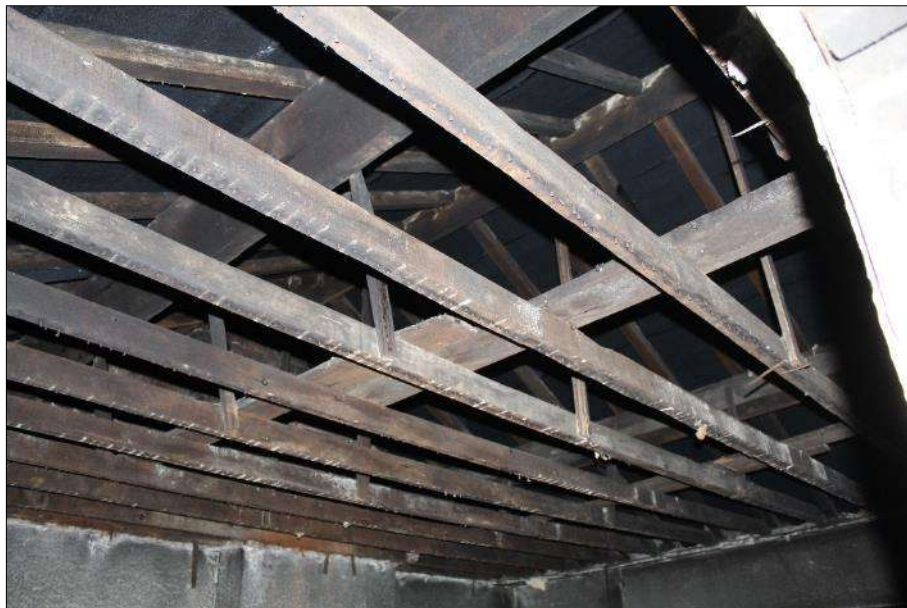
- 6.13 The roof structure comprised two heavy purlins supporting common rafters tied at the apex by a ridge plank (Plate 12).

*Plate 12 (shot 71): Representative view of the roof above Structure A. Looking southwest*

- 6.14 The rafters and ceiling joists displayed vertical saw kerf marks, evenly spaced and similar to those found in Structure B (6.20-6.21), suggesting these were sawn by a machine operated pit saw.

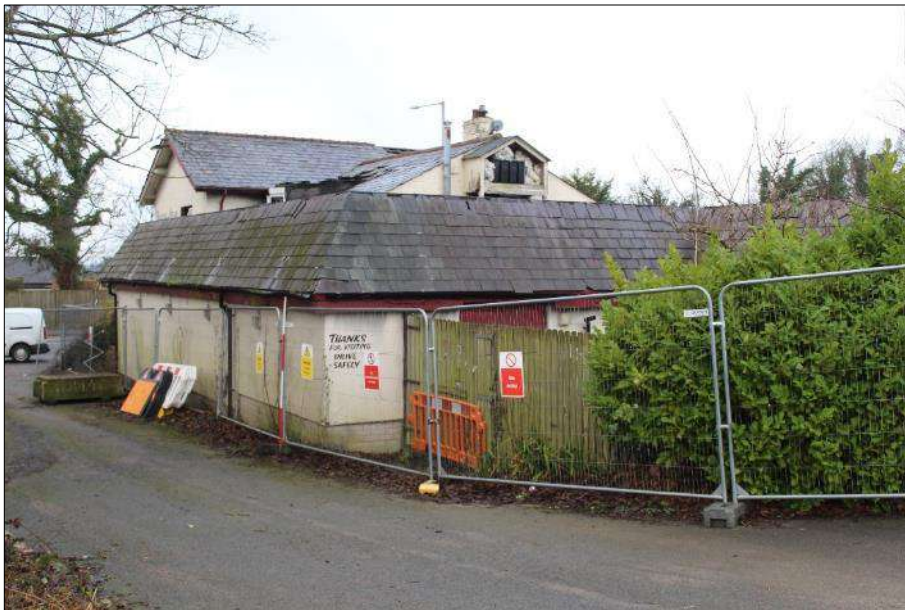
*Plate 13 (shot 12): General view of exterior of Structures A, B, and C, looking northwest, 2m scale*

- 6.16 A single, blocked, window with wooden frame is present at the gabled end of Structure B, with a more recent addition of a flue pipe located around one metre to the south (Plate 13).

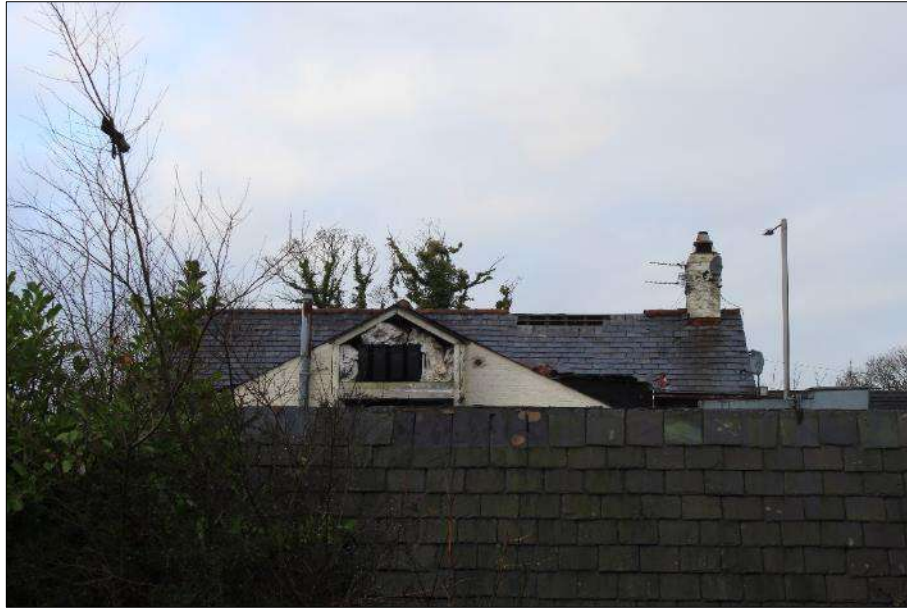
*Plate 14 (shot 28): General view of gabled end of Structure B, looking west*

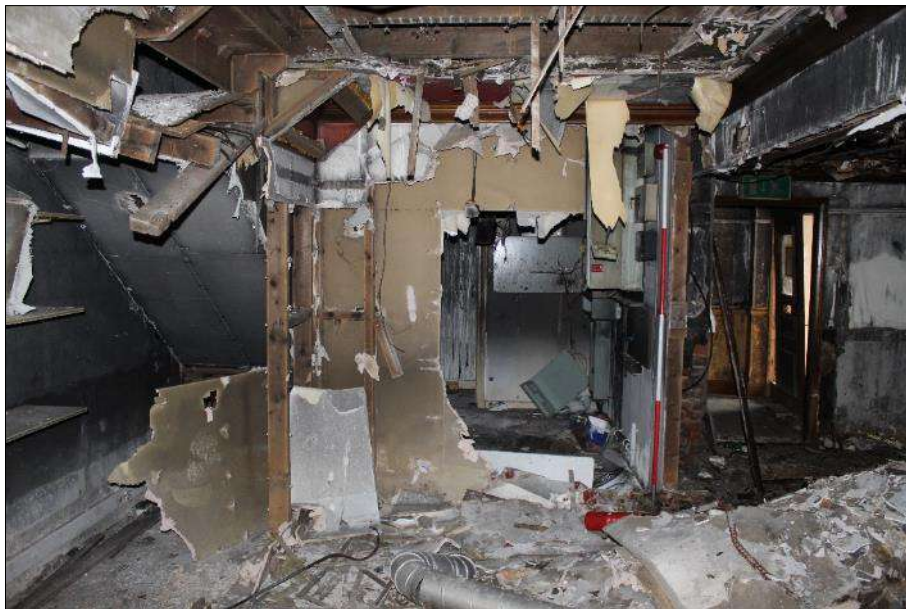
- 6.17 The ground floor of Structure B features a number of small rooms connected to a central hallway, such as toilets and storage areas. These rooms are for the most part divided by stud walls many of which have been wholly or partially removed (Plate 15). Some of the walls are older exterior brick walls of Structure B, with modifications for access.

*Plate 15 (shot 39): General view of the ground floor of Structure B, showing partially removed plasterboard panelling, looking south, 2m scale*

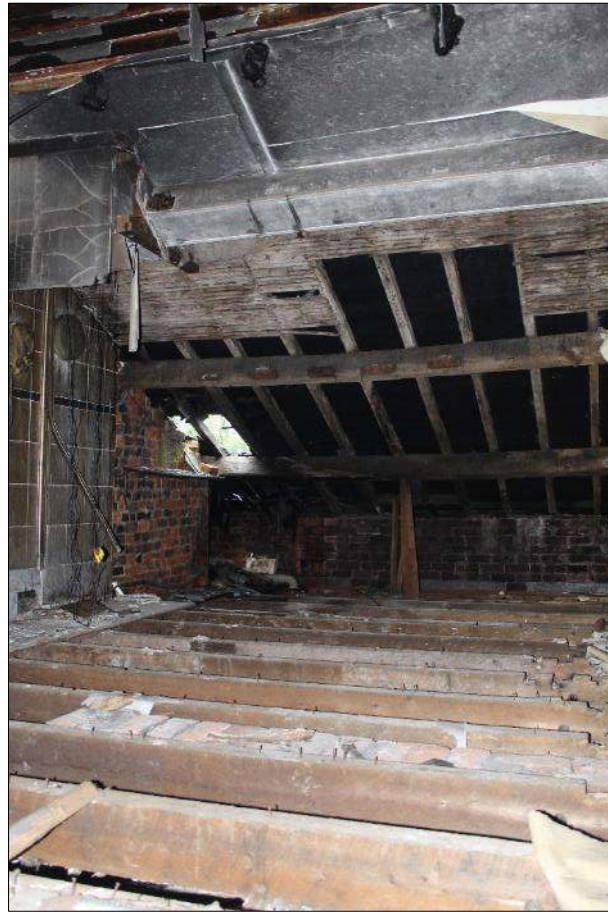
- 6.18 The first floor of the interior of Structure B includes a large open plan area to the east, measuring c.8m x 4m, and is accessed directly from the stairway. This room was previously divided by stud walls, judging by the remains of a tiled shower area at the northern end of the room (Plate 16).

*Plate 16 (shot 94): General view of the first floor of Structure B, looking northwest*

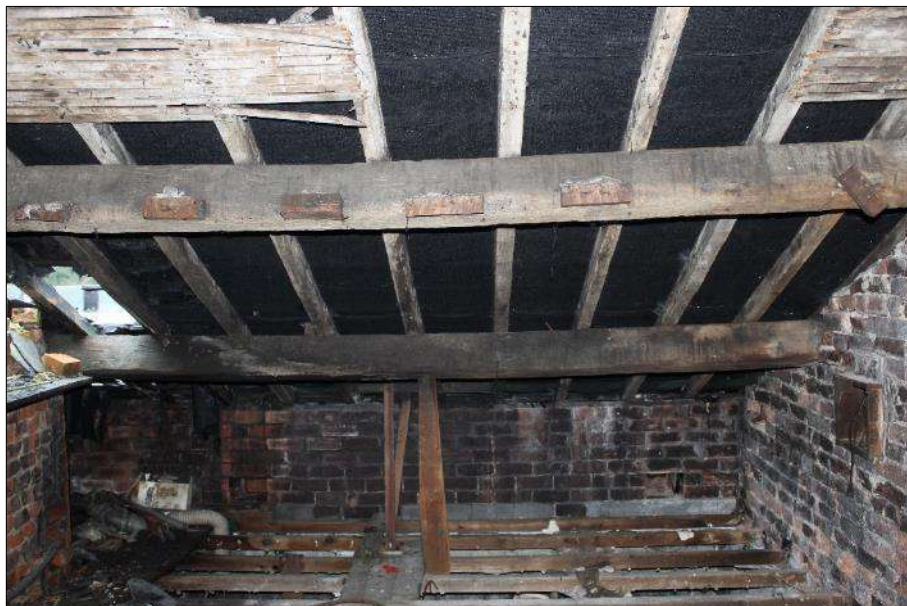
- 6.19 The roof structure comprises purlins supporting common rafters. The apex was blocked from view by painted laths. The rafters were also painted, and were placed around 0.7m apart (Plate 17).

*Plate 17 (shot 89): General shot of the gabled roof of Structure B, looking north*

- 6.20 The purlins displayed axe/adze marks where the bark had been removed. These were crossed by saw kerf marks, indicating the post-processing of the timber, when it was cut into logs. The marks appeared to be vertical and evenly spaced, suggesting these were sawn by a machine operated pit saw.

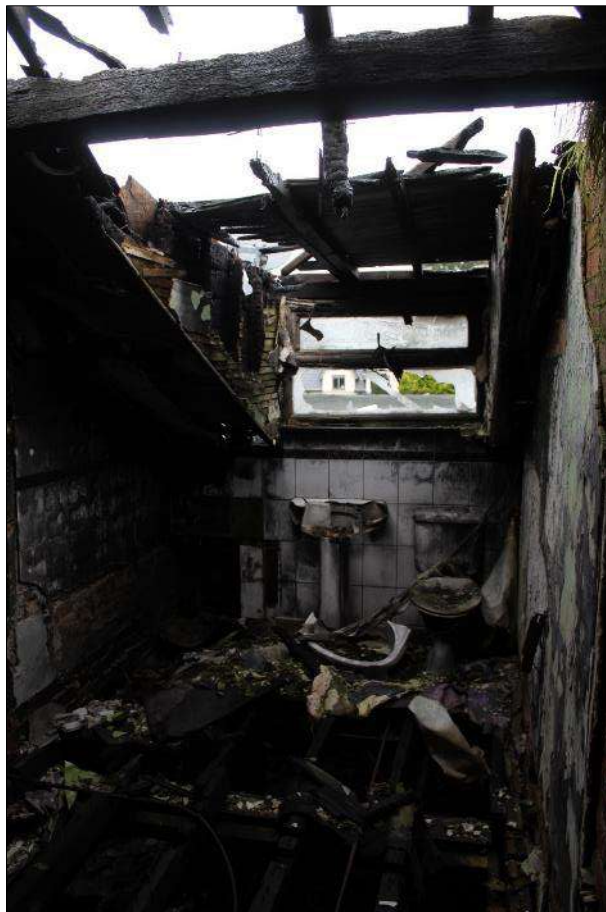
- 6.22 There are two further rooms on the first floor of Structure B; a bathroom on the northern side (Plate 18), and a small box room on the southern side, separated by a thin hallway that also connects to the first-floor chamber rooms of Structure B. Both the bathroom and the box room contained modern windows with top opening casement, the bathroom window is fitted within a later added dormer.

*Plate 18 (shot 74): General view of first floor bathroom, looking north*

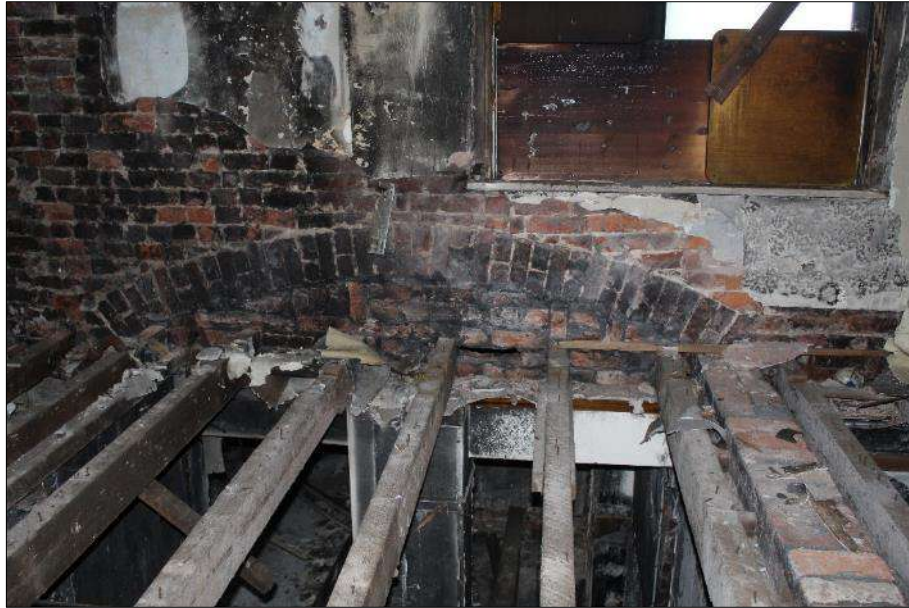
- 6.23 A tall segmental arch was visible on the northeast wall and may suggest the structure was originally used as a coach house (Plate 19).

*Plate 19 (shot 84): Segmental arch on the northeast wall. Looking east-northeast*

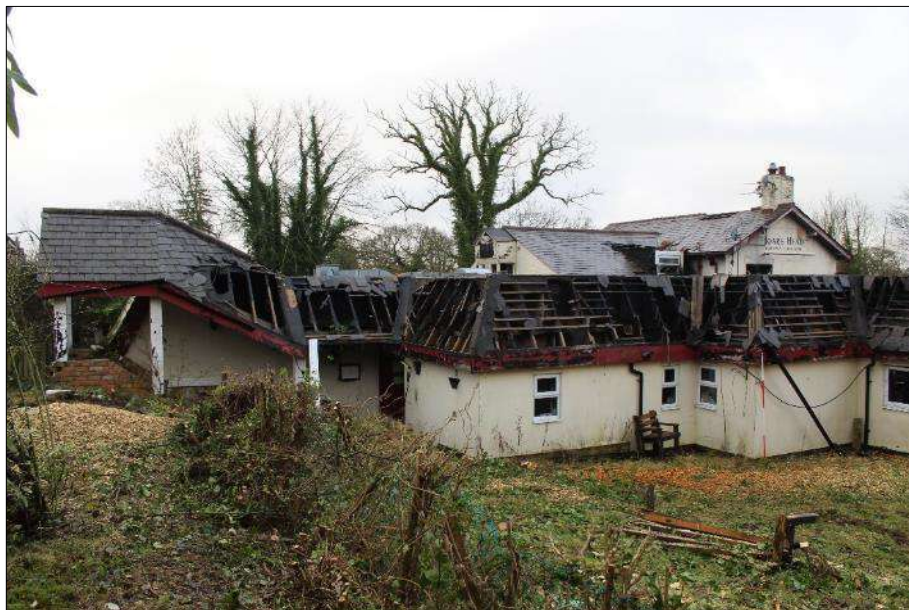
*Plate 20 (shot 18): General view of Structure C to the rear, looking southwest, 2m scale*

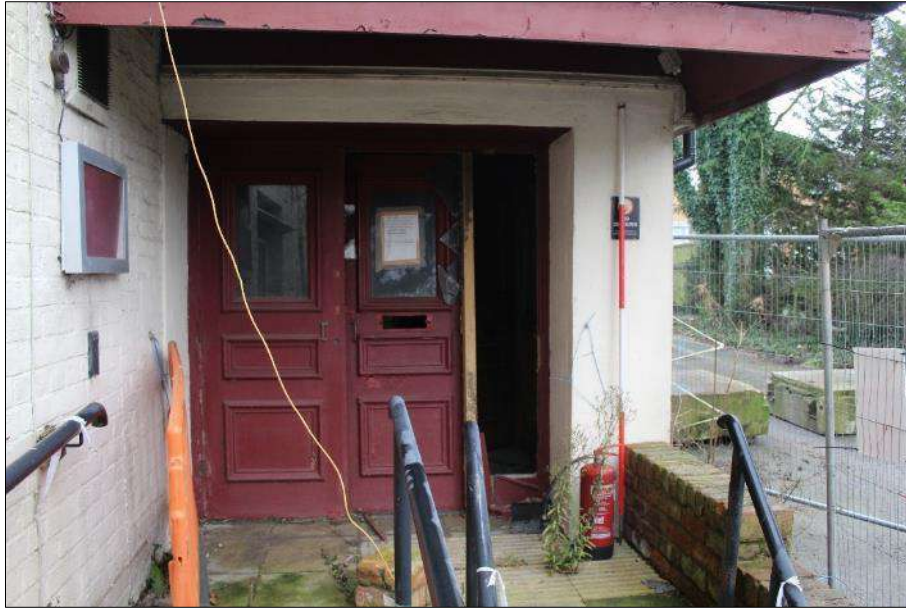
- 6.24 The majority of the Boar's Head footprint belongs to Structure C, an extension undertaken in the 20<sup>th</sup> century that extends the ground floor space substantially to the north and east (Plate 18), enclosing the original building. Structure C is a single-storey structure with a flat mansard roof covered in slate. The external walls are probably of cavity wall construction, and are of rendered brick with occasions of exposed brickwork at the base of the walls in stretcher bond. There are two entrances to Structure C, one to the rear of the property through a columned overhang (see left of Plate 20), and one abutting the south side of Structure A (Plate 21).

*Plate 21 (shot 11): Front entranceway to Structure C, looking east, 2m scale*

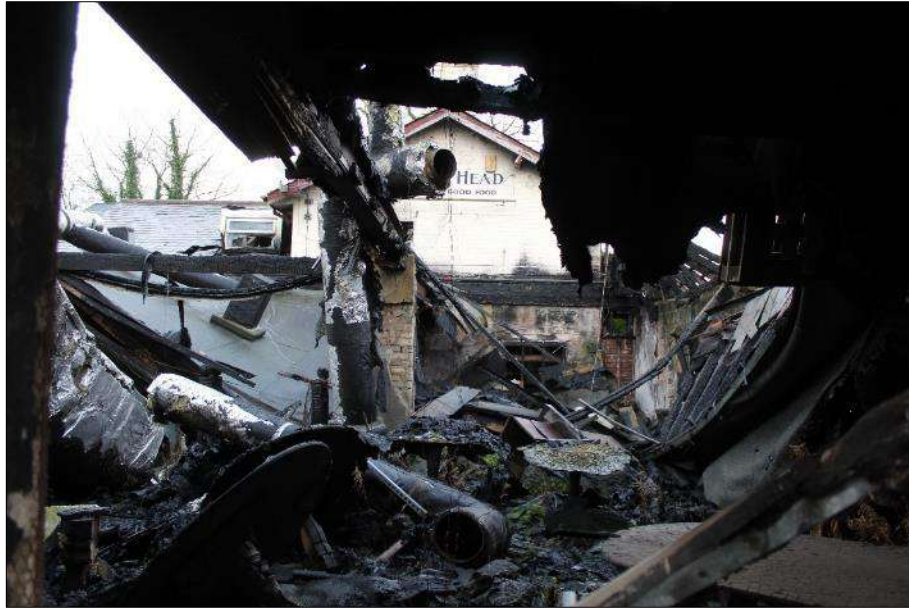
- 6.26 The majority of Structure C was inaccessible due to the structural damage caused by fire, resulting in disturbance of asbestos on the property and causing a significant health and safety risk (SPA 2020). Where possible, representative photographs were taken from strategic positions outside of the property or from within A and B (Plate 22).

*Plate 22 (shot 22): General view of the interior of the northern side of Structure C, looking south-southeast*

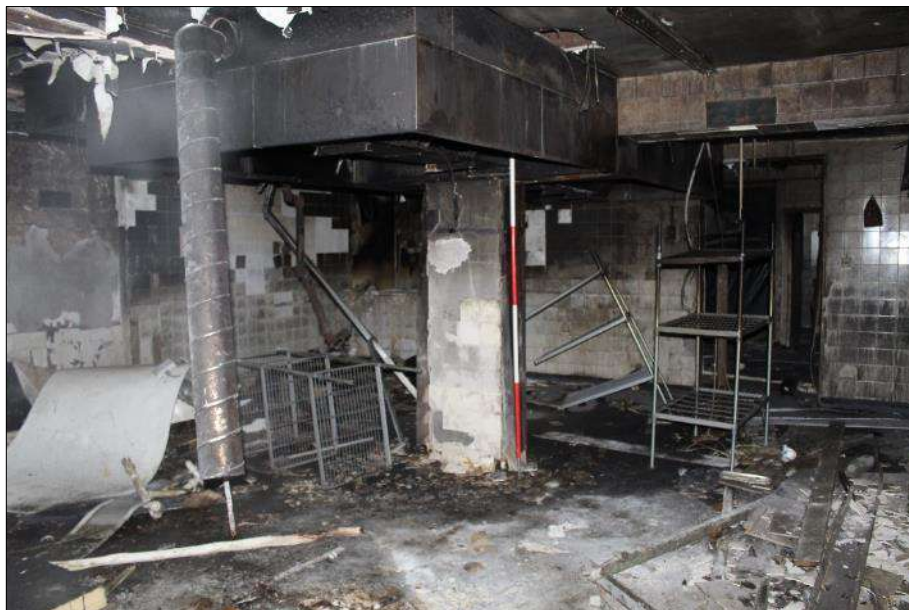
*Plate 23 (shot 58): General view of the larger kitchen of Structure C, looking northeast, 2m scale*

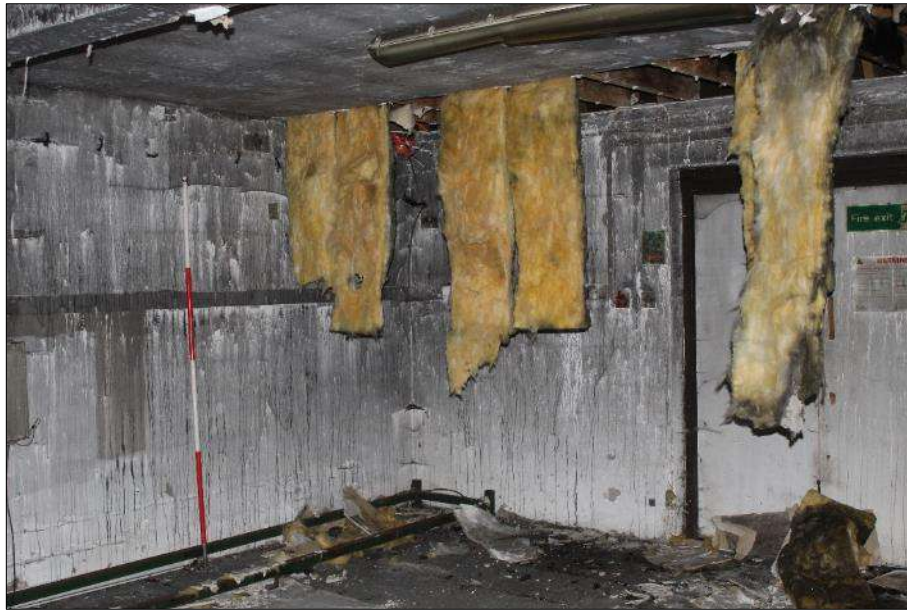
*Plate 24 (shot 41): General view of the smaller kitchen of Structure C, looking northeast, 2m scale*

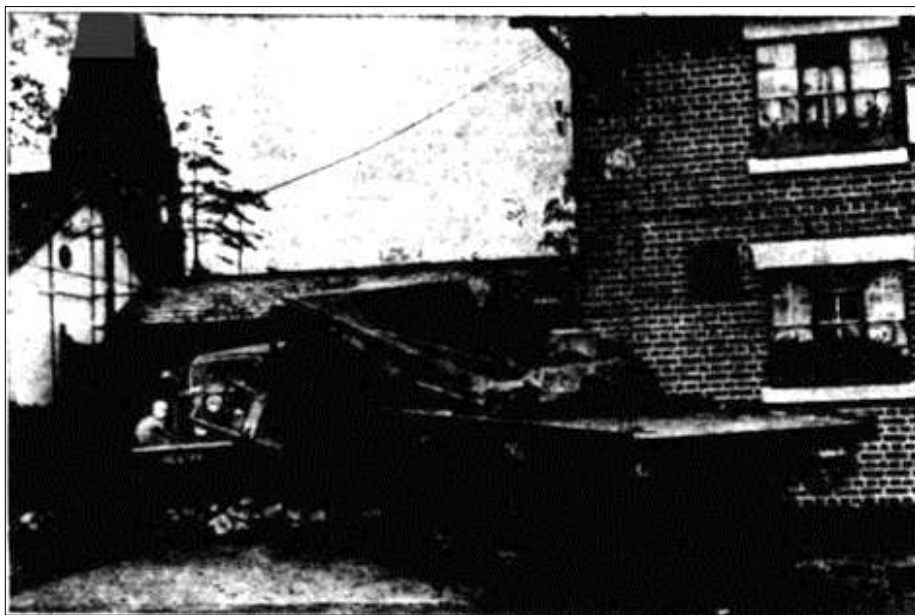
*Plate 25: Car crash in front of Boar's Head Hotel in 1954. Notice the unrendered walls and late 18<sup>th</sup> century style windows (Lancashire Evening Post)*

- 7.9 It is possible the crash in 1954 shown in the image above prompted repairs to the extension, which may have been replaced or extended to flank the roadside and as seen in (Figure 5).
