BUILDING SURVEY REPORT:
TOWNGATE HOUSE FARM, TOWNGATE WEST,
MARKET DEEPING, LINCOLNSHIRE

Planning Reference: N/A
NGR: TF 13258 10852
AAA Site Code: MADE 09
LCCM Accession Number: 2009.004
Oasis Reference: allenarc1_56812

Allen Archaeological Associates
Report Number 2009/011

March 2009

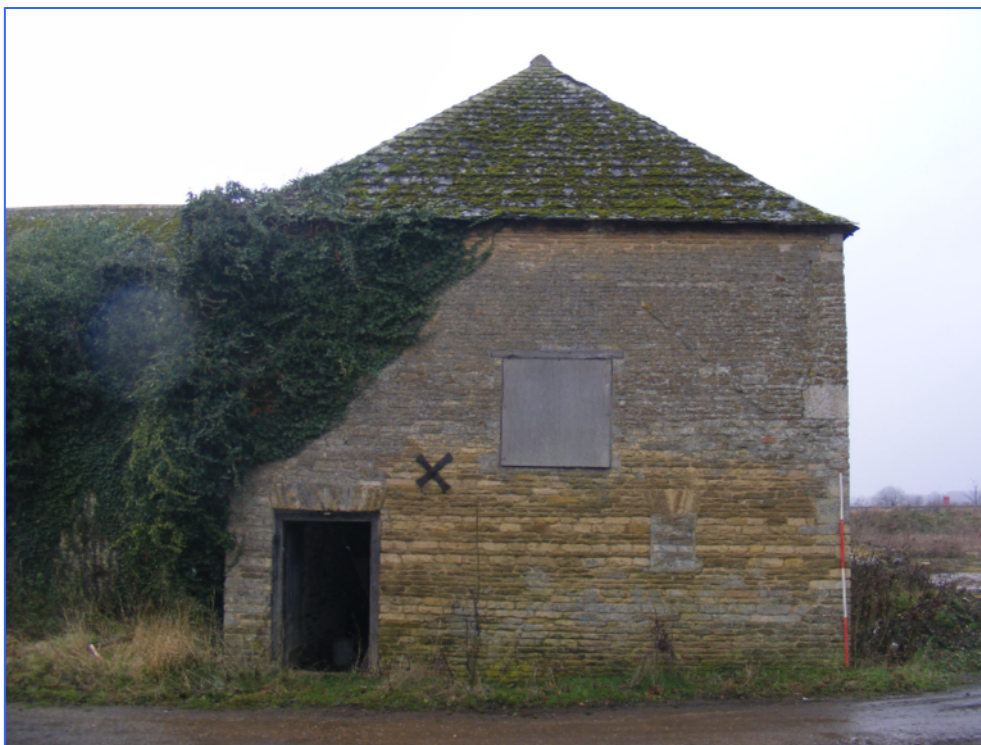
Plate 3 (Shot 90): East elevation of oast house, looking west-south-west. Note the faint roof scar on the north side of this elevation.

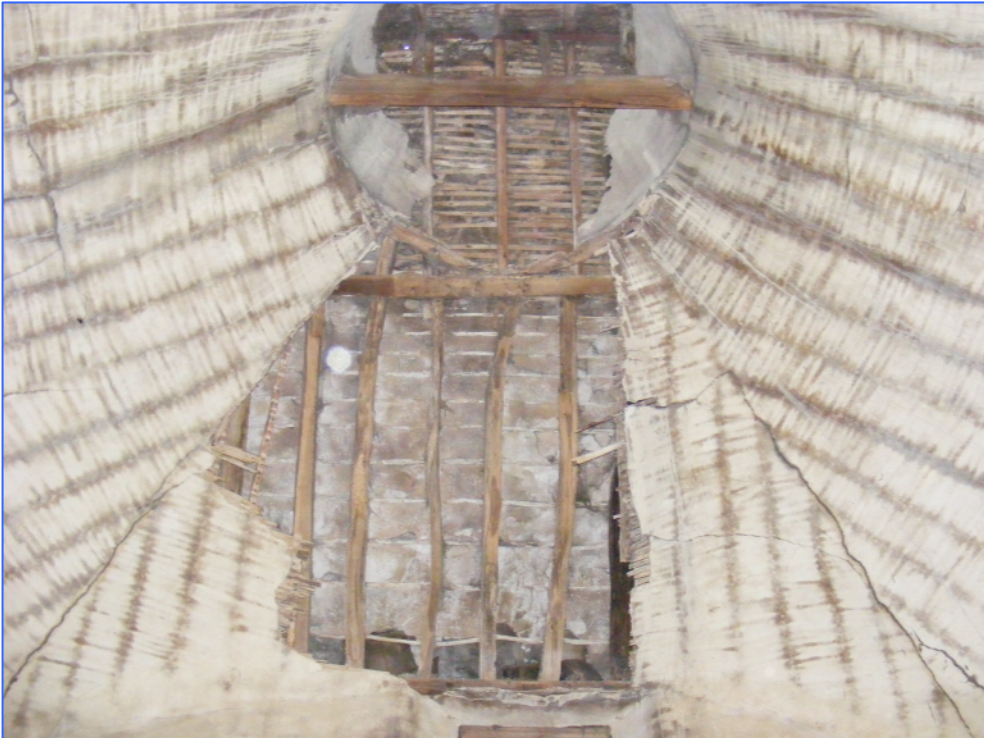
- 5.1.11 The original plasterwork beneath the roof in the oast house is a rare survival, but is in a poor state of repair with several large cracks, and an area to the north that has fallen away completely (Plate 6). Without urgent remedial work taking place, further episodes of collapse of this plasterwork are likely to be imminent.

Plate 6 (Shot 77): Roof structure of oast house, looking north, showing area of recent collapse.

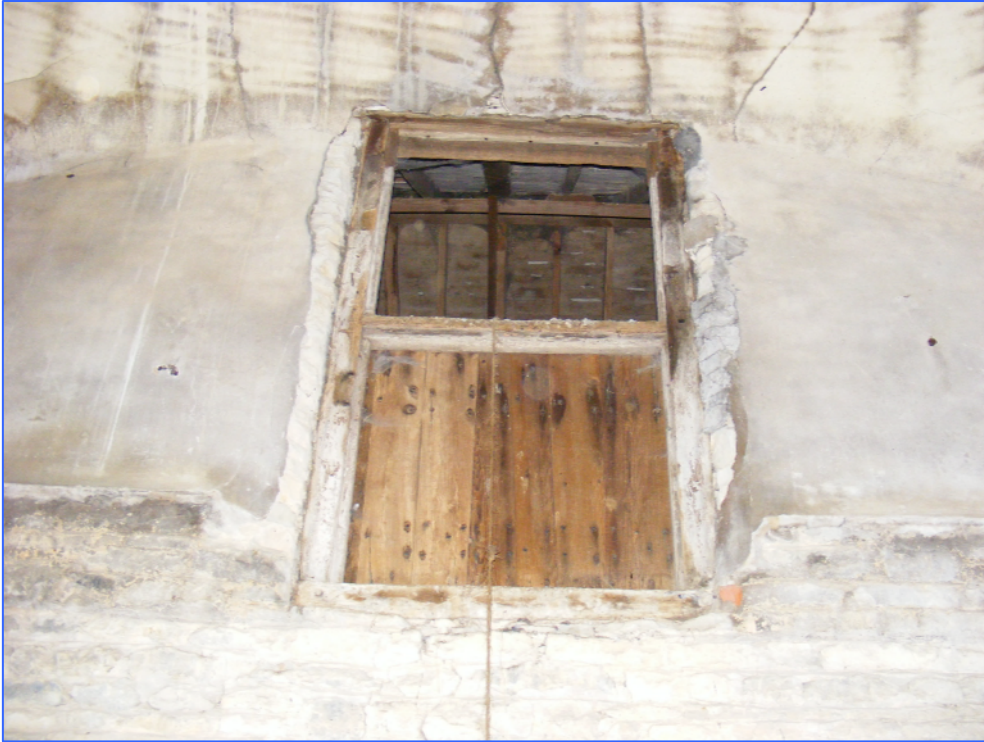
Plate 7 (Shot 83): Partially blocked doorway between the oast house and barn, looking west-south-west.

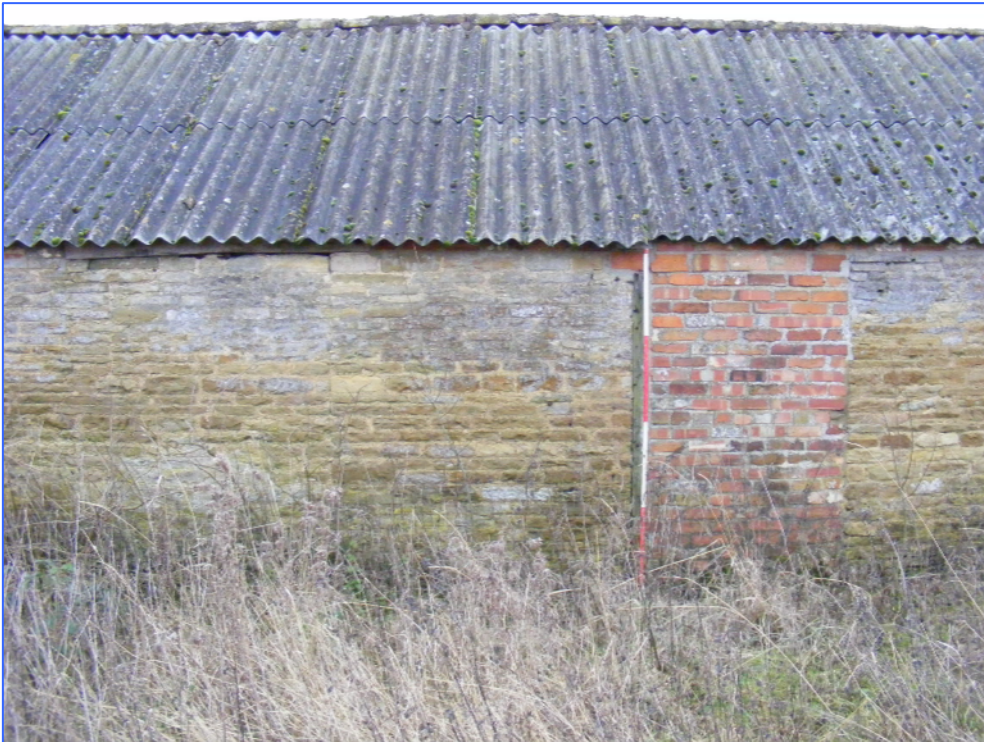
- 5.5.2 The north elevation is in coursed limestone (Plate 28). There are two blocked doorways visible approximately in the centre of the elevation, one blocked in stone and the other in brick (Plate 34). The south elevation is faced in breeze blocks, representing a later repair (Plate 35). There are eleven wooden stable doors in this elevation, two of which access room E5, and one each for the remaining nine rooms. All the rooms in this range were painted the same as D1 to D9, with the lower half in black and the upper half in white.

Plate 34 (Shot 32): Detail of blocked doorways in north elevation of Building E, looking south-south-east.

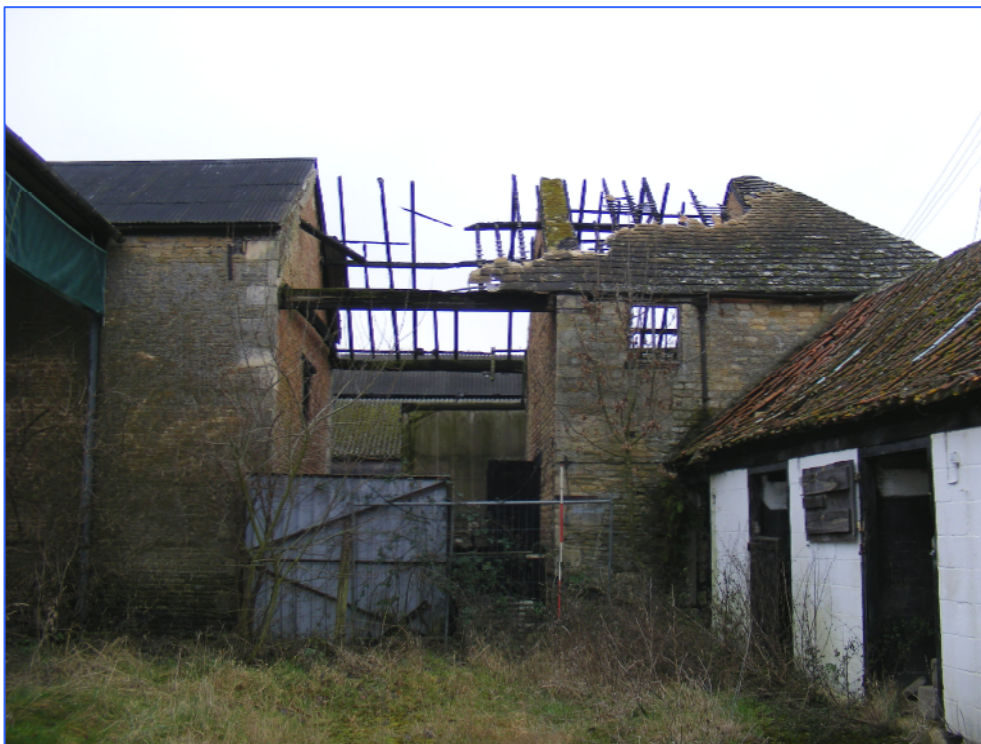
- 6.8 Barn F is in a poor state of repair, having suffered fire damage to the roof, to the south elevation, and to a covered passage that extended to the threshing barn to the south.

Plate 39 (Shot 60): East elevation of Building F, looking west-south-west, showing fire damage to the roof.

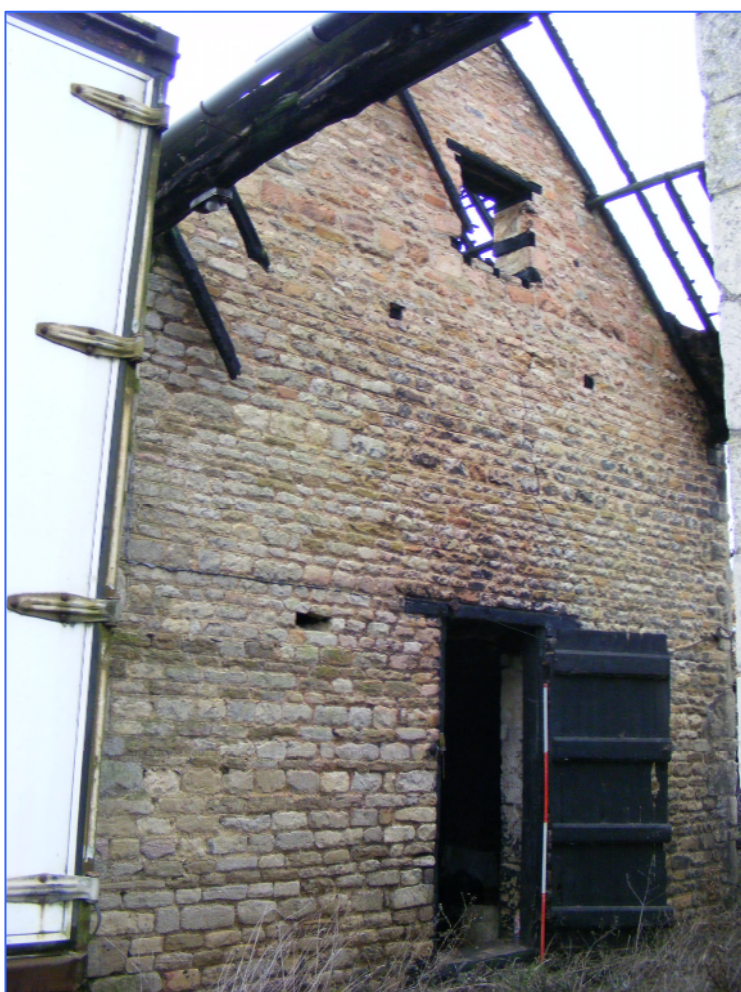
Plate 40 (Shot 67): South elevation of Building F, showing extent of fire damage, looking north-east.

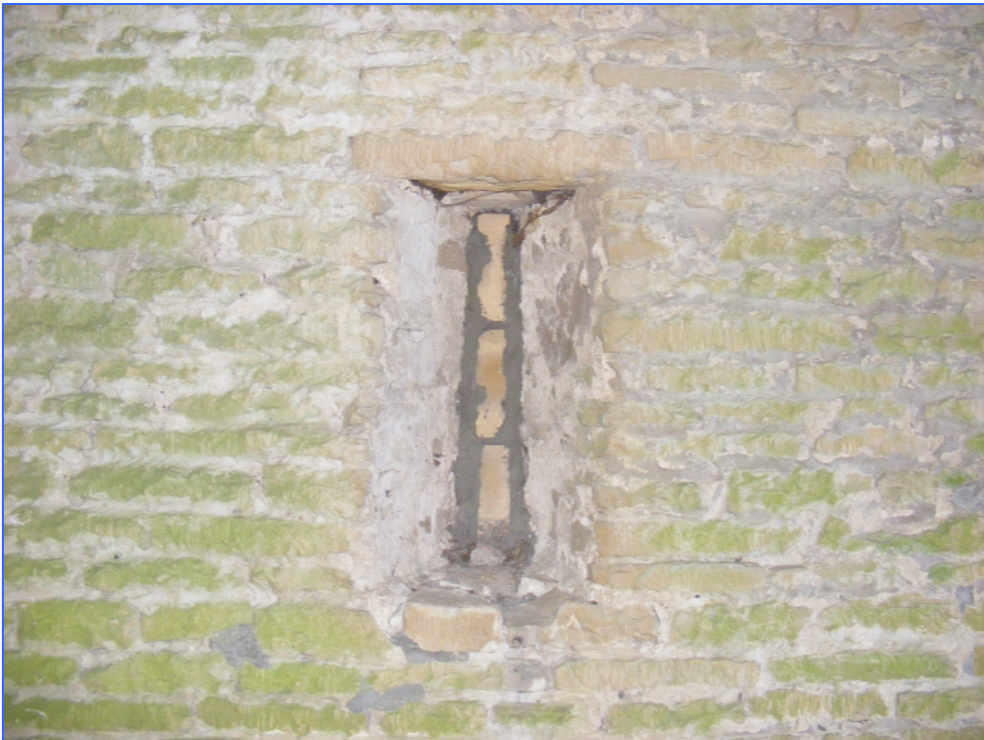
Plate 46 (Shot 113): Detail of blocked ventilation slit, internal east elevation of Building G, looking east-north-east.

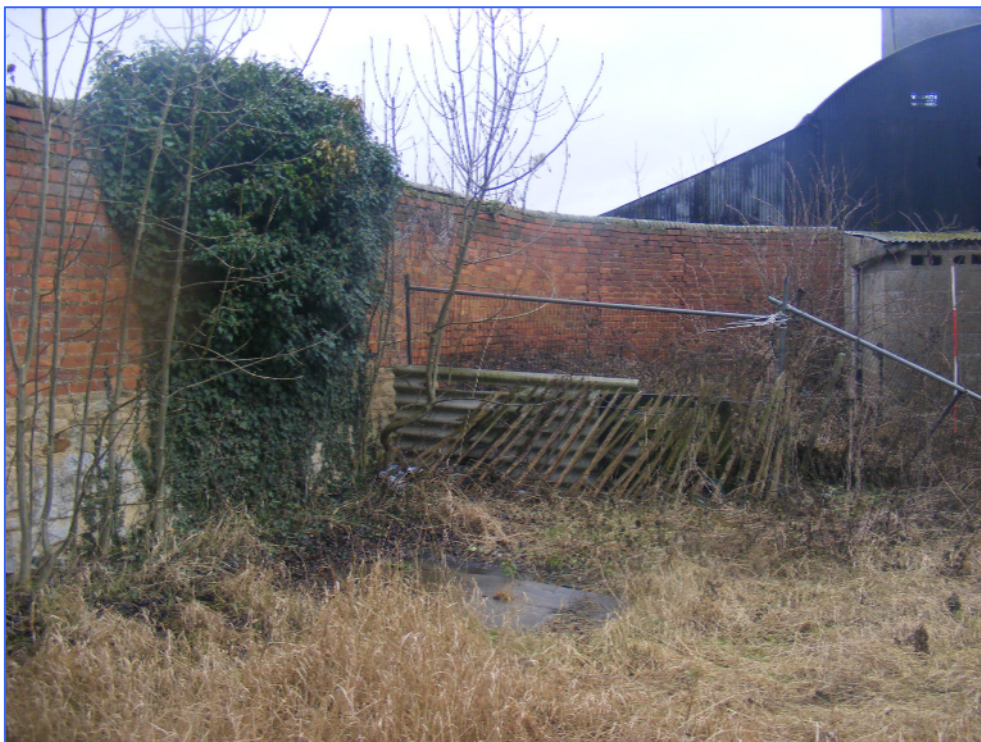
interior of the wall, and part of the eastern wall have been repaired in brick stretcher bond with half-round capping bricks (Plates 51 and 52).

Plate 51 (Shot 103): Brick repair to west end of garden boundary wall, looking north-north-west.
