**ARCHAEOLOGICAL BUILDING SURVEY REPORT:  
THE OLD COACH HOUSE, CHURCH LANE  
EDINGALE, STAFFORDSHIRE**

Planning Reference: 10/01214/LBC  
NGR: SK 21438 12128  
AAL Site Code: EDOV 10  
OASIS Reference Number: allenarc1-90310

By  
Allen Archaeology Limited  
Report Number 2010079

December 2010

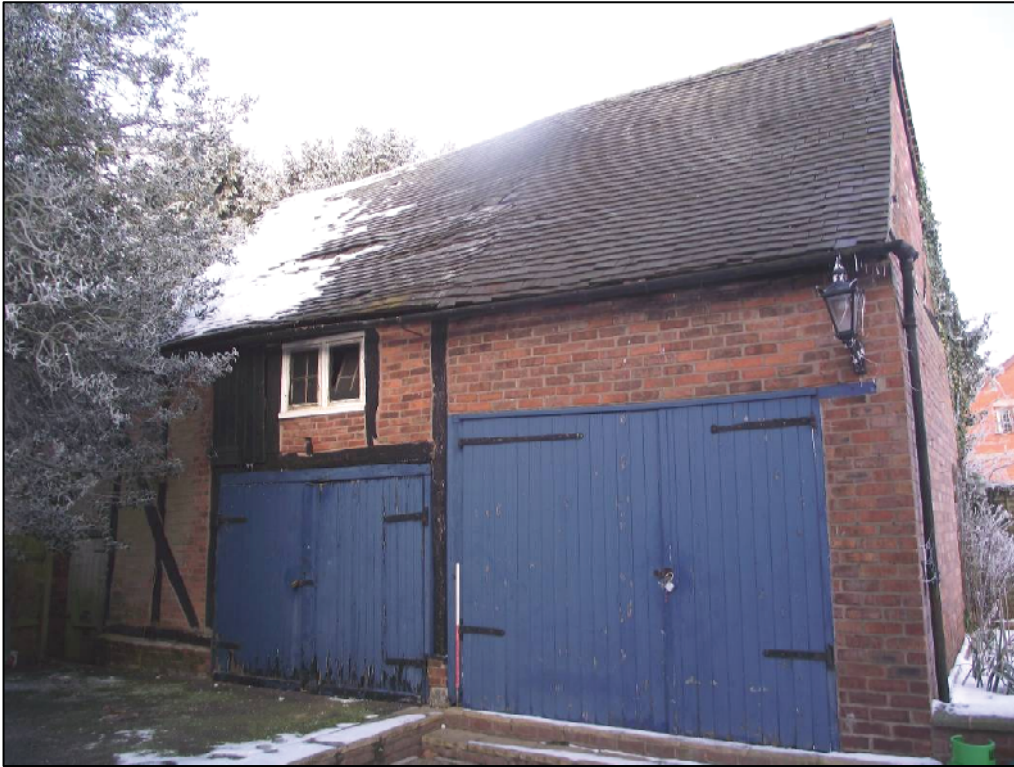
- 6.3 The south elevation contains two sets of vertical planked outward opening double wooden doors, one in each of the two bays (Plate 1). A pair of bottom opening casement windows, or hopper windows, sit above the door to the left, with a square pitching hole with wooden shutter to the left of this window. A modern gutter runs along the eaves to a downpipe at the south-east corner of the building.

**Plate 1 (Shot 1):** South elevation of building, looking north-west. Note two phase construction, with earlier part to the left

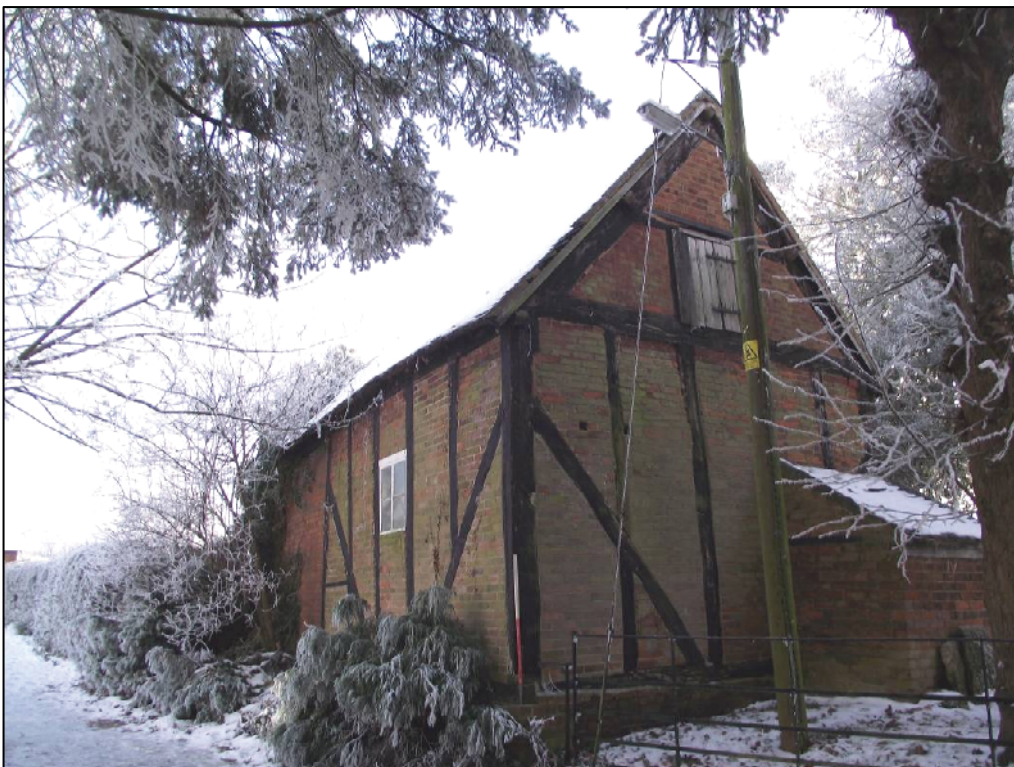
- 6.5 Also in the west gable there is evidence for a brick repair in the eaves (Plate 2), possibly occasioned due to a failing wooden beam below, which has since been replaced. A square pitching hole sits beneath this beam, covered by a wooden shutter with metal strap hinges (Plate 4).

**Plate 2 (Shot 5):** North-west corner of the coach house showing timber framed construction of north and west elevations. Looking east-south-east

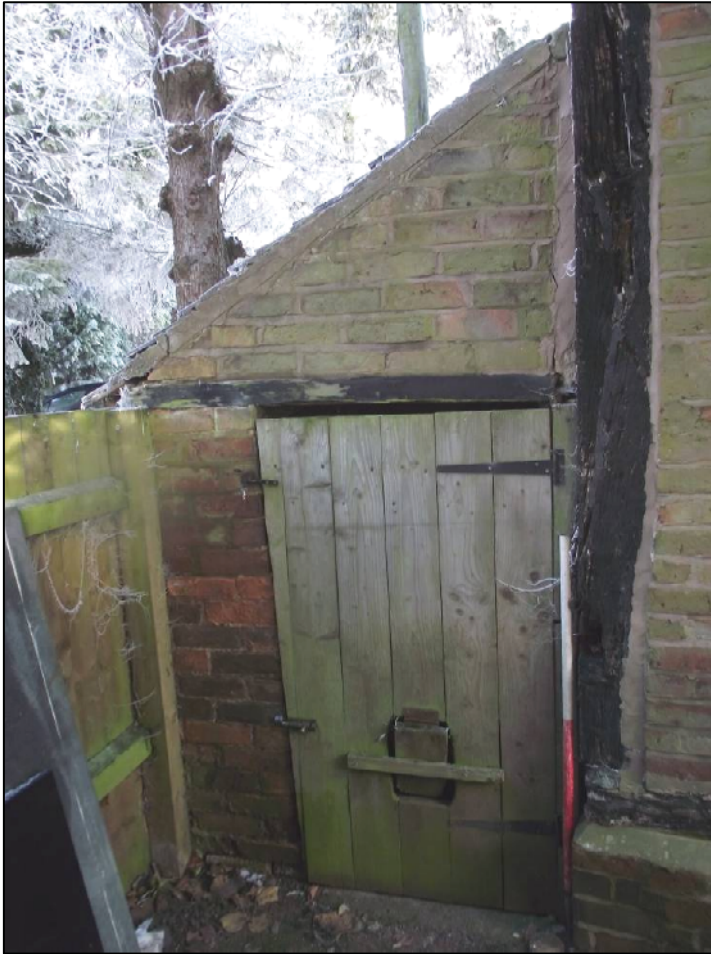
- 6.4 A brick built coal store with a single pitched roof is attached to the south end of the west elevation of the building, which appears to represent a later addition. Horizontal wooden beams, one serving as a lintel over the modern door, were observed on all elevations of the structure at eaves height (Plate 3).

**Plate 3 (Shot 6):** Coal store on the south-west corner of the building. Looking north

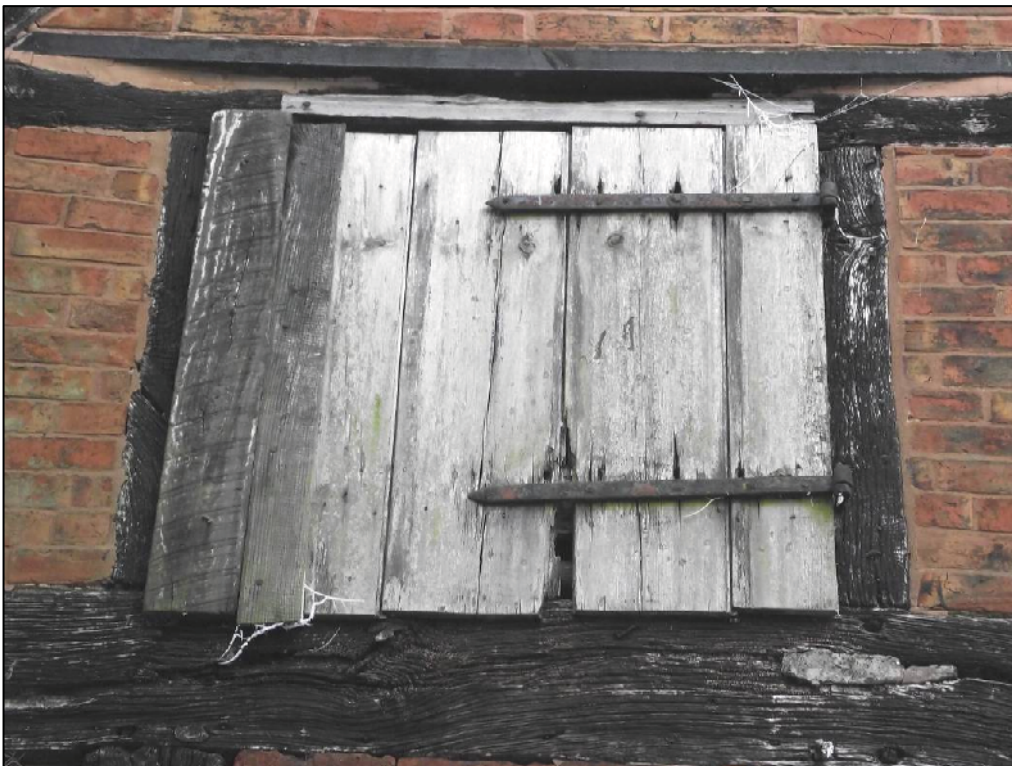
**Plate 4 (Shot 8):** Detail of pitching hole in west elevation, with replacement beam above. Looking east

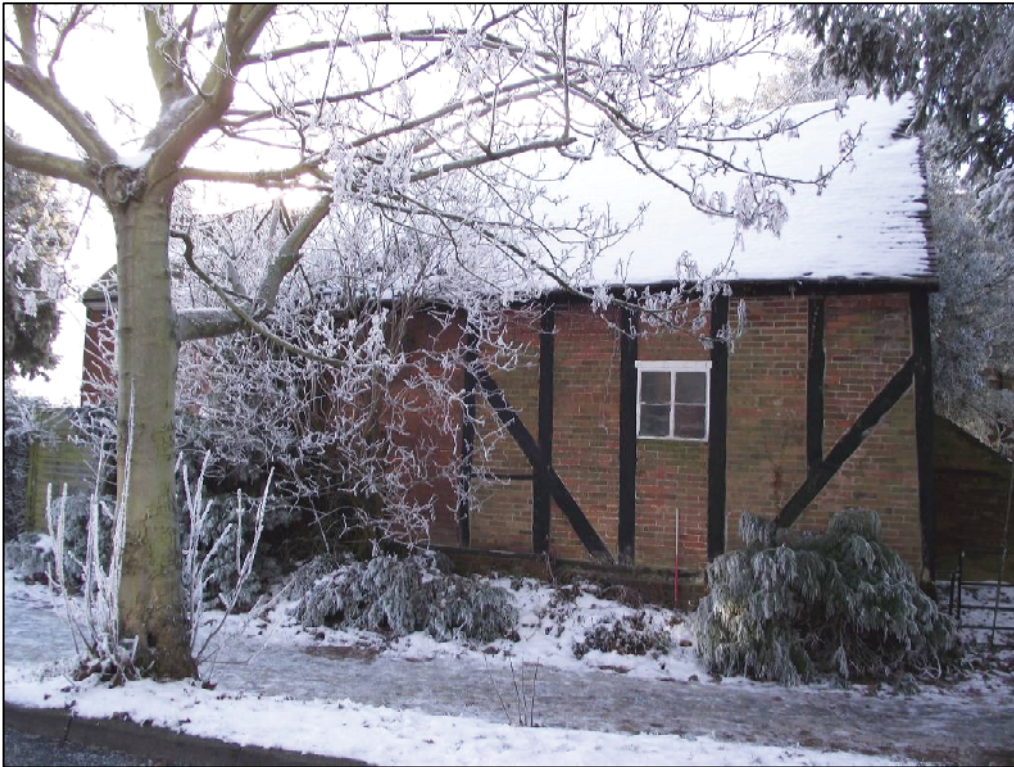
- 6.6 The western bay of the north elevation also has a later addition of a square four light window with a wooden frame, and modern wire-reinforced glazing (Plate 5).

**Plate 5 (Shot 4):** North elevation showing later added window. Looking south

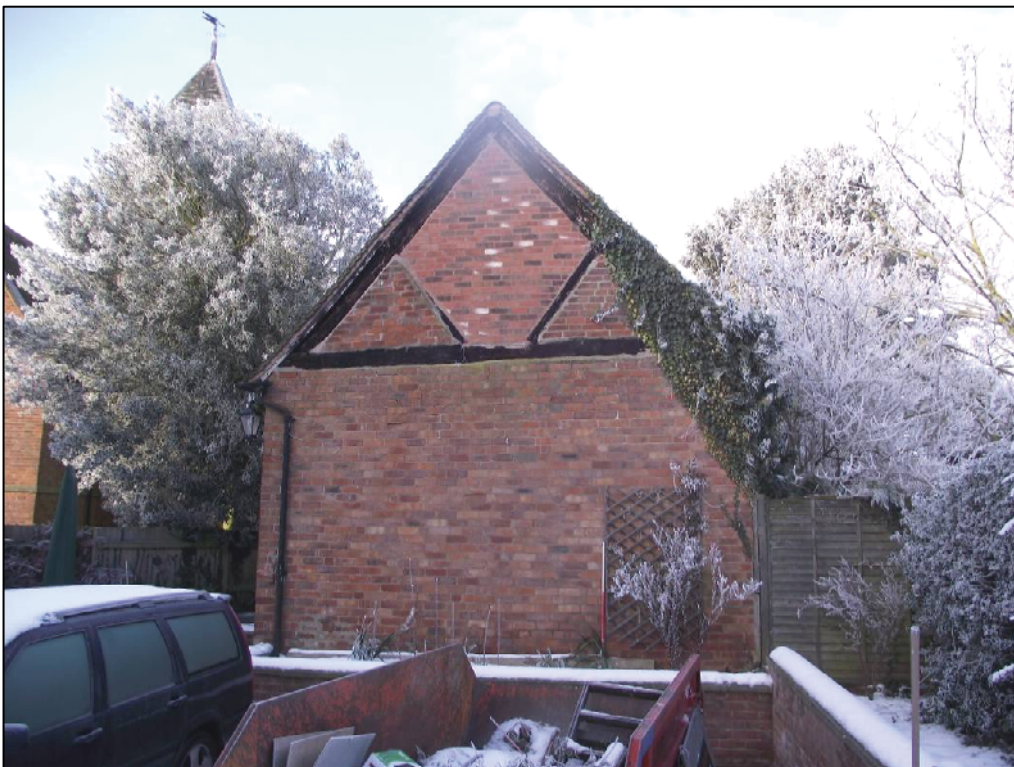
- 6.7 In a possible attempt to keep with the earlier style of the building, the east elevation has exposed wooden rafters, tie beam and supporting bracing struts, with a modern brick repair evident between the diagonal struts (Plate 6).

**Plate 6 (Shot 3):** General view of the east elevation of the later extension. Note the exposed roof structure and the modern brick repair. Looking west

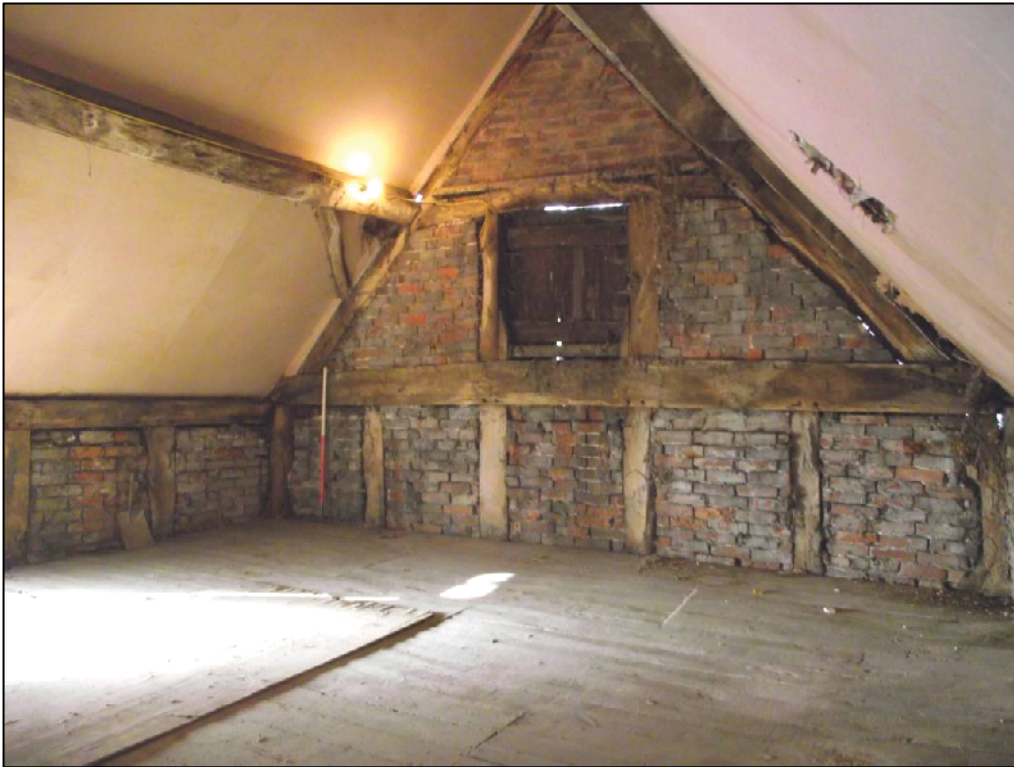
**Plate 7 (Shot 15):** Representative shot of the queenpost truss in the west gable. Looking west-south-west

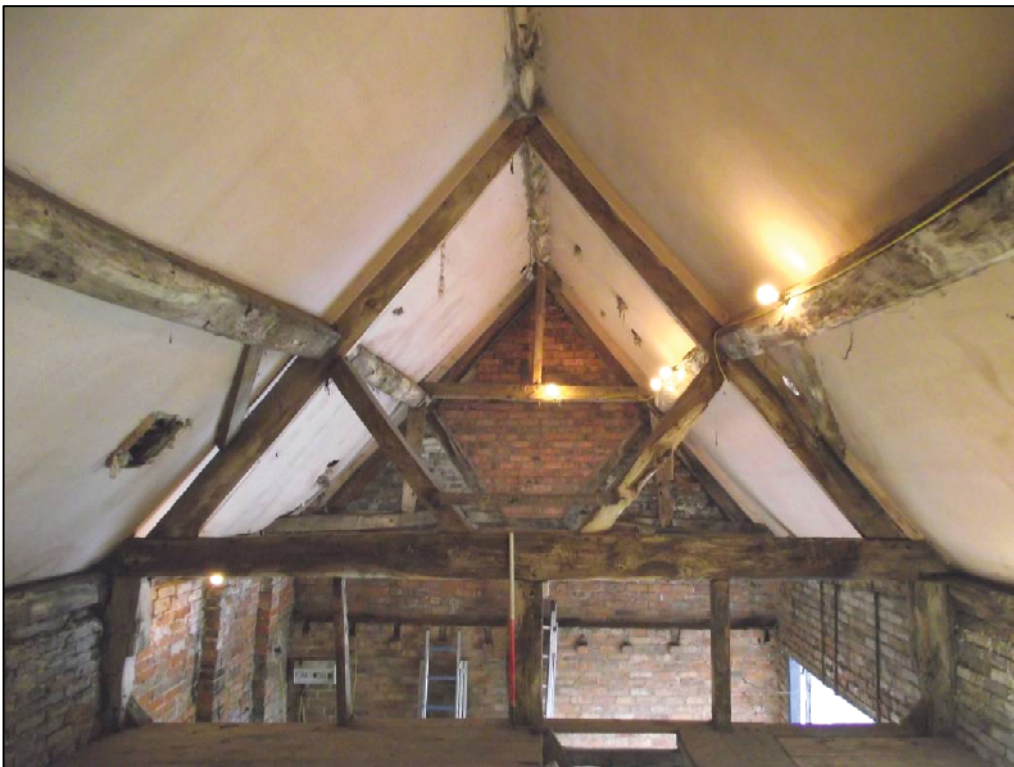
**Plate 8 (Shot 17):** Interior roof shot of roof trusses, looking east

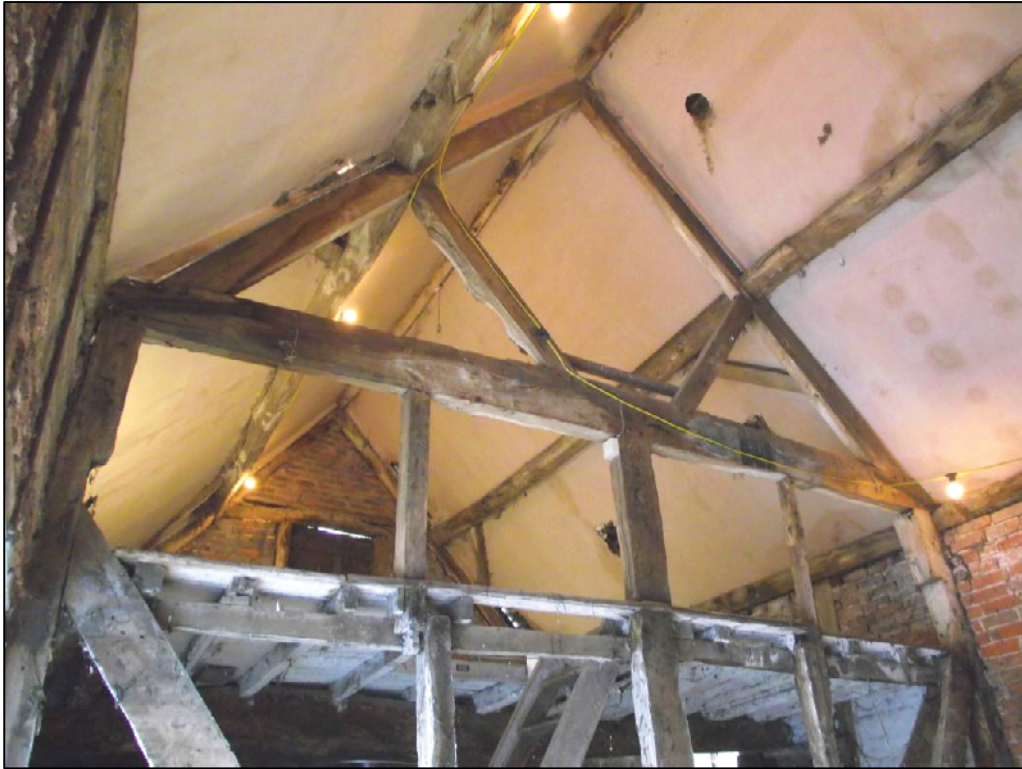
- 6.9 The western bay of the building has a hayloft accessed by a wooden ladder, with a planked wooden floor (Plate 9), while the ground floor is subdivided by the timber framing that would originally have formed the eastern elevation of the earliest phase of the building. The walls of the western bay are whitewashed with bare walls to the east, and a brick floor throughout (Plates 10, 11 and 12).

**Plate 9 (Shot 19):** Tie beam roof truss and hayloft, looking west-north-west

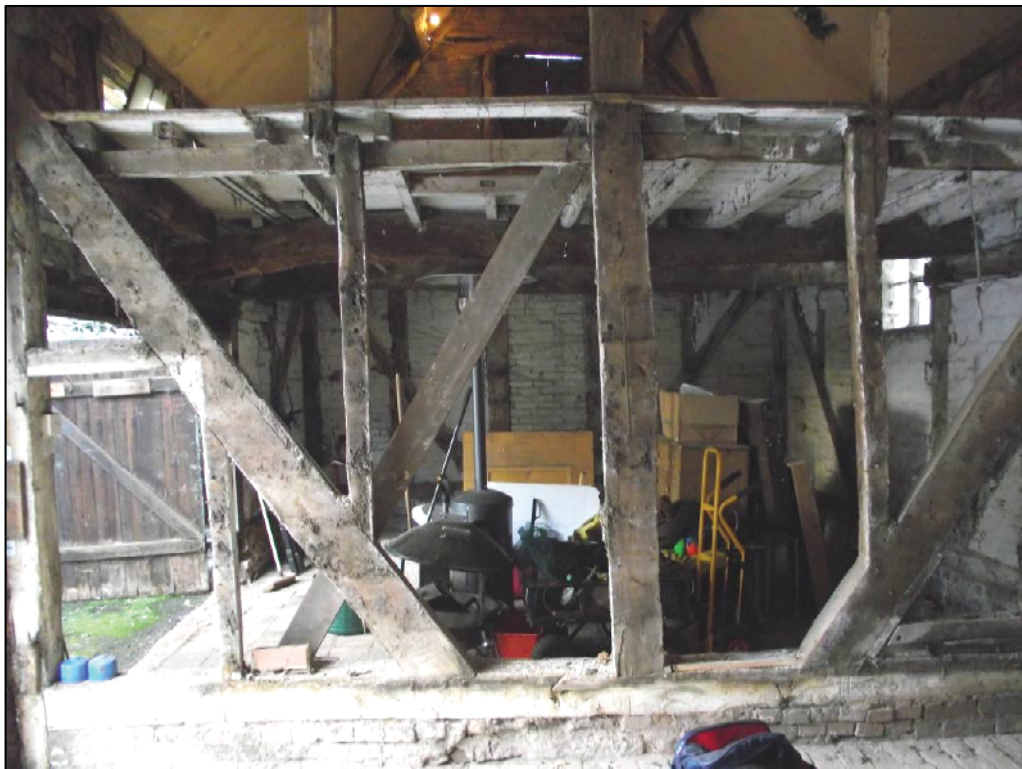
**Plate 10 (Shot 13):** General interior shot of the building, looking west from the eastern bay

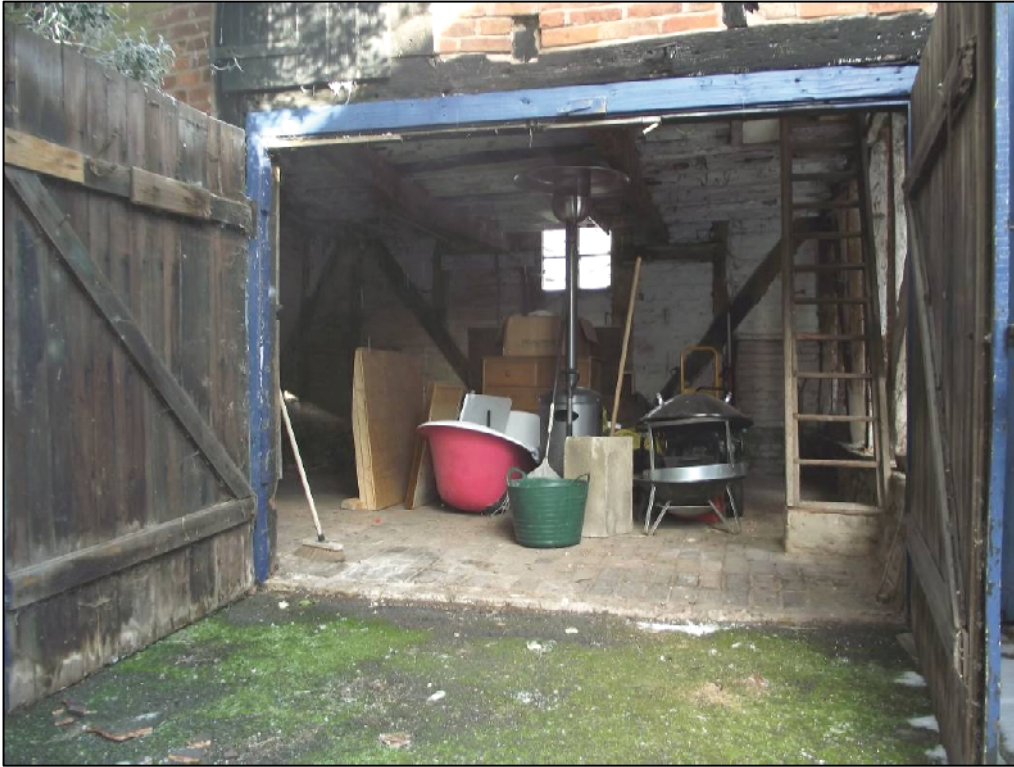
**Plate 11 (Shot 14):** General interior shot of the western bay of the building, looking north

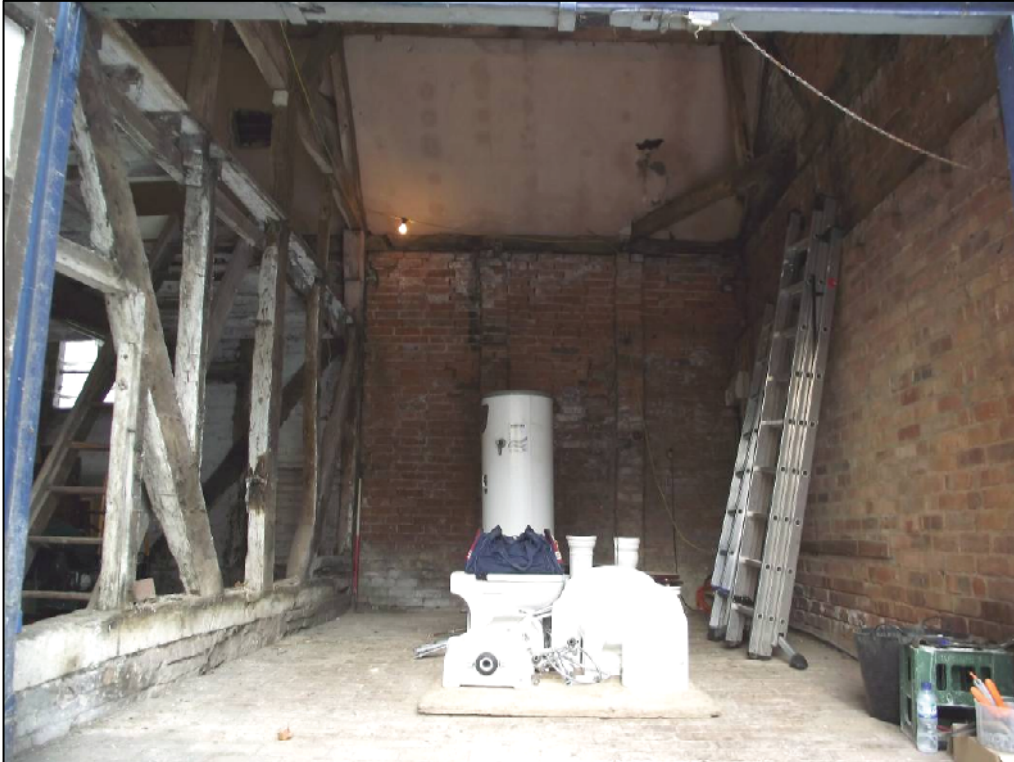
**Plate 12 (Shot 12):** General interior shot of the eastern bay of the building, looking north
