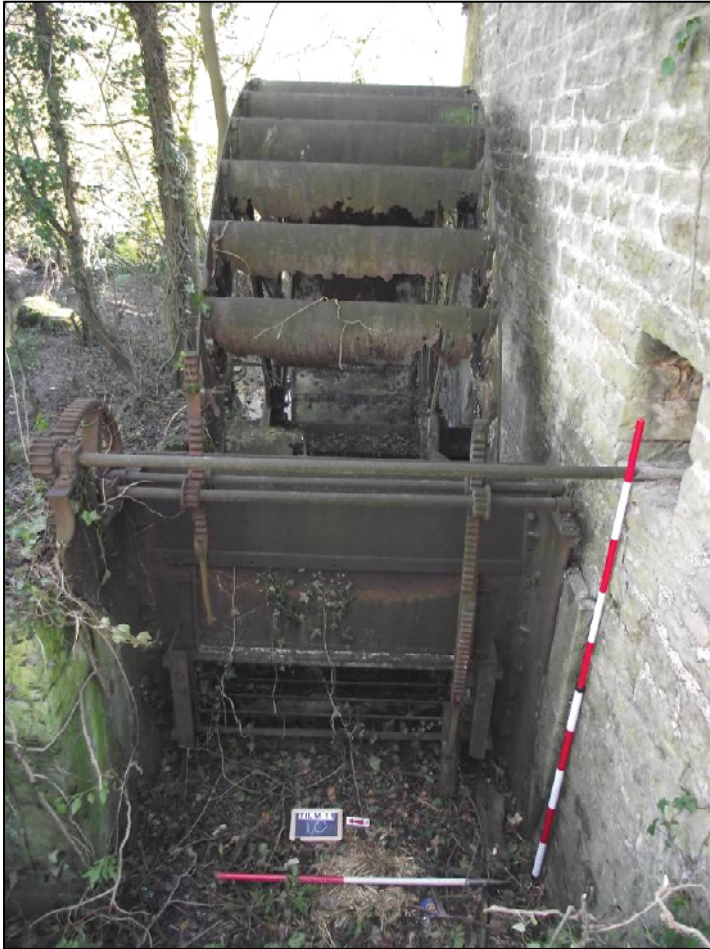
**Plate 9 (Shot 10):** Detail of the waterwheel and feed tank. Note the horizontal shaft leading into the mill where the control lever for the sluice is situated. The metal bars at the bottom of the tank would sieve the water, keeping the buckets clear from any larger object that could cause damage to the wheel. Looking east

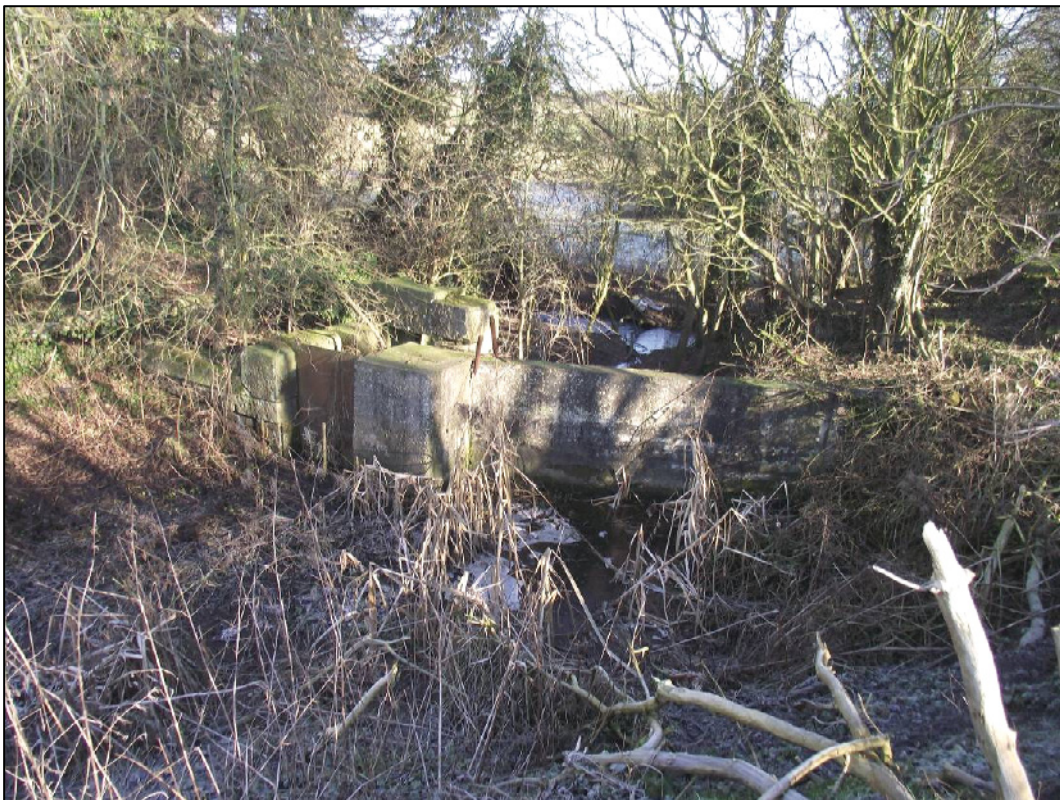
**Plate 10 (Shot 19):** Overgrown mill dam and weir west of the mill and mill race, looking east-north-east

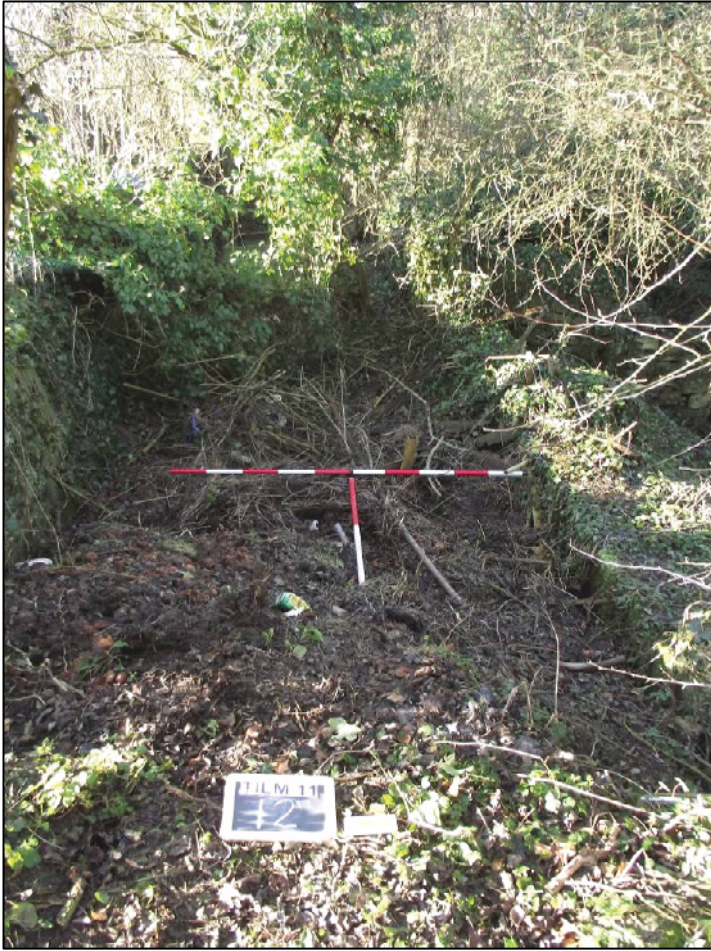
**Plate 11 (Shot 12):** General shot of the overgrown mill race directly west of the mill, looking west

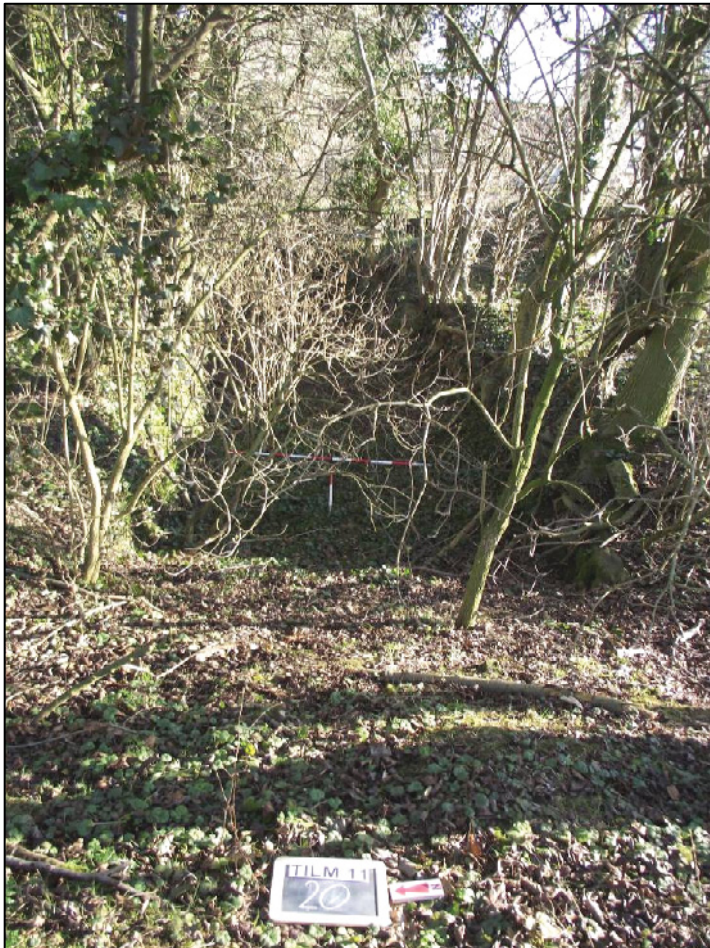
**Plate 12 (Shot 20):** Start of the mill race south-east of the dam. Looking east towards the mill

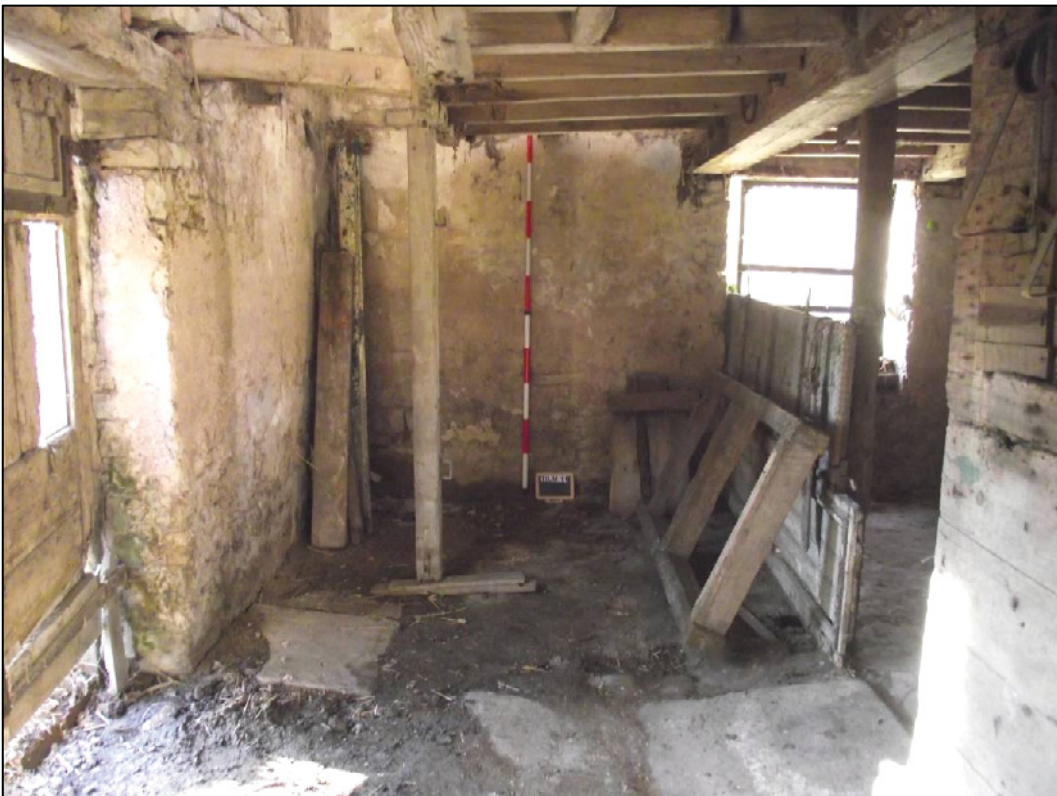
**Plate 14 (Shot 29):** General shot of the ground floor interior showing south and west elevations with plastered walls, remains of a stone slab floor, partition wall and above wooden support beams of the first floor. The opening in south-west corner of the ceiling would be used for hoisting up sacks of grain to second floor. Looking west

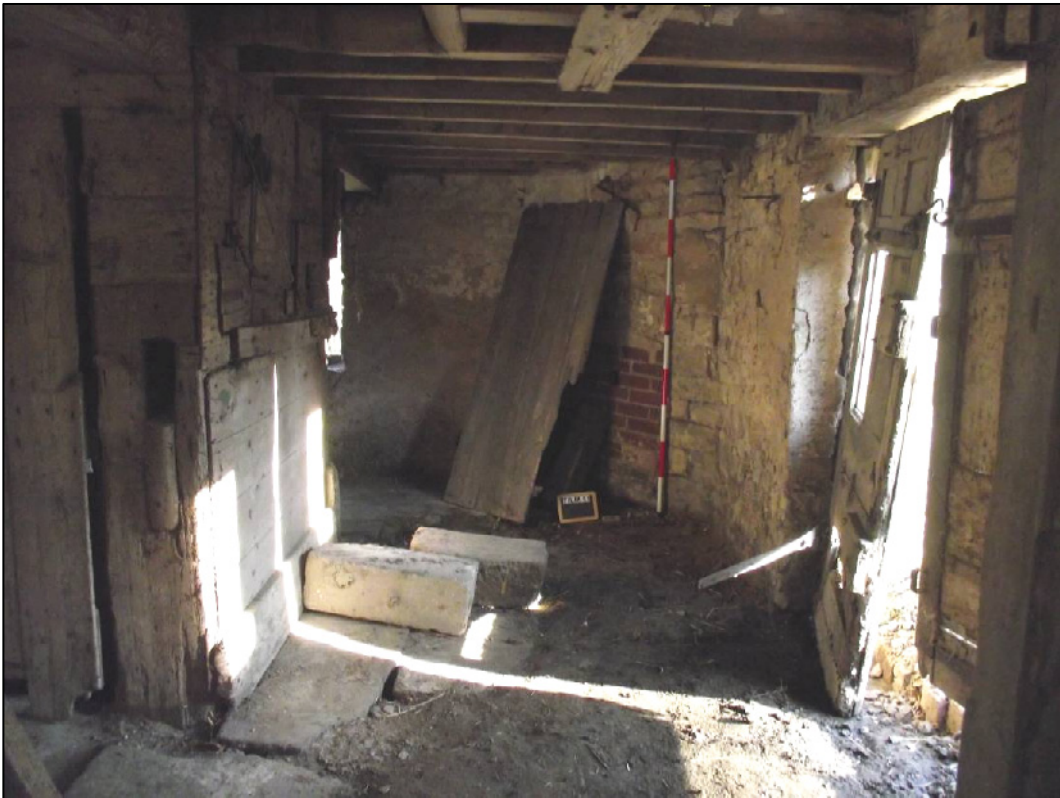
**Plate 15 (Shot 30):** General shot of south and east elevation showing a brick repair in the south-east corner and the south partition wall of the cog house to the left. Looking east. A flour sack would have hung from the hooks on the cog-house wall and was filled by a chute inside the cog-house (Plate 23)

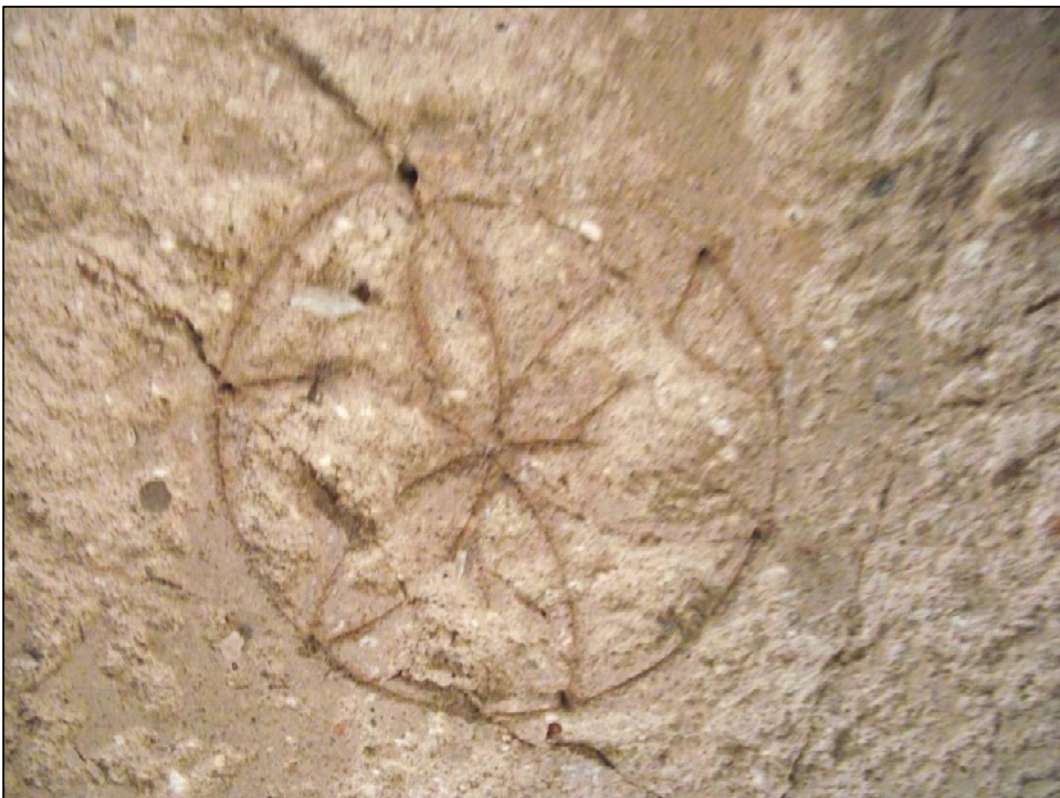
**Plate 16 (Shot 76):** Detail of graffiti on the south elevation, located east of the main doors. Looking south

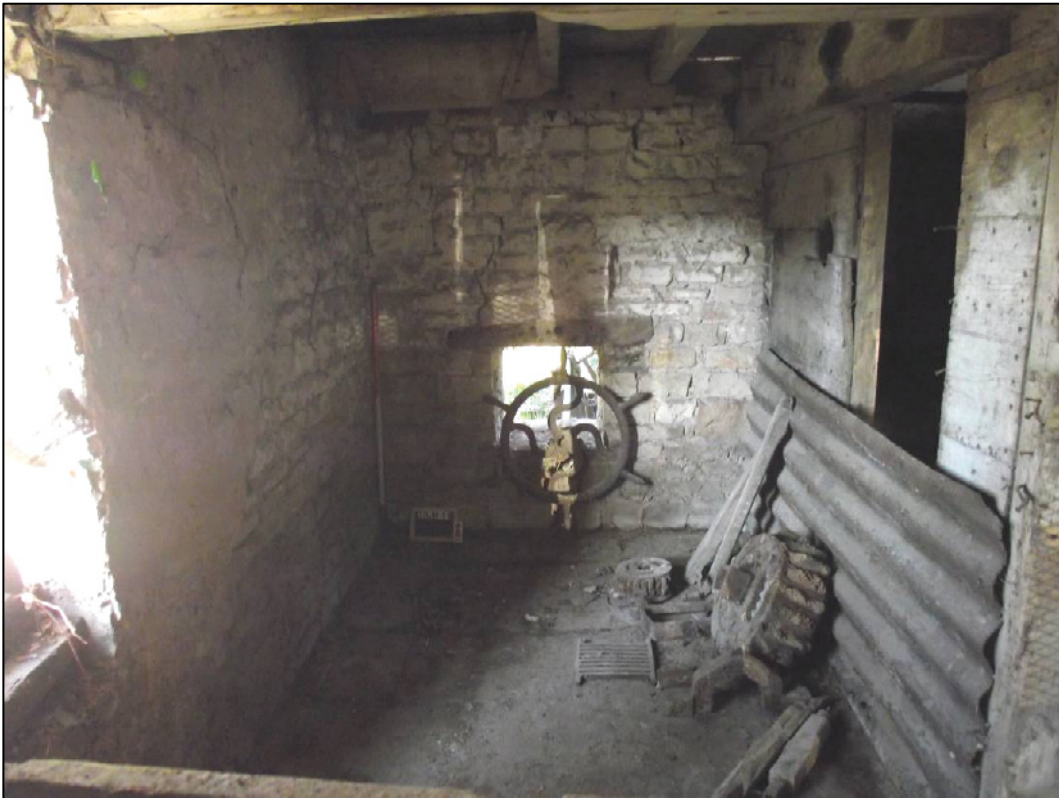
**Plate 17 (Shot 32):** General shot of north-west corner of the ground floor showing sluice wheel and wooden partition within cog house. Note the absence of plaster from the majority of the walls in this area. Note also the cog (stone nut) and other ephemera. Looking north
