Butlers Farm, Broomfield, Essex.

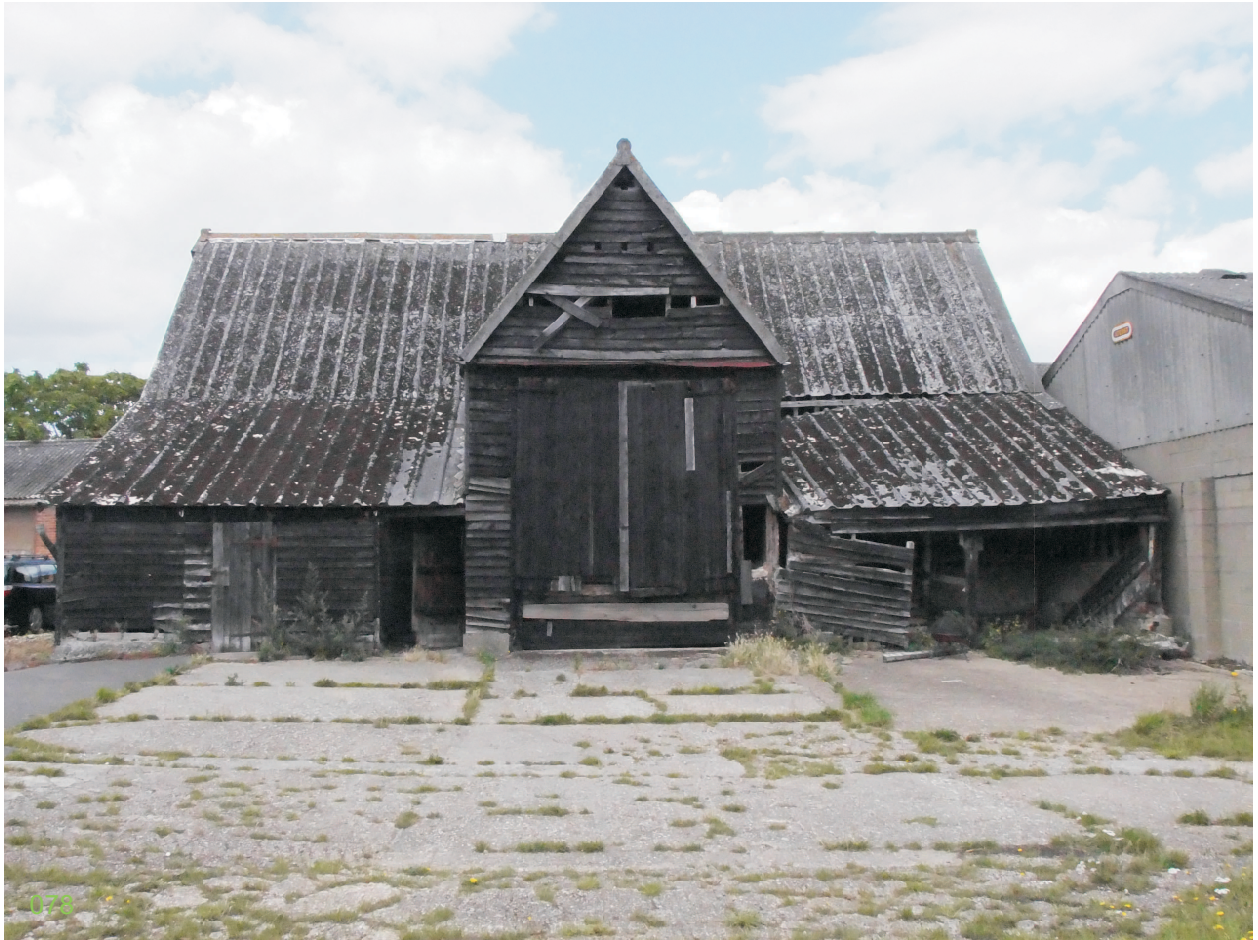
Building 1. The front, south elevation of the barn. The midstrey gable has a high level floored storage area accessed from inside. High in the gable are four pigeon holes with the normal round arch tops. The main doors although in very poor condition are complete. Two of the original four leap boards survive at the bottom. The side access door to the midstrey has a vestibule constructed in the later lean-to for unrestricted entry. A bottom extension was added to the door when the internal side boards were cut back.

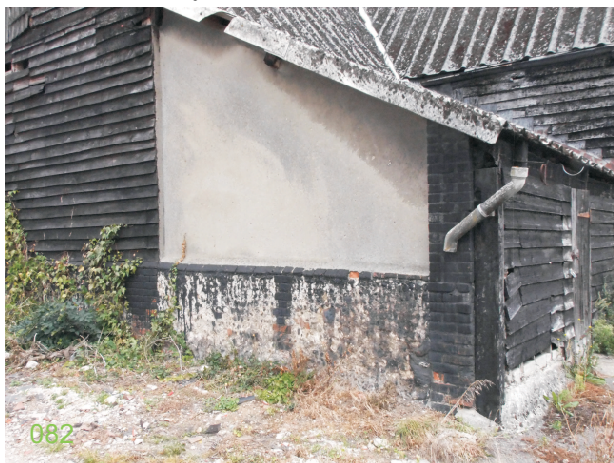
The western lean-to has a plinth to the side built in a similar way to that of the barn. The area above is rendered but as the building was not entered its structure was not recorded. Inside it is divided into two rooms. Its original use is unknown.

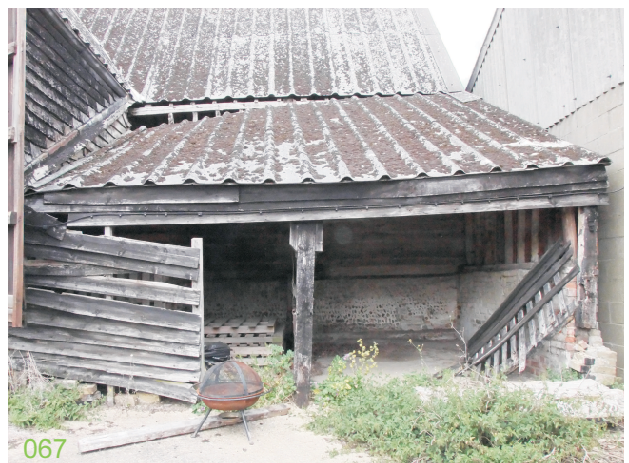
The eastern lean-to in a very poor state had a similar side plinth wall. It appears to have been originally designed to be open but later converted into two small loose boxes with an iron hurdle fence between, behind the centre post, with boarded infill to each side of the two entry doors. The roof is of minimal structure with new rafters for the asbestos sheeting.

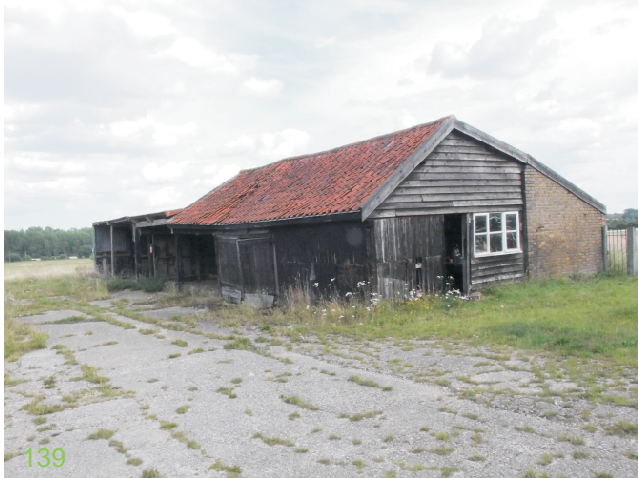
Building 2. Asymmetric pan tile roof covers an open fronted range to the north from the end of the brick wall. West end now enclosed. The rest is open but beyond the tiles it is much rebuilt and covered in corrugated iron.

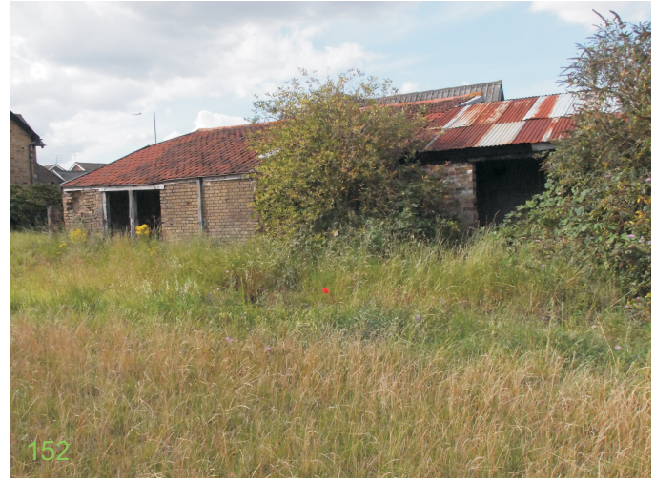
The south side is in brick divided into small loose box units. The east end now has a corrugated iron roof as that to the north.

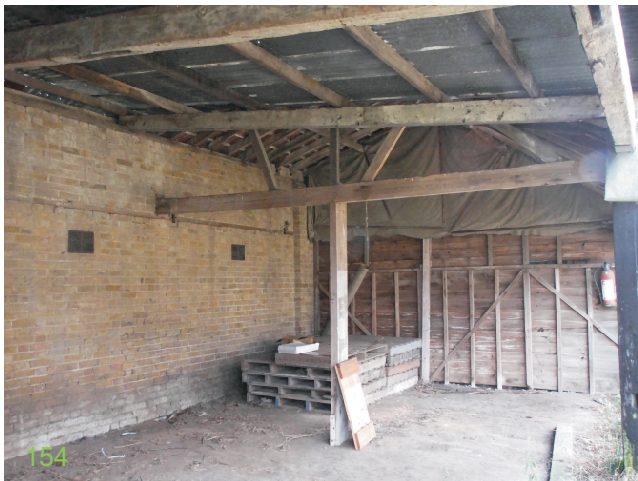
The north open side shows the spine brick wall with ventilation grills set in the wall. The tiebeams join at the wall and the roof purlins are supported by nailed angled Queen struts from the tiebeam.

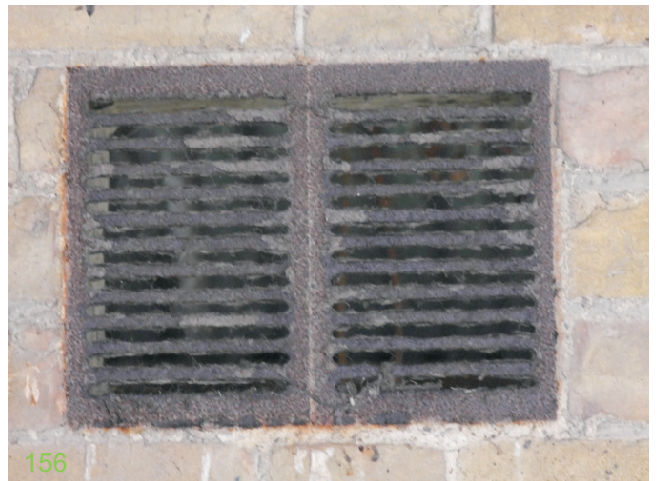
Detail of the cast iron ventilation grills fitted into the wall to vent the loose boxes to the south side.

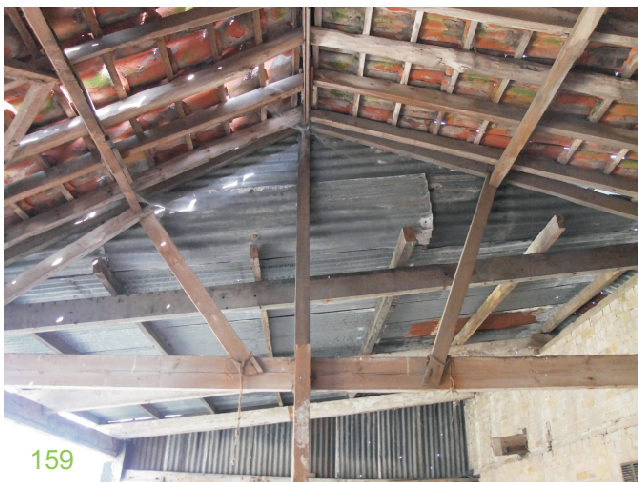
The last surviving truss to the east and the rebuilt corrugated iron roof beyond. A cut off original tiebeam survives in the wall.

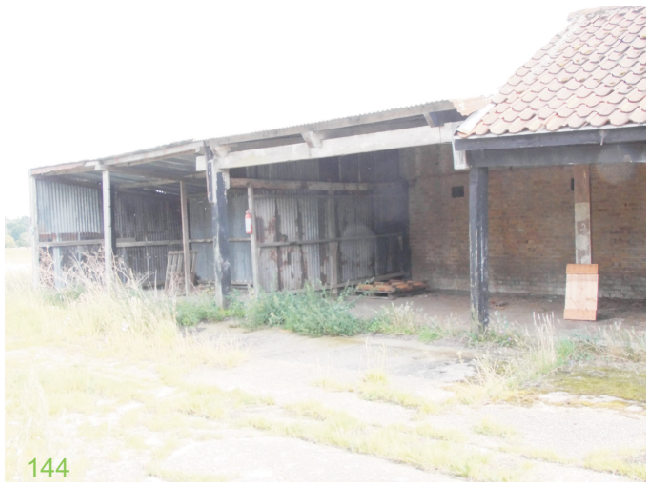
The rebuilt east end with minimal framing to the furthest bay. The middle front post could be a surviving original post.
