Butlers Farm, Broomfield, Essex.

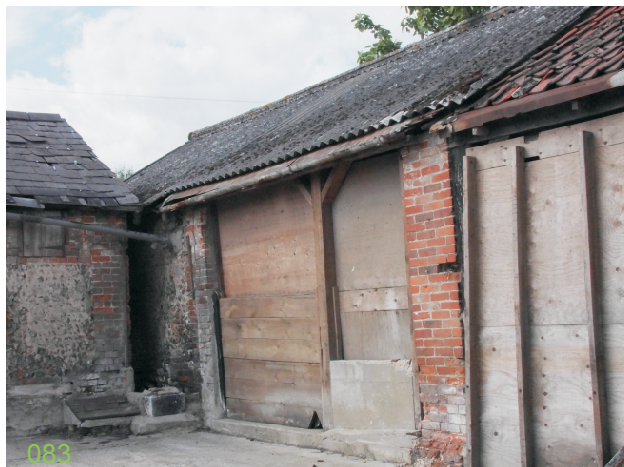
Building 3. This brick and flint building now with an asbestos roof, by the remaining lathing the roof was originally covered in pan tiles. The south opening now blocked was most likely original but was not as wide.

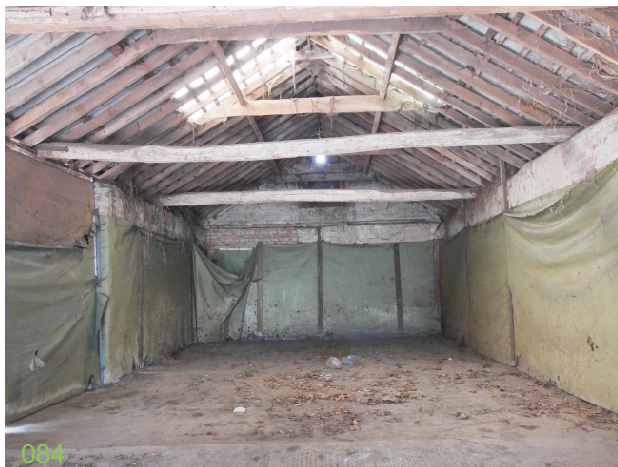
Inside the building looking to the west (towards the main road). The brick gable above the tiebeam has a window and top vent. The covering of the walls removes any chance of picking up signs for any fittings.

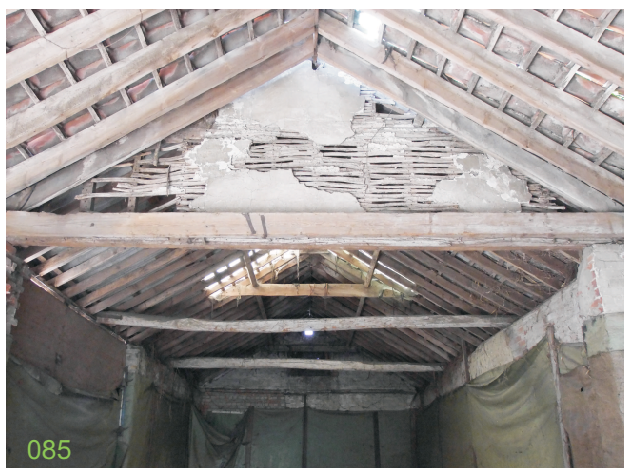
The south wall has been removed but the gable wall above survives from the tiebeam as a framed and plastered wall.

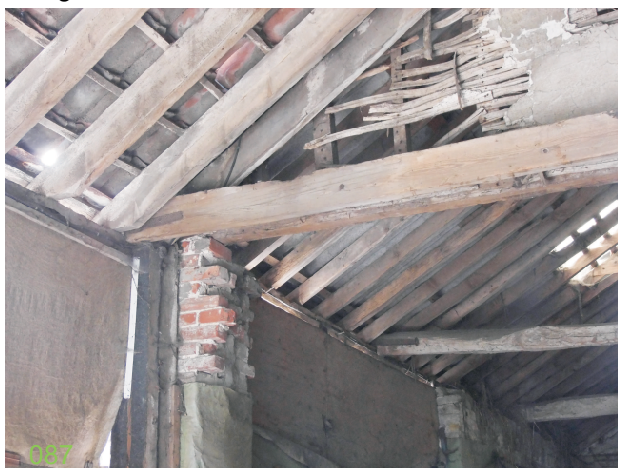
Detail showing the broken end to the east wall. The tiebeams of hand converted timber were fastened with iron straps.

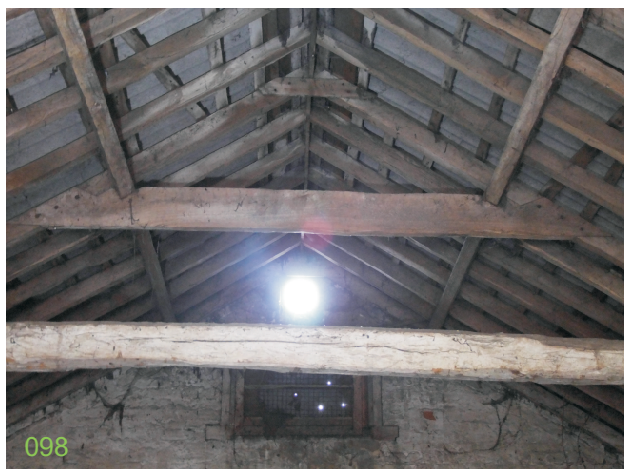
View into the roof showing it to be a simple side purlin with trenched and nailed collars on slightly thicker principle rafters with a top saddle under the ridge board.

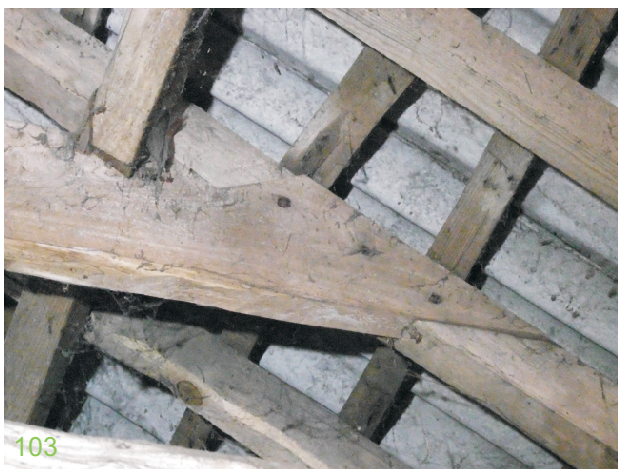
Collar to principle with its bare faced dovetail halved and nailed to the rafter as the detail found in the barn, building 1.

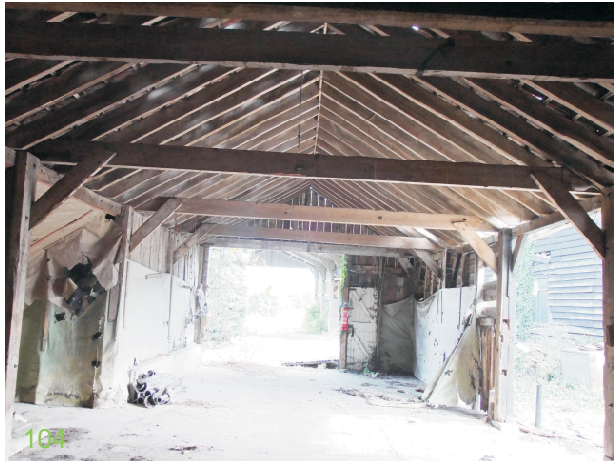
Building 3. The east part is a separate building. It is single aisled and was open to the south and east originally. A simple rafter roof, the rafters of heavier section as no purlin is used. Posts to the left are the arcade posts into the aisle.

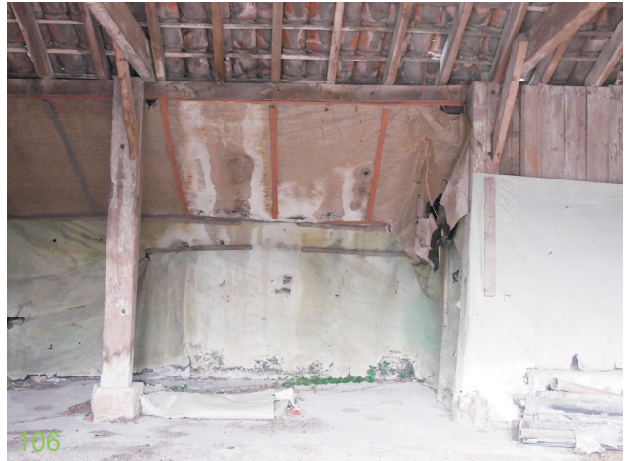
Two bays still open through into aisle. The arcade plate sits on a reduced height half post, the other half (visible) is bolted to the rear post and the arcade plate.

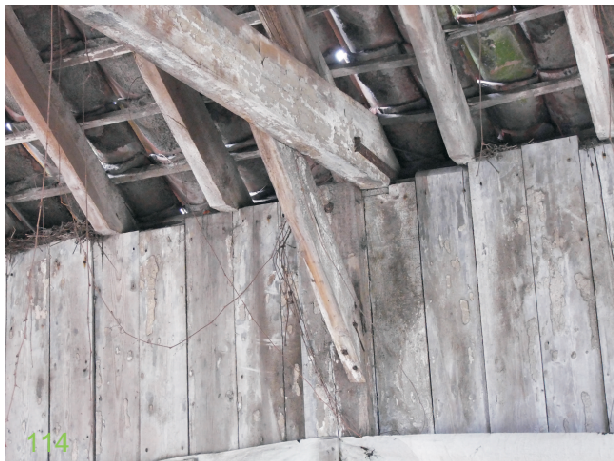
Two bays have the aisle boarded off to form a small store behind. Access was from inside and the outer east wall. Tiebeam has fastening iron strap and the braces are nailed. The roof still covered in pan tiles.

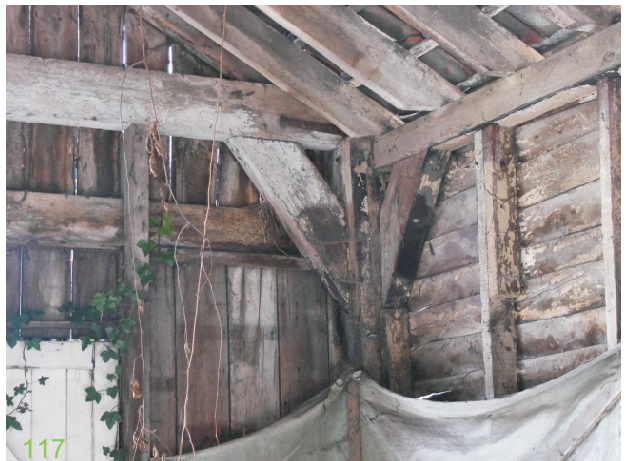
South east corner of the building has bracing in both directions for open end and bays. Some of these are mortised in and some nailed. The single piece posts have a bolted top plate.

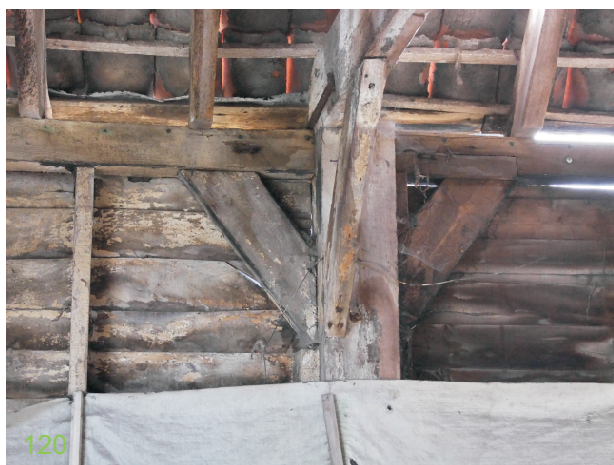
Each bay on the south has the small tight corner bracing as often found on open frames.

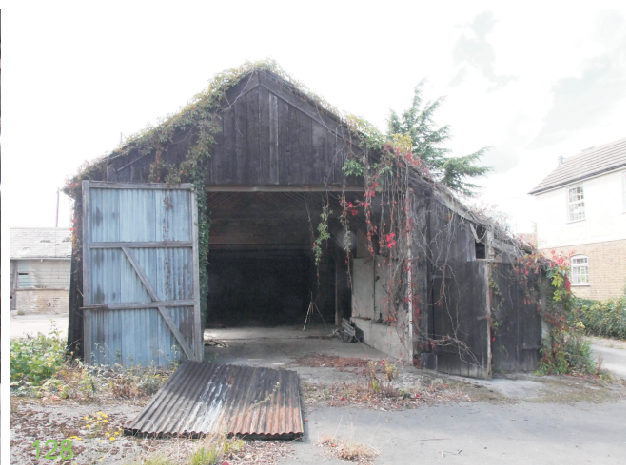
The east elevation shows the inserted double doors. The vertical boarded gable is original. To the side is the end of the aisle with access door. The north wall is brick and flint panelled.
