## Stone Hall Barn, Matching, Essex.

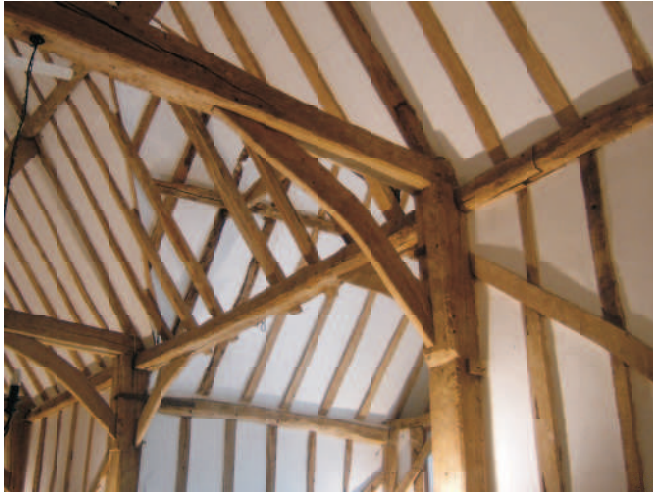
Owners digital 66 - to E showing the entry into the midstrey with storey posts and the slightly cranked arch braces to the tiebeams. note the scarf in the wallplate is a face halved and bladed as appears in the aisle wallplate.

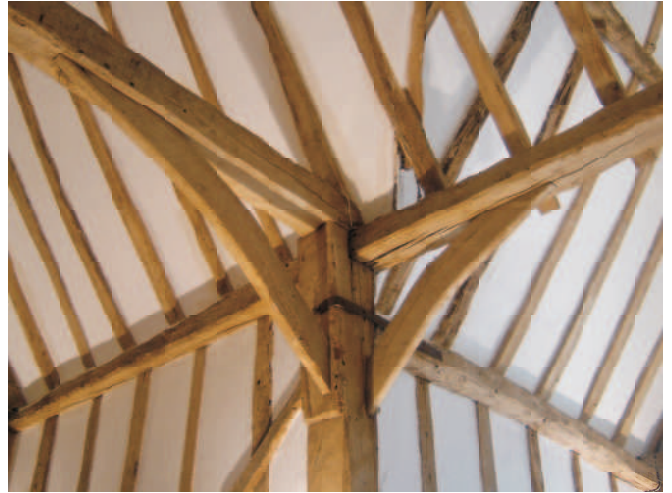
Owners digital 48 - to E showing storey post to midstrey with added iron tie to midstrey wallplate.

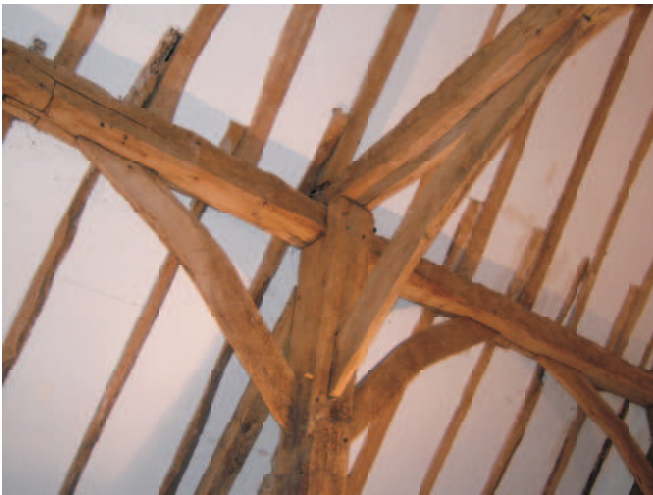
Owners digital 25 - to N showing third arcade post to aisle side and edge halved and bridled scarfs to the arcade plate.

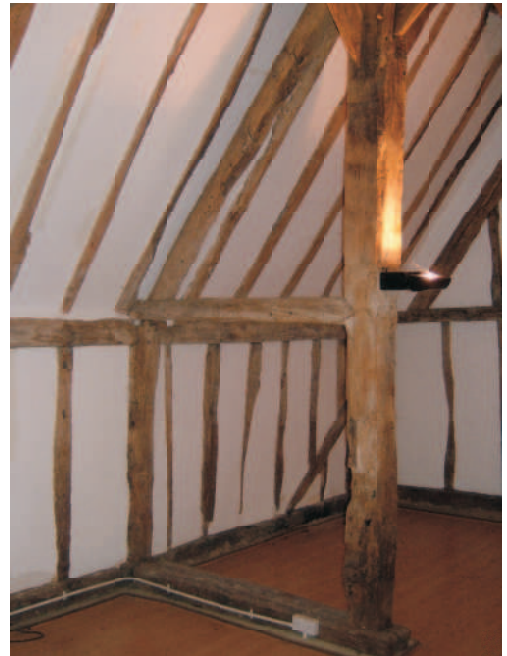
Owners digital 27 - to NE showing the lower part of third arcade post with sill return to aisle.

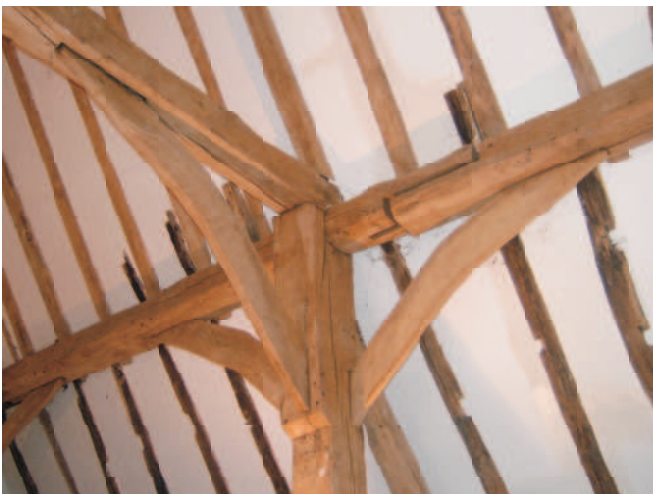
Owners digital 17 - to W showing top of arcade post, cranked arch braces and the edge halved and bridled scarfs to the plate. Note the reuse of crown post roof rafters in the construction that have most likely come from an earlier domestic building as they show signs of sooting from an open fire.

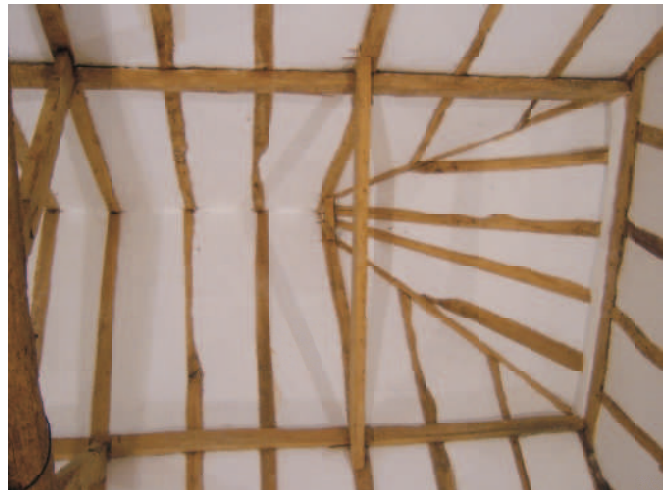
Owners digital 76 - to NE showing the roof end construction with half hip. The hip rafters rise to a very high set saddle not leaving space for gablet ventilation.
