West side visible frame of barn

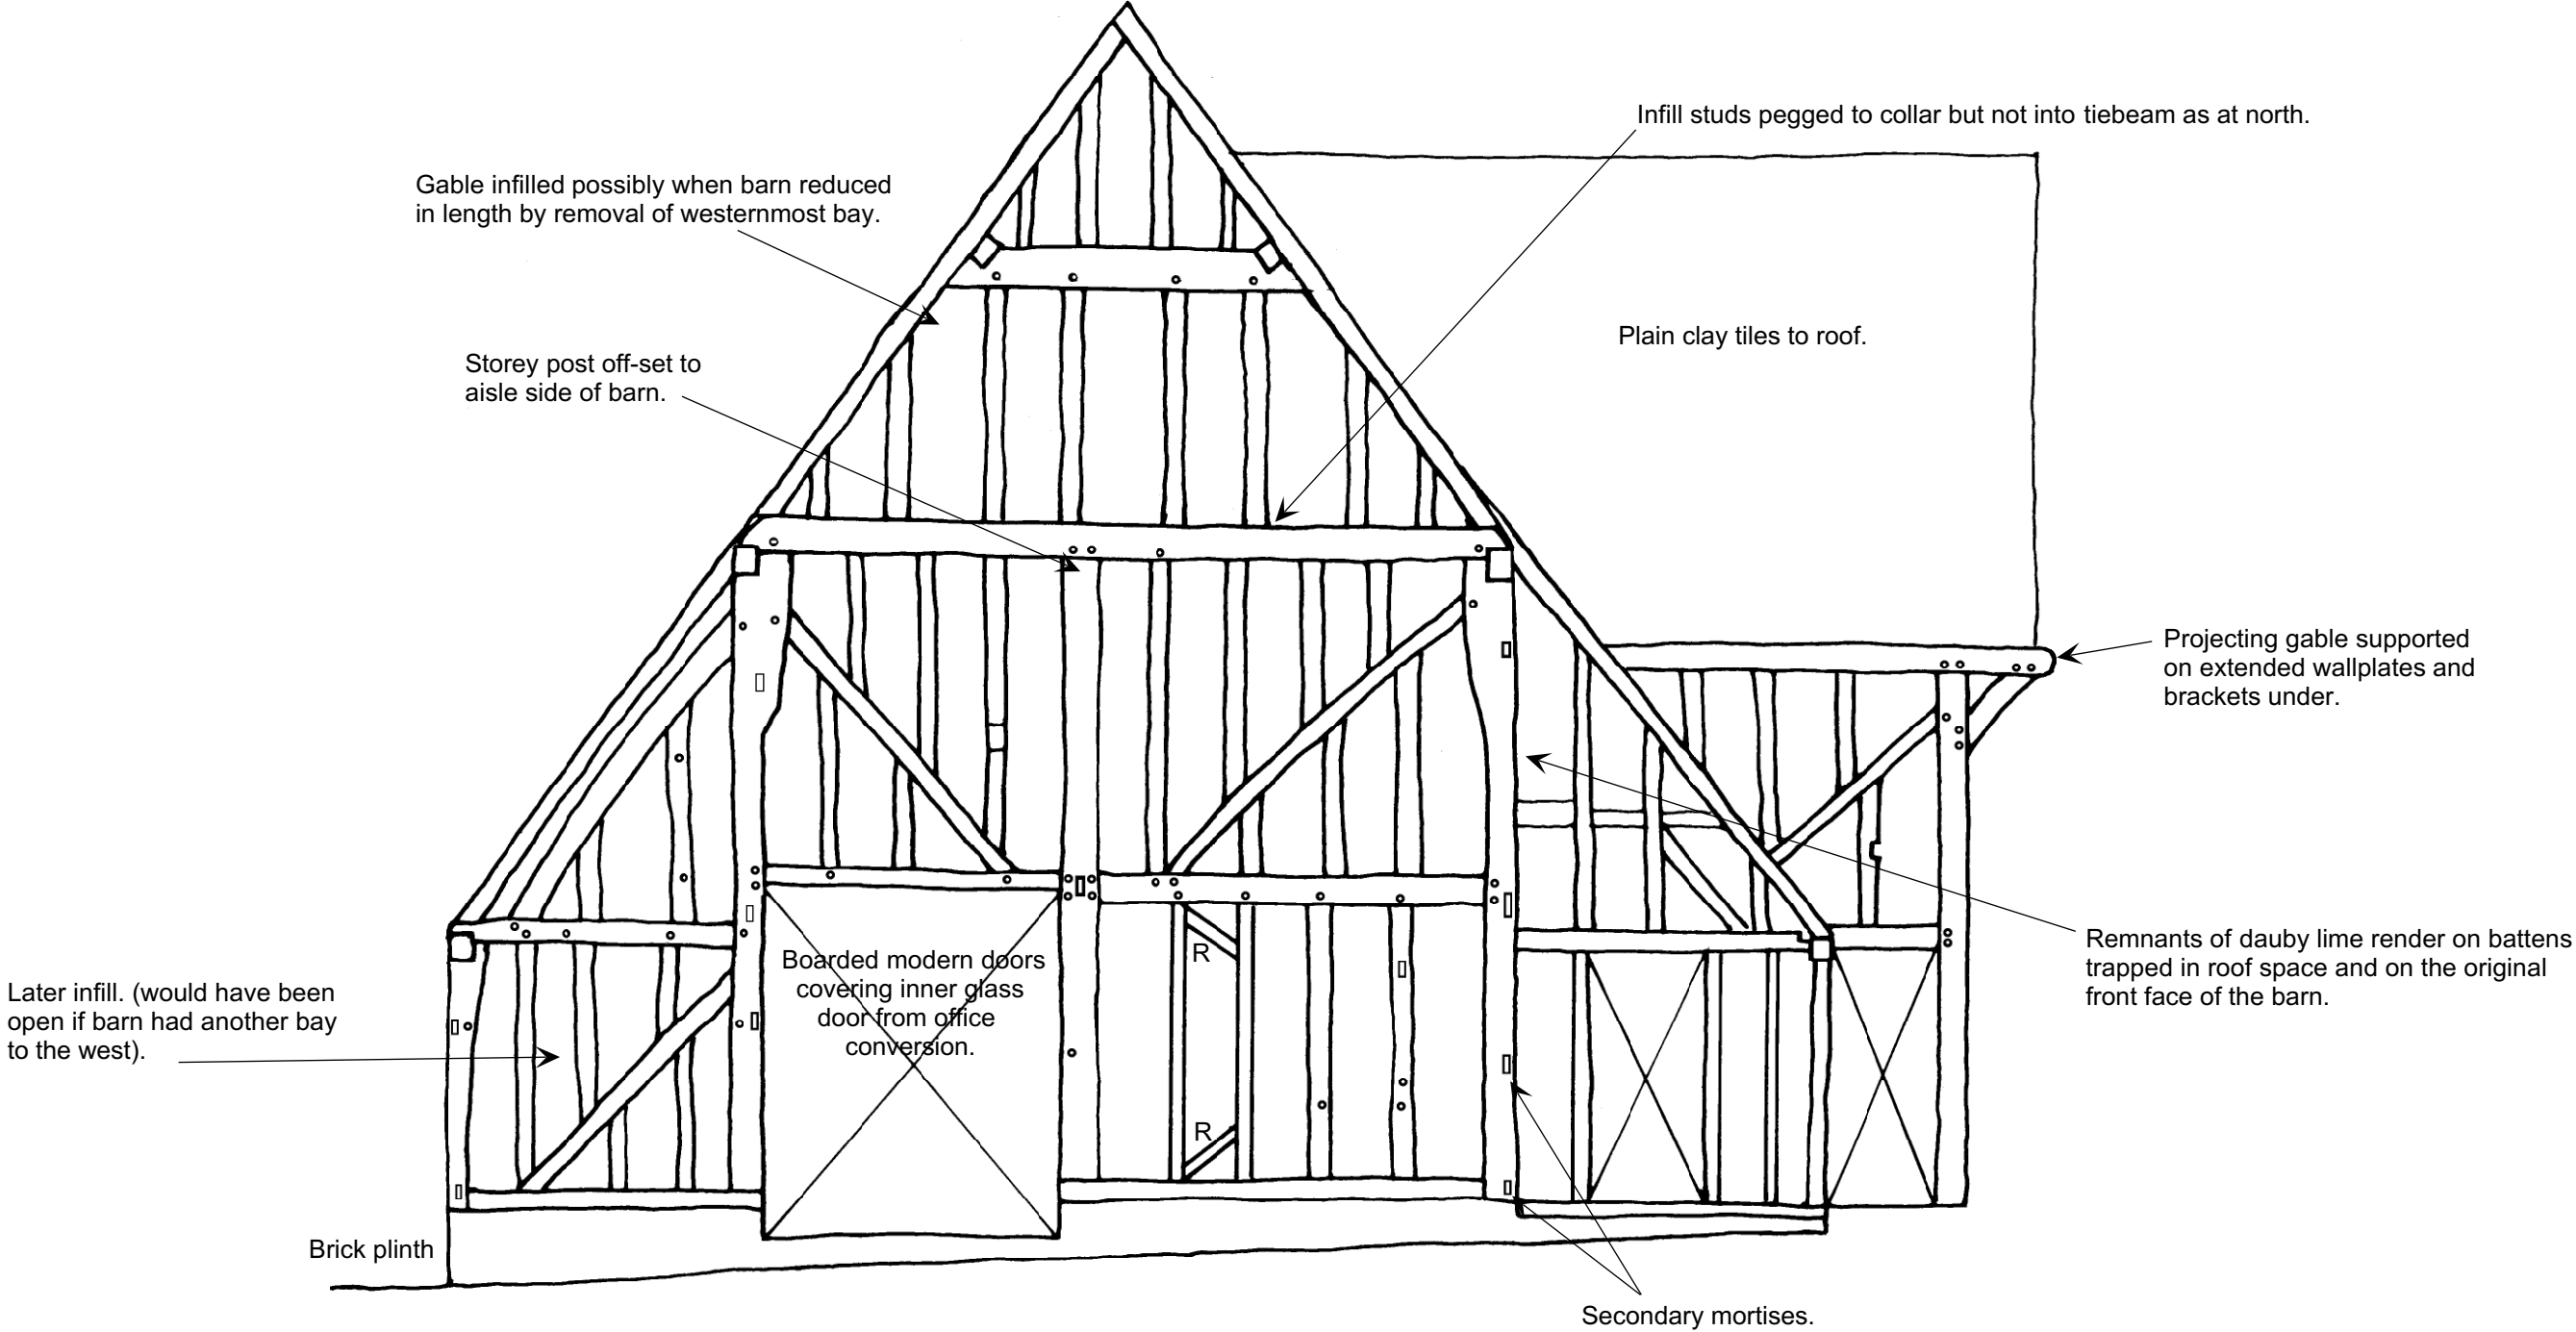
Main details added to outline shape from customer drawings. No detail frame survey available. All timber positions sketched in.

R =Repair timber
