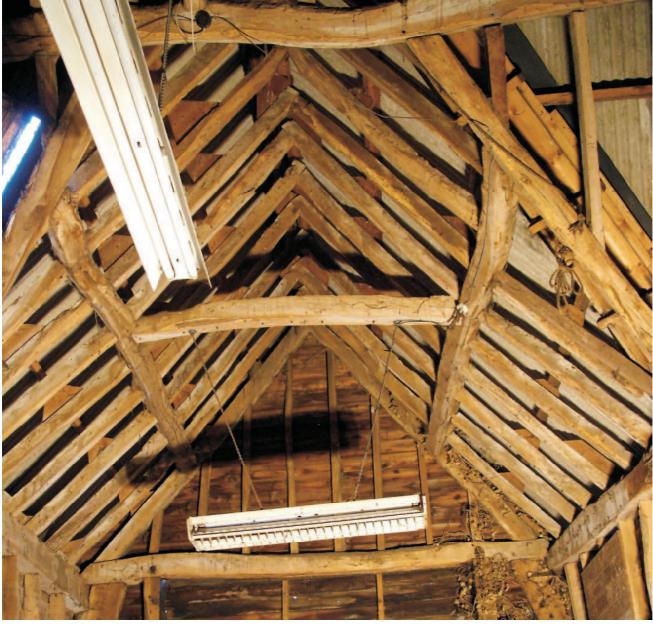
View into midstrey roof, built a single bay unit with purlins framed front and rear and birds mouth collar between. Purlins converted from one tree sawn through the centre. These again suggest possible coppice growth pattern.

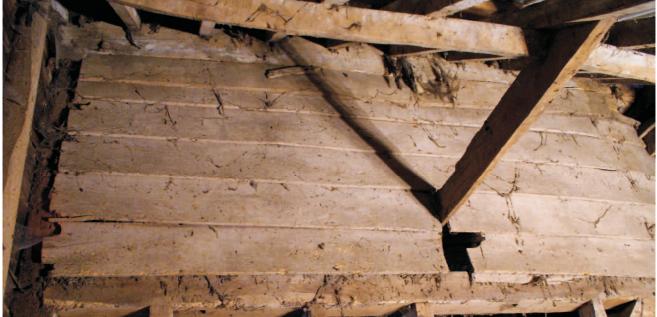
Possible original elm weatherboarding trapped by the lean-to roof. Still in good condition.
