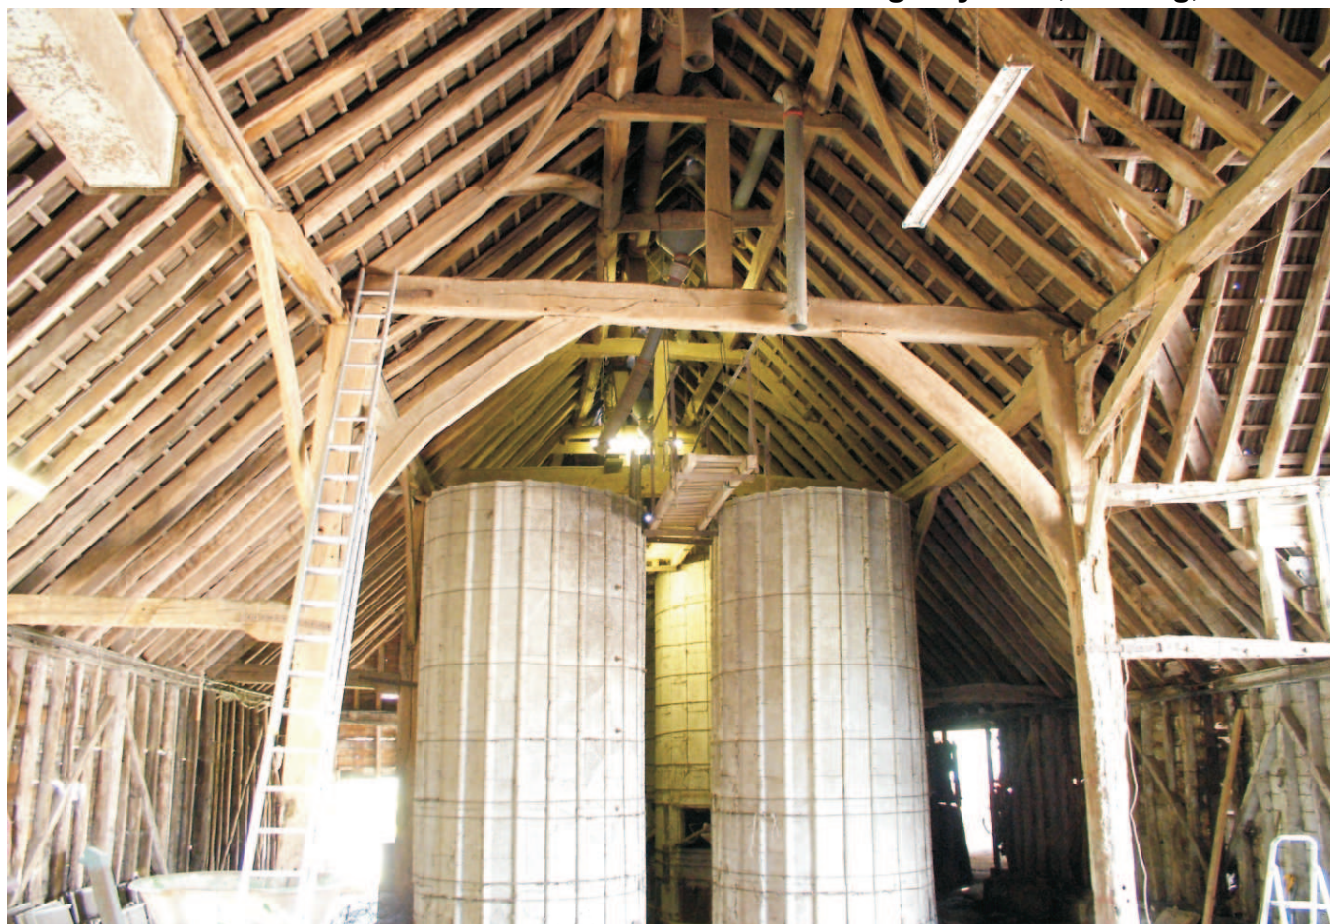
Photo 172. Inside view looking to the north west with concrete grain silos & associated operating gear and walkways. Original aisle tie to left replacement to right. Brace problems to right arcade plate.

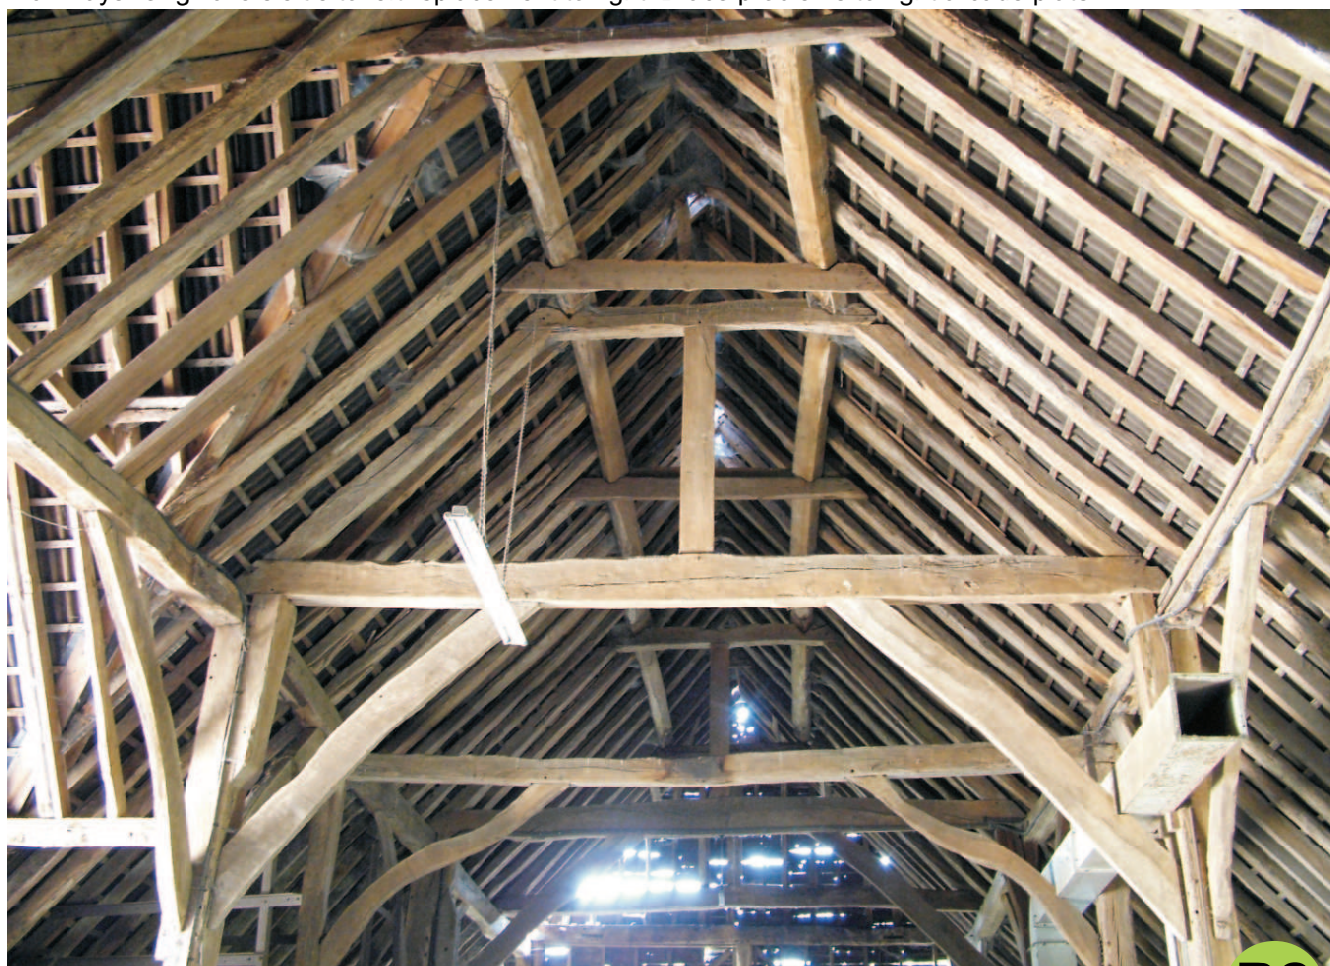
Photo 208. Inside view above aisle level looking to the south east with heavy duty trunking on arch braces, crown strut from tiebeam to collar with extra part truss with serpentine bracing at mid bay.
