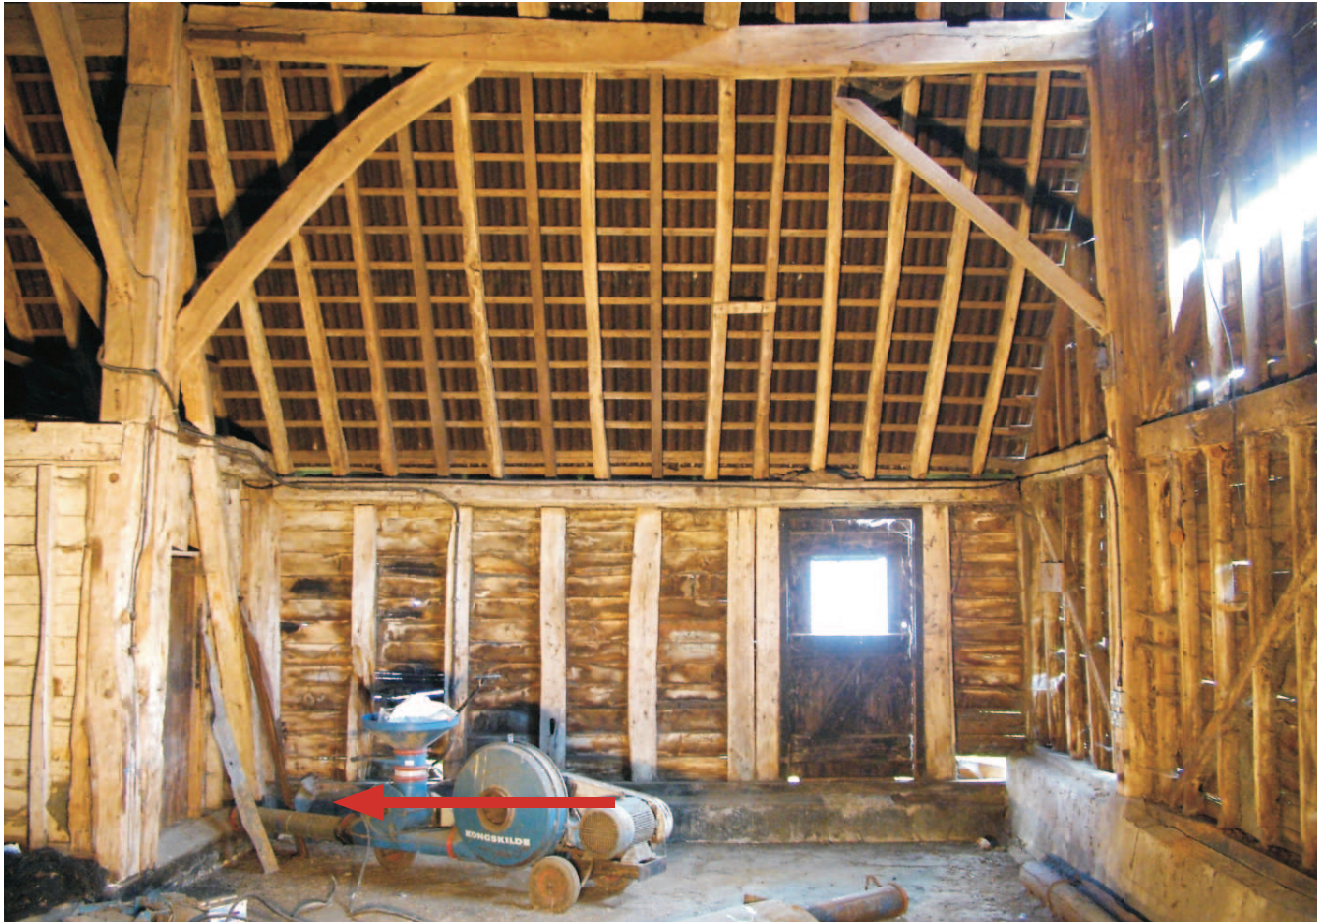
Photo 76. One of two bays with original walling. Wall D, Bay 1 - 3. Good relatively large section timber typical of middle sixteenth century. Later door inserted in nineteenth century. Aisle roof rebuilt as is end wall.

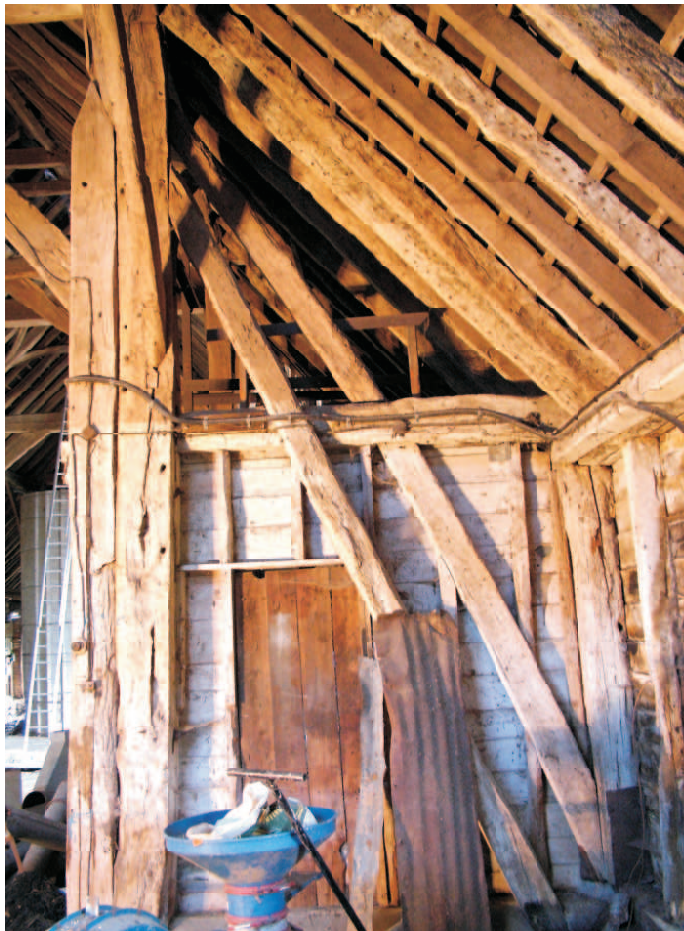
Photo 78. View in direction of arrow above showing aisle tie and shore with extra shore but brace to return sill missing.

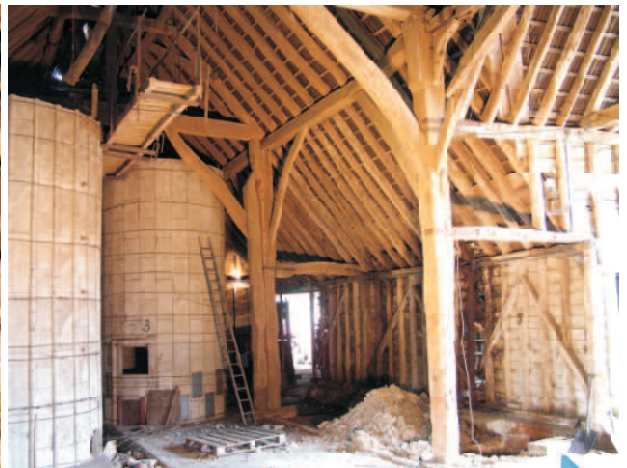
Photo 191. View from midstrey looking north with 2 silos removed. Aisles rebuilt nineteenth century.

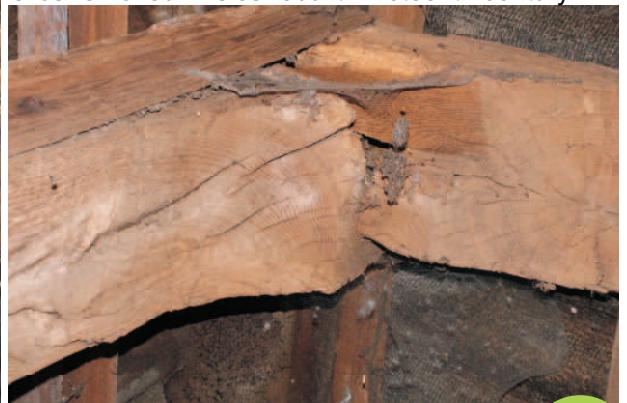
Photo 48. Typical ridge joint to main trusses showing swelled end of reduced principal rafters.
