Feeringbury barn, Feeringbury, Essex.

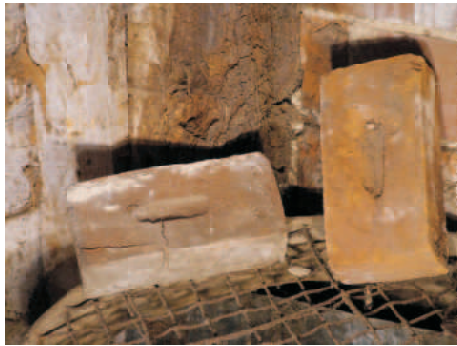
Photo 187. Samples of bricks with small scratched out frogs suggesting a manufacture about the turn of the nineteenth century. Plenty of inclusions and left brick over fired but right brick about correct and size is 9" x 4.375" x 2.75" with horizontal pressure marks again suggesting very early nineteenth century. All laid in lime mortar.

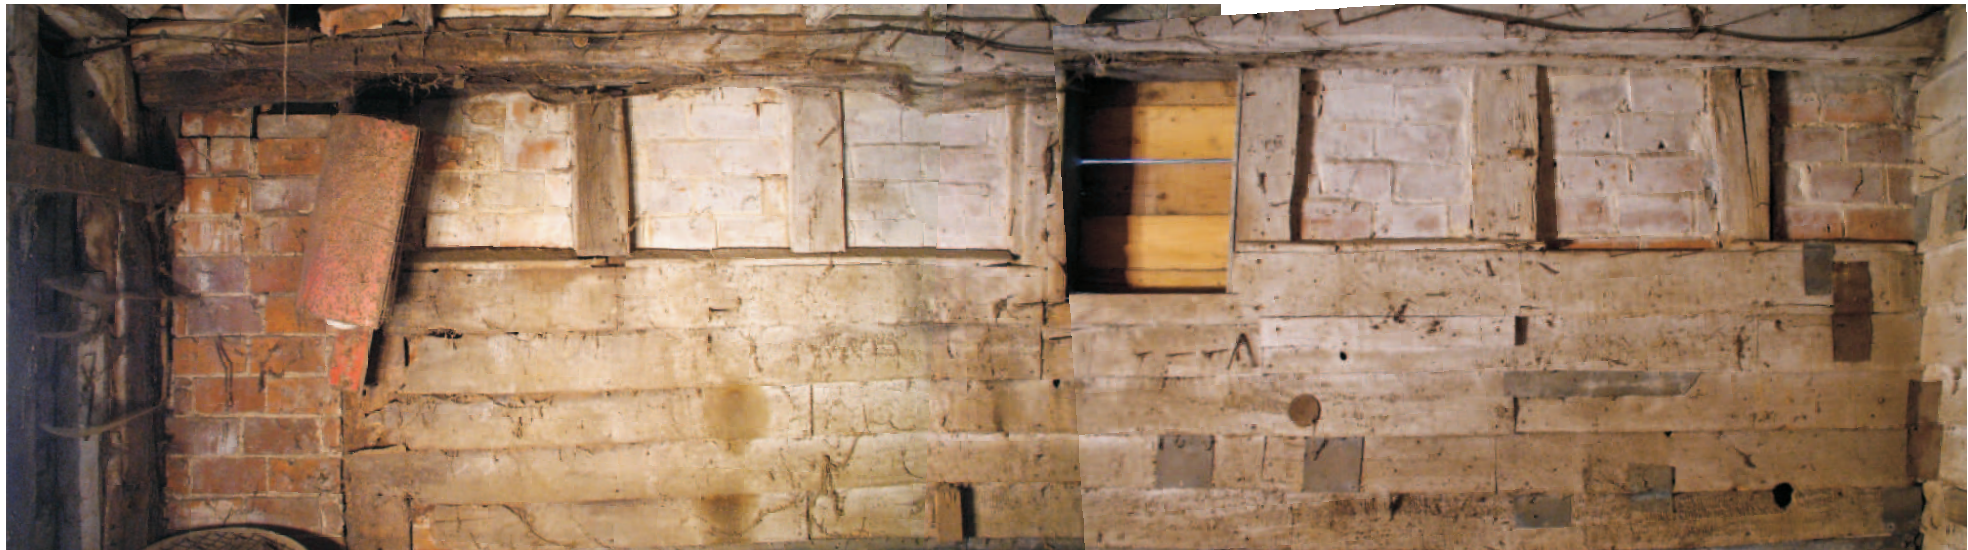
Photos.

VIEW TO AISLE WALL INSIDE BAYS 3 - 5 ON WALL D. THE AREA IS ENCLOSED AND ROOFED TO THE HEIGHT AND WIDTH OF THE AISLE.

The wall is original to the barn, has been infilled with brick on edge in the early nineteenth century and the lower part lined with sawn elm boarding. (Appears to be a reciprocating saw for the original and circular sawn for replacements) This boarding extends around all sides but the lower area has been covered with corrugated sheets at a later date sometime in the twentieth century. A clamp has been attached to the aisle plate to support the roof joists for a board cover. A door has been cut in from the midstre and the building with its careful sealing appears to have been an internal granary.
