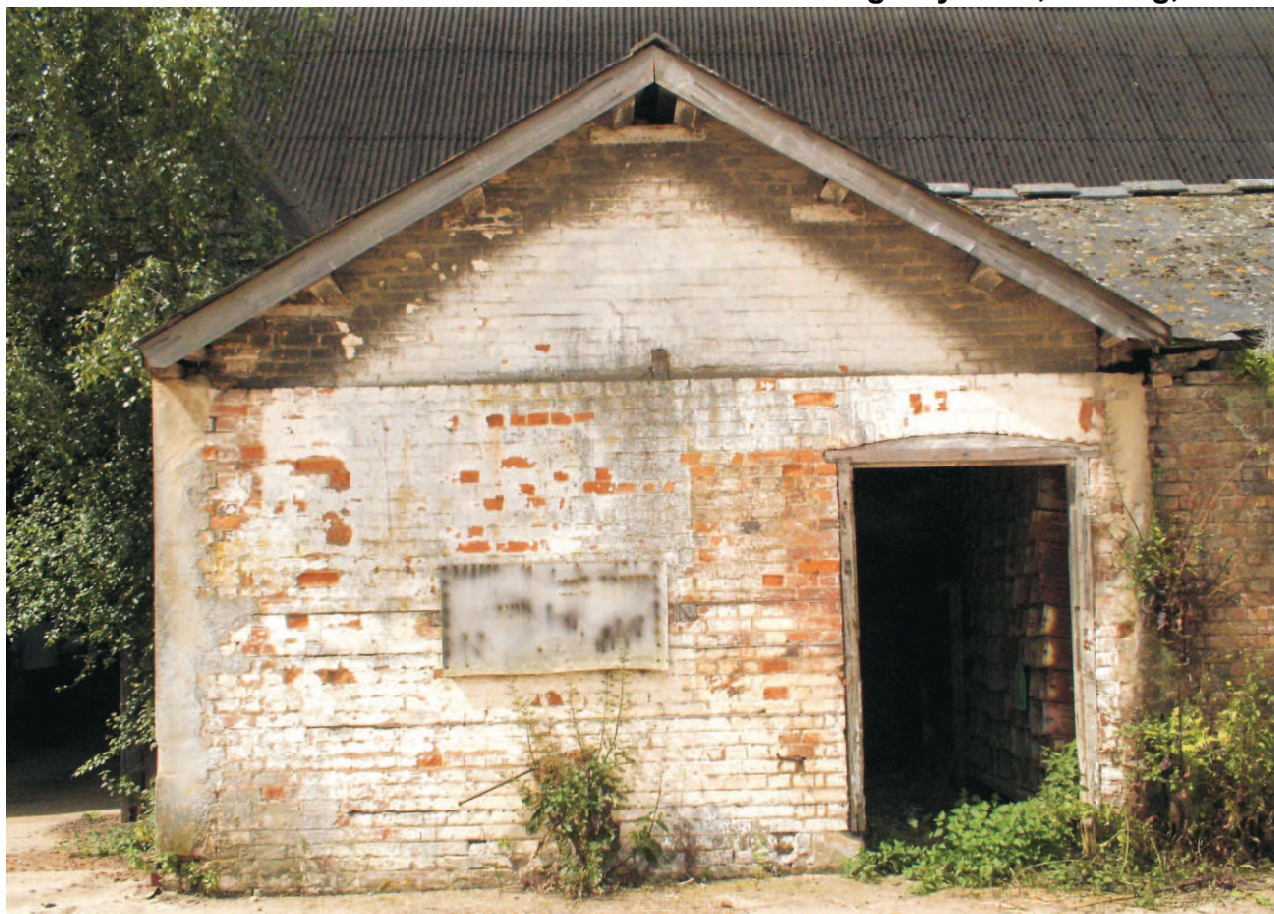
Photo 5. View on 6 - 6A wall F. Broken brick to outer edges shows this was internal wall. Original doorway.

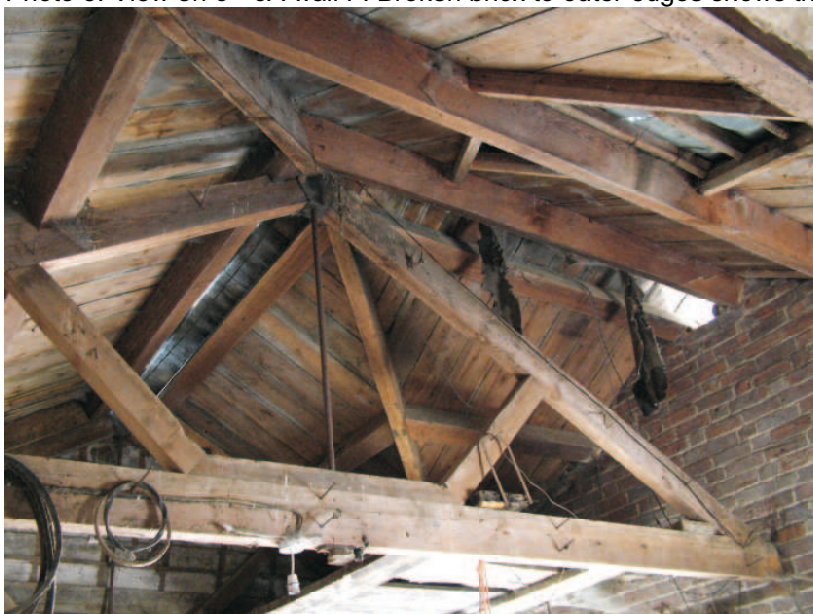
Photo 131. Direction change to roof of harness room.

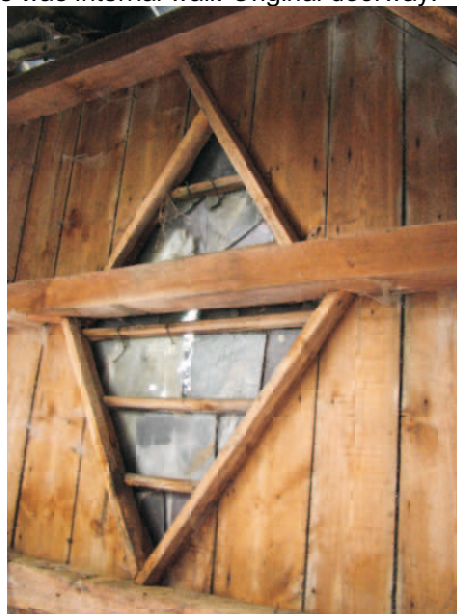
Photo 133. Detail of roof light.

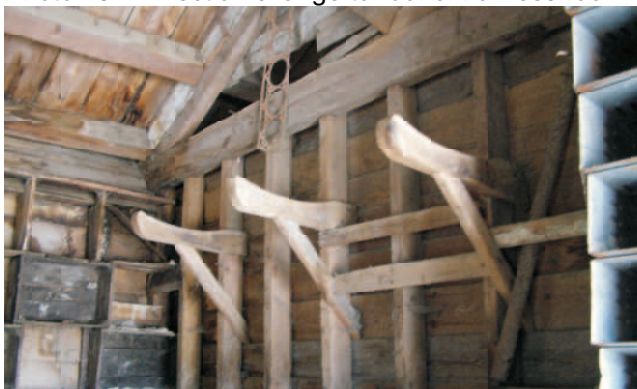
Photo 134. Harness hooks still place.

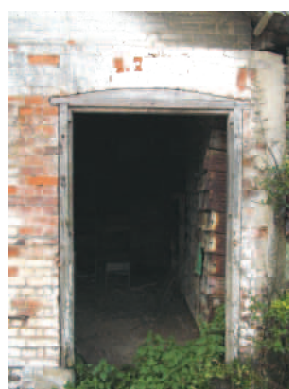
Photo 135. Present outside door to north east was an internal door. Has double header arched head.
