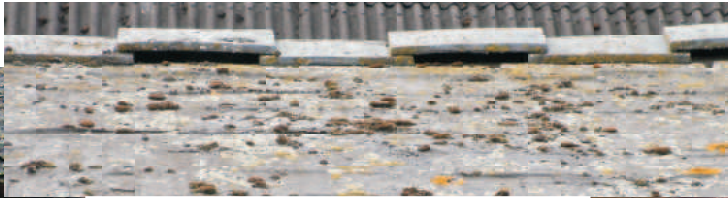
Photo 192. Ventilated ridge to slated roof.

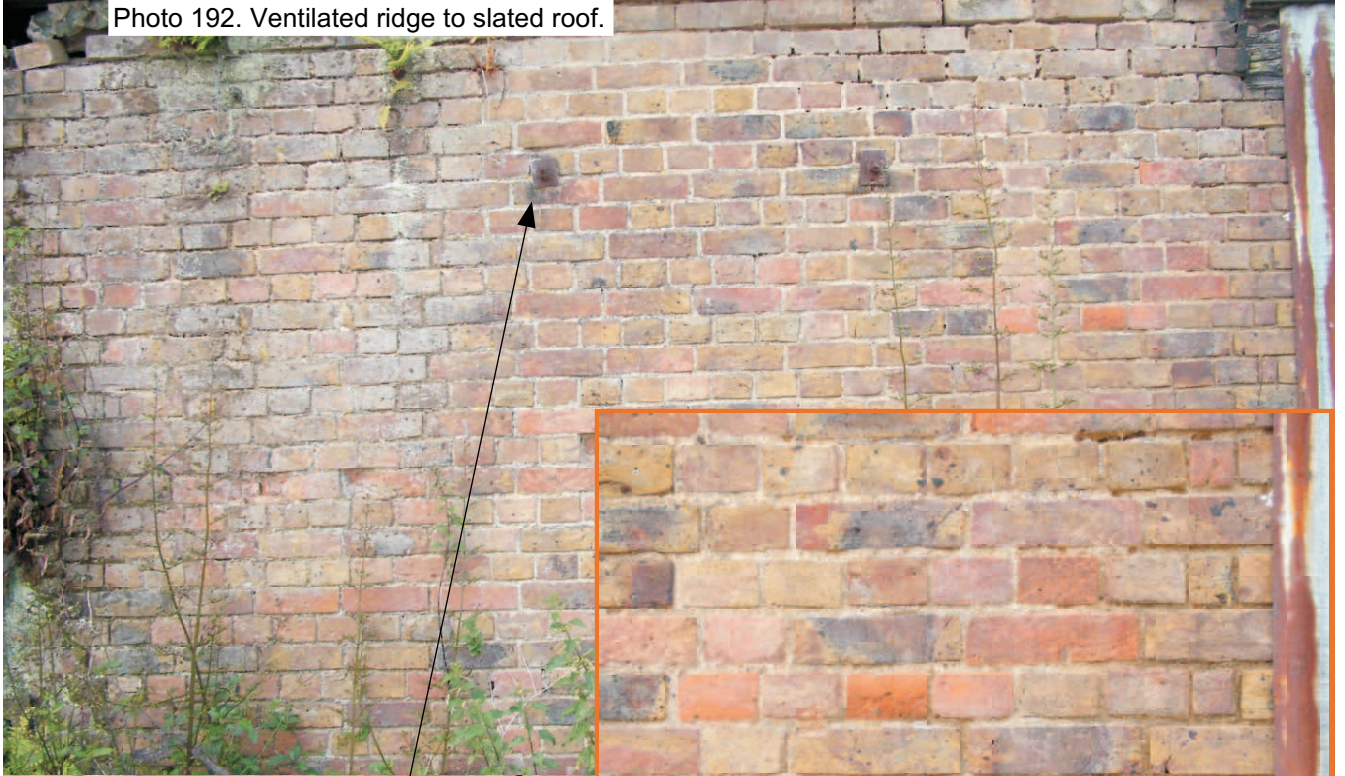
Large photo 136. Typical outside of stable block with good stock bricks.

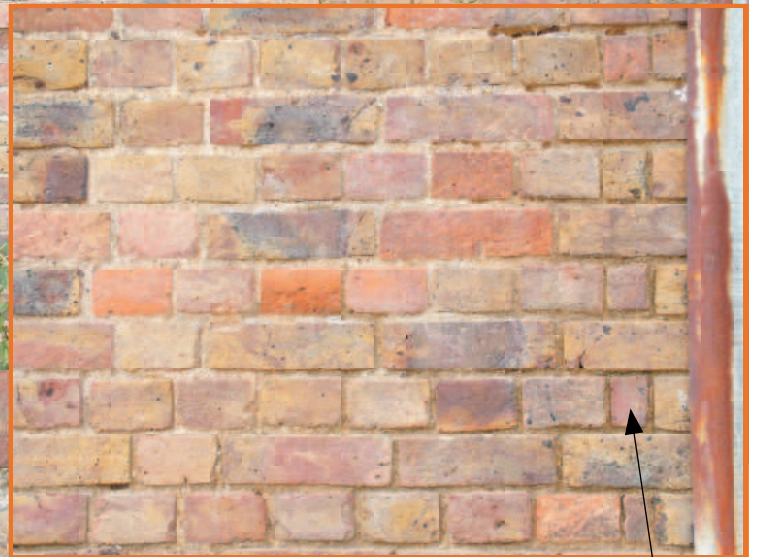
Inset photo 193. Detail of brickwork with Queen closers to opening.

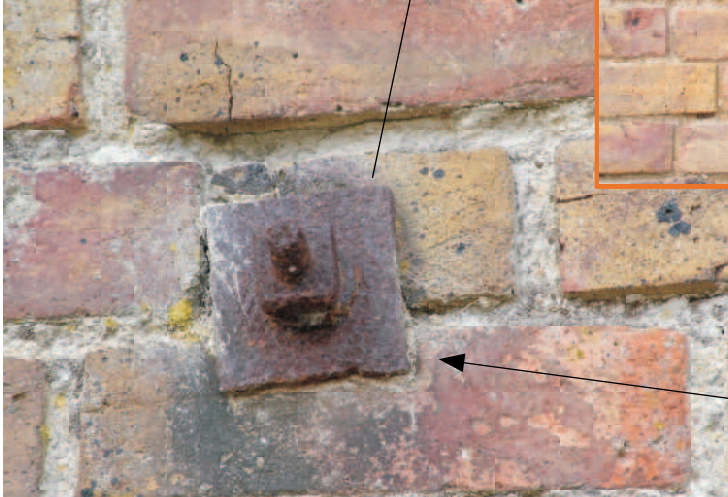
Photo 137. Detail of harness rack bolt.

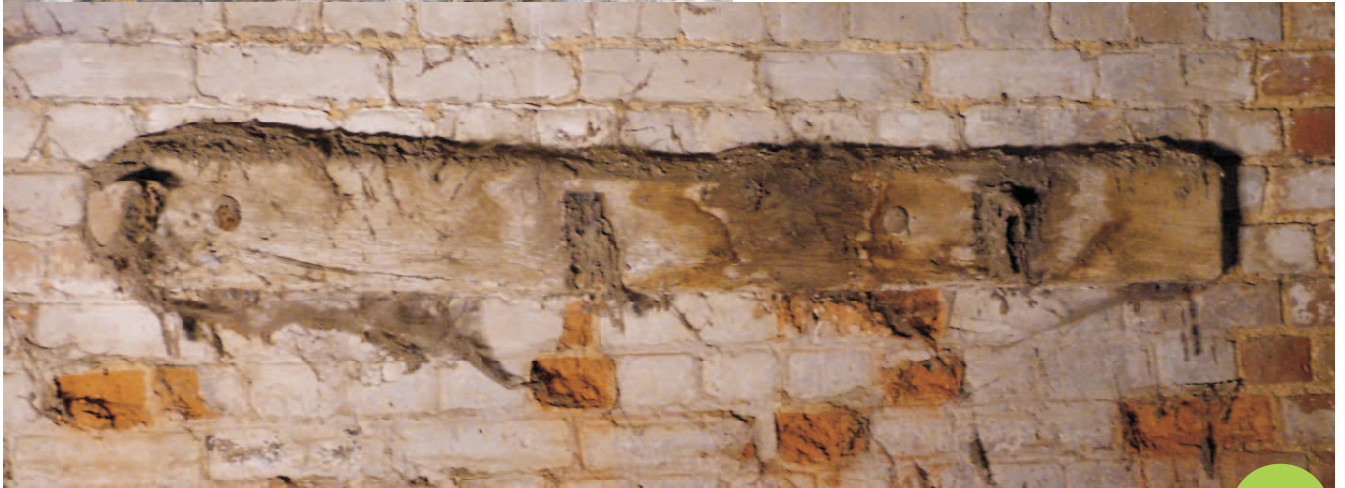
Photo 142. Inside wall showing remains of harness rack.
