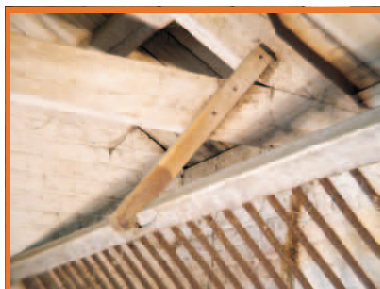
Photo 158. Support bar hay rack.

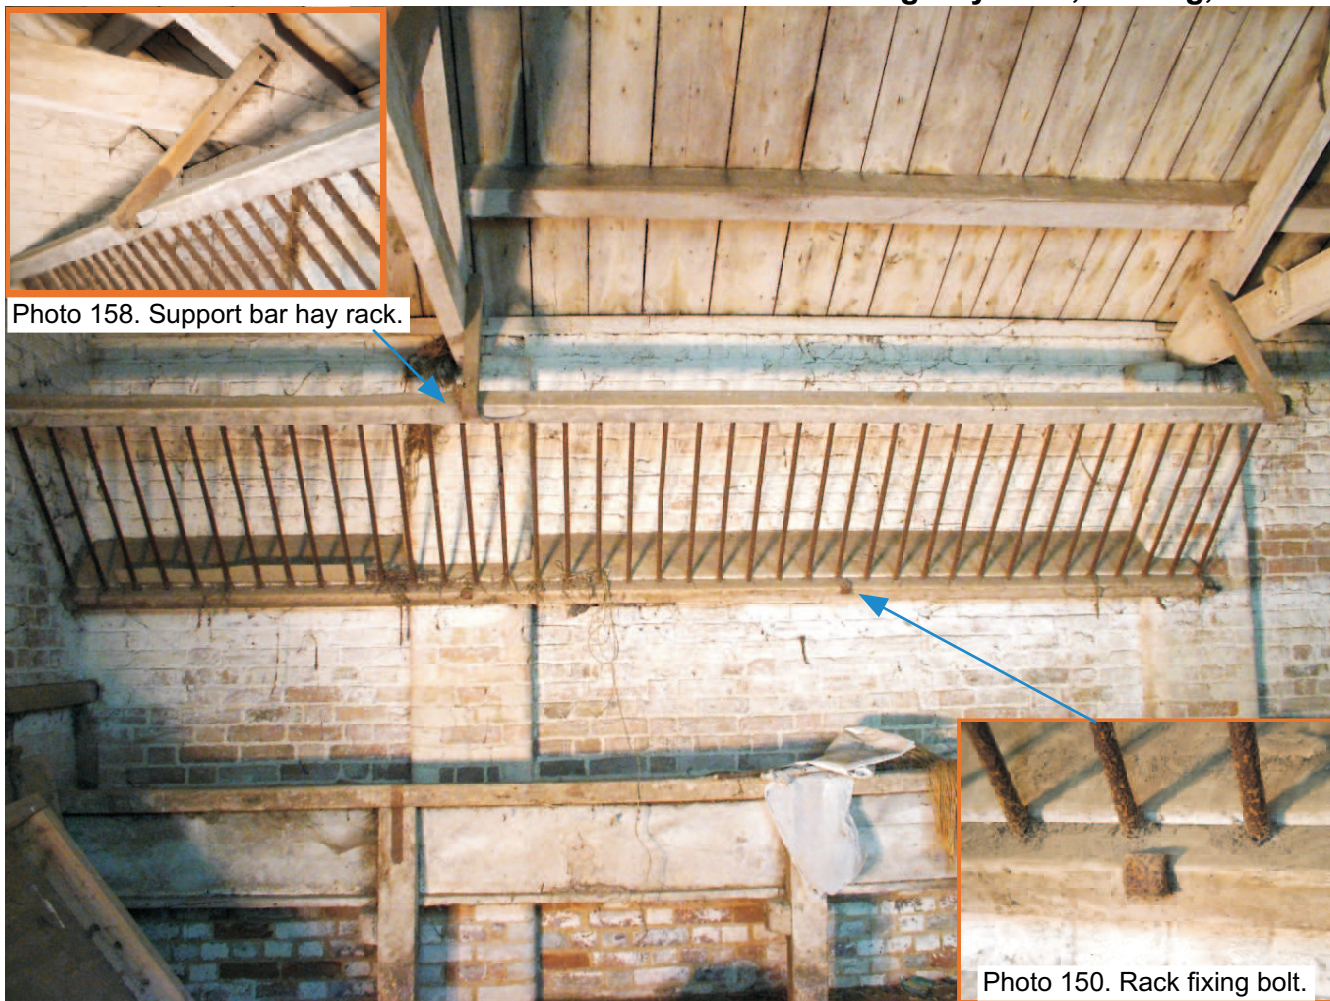
Photo 150. Rack fixing bolt.

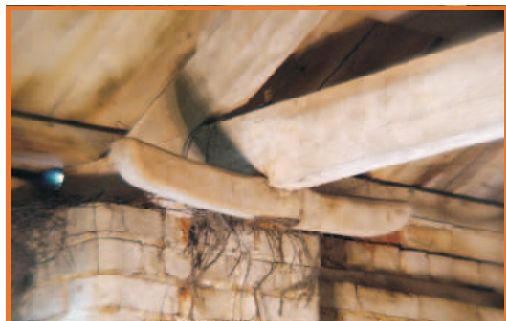
Photo 154. Harness rack fitted under tiebeam. Were fitted to both sides of the opening

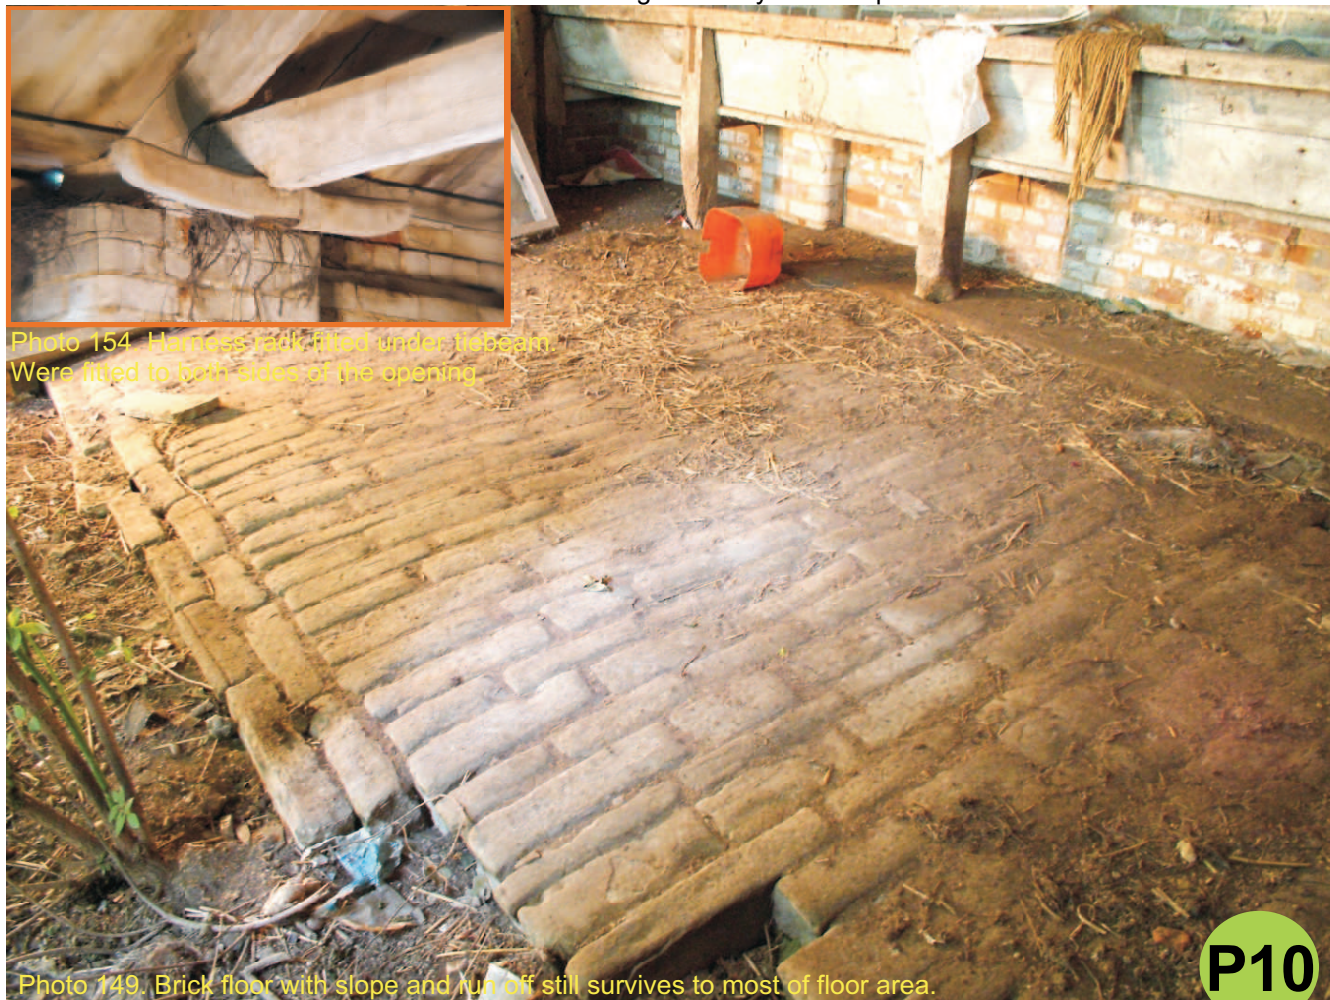
Photo 149. Brick floor with slope and run off still survives to most of floor area.
