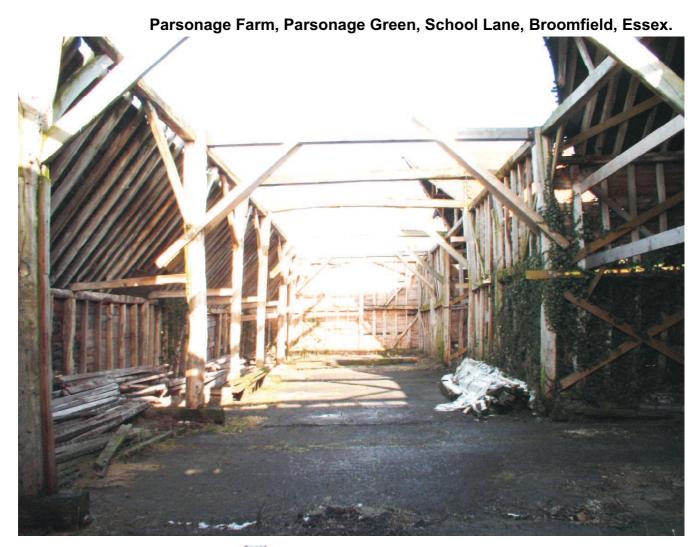
A general view looking north through the nave of the barn, A, showing the rear aisle main trusses to tiebeam level and salvaged timbers from the collapsed roof. Stabilising timbers are bolted through the structure and into the midstreys.

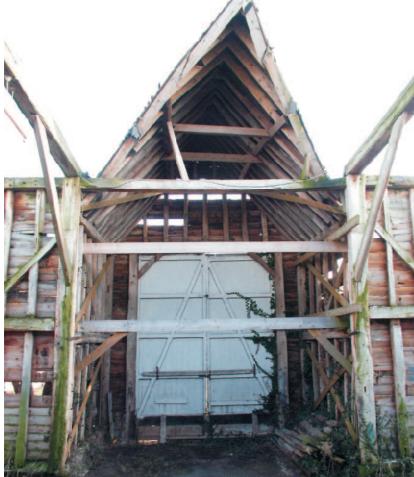
A view into the north midstrey showing the nineteenth century door structure with leap boards below for which partial slots survive on the main door posts. It has a side purlin roof with one framed collar and one bird's mouth jointed to the purlin. At the lower front left, north, is a side access door.
