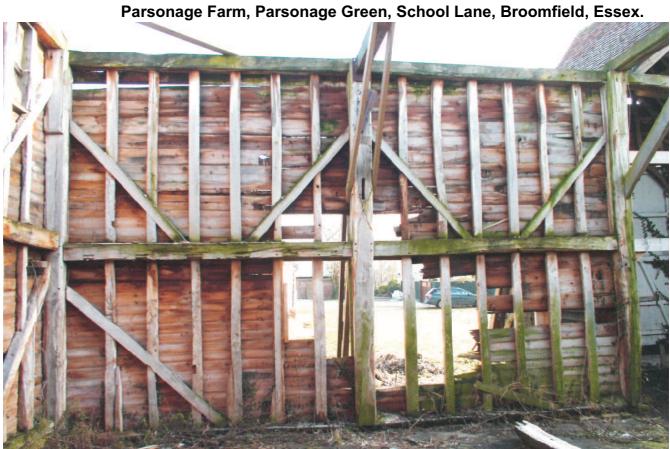
Barn, A. View of two northern bays on the east wall. Shows the typical primary braced frame structure found through the barn. Note reused toplate as midrail.

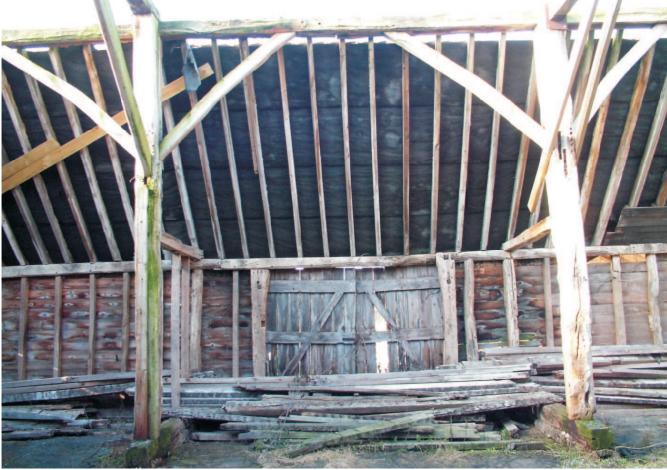
16.CNV

Barn, A. View to west aisle showing extended width rear nineteenth century doors opposite each of the midstreys. Aisle wall to right original, to left rebuilt in nineteenth century.
