Newhouse Farm, Purton End, Debden, Essex.

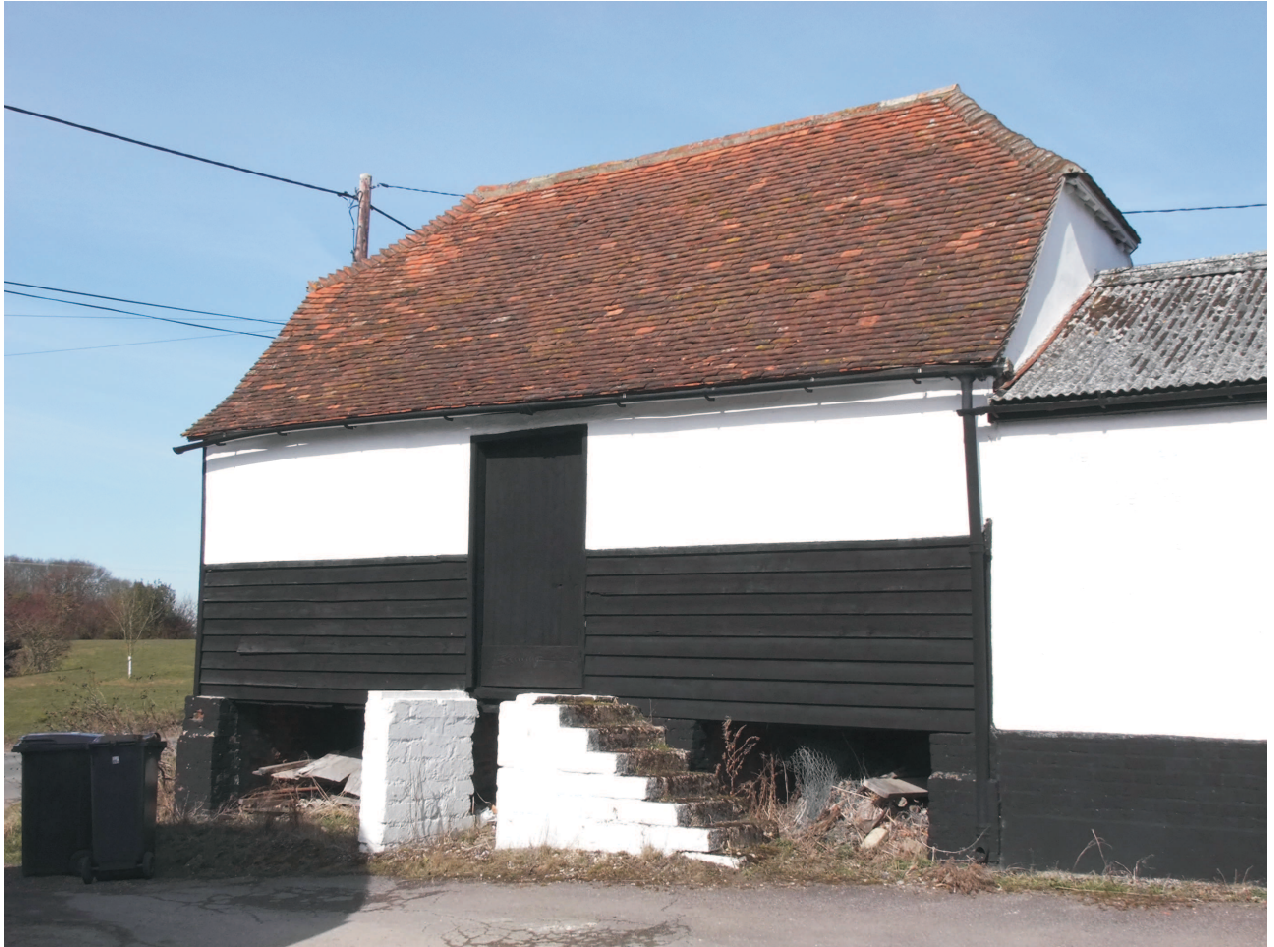
Granary south entrance side with brick formed steps to platform entrance. Pier walls return at each end and behind the steps from the intermediate walls. Weatherboarding part replaced as is plasterwork.

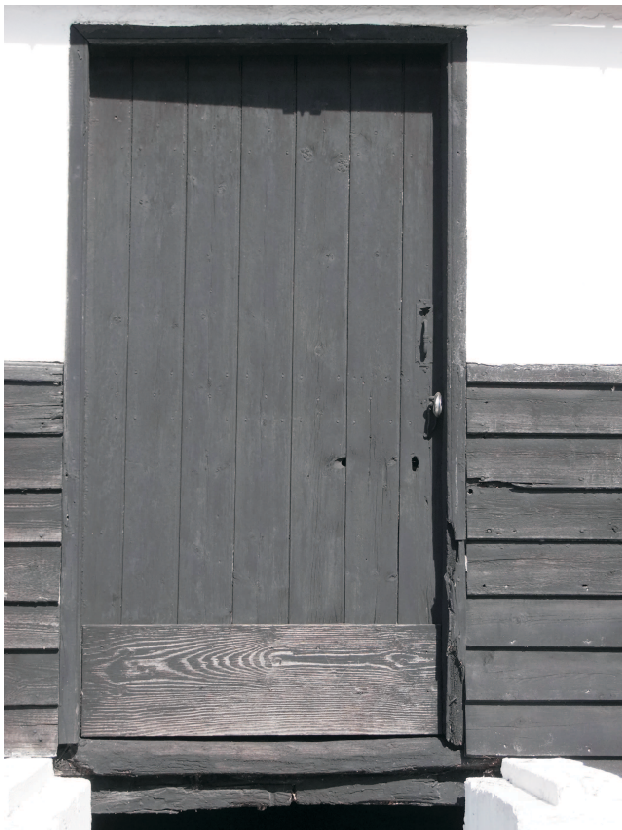
Granary entrance door appears original with lower patch repair

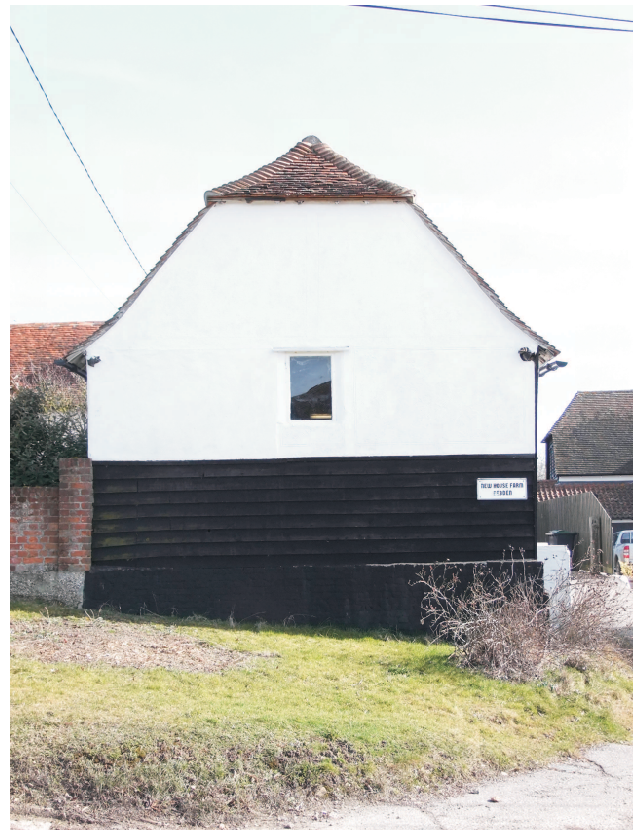
Granary west end to roadway with tarred brick plinth wall and weatherboarding and mixed age plaster above. The window is a later insertion.

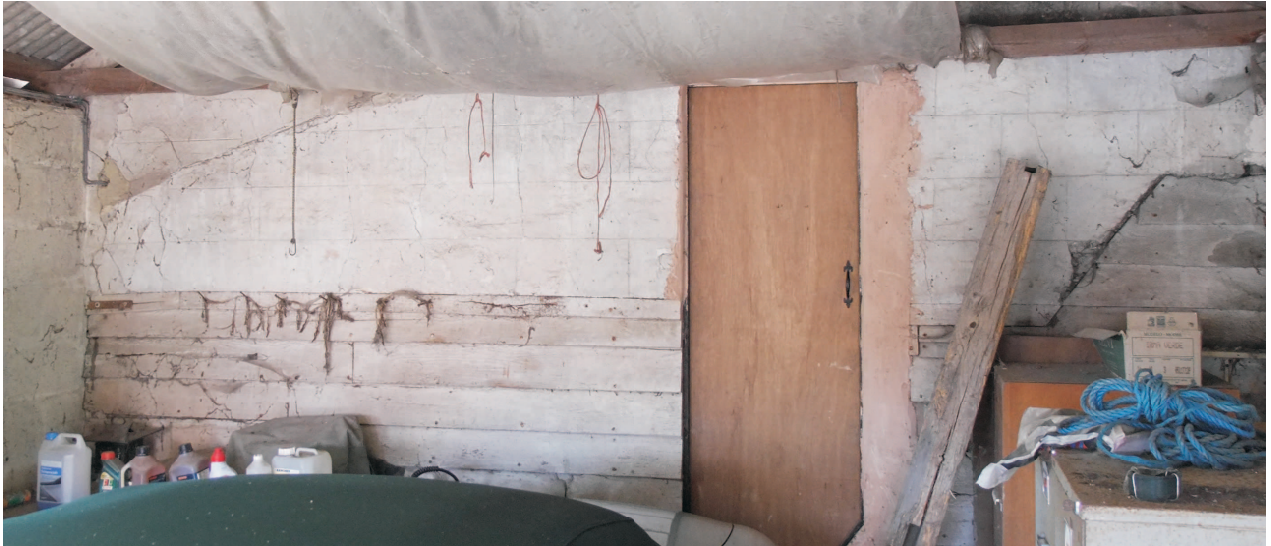
Granary east end with ashlar plaster to house. Late door insertion from modern garage. Note structural brace line in plaster and at bottom of door. Weatherboarding to left of door appears to be original.

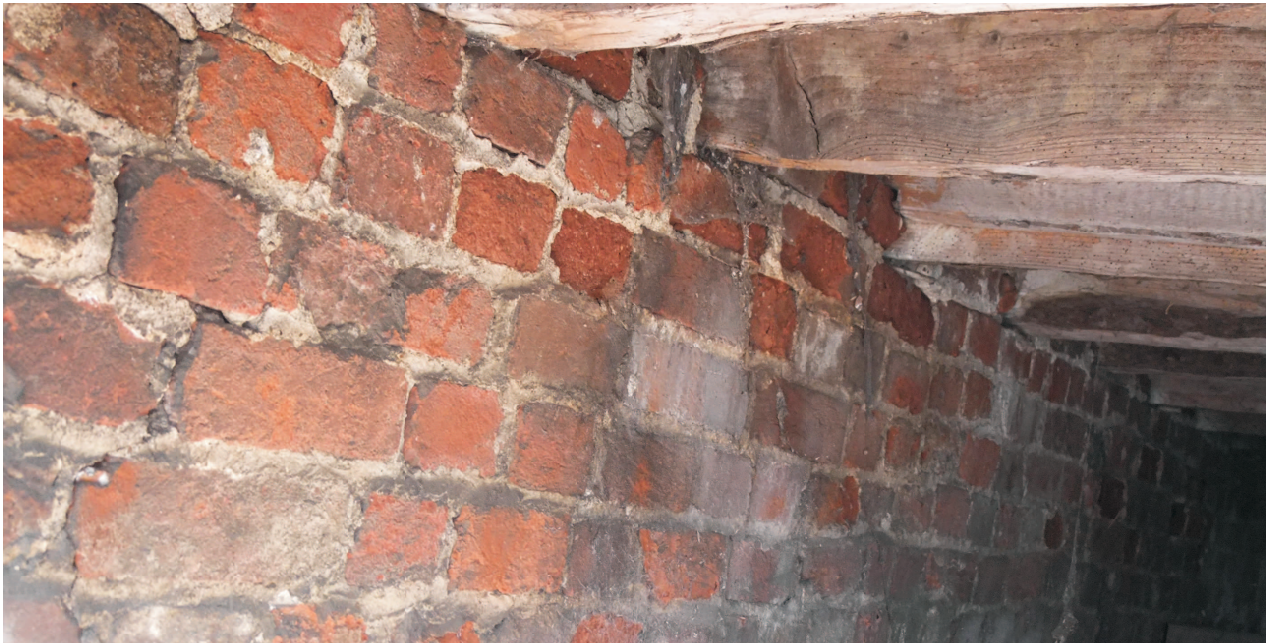
Granary under view showing west support wall of mixed bond brickwork and softwood floor joists.

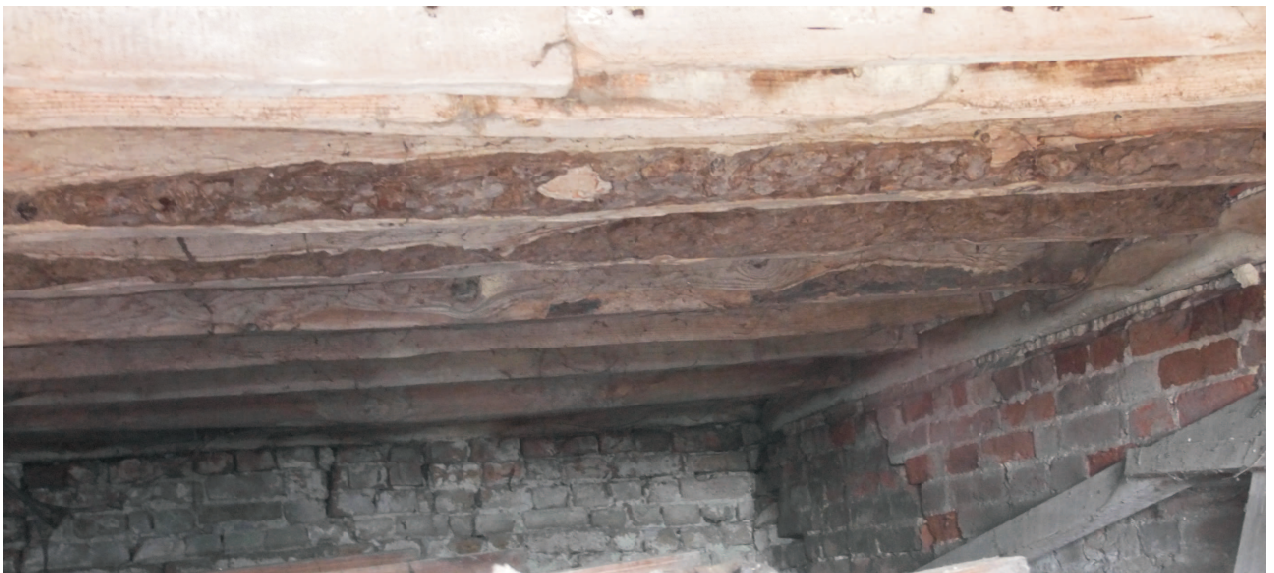
Granary under view showing north retaining wall against slope and intermediate pier wall. Note the amount of bark surviving on floor joists showing how maximum possible section was being produced from limited size trees.
