Summers Hall East Barn, Blackmore End, Essex.

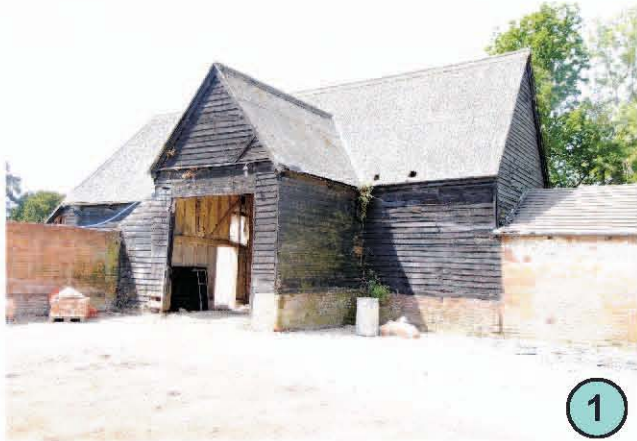
1

East Barn from the east with midstreys. Gable roof at north added when late C18 Stable/Loose box built. C19 walling to the left as yard edge for shelter sheds and yards now lost, also garden division.

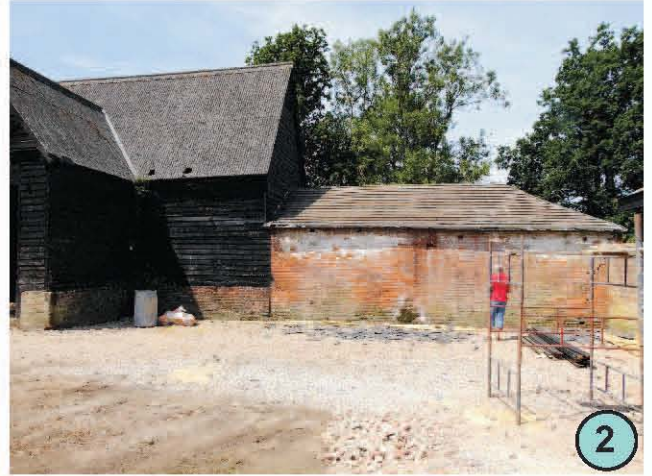
2

East barn with attached Stable/Loose box. Wall to roadway at north is all that remains of shelter sheds and yards to east of barn. Stable was roofed in slate.

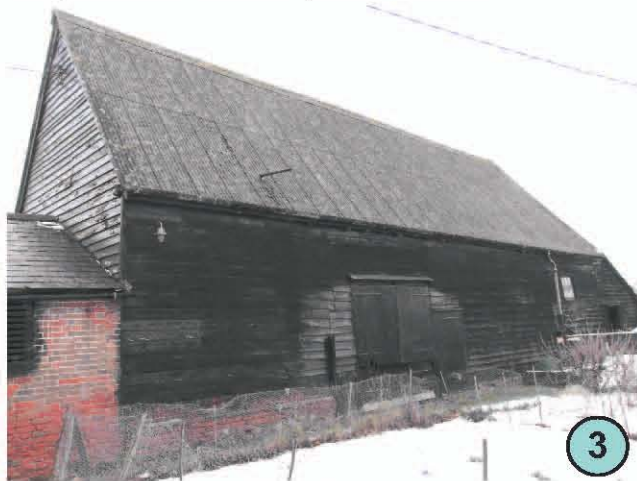
3

View of west side of East Barn looking south with Stable/Loose box at the north. Stable extension to south of barn with a window added to last bay of barn when converted to stabling.

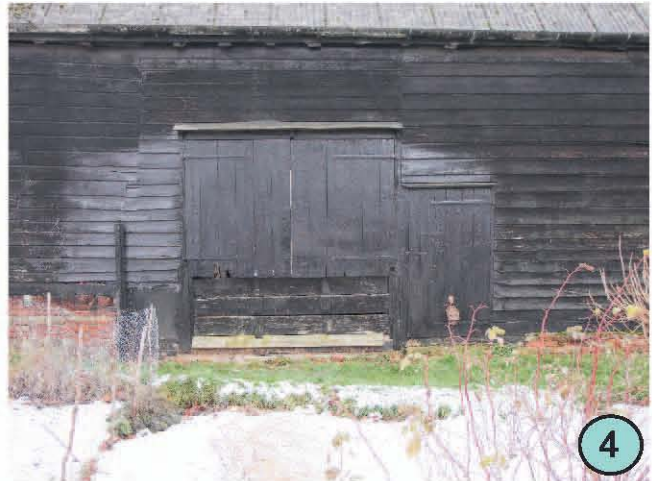
4

West lower doors to east barn possibly from C19. Leap boards in position below doors. Small door fully framed into barn structure. Brick plinth height varies around barn.

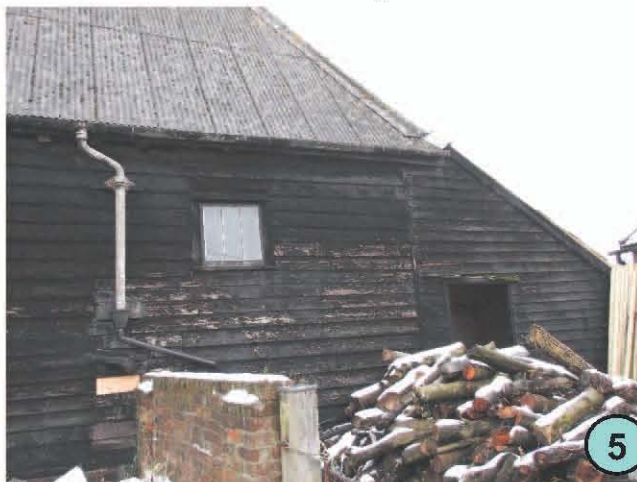
5

Southern end of East Barn with lean-to stable extension added when southern bay of barn also converted to stabling. Window is an addition from that time to light the stable bay.

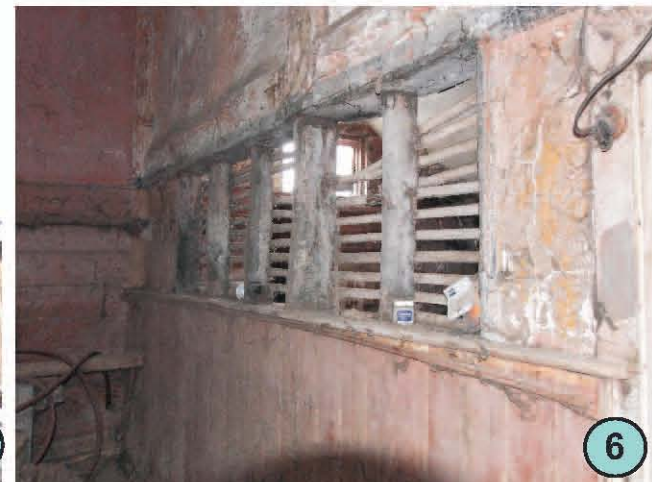
6

Converted end wall of barn when stable extension added. Existing wall studs worked to form mullions for ventilation window between stables. Some board lining and parts of feed trough survive in end bay, the rest was plastered and ceiled at tiebeam height.

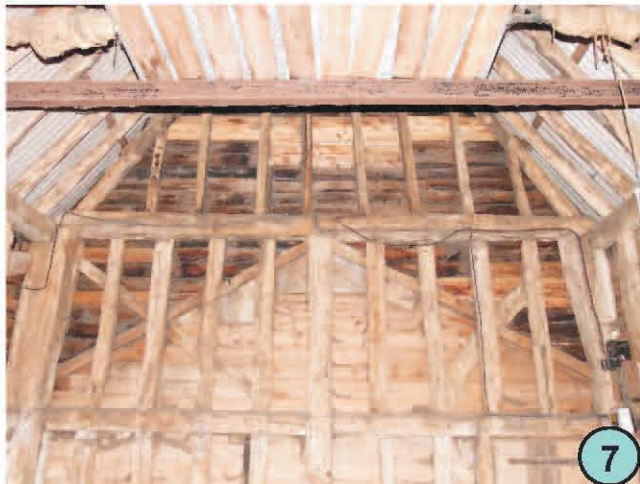
7

View inside east barn looking north. Roof form of attached stable shows below tiebeam and cut in entrance door at lower right hand side. Roof above tiebeam modified to a gable end when stable built.

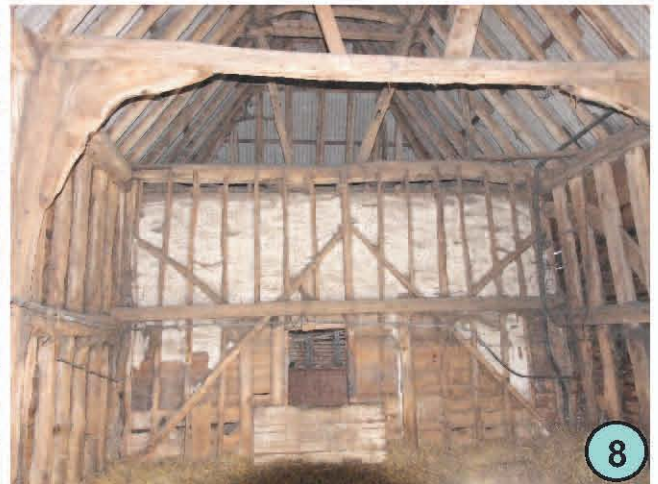
8

View inside east barn looking south. Shows inserted late nineteenth century partition when southern bay converted to stable when the southern extension to the barn was added.

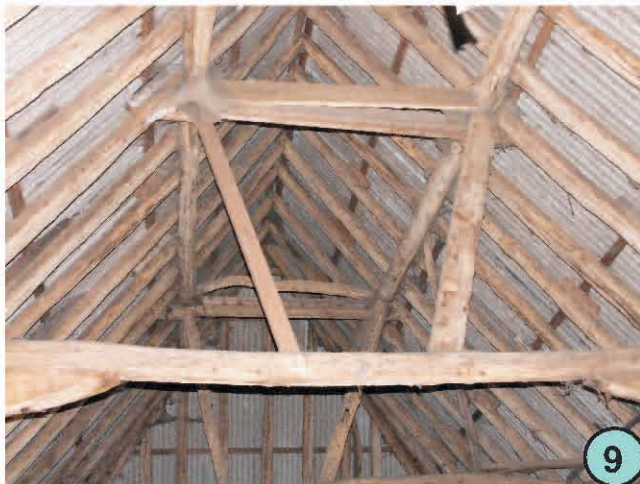
9

Typical view of roof construction, here looking south to original hipped end. Queen strut roof using many reused timbers and later strengthening. Reused tiebeam shows original brace mortises and knees from C18 repair.

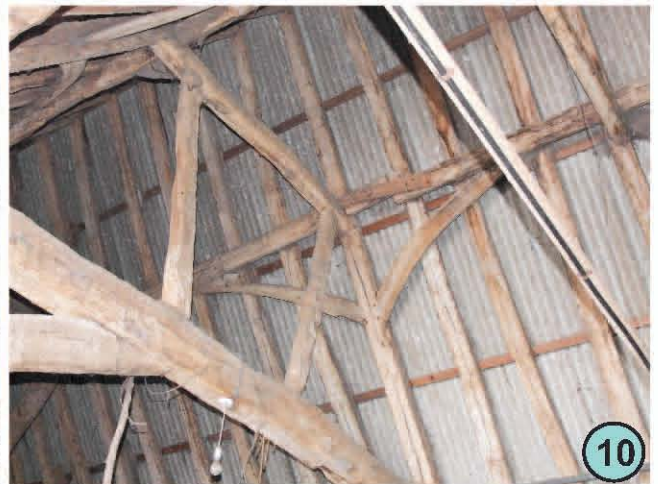
10

View up to roof showing wind braces, queen struts and collar on reused tiebeam with partial arch bracing. Purlin with simple half lap joints has failed. Wind braces only fitted to either side of midstrey.

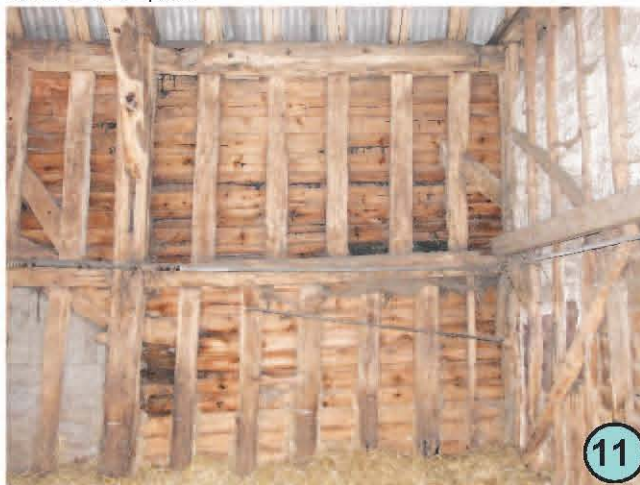
11

Typical section of walling to the barn with reused timbers and some bits of bracing surviving not in original positions from original use. This section to south east shows added division to south and end of late lean-to added to midstrey.

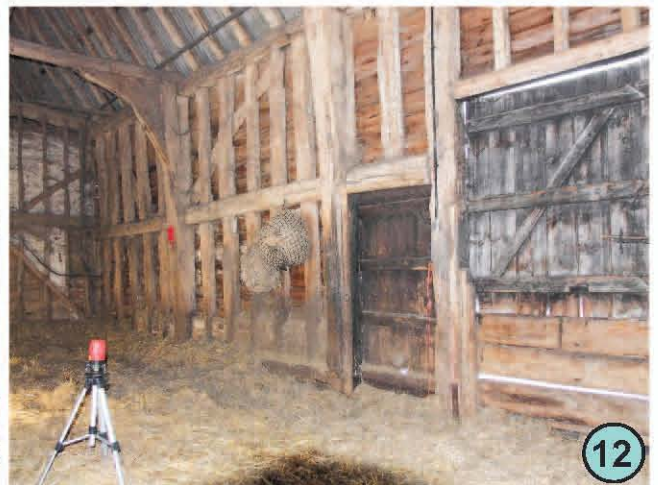
12

View along west wall of barn showing walling to south and doors opposite the midstrey. Small door original but large doors are into a lower opening than the reused framing originally had and this barn as rebuilt. Possibly changed to lower opening in second half of C19 when yard to west was completed.
