Summers Hall East Barn, Blackmore End, Essex.

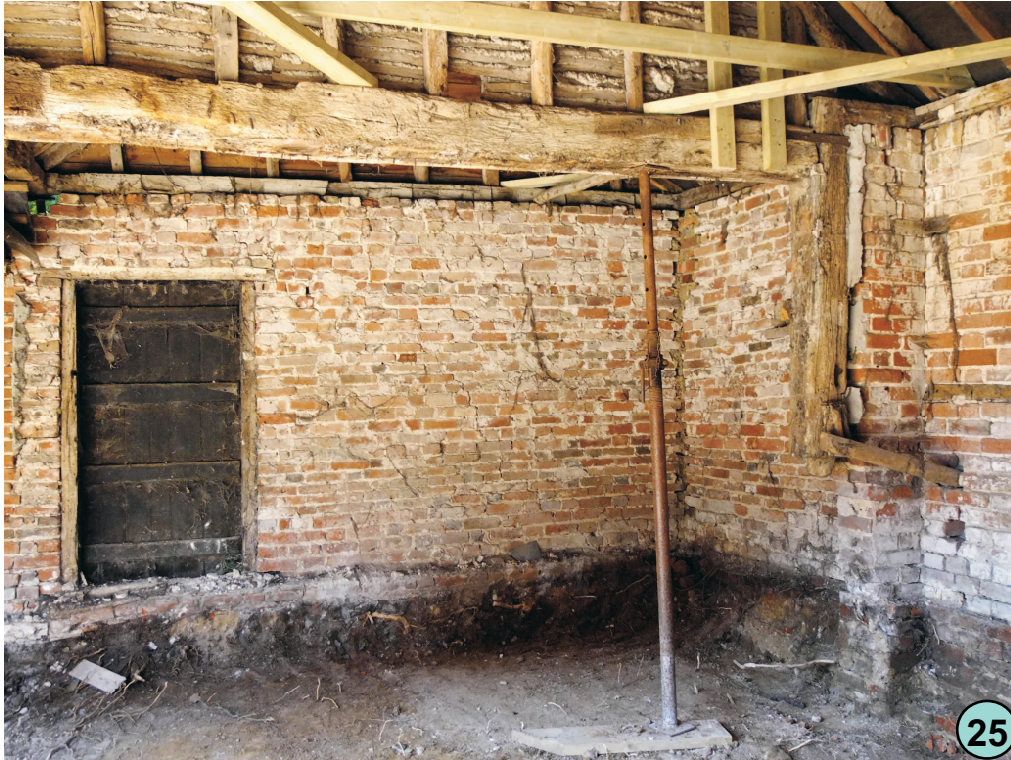
North open range view into north-west corner. Shows cut return of what was original end to this building with timber frame infill. Plastered gable to the west. Beyond this point brickwork changes and is part of the western north-south range. Door in west wall appears to be C18 so could have been moved from the end wall of the north range. This corner a closed room after C19 build.

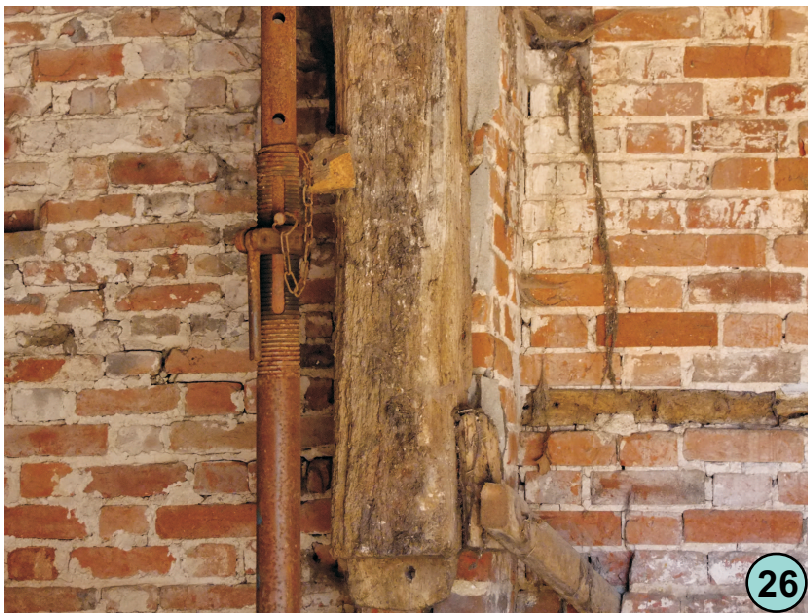
26

Junction of walls to the north showing later build on the left tending to fall away.

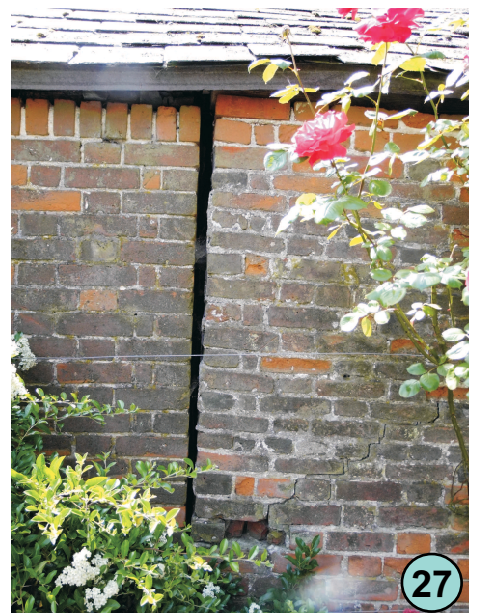
27

Same wall from the north showing later brickwork to the right.

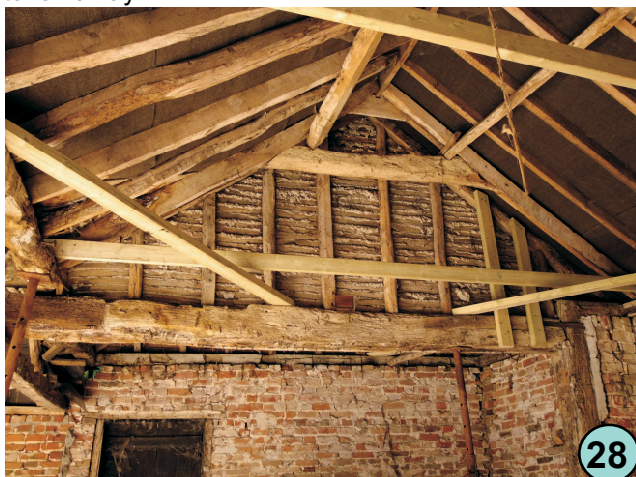
28

View to west showing end truss of north range.

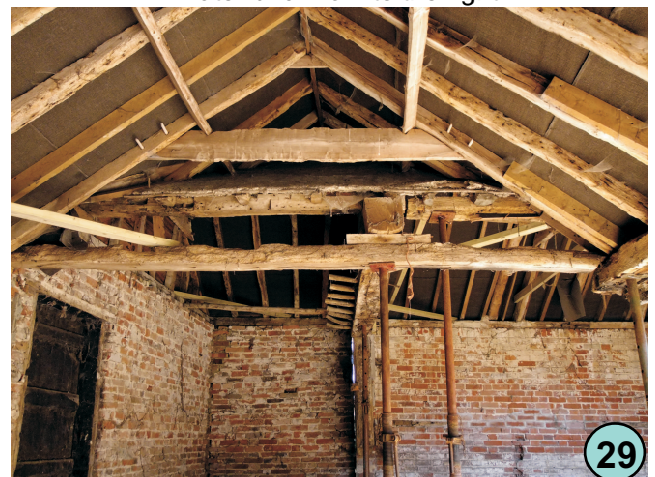
29

View to north showing how west range linked to north.

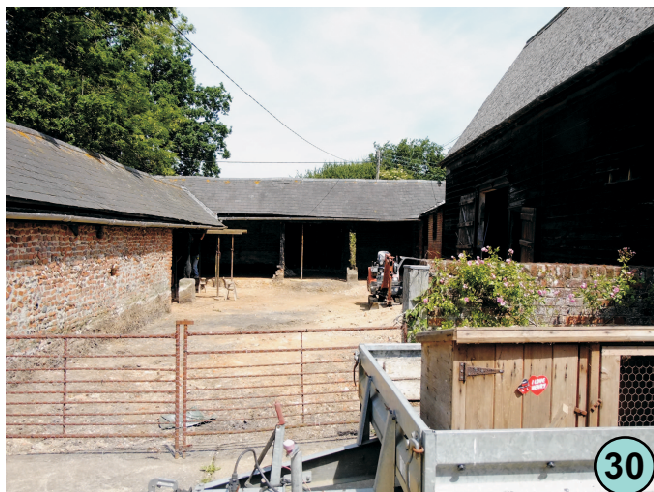
View to north with east barn, late C18/early C19 stable beyond with open area at the north. Mid C19 shelter and storage to the west. C19 yard closure wall to the south-east.

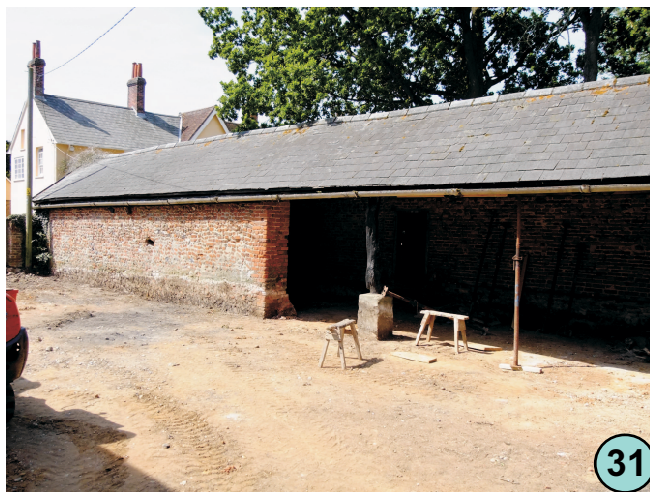
Mid C19 shelter and storage sheds to the west of the yard. Good northern quoined brick pillar to sheds but infill wall uncoursed flint and random brickwork.

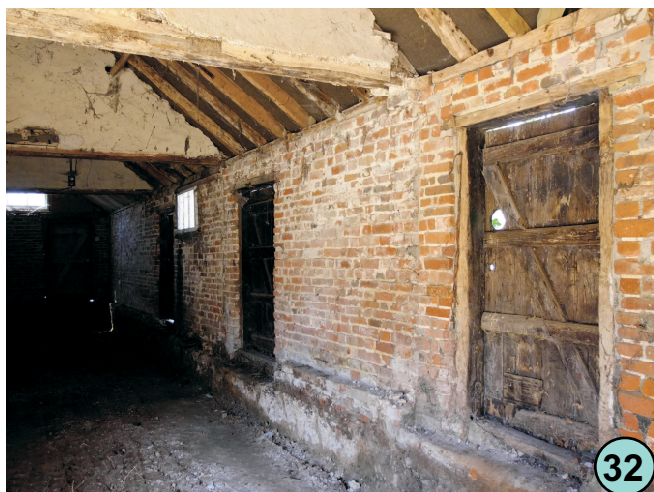
View to south in C19 shelter/storage sheds with minimal partitions removed but plastered area of gables left in place. Both windows are late insertions. Brickwork only fair faced to outside west.

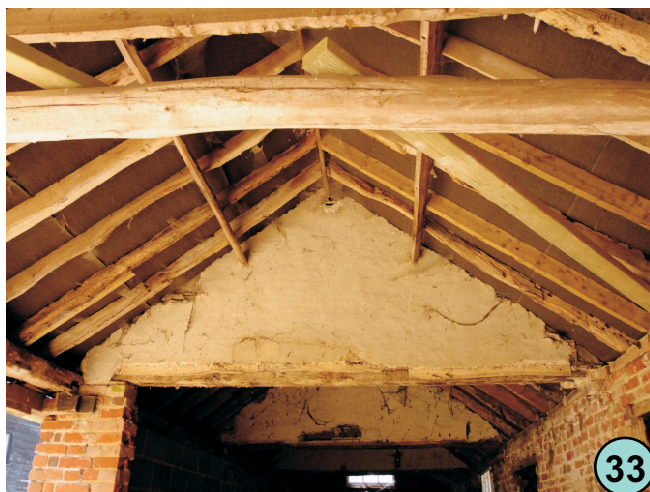
Typical area of roof structure with re-cut reused timber and all reworked in twentieth century. Was closed brick end wall under gable against start of open area to the north.

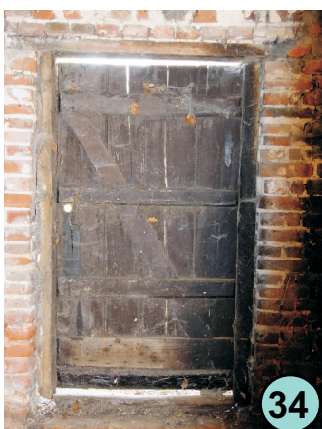
1. South door typical mid C19 construction. Slightly wider than other doors. This store was north of the most southern store which had access from the south gable wall.
2. South intermediate door normal width construction similar to 1.
3. North C19 door very similar to 2 for access to the open fronted section.
4. North door. This is earlier construction and may have been moved when C19 range added. would have given access to the small corner room.
