Summers Hall East Barn, Blackmore End, Essex.

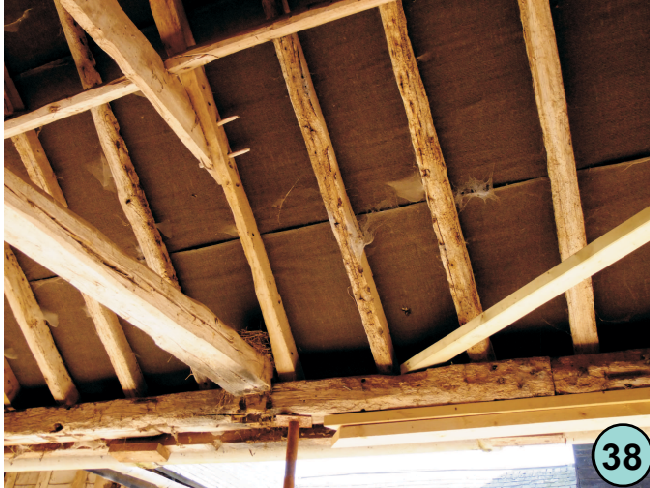
38

View in C19 west range looking up to show typical roof construction with reused timbers. Simple scarf joints but collars are pegged.

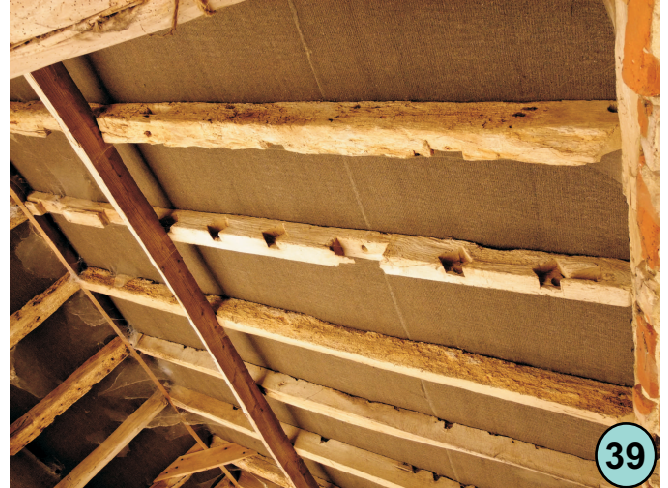
39

Detail in roof showing some reused timbers that have had their original cross section reduced possibly by sawing to increase the amount of available lengths. The window mullion mortises are in what is now a possibly quartered timber.

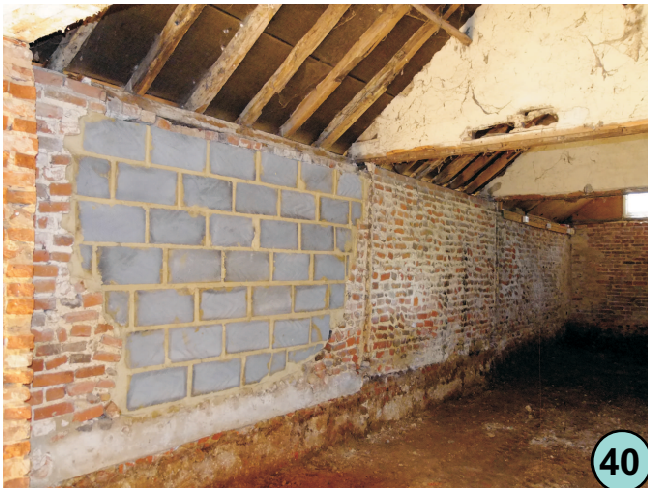
40

East wall of closed section of the west range, previously repaired with blockwork. Note vertical lines at cross divisions where end timber of infill was mortared to wall.

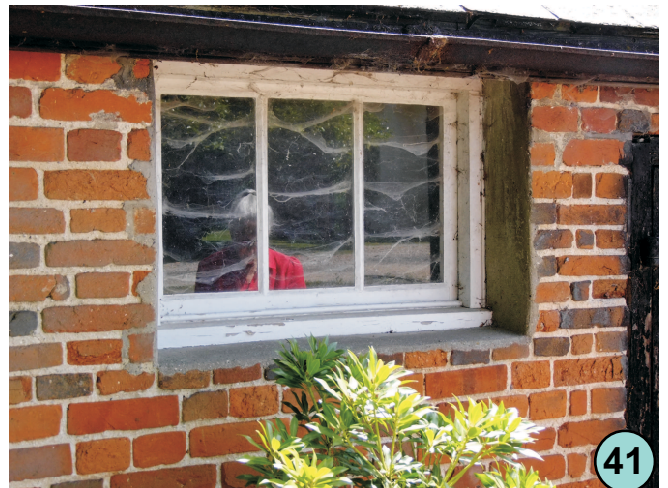
41

Window in the west wall of the range cut into the brickwork at a later date. This is beyond the area of conversion.

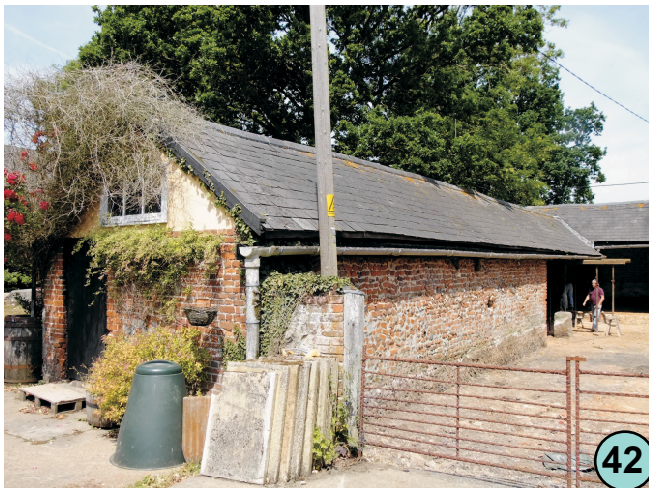
42

View of west C19 range from the south showing the end gable with doorway and an added window. Brick walling to east is all random coursed brick pieces.

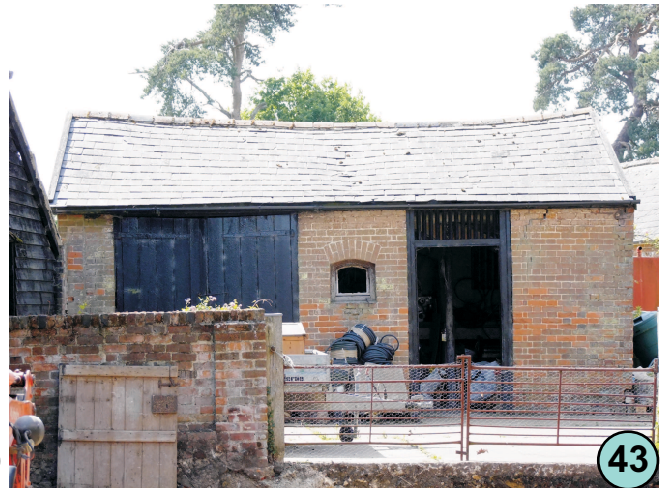
43

Nag stable and trap building at southern end of yard and not part of present conversion. Possibly dates to about the middle of the nineteenth century.
